# ANALYSIS OF IRRADIATED CONCRETE

REPORT 2016:239

Microscopic and mechanical tests on concrete from a  
nuclear power plant containment structure

JAN ERIK LINDQVIST, CBI, MATHIAS FLANSBJER, SP AND ERIK HANSSON, INSPECTA

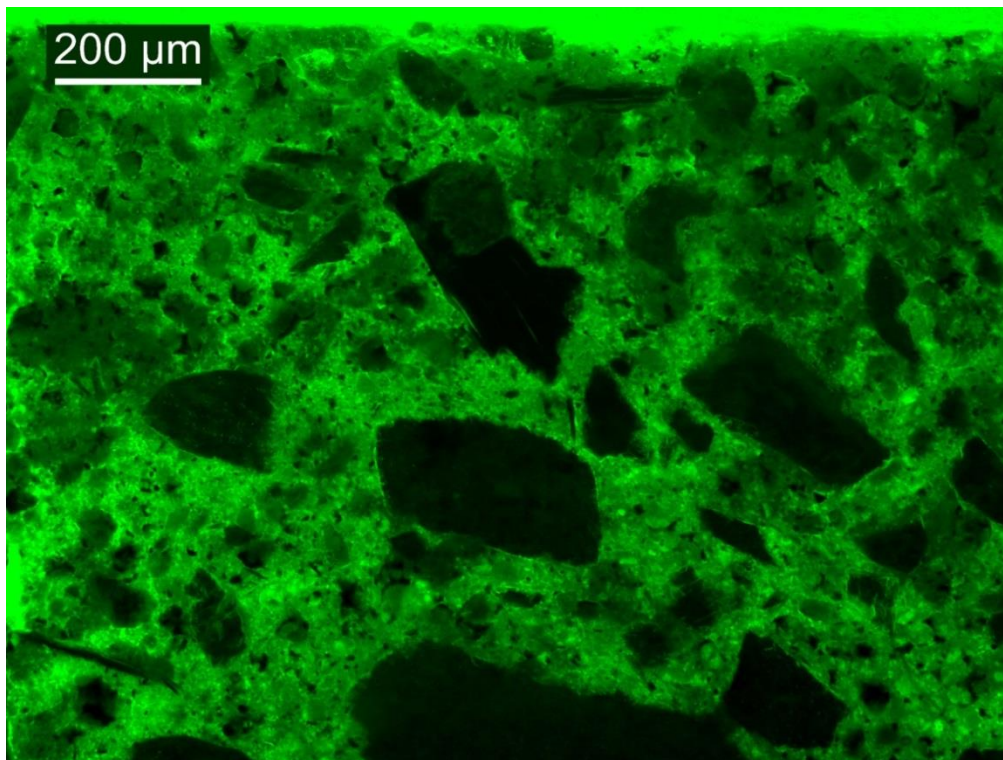
The cement paste in the concrete surface has a slightly darker colour in the outermost 0.5 to 2.5 mm. There is a 0.3 mm thick surface layer with more dense cement paste (figure M-3). In this layer the relative proportion of unhydrated cement clinker minerals is higher (figure M-4). There are also small irregular pores in this layer. The diameter of the pores is in the range 10 to 50 microns. The outermost part of the sample is composed of an uncarbonized cement mortar with limestone filler. Most of this cement mortar was ground off during the preparation of the samples before they were allowed to be removed from OKG. The aggregate that has been exposed in the concrete surface has cracks that are assessed to be dynamic cracks caused by grinding during sample preparation. These cracks had propagated to a maximum depth of 0.5 mm. The micro-crack frequency in the cement paste is very low. Cracks in the adhesion zone around the aggregate particles are rare. Micro-cracks radiating out from aggregate particles that would indicate an increase in the volume of the aggregate particles were not observed. A typical example is given in figure M-5.

Figure M-3. Fluorescence image that shows the denser cement paste near the concrete surface in sample 1 2.2.

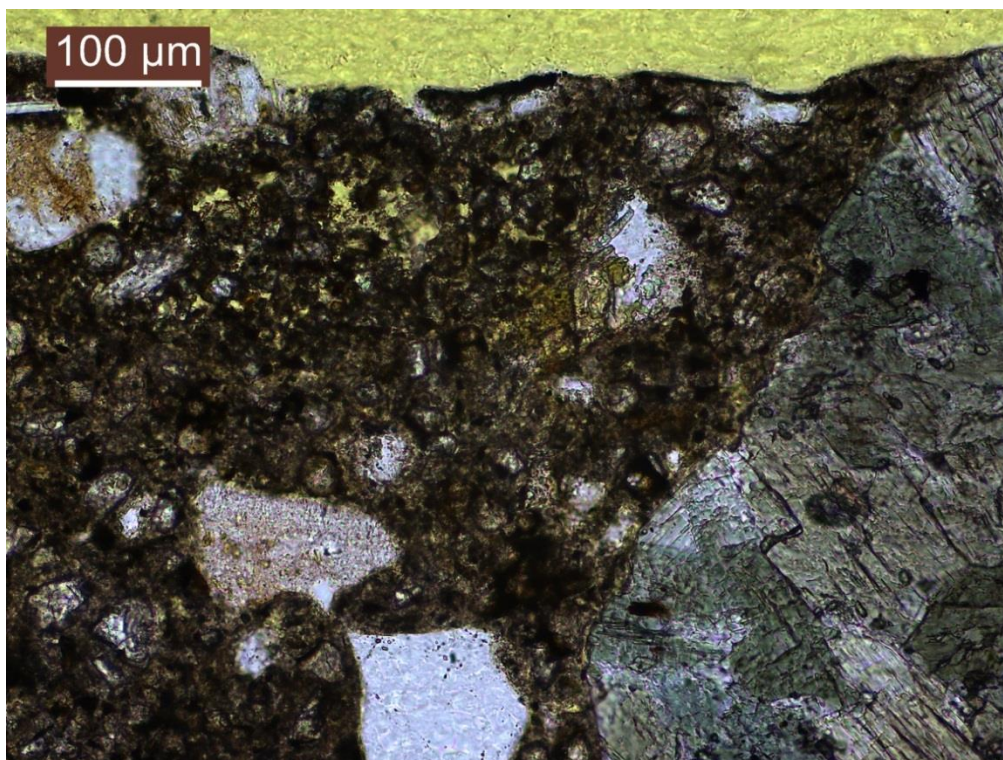
Figure M-4. Microscope image taken in plain light. The images show the surface layer with unreacted cement clinker and irregular voids close to the concrete surface in sample 1.

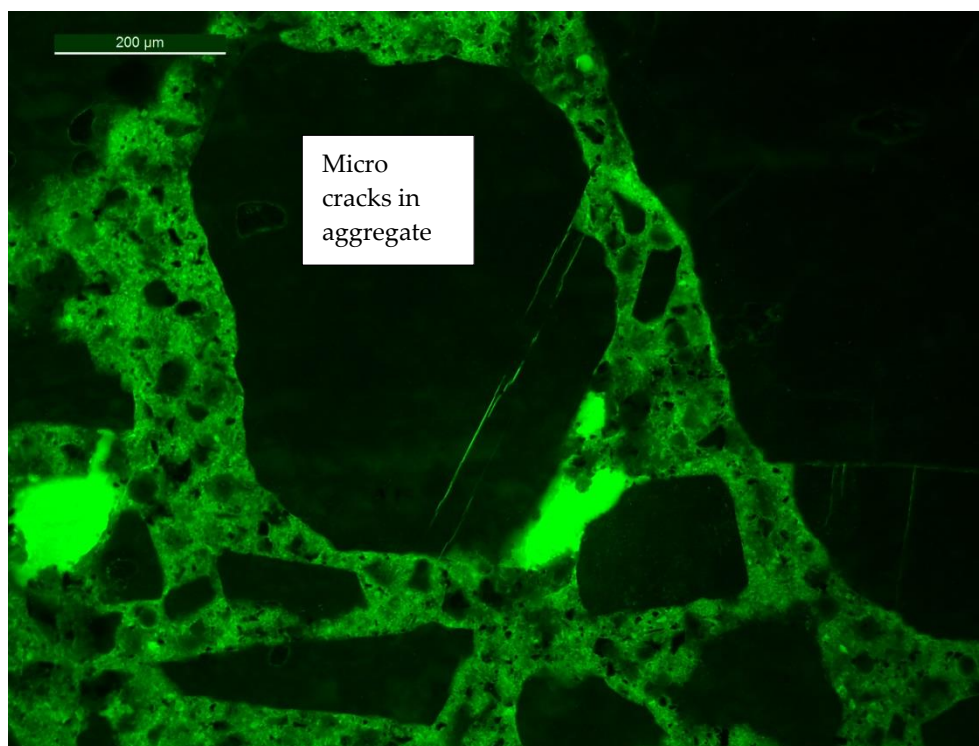
Figure M-5. Fluorescence image that shows internal micro-cracks that do not propagate into the cement paste.

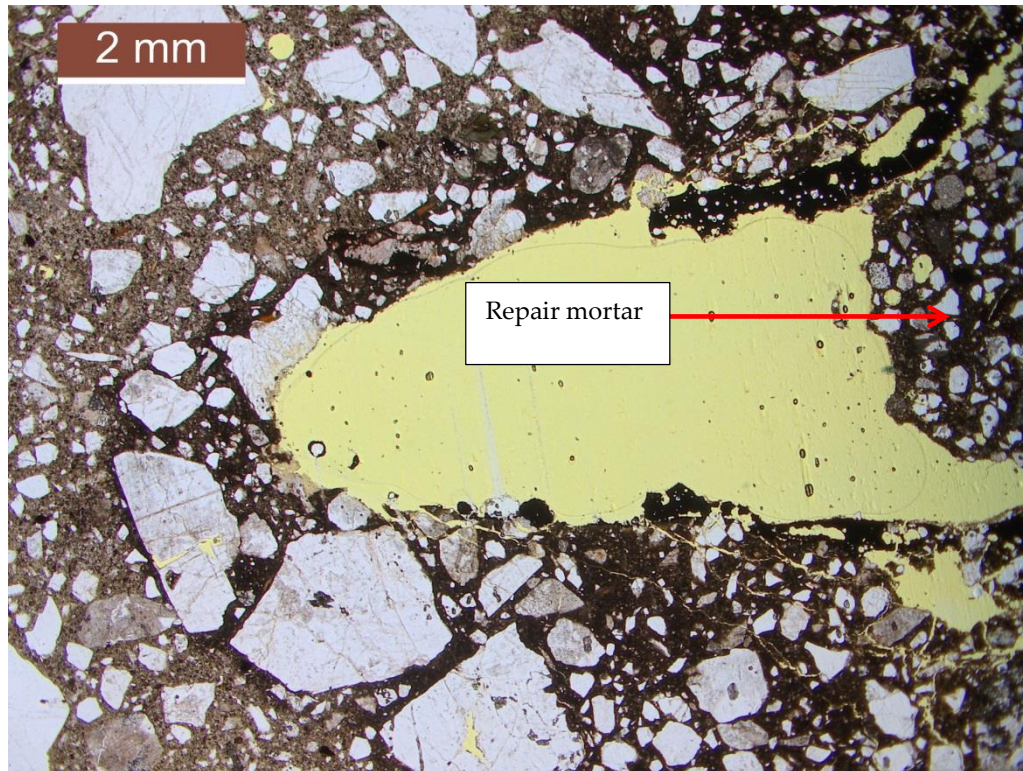
There is an opaque layer on part of the concrete surface. The concrete near this opaque layer has a high frequency of micro-cracks (figures M-6 and M-7). This crack pattern indicates a rapid and local dynamic load. This damage is local and superficial. The occurrence of portlandite a few millimetres from this structure shows that the temperature has not been above 450°C. It is not the type of crack pattern that is formed by a high-temperature event such as fire. The opaque layer is probably a repair

material. The damage is probably due to mechanical impact. It had been repaired with the same type of mortar as covers the rest of the concrete surface on the two samples.

Figure M-6. Shows the damaged area. Thin section image taken in plain light.

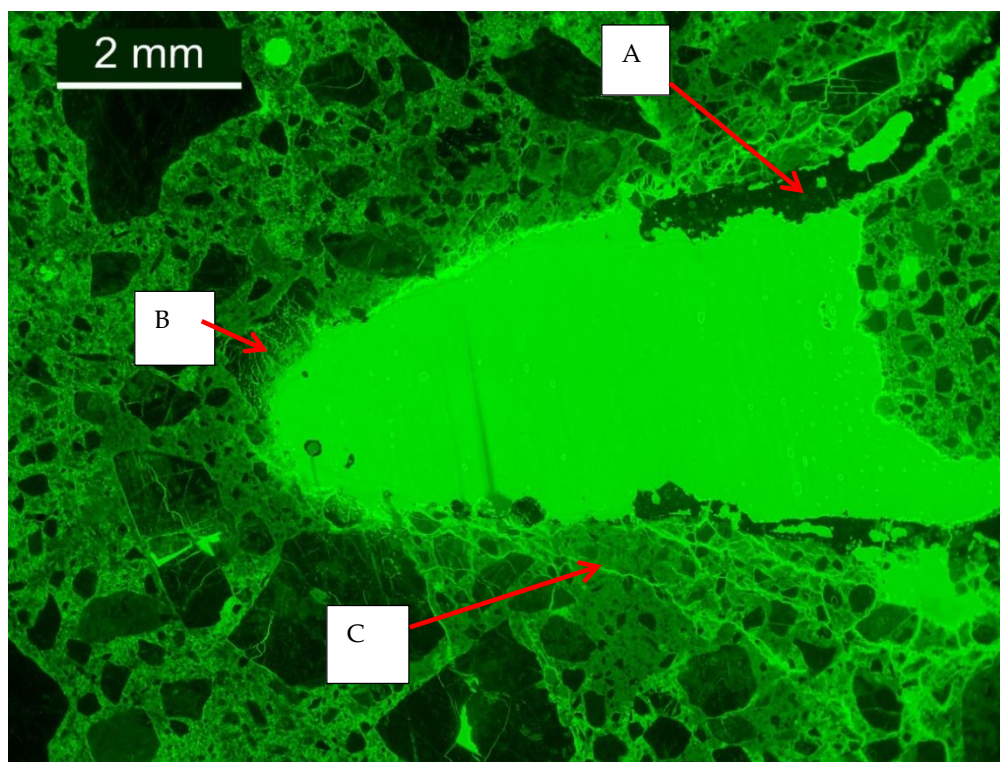
Figure M-7. The same area as in the figure above. The image is taken in fluorescent light. A is probably a repair material. B marks aggregate with a very large number of micro-cracks. C is an area with fine cracks in the cement paste. In this image porous materials are shown in brighter green and denser materials in darker green. Cracks and pores are shown in bright green.

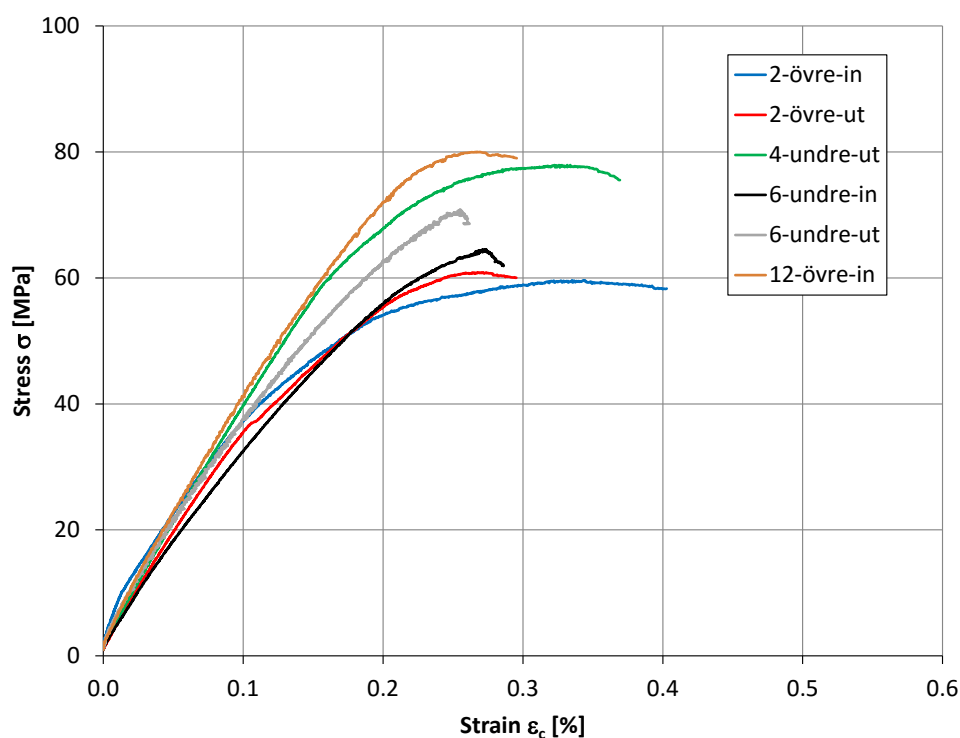
A comparison of the measured stress-strain relationships is shown in Figure T-3. The compressive strength  $f_c$  was evaluated as the maximum axial stress and the modulus of elasticity  $E_c$  was evaluated from the stress-strain relationship as the secant modulus between 5 MPa and  $f_c/3$ . Table T-1 presents a summary of the determined concrete material properties.

Although there is a relatively large variation in compressive strength between the samples, the average compressive strength and average modulus of elasticity show no significant difference between cylinders taken close to the inside and close to the outside of the structure.

Figure T-3. Stress-strain relationships for the tested cylinders.

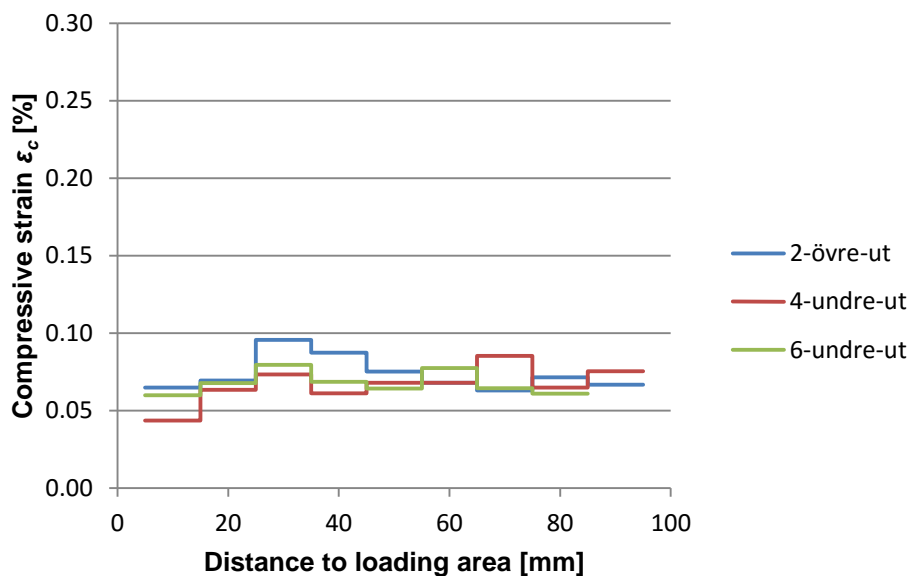
Figures T-6 and T-7 show the distribution of axial compressive strain in the various segments of the cylinders taken towards the outside and towards the inside of the structure, respectively. For all samples, the strain distribution was evaluated at a compressive stress of 23 MPa, which approximately corresponds to  $f_c/3$ , the level at which the modulus of elasticity was evaluated as described above.

That there is some variation in strain between the various segments is natural, since the local stiffness depends on aggregate size and location. The general picture is that the strain distribution is relatively uniform along the length of the cylinder, which indicates that the tested cylinders do not exhibit any degradation of mechanical properties. There is also no significant difference between the cylinders taken towards the inside of the structure, compared with those taken towards the outside, even if the cylinders towards the inside, on average exhibit somewhat lower strains, i.e. higher stiffness, see Figure T-8.

Figure T-6. Axial compressive strain in the different segments  $\epsilon_{c,s}$  as a function of the distance from the lower loading area, for the cylinders taken towards the outside of the structure.

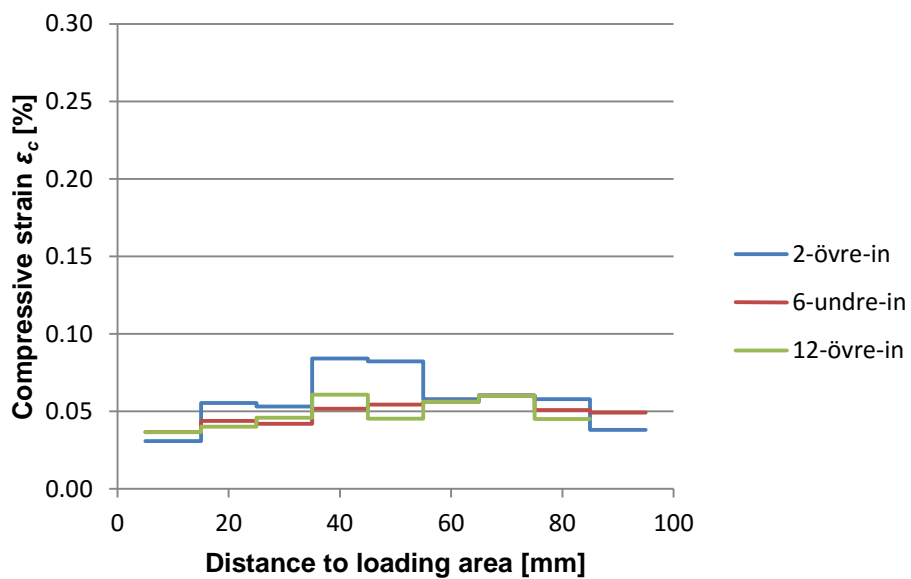
Figure T-7. Axial compressive strain in the different segments  $\epsilon_{c,s}$  as a function of the distance from the lower loading area, for the cylinders taken towards the inside of the structure.

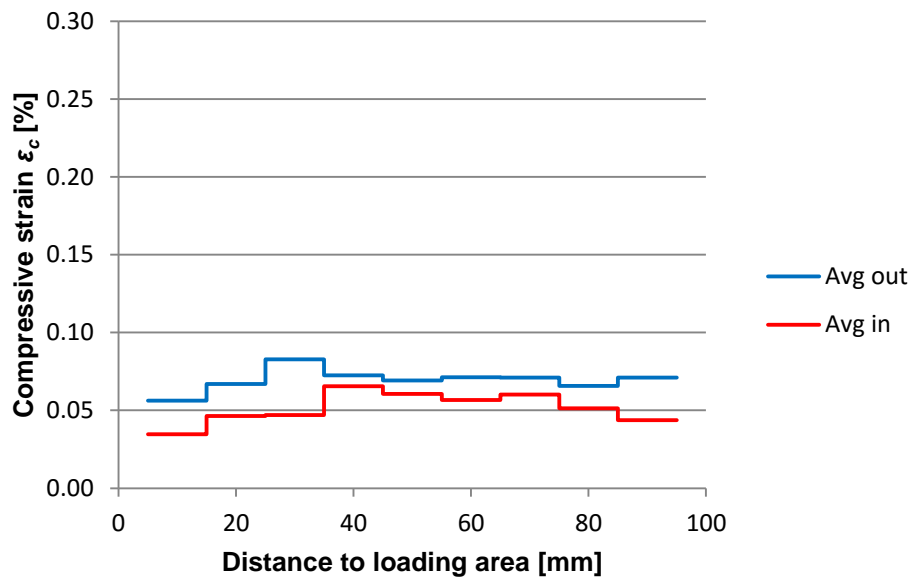
Figure T-8. Axial compressive strain in the different segments  $\epsilon_{c,s}$  as a function of the distance from the lower loading area, represented as average curves for cylinders taken towards the inside (red) and outside (blue) of the structure.
