# **Advantages and disadvantages with different types of transducers measuring valve vibration**

*Elisabet Blom*

Tests done on big  
high pressure  
valves

The electric-  
hydraulic control  
valve has broken.

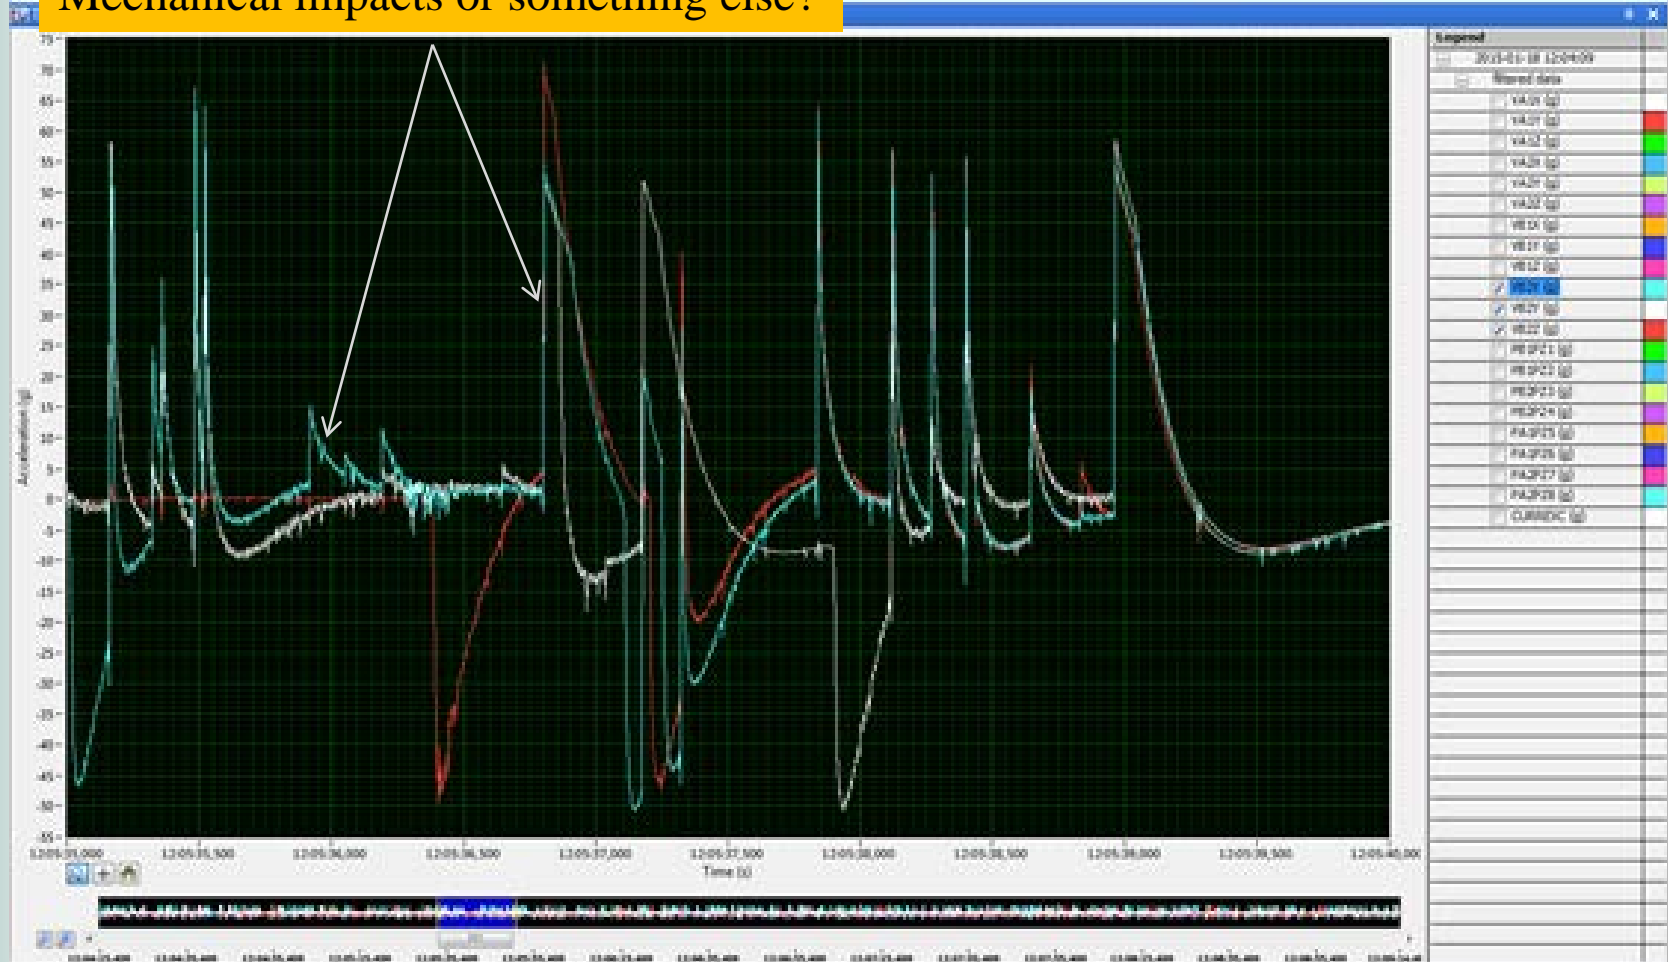
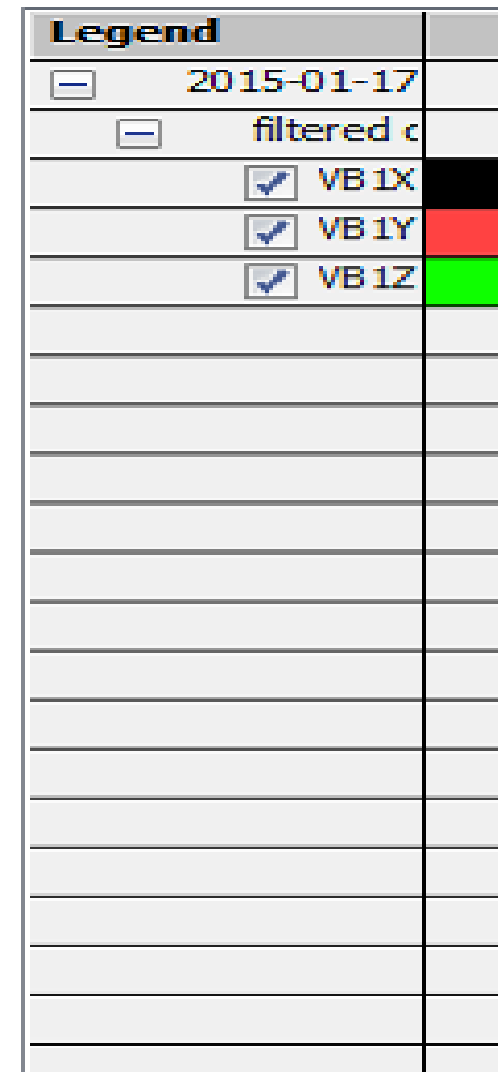
## Example Time Signals

Mechanical impacts or something else?

- DC-offset
  - The measurement frontend was placed on metal bench that was in contact with (not connected) cable shield.
  - This was found to cause DC offset on input amplifier which could explain why a 50g accelerometer clips at 20g.
  - DC offset comes and goes without 50 Hz hum
- Spikes
  - There were still strange spikes present in the signal that sometimes clipped and sometimes did not clip.

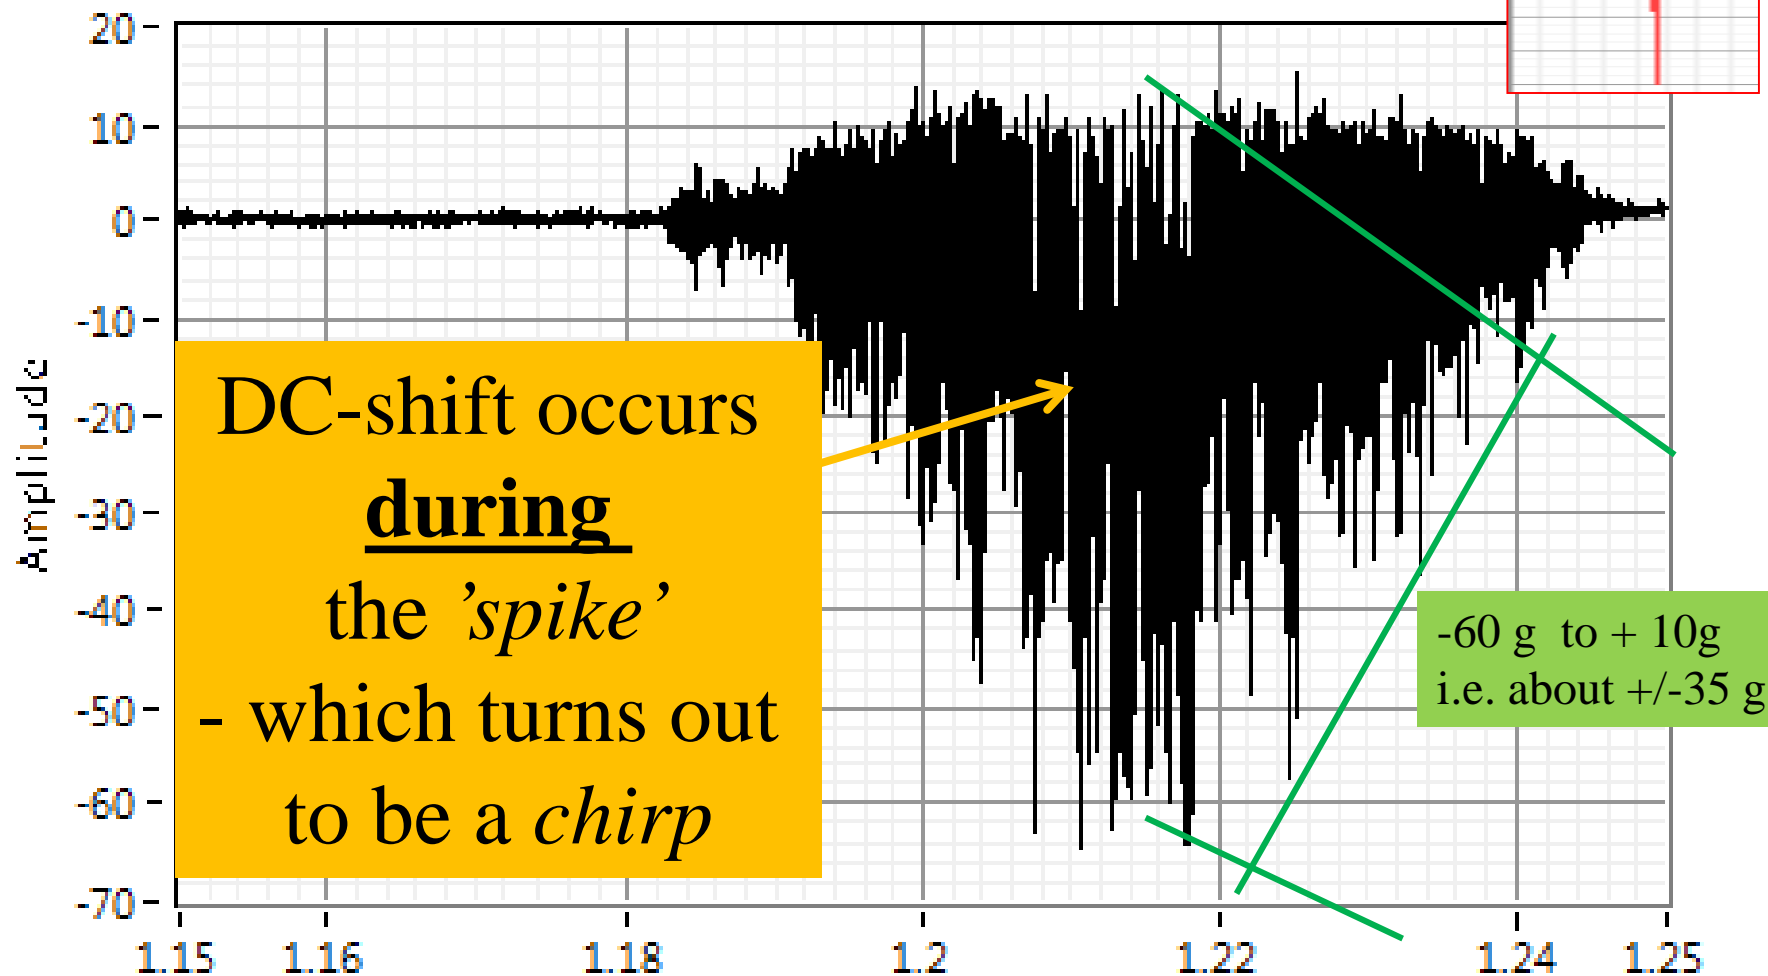
## Zoom In on Single 'Spike' sampled at 1 MS/s

- DC shift in sensor electronics when sensor is loaded at 25+ kHz resonance.
- Not '*Spikes*' - *Chirps*
  - *Transmission* of chirps may be explained by things like
    - Compression modes in mechanical components, e.g. a compression wave propagates at 5000 m/s in steel, a length of 2 m  $\Rightarrow \lambda/2$  @ 1250 Hz.
    - The compression/shear wavelength at 25 kHz is 0.2 m/0.1 m which is small enough for resonance in the breast plate height direction, etc.
  - What is driving these chirps?
  - Is it a problem for the EHS?

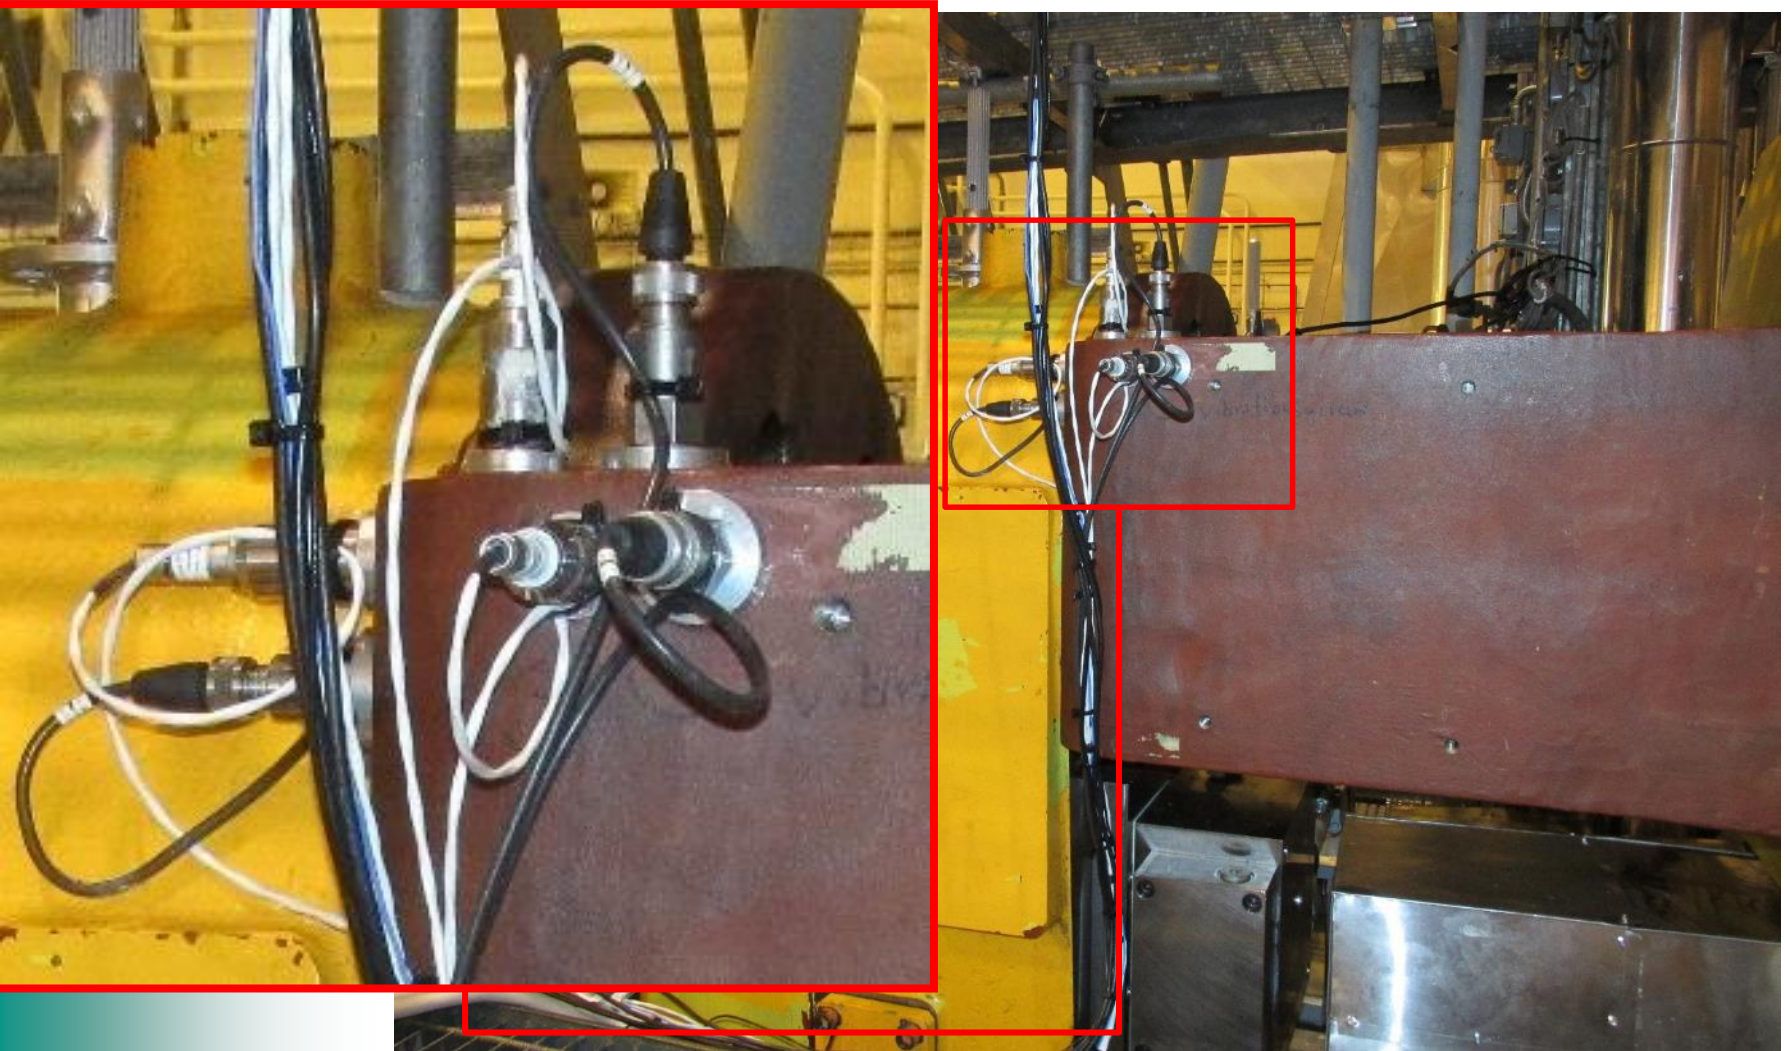
# Industrial Accelerometer 100 mV/g & Velocity transducer

- Dytran & Wilcoxon general purpose 100 mV/g industrial accelerometers did not provide usable signals.
- Velocity transducer VT1613 provides slightly asymmetric histogram.
- 356B21 (glued) 10 mV/g shows symmetric histogram.
- 356B21 w. mech. Filter not measured by 3rd party
- Data up to 60% load.

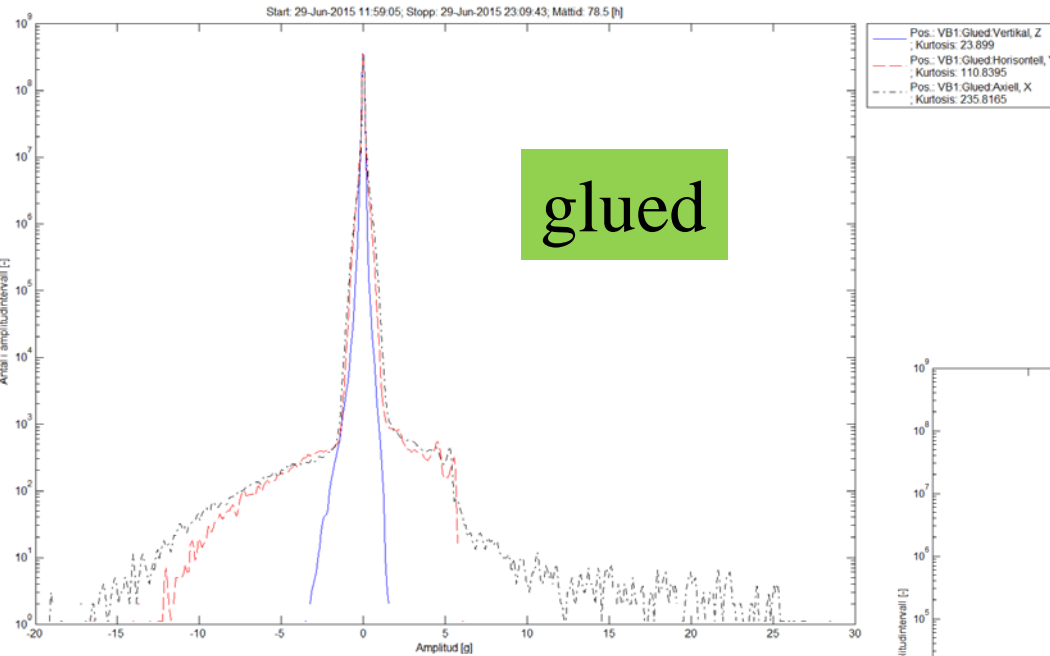
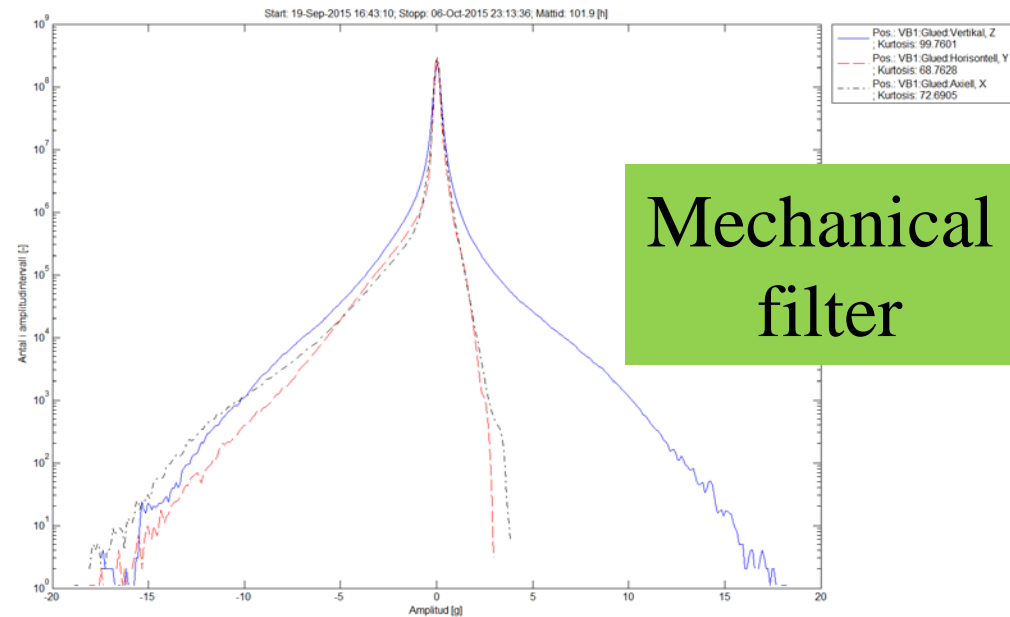
Also 356B21 misbehaved when glued

- All glued accelerometers were affected by internal sensor resonance and zero shifted because of this.
- Accelerometer with mechanical filter & Velocity transducers worked best because they did not pick up high frequency vibration.
- 4x triaxials with filters were input.
  - 2x fell off after a while
  - 2x worked through the while measurement .

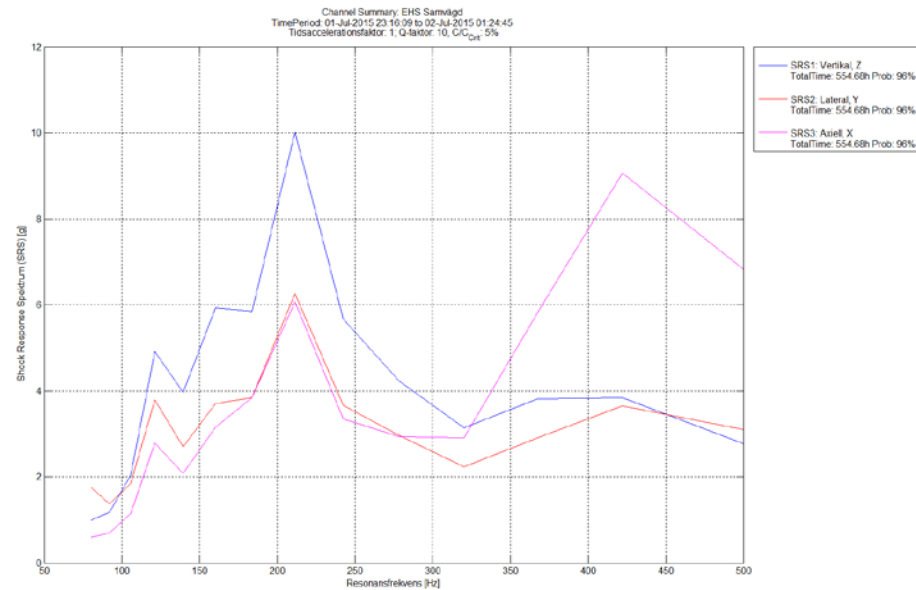
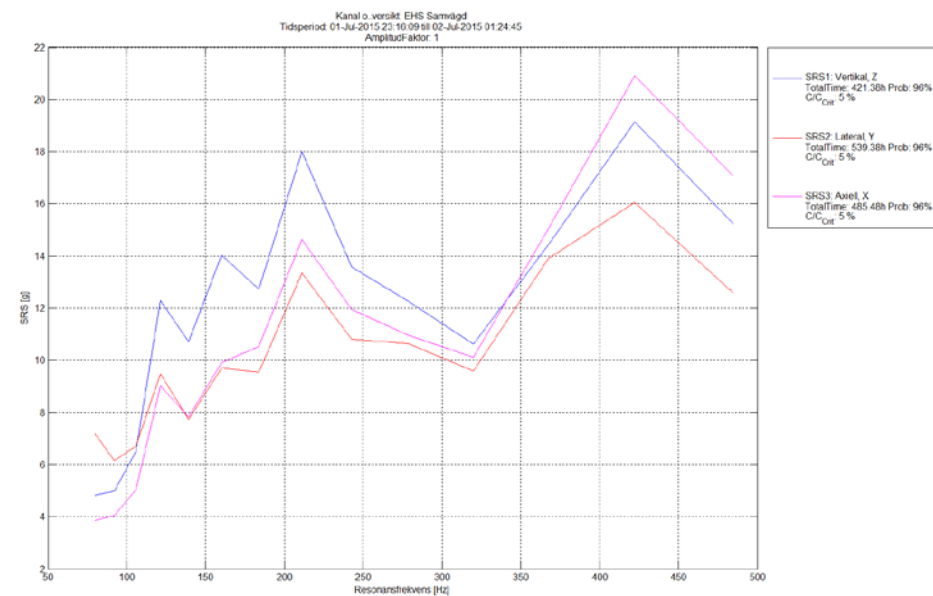
# Shock Response Spectrum

SRS shows the outlier peaks to be covered  
by the noise excitation variability
