KME-508/515

# **Furnace wall corrosion in biomass-fired boilers at higher steam temperatures and pressures**

## Summary

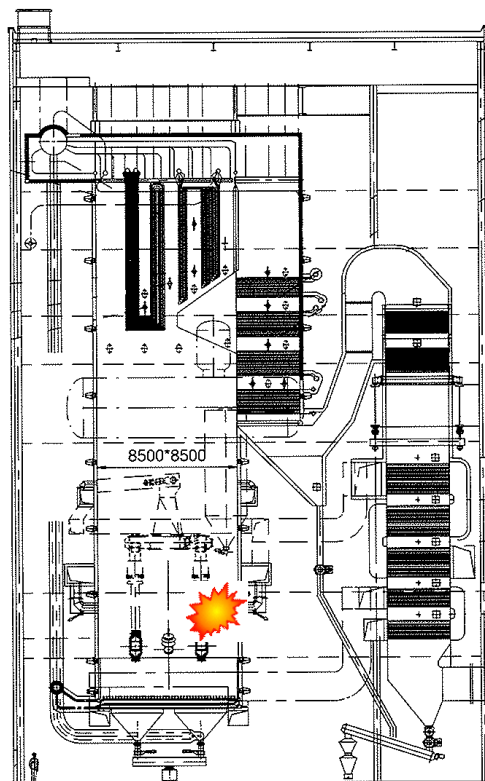
**Fig. 2.1.2**

**Section of Stevens Croft boiler showing position of tube failure that occurred in January 2013 at 4.3 m above refractory, 6 m above bed.**

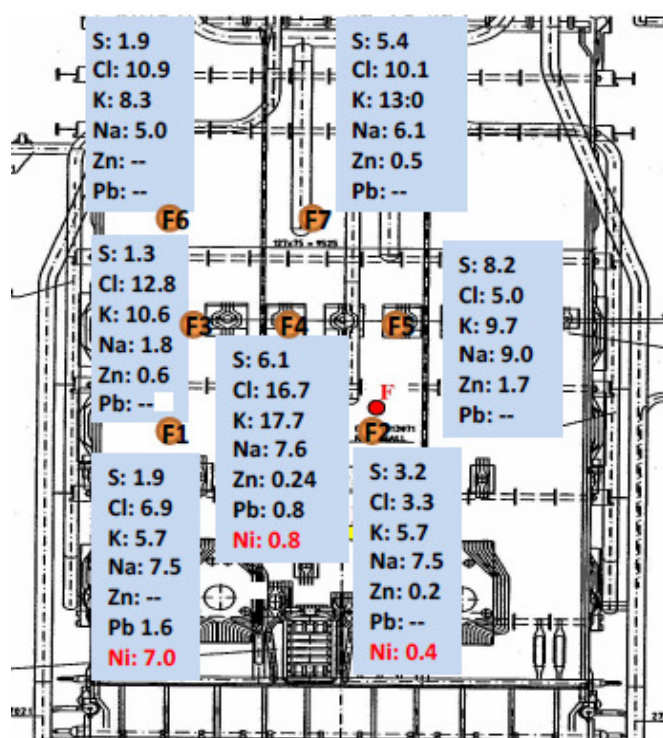
The deposits showed a wide spread in chemical composition, although Cl was found in all the samples, sometimes at very high levels (27 atomic %). K and S were found in all the deposits samples and Na was found in most. A higher K content was always associated with a high Cl content. Zn was found in three-quarters of the samples at low concentrations and Pb was found in a third of the samples at low average concentrations, but high concentrations locally. The results for the front wall are shown in Fig. 3.1.1.

**Fig. 3.1.1** Sketch of front wall showing the positions, F1 to F7, from where deposits were removed and chemical composition in atomic % of key elements in the deposits. The nickel comes from the Alloy 625 coating which had found its way into the deposits. F6 and F7 are above the tertiary air ports

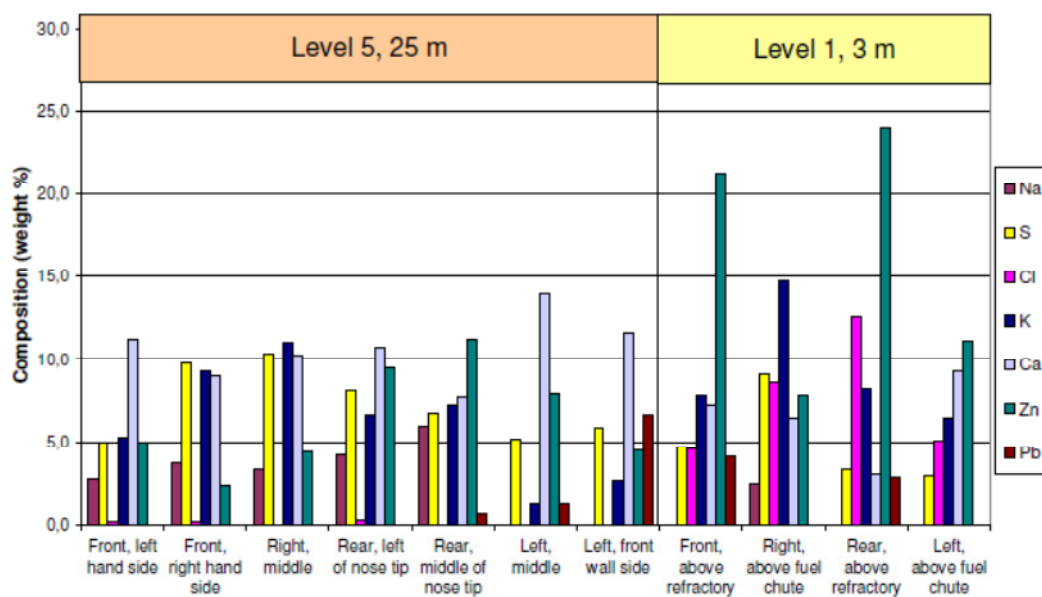
**Fig. 3.1.3** Content of some selected elements in deposit samples from Steven's Croft, outer, light brown part of deposit

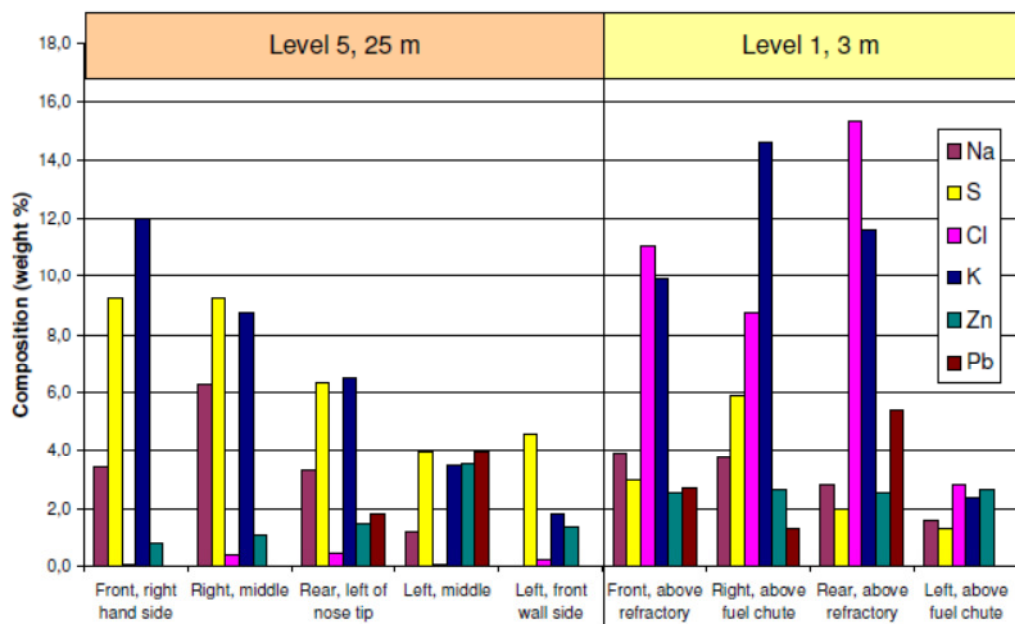
The parts of the deposit facing the tubes (inner deposits) were black or in some cases rusty red. The outer part of the deposits contained 2-6 wt% iron, whereas the inner part of the deposits contained 20-46 wt% iron indicating that the inner part probably contained corrosion products and oxide from the tube surfaces. Magnetite ( $\text{Fe}_3\text{O}_4$ ) is black and hematite ( $\text{Fe}_2\text{O}_3$ ) is reddish brown which ties in with appearance of the inside of the deposit. As with the outer part of the deposit, the chlorine content was much higher in the samples from level 1 than in the samples from level 5. Figure 3.1.4 shows some key elements in the inner parts of the deposits.

**Fig. 3.1.4.** Content of some selected elements in deposit samples from Steven's Croft, inner, black part of deposit

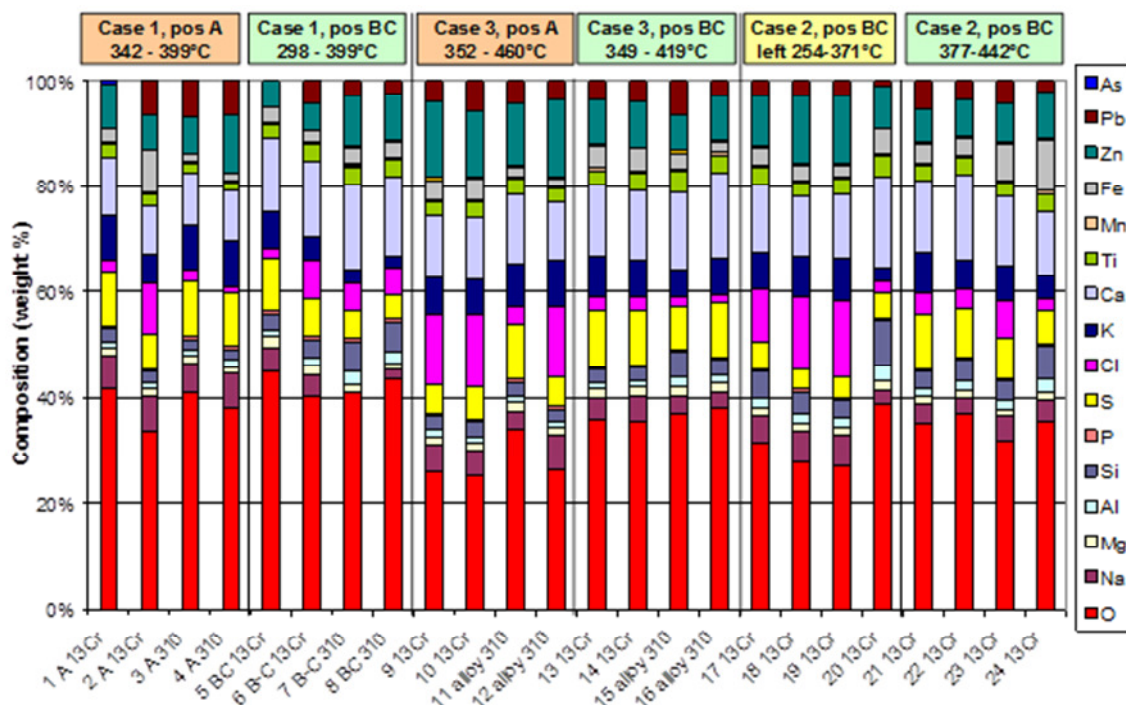
It was expected that the deposit composition might vary with metal substrate temperature, type of steel, or position in boiler. However, no such correlation could be found. K, Cl, S, Pb and Zn were found in the deposits. The levels varied considerably and in a seemingly random manner as can be seen in Fig. 3.3.1.

**Fig. 3.3.1 Composition of the deposits collected on probes at the different positions on the wall.**

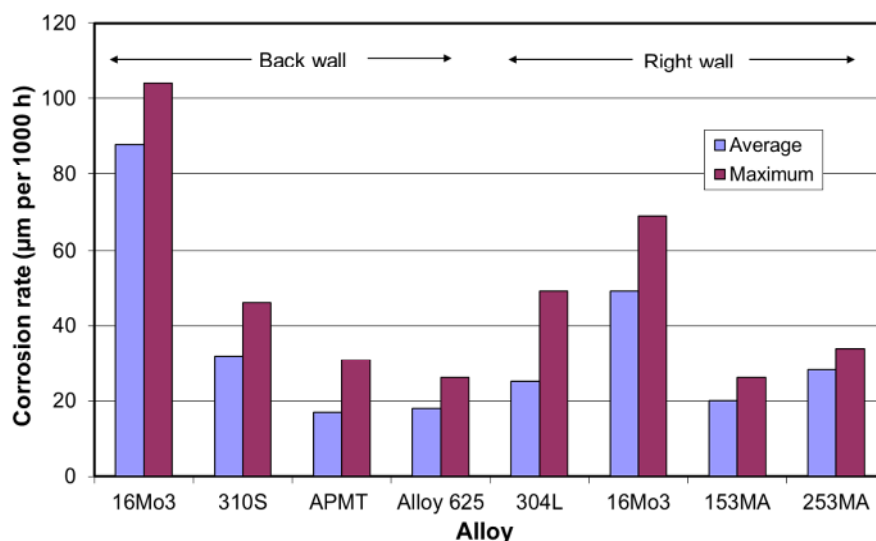
The results from the second probe campaign are shown in Fig. 3.4.1. It can be seen that APMT, Alloy 625 and the stainless steels 153MA, 253MA and 310S perform better than 16Mo3 and that the corrosion rate was higher on the back wall, position A. This became the main position for future probe testing.

**Fig. 3.4.1 Average and maximum corrosion rates for specimens on probe A2 (back wall) and B2 (right wall). Metal temperature 400°C. The corrosion rate was higher on the back wall.**

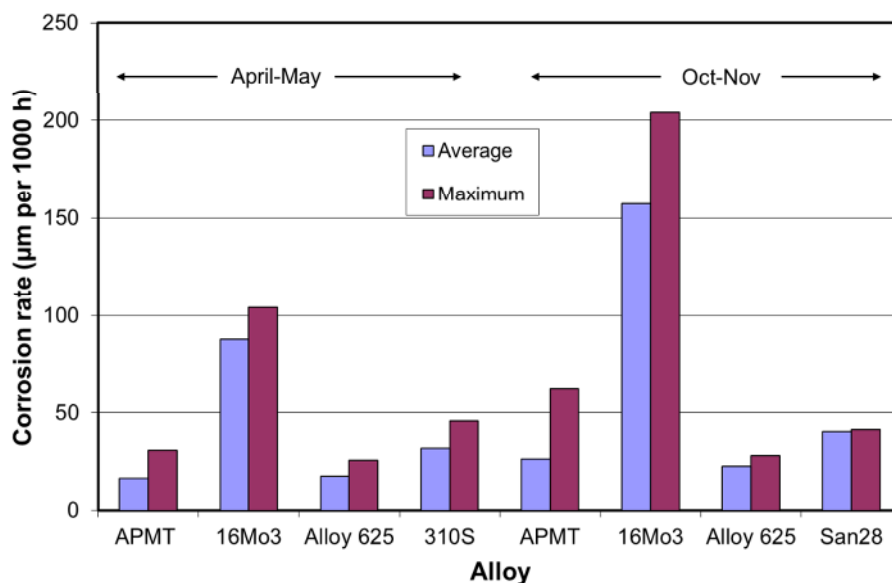
The results for probe tests 2 and 3 on the back wall are presented in Figure 3.4.2 which shows that APMT, Alloy 625 and the stainless steels Sanicro 28 and 310S perform better than 16Mo3. The boiler load was higher in the autumn than the spring, which is why the corrosion rates for APMT, 16Mo3 and Alloy 625 on the right of the diagram are higher than those on the left. It also shows that the advantages of using a high alloy coating increase at increased boiler loads.

The dominant corrosion mechanism in the 16Mo3 specimen was found to be chloride corrosion, while attack by a potassium-lead combination seemed to be the main attack in the nickel alloy coating material. SEM analysis for the stainless steels showed chlorine, lead and potassium at the corrosion front. Lead and potassium were in connection together; however they were not in reaction with chlorine. The corrosion mechanism in the stainless steels therefore seems to be mixture of both mechanisms. The corrosion rate of the stainless steels is between of 16Mo3 (the highest corrosion rate) and Alloy 625 (the lowest corrosion rate). This indicates that stainless steels, could be a cheaper alternative to Ni-base alloys for protecting furnace walls.

**Fig. 3.4.2 Average and maximum corrosion rates for probes A2 (April-May 2012) and A3 (Oct-November 2012) in position A Idbäcken – centre of back wall, height 16 m. Metal temperature 400°C.**

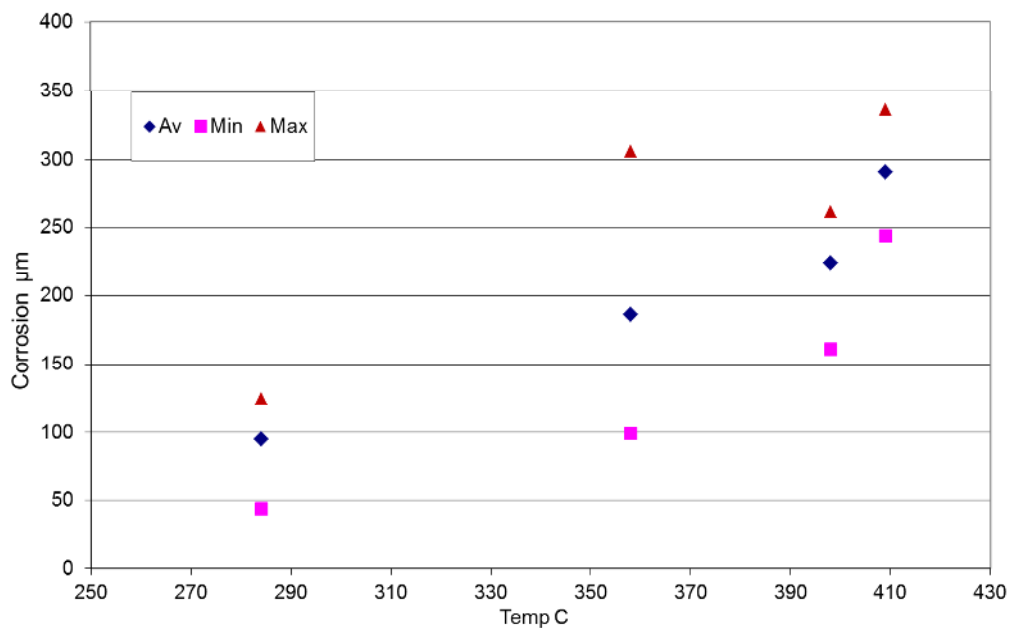
The corrosion rate decreased with decreasing metal temperature and the amount of K and Cl in the deposit also decreased with decreasing temperature. However the amount of Pb peaked at about 360°C. XRD analysis of the deposit on the 360°C sample showed that the chloride was associated with alkali and the deposit mostly contained KCl and NaCl. Lead was detected as pure lead but some lead oxide was also present.

**Fig. 3.4.3** Variation of corrosion rate in  $\mu\text{m}$  per 1000 h with metal temperature in  $^{\circ}\text{C}$  for 16Mo3. The average, maximum and minimum of 20 measuring points are shown.

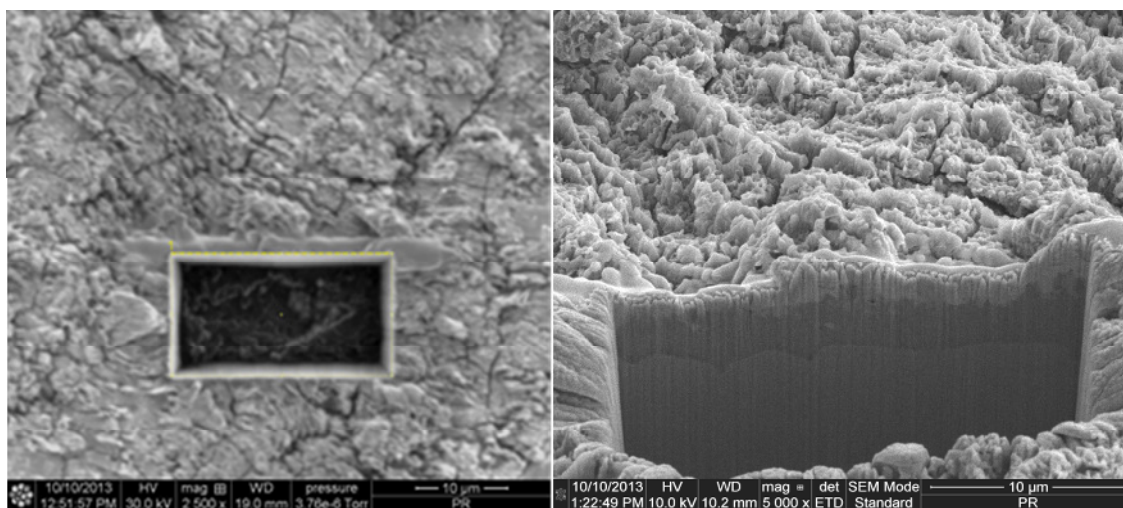
The FIB sections of the specimens at the highest and lowest temperatures showed very similar results. A band of iron chloride  $2\ \mu\text{m}$  wide was found next to the metal and no overlap of oxygen and chlorine signals was observed. An FIB section is shown in Fig. 3.4.4 and the measurement profile in Fig. 3.4.5.

**Fig. 3.4.4** (Left) Surface view of hole made by FIB. (Right) After tilting by 52 degrees to expose cross-section in the  $409^{\circ}\text{C}$  16Mo3 sample.

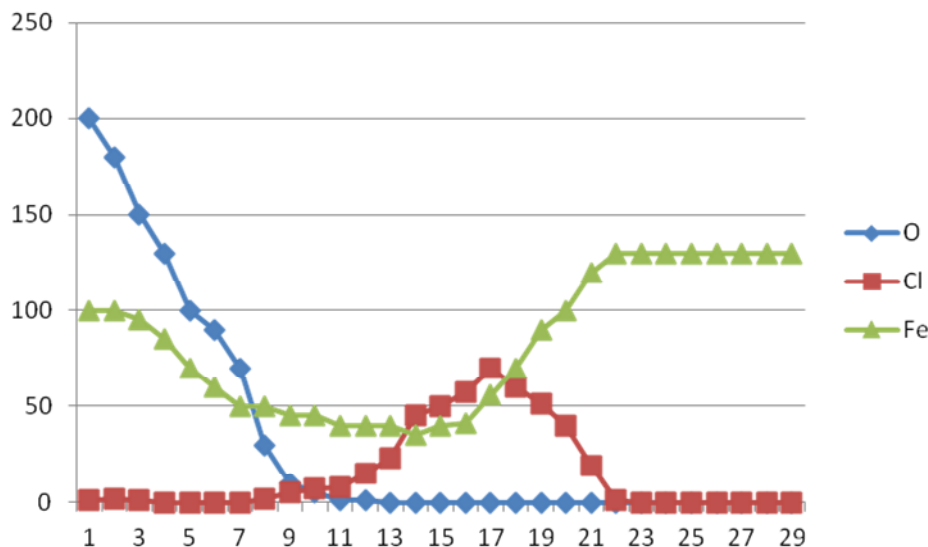
**Fig. 3.4.5.** Measurement profile from 409°C 16Mo3 sample, 5µm deep, covering 29 measurement points, from the surface of the specimen in to the metal. The iron chloride band is 2µm wide. There is no overlap of oxygen and chlorine, i.e oxychlorides are not seen. The intensities of Fe, Cl and O are related to weight %, but have not been calibrated.

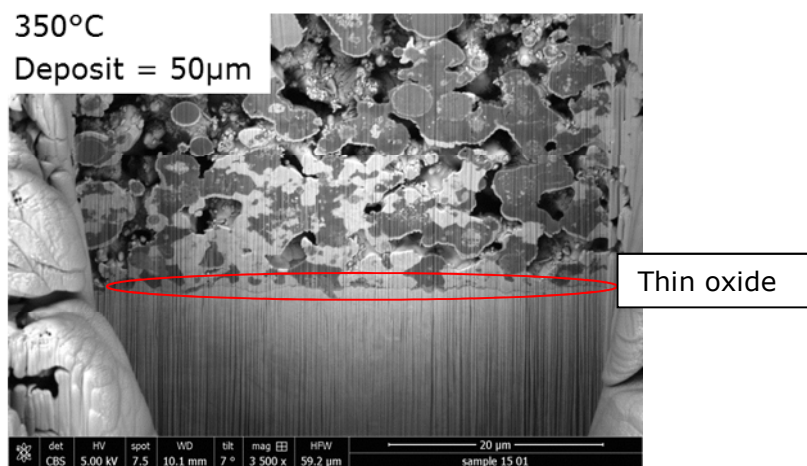
**Fig. 3.8.1** Section produced by FIB technique on a 310 stainless steel sample exposed for 24 h at 350°C. The porous deposit and very thin oxide layer can be seen.
