# The analysis of furnace wall deposits in a low-NO<sub>x</sub> waste wood-fired bubbling fluidised bed boiler

Yousef Alipour, Peter Viklund and Pamela Henderson

## The Idbäcken combined heat and power (CHP) boiler

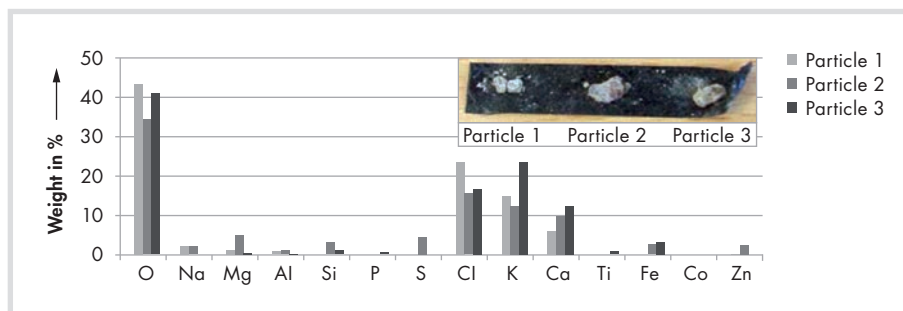
Fig. 1. EDS chemical analysis from deposit F3 (front wall position 3), showing results from the three separate analyses. Within an individual deposit sample/position the spread in chemical composition was low.

The deposits were mounted on carbon tape for SEM analysis, so the carbon counts were removed from the analyses presented here. However, they were in the range 5 to 10 weight % for most particles. The spread in chemical composition results was low within individual deposit samples (individual positions on the furnace wall), as shown in Figure 1.

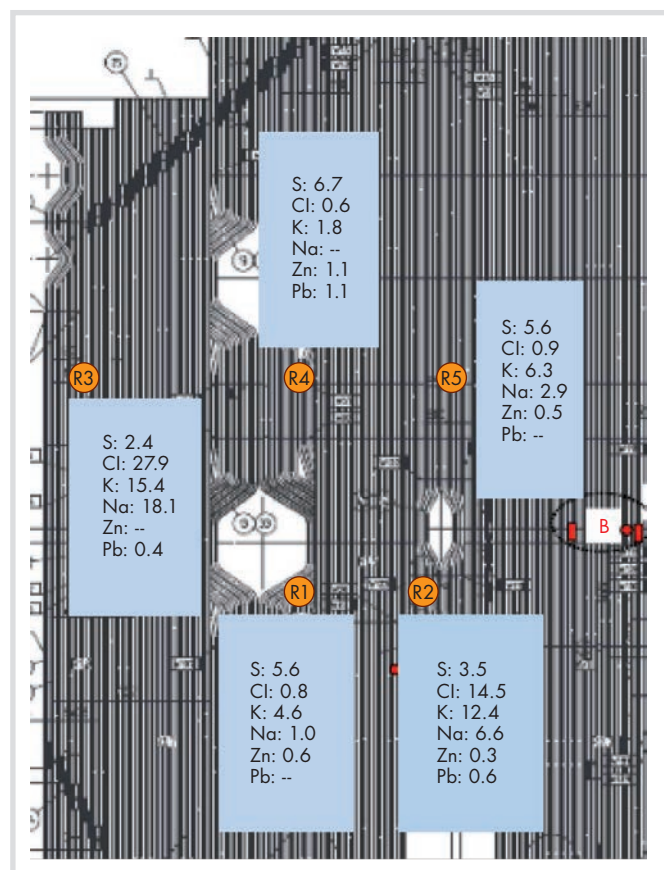
The average content of key elements that are thought to be corrosive or form corrosive salts in the deposits (sulphur, chlorine, potassium, sodium, zinc and lead) and their position on the four furnace walls are shown in Figures 2 to 5.

Fig. 2. Sketch of the right wall showing the positions, R1 to R5, from where deposits were removed and chemical composition in atomic % of key elements in the deposits.

There was considerable spread in the composition, depending on the position, but a higher K content was always associated with a high Cl content. Cl was found in all the deposit samples, sometimes at very high levels (27 atomic %). K and S were found in all the deposits samples and Na was found in most samples (19 of 20). Zn was found in 15 of 20 samples at low concentrations. Pb was found in 7 of 20 samples at low average concentrations, but high concentrations locally.

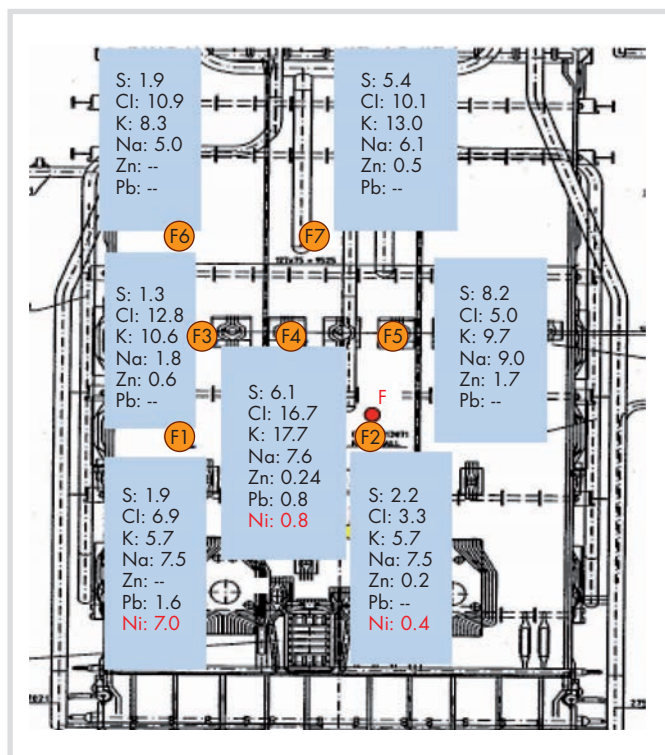
Fig. 4. Sketch of front wall showing the positions, F1 to F7, from where deposits were removed and chemical composition in atomic % of key elements in the deposits. The nickel comes from the Alloy 625 coating which had found its way into the deposits. F6 and F7 are above the tertiary air ports.

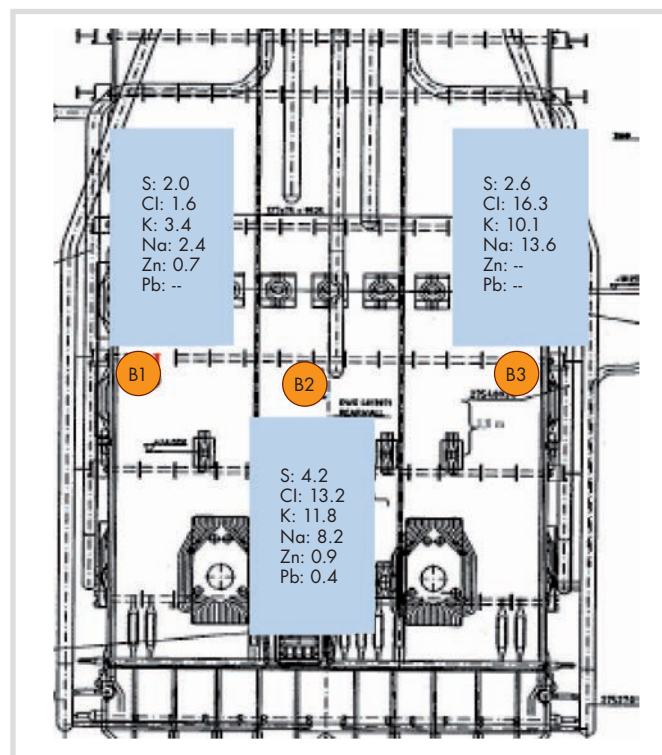
Fig. 5. Sketch of back wall showing the positions, B1 to B3, from where deposits were removed and chemical composition in atomic % of key elements in the deposits.

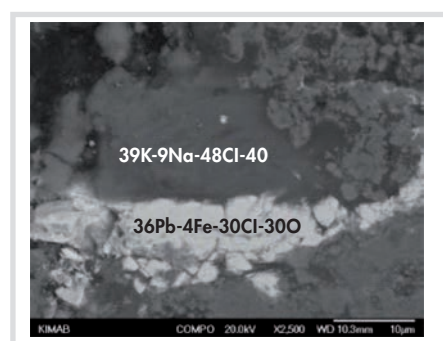
Scanning electron microscopy showed that lead, when it was present in a deposit, was heterogeneously distributed and could be observed as “islands” of pure lead or in mixtures containing oxygen, for example Pb-Cl-O mixtures or Pb-K-S-O mixtures. Figure 6 shows an “island” of a lead mixture in a “sea” of alkali chloride.

Fig. 6. Section of a deposit showing lead concentrated as a Pb-Cl-O mixture. Analysis in atomic %.

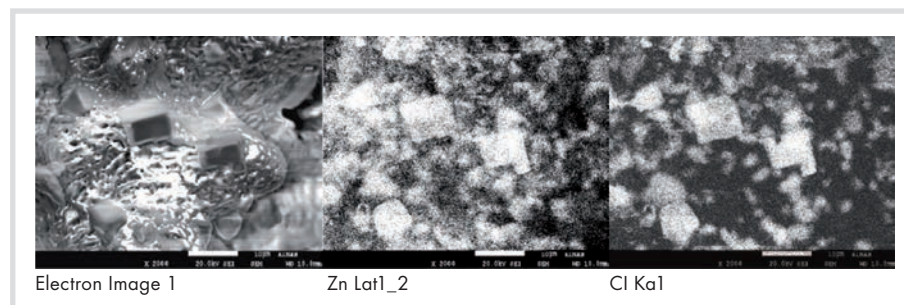
Zinc was less frequently observed, but was seen as crystals of zinc chloride as shown in Figure 7.

Fig. 7. Crystals of zinc chloride from sample L3, which contained the highest amount of zinc of all analysed samples. The marker bar is 10 µm.

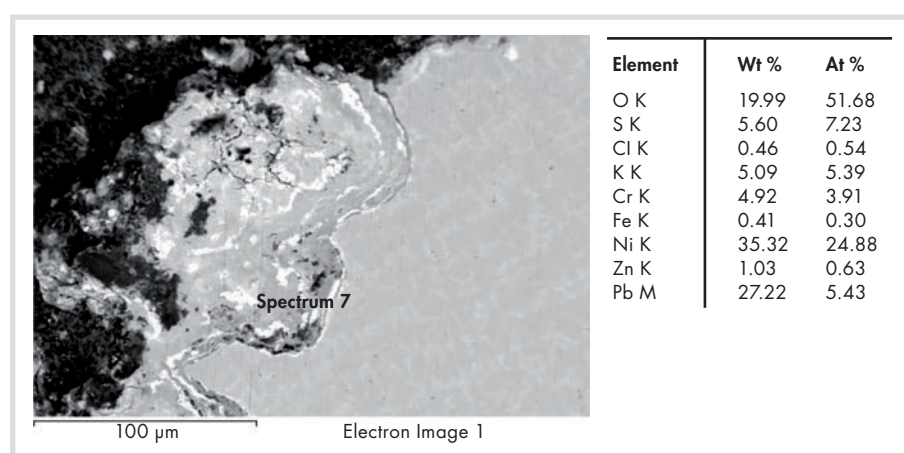
Initial metallographic investigation of corroded Ni-alloy coated tubes, using SEM and wave-length dispersive x-ray

spectroscopy (WDS), revealed that lead was greatly concentrated at the corrosion front in the pits (Figure 8). The tube section shown in Figure 8 was located near deposit sample R2.

Coating the furnace wall tubes with the Ni-base alloy, Alloy 625, reduced the corrosion rate and metallographic examination using SEM and WDS showed that there was very little chlorine at the corrosion front in this alloy. However, although only small amounts of lead were found generally in the deposits, the lead together with potassium, was concentrated at the corrosion front in the pits and appeared to be highly active in the corrosion process on the nickel-based alloy coating.

Fig. 8. A section through the surface of weld overlay IN 625 and the chemical composition of the analysed spot. The micrograph shows a pit filled with a mixture of deposit and corrosion products, with the un-corroded alloy on the right and the outer surface on the left. The spot analysis was made by WDS.

Corrosion tests with other alloys are being performed in order to find more cost effective protection systems
