# **Critical corrosion phenomena in power generation from biomass**

Identification of chlorine resistant high  
temperature coatings/materials

Participants

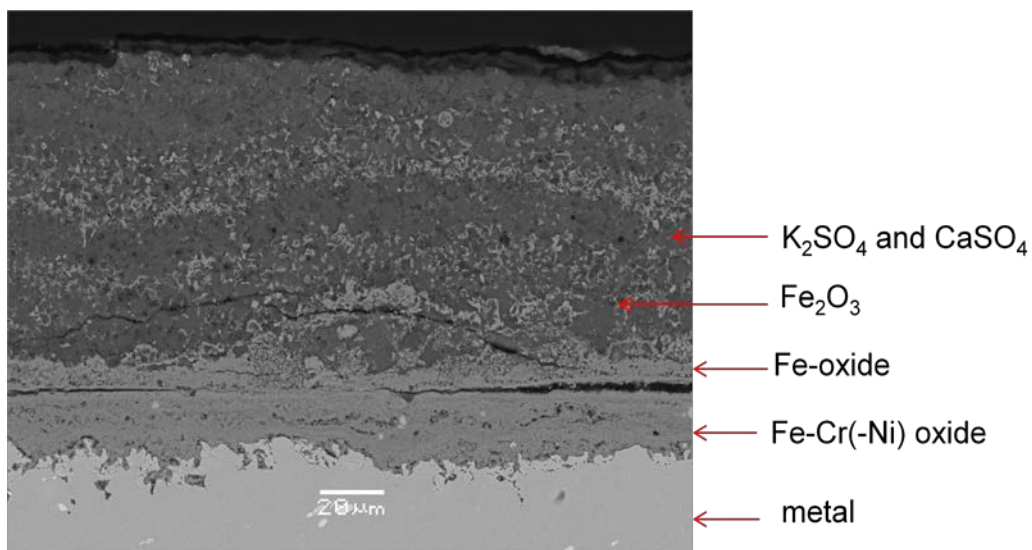
Figure 1 shows an SEM image of the corrosion attack on TP347HFG exposed at a steam temperature of 535°C, which is very near to the present upper acceptable temperature limit, which is 540°C.

A thick layer of deposits and oxides is found at the outer surface. EDX reveals that the deposit is rich in K, Ca and S. It is assumed to be primarily  $K_2SO_4$  and  $CaSO_4$ . The oxide is iron-based. Outwards and inwards growing oxide layers are found closer to the steel, the outwards growing oxide layer is primarily iron rich, while the inwards growing layer is a mixed Fe-Cr(-Ni) oxide.

**Figure 1:** Deposit and oxides formed on TP347HFG after 5900 hours of service. Backscatter electron (BSE) contrast image.

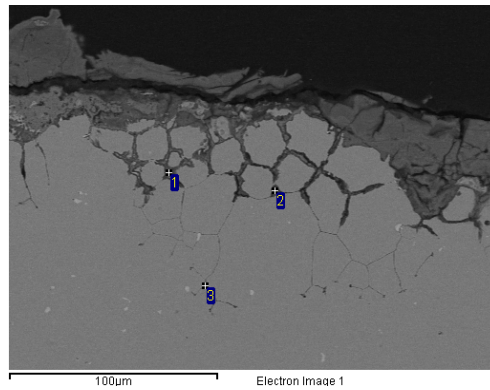
At many locations, extensive attack can be observed along grain boundaries. Corrosion products containing both Cl and K and also some S can be identified in the grain boundaries. Two locations with corresponding EDX measurement results are shown in Figure 2 and Figure 3. The corrosion products lying above the zone of grain boundary attack are rich in S and are highly inhomogeneous with some areas rich in Ni and others rich in Cr, see Figure 4.

**Figure 2:** Extensive attack along grain boundaries, K and Cl are located in the boundaries. BSE contrast image.

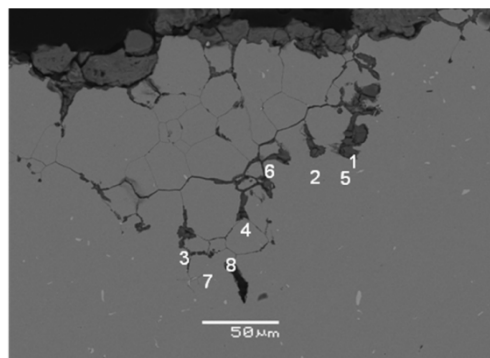
**Figure 3:** Extensive attack along grain boundaries, K and Cl are located in the boundaries. BSE contrast image.

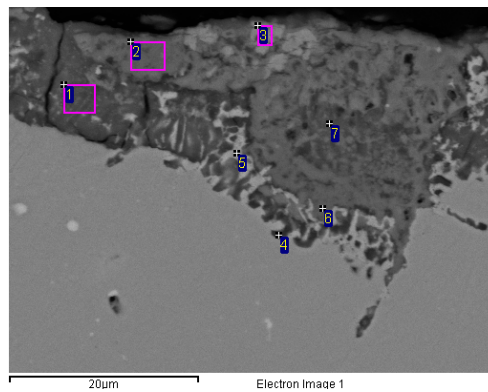
**Figure 4:** Highly inhomogeneous corrosion products are formed above the zone of internal grain boundary attack. Generally these corrosion products are enriched in S with local Ni or Cr rich areas. BSE contrast image.

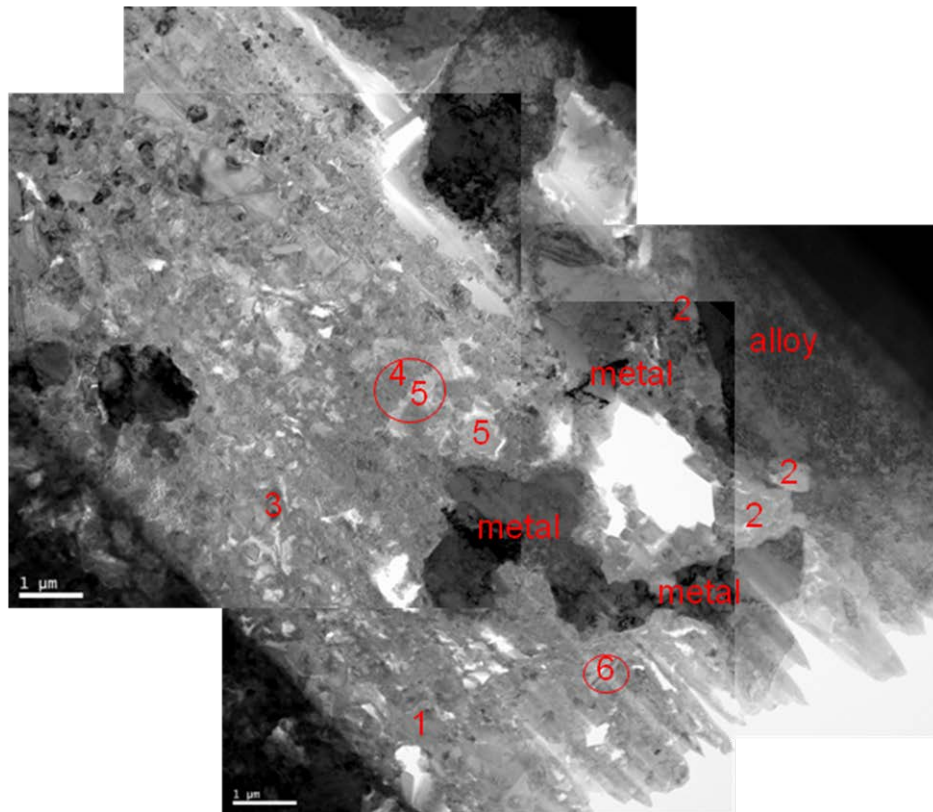
**Figure 6:** TEM thin foil showing an inhomogeneous oxide/corrosion product layer that still contains some metallic parts, the bulk alloy starts in the upper right hand part of the picture.

Close to the interface towards the alloy, EDX measurements shown in Figure 6 indicate the presence of an Fe-Cr rich oxide. The outer part of the layer is a highly inhomogeneous mix of different corrosion products and metallic parts.

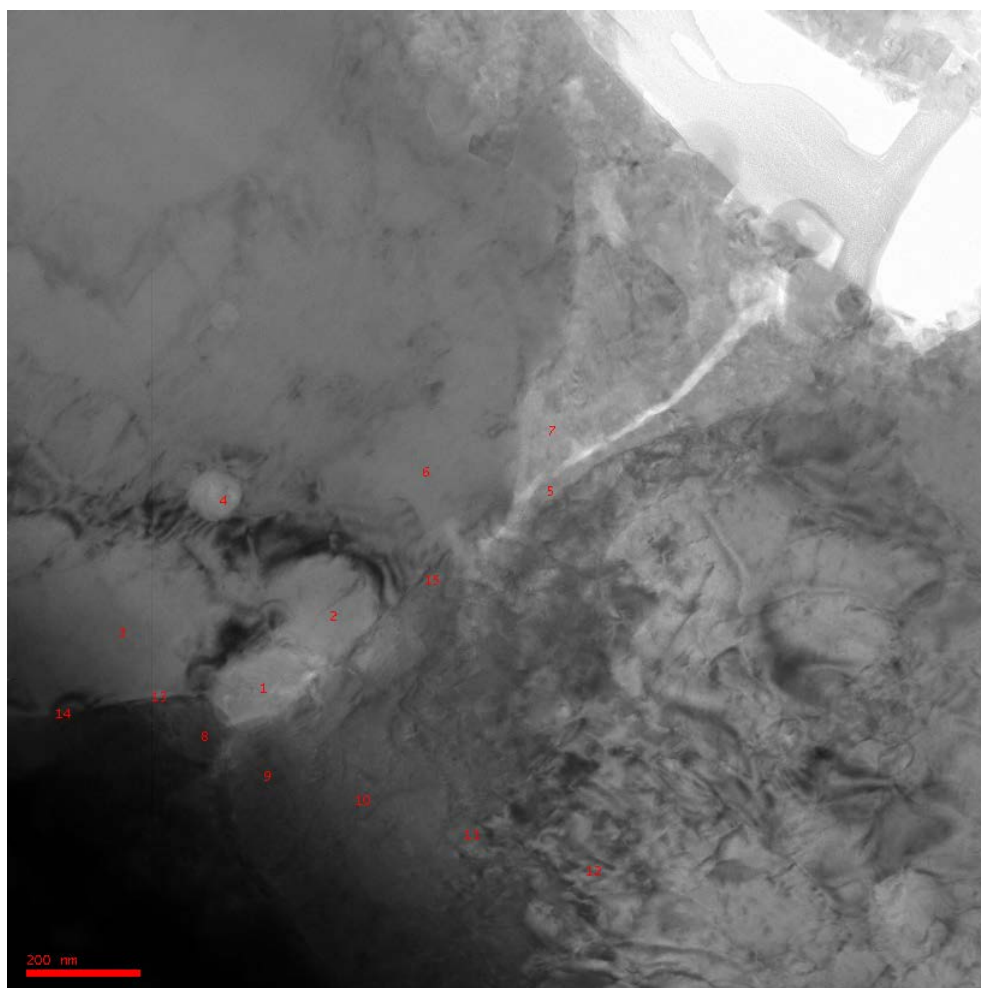
TEM EDX in the vicinity of a grain boundary just below the outer corrosion layer showed primarily S-rich corrosion products; see Table 3, as well as Cr-depletion inside a single grain, EDX analysis 9-12 in Figure 9 and Table 3.

**Figure 9:** TEM brightfield image of a grain boundary below the outer oxide layer.
