# **FeCrAl alloys as components in biomass– and waste– fired boilers**

Kristina Hellström, Niklas Israelsson, Jan–  
Erik Svensson, Bo Jönsson, Dilip  
Chandrasekaran, Johanna Nockert–Olovsjö,  
Anna Jonasson, Bengt–Åke Andersson, Paul  
Cho, Per Kallner, Pamela Henderson

The corrosion resistance of certain components in a waste-fired boiler can be improved significantly if the existing material is replaced with FeCrAl material, such as thermo shield tubes and shielding of superheaters. The results also surprisingly show that the pre-oxidation is not favorable when the material is used at lower temperatures, below 700 °C. This means that production of major boiler components in FeCrAl material would be greatly facilitated.

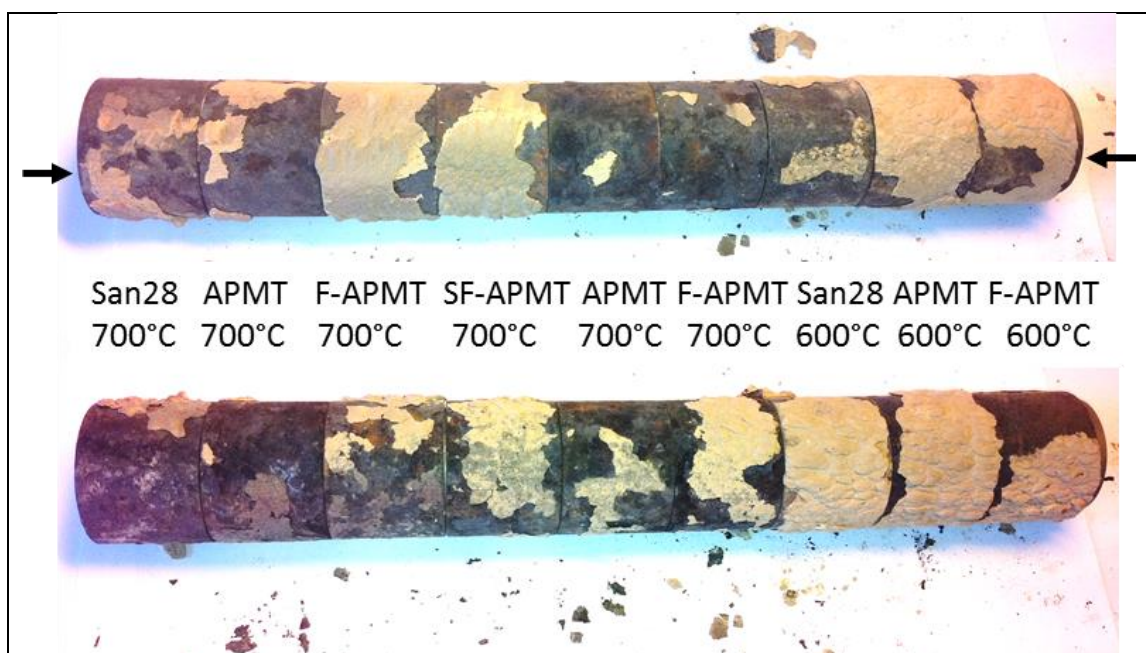
Figure 6-28. Photo showing the samples after probe exposure for 24 h. Sanicro 28 to the left followed by Kanthal<sup>®</sup> APMT, pre-oxidised Kanthal<sup>®</sup> APMT, standard pre-oxidized Kanthal<sup>®</sup> APMT, Kanthal<sup>®</sup> APMT, pre-oxidised Kanthal<sup>®</sup> APMT, Sanicro 28, Kanthal<sup>®</sup> APMT and pre-oxidised Kanthal<sup>®</sup> APMT to the right. The arrows on the topmost image mark the position of the thermal element (facing the windward side). The samples below have been turned 180°.

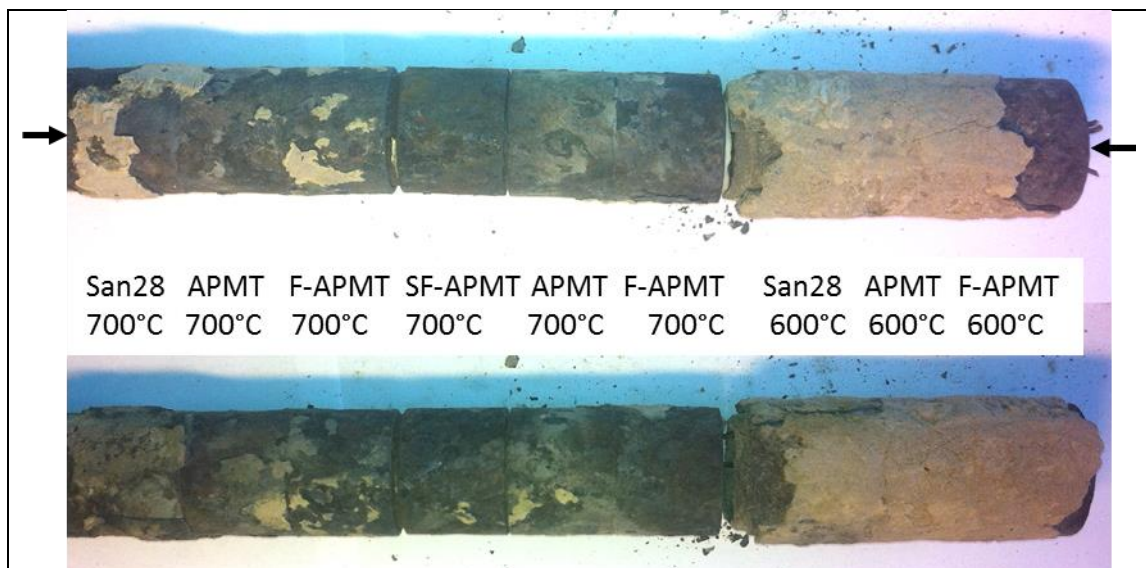
Figure 6-29. Photo showing the samples after probe exposure for 400 h. Sanicro 28 to the left followed by Kanthal<sup>®</sup> APMT, pre-oxidised Kanthal<sup>®</sup> APMT, standard pre-oxidized Kanthal<sup>®</sup> APMT, Kanthal<sup>®</sup> APMT, pre-oxidised Kanthal<sup>®</sup> APMT, Sanicro 28, Kanthal<sup>®</sup> APMT and pre-oxidised Kanthal<sup>®</sup> APMT to the right. The arrows on the topmost image mark the position of the thermal element (facing the windward side). The samples below have been turned 180°.

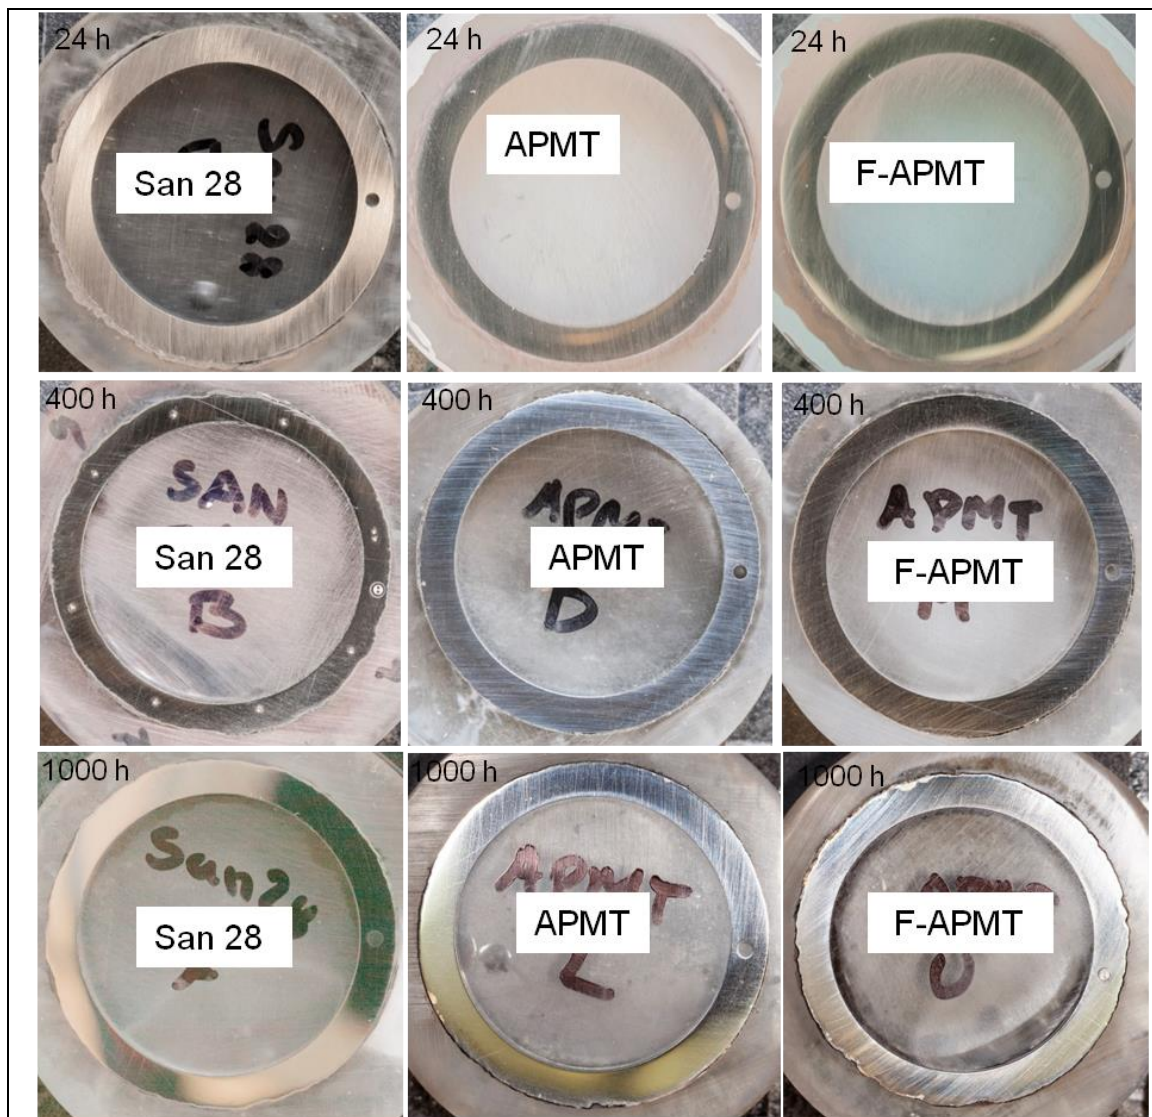
Figure 6-31. Photo showing the cross-sections of the samples after probe exposure at 600°C for 24-1000 h. The pre-oxidized APMT is marked "F-APMT" and Sanicro 28 "San 28".

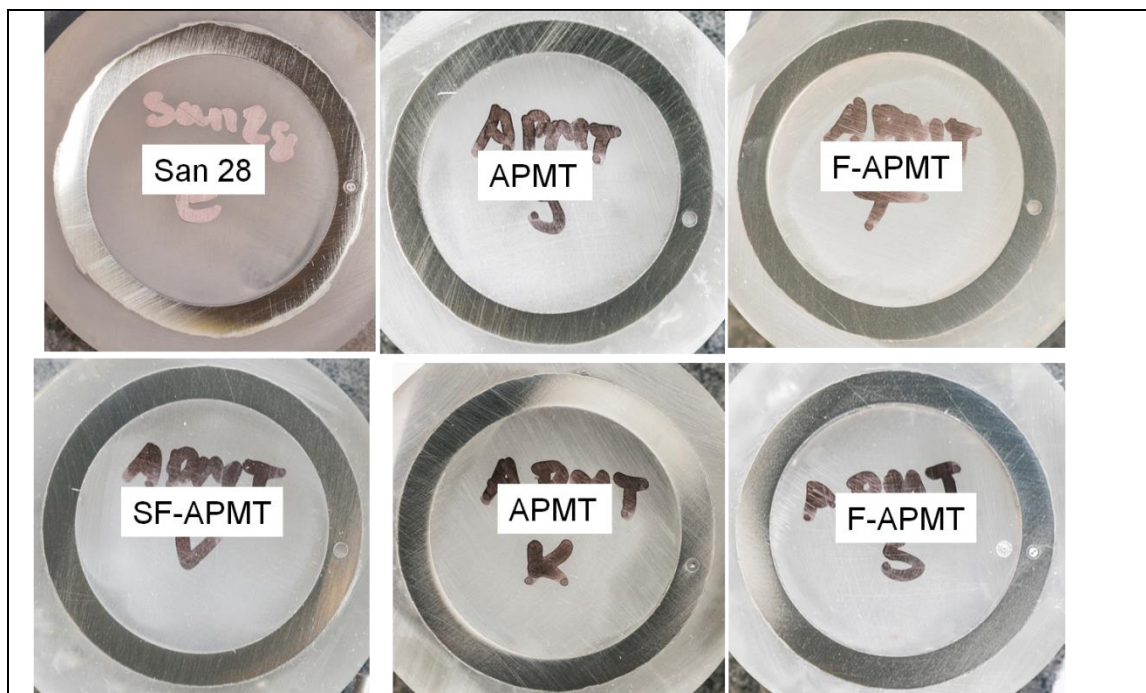
Figure 6-34. Photos showing the cross-sections of the samples after probe exposure at 700°C for 1000 h. The pre-oxidized APMT is marked "F-APMT" and Sanicro 28 "San 28".

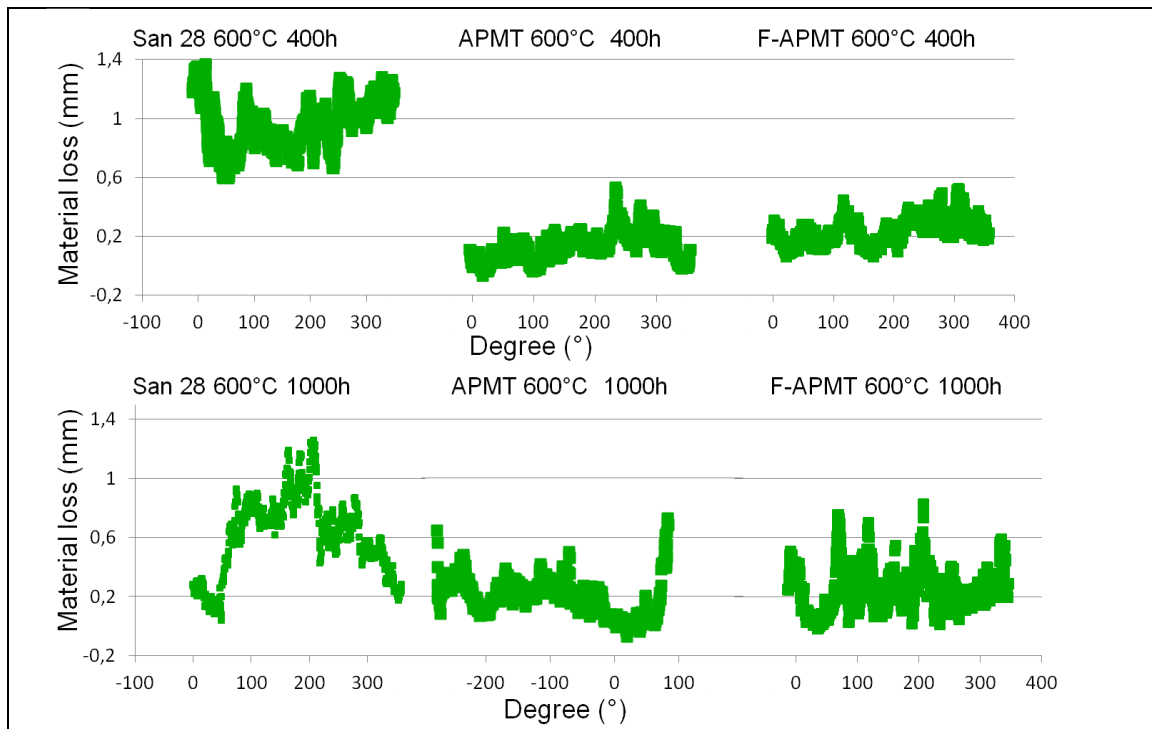
Figure 6-35. Curves showing the material loss around the circumference of Sanicro 28, APMT and pre-oxidized (1100°C, 24 h) APMT after probe exposure at 600°C for 400 h and 1000 h. 0° at the x-axes is the position of the thermo couple.

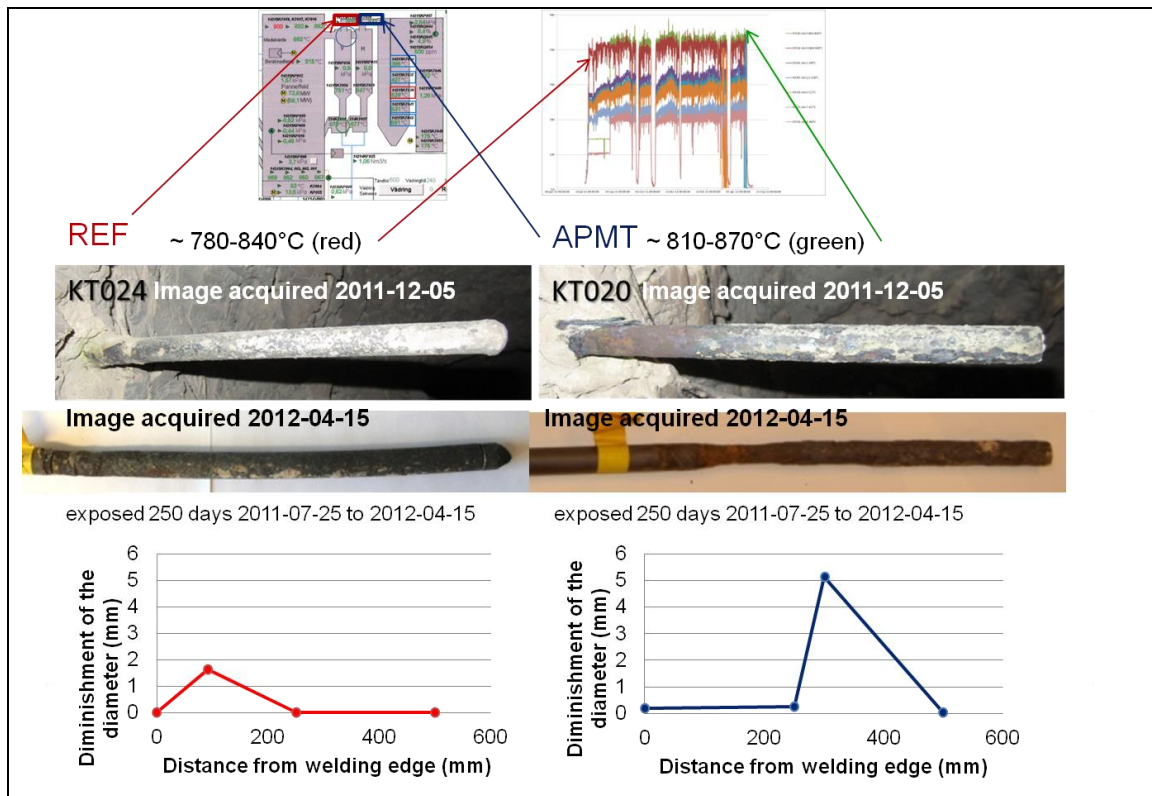
Figure 6-54. Images and material loss diagrams of the thermal shield tubes exposed at the positions KT020 and KT024, together with illustrations of the position and temperature during the exposure.

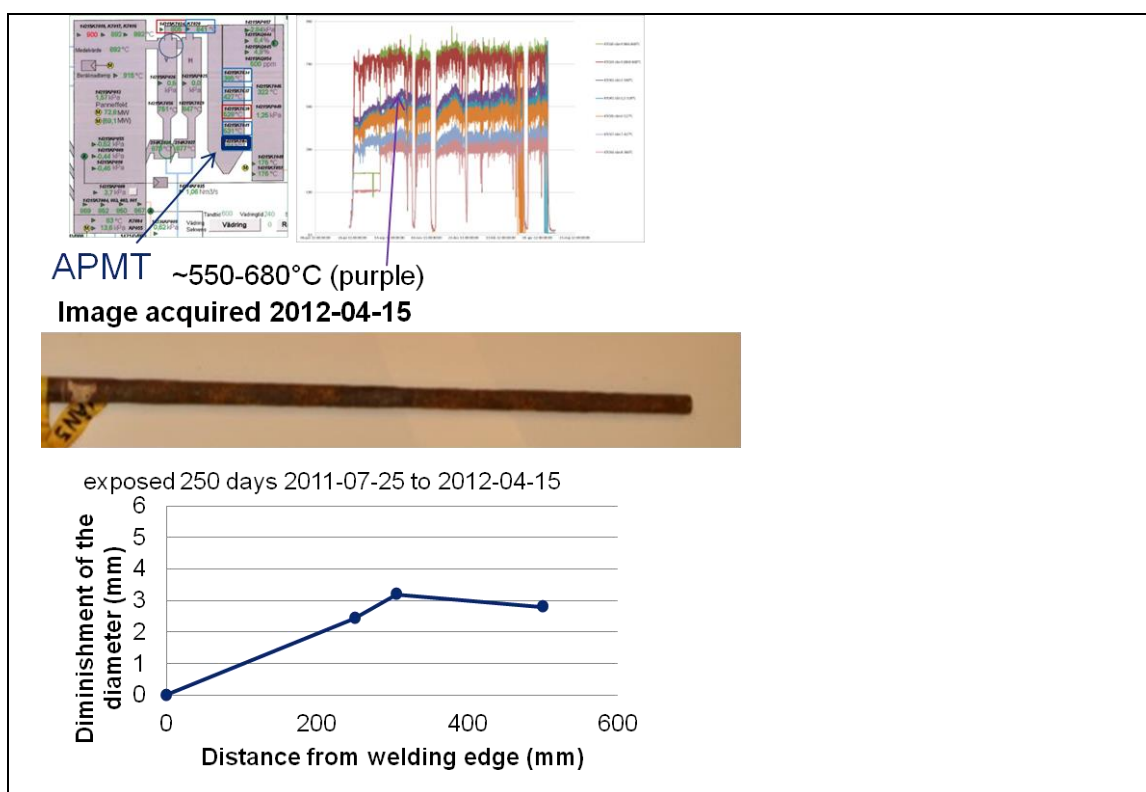
Figure 6-57. Image and material loss diagrams of the thermal shield tube exposed at the positions KT043, together with illustrations of the position and temperature during the exposure.

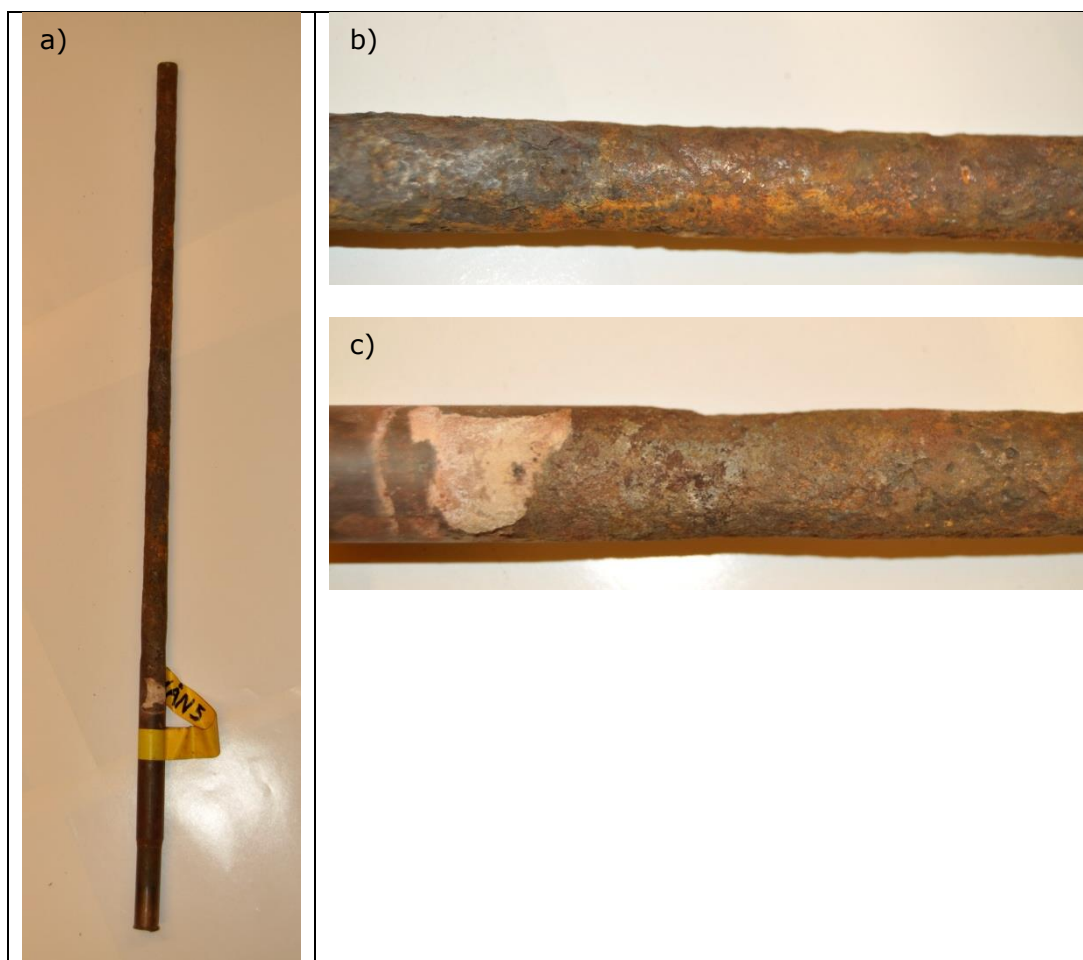
*Figure 6-58. Images of the thermal shield tube exposed at position KT043.*

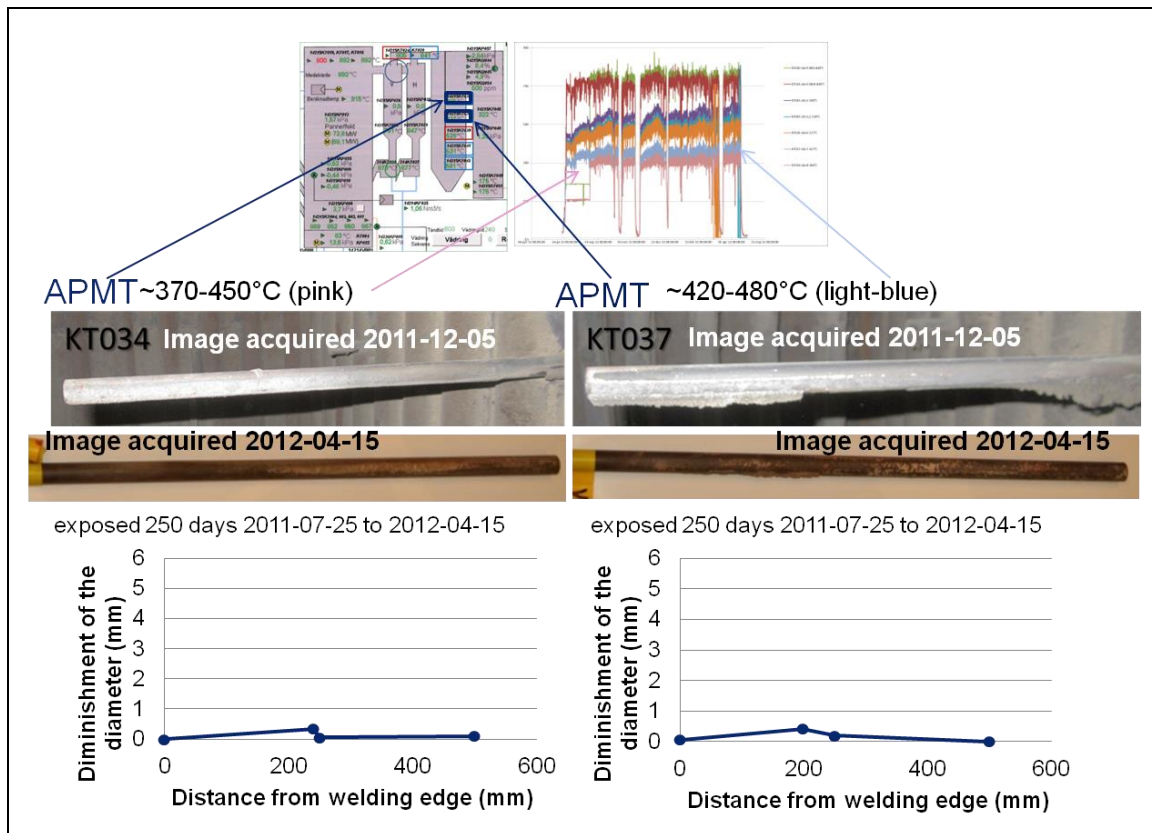
Figure 6-59. Image and material loss diagrams of the thermal shield tubes exposed at the positions KT034 and KT037, together with illustrations of the positions and temperatures during the exposure.

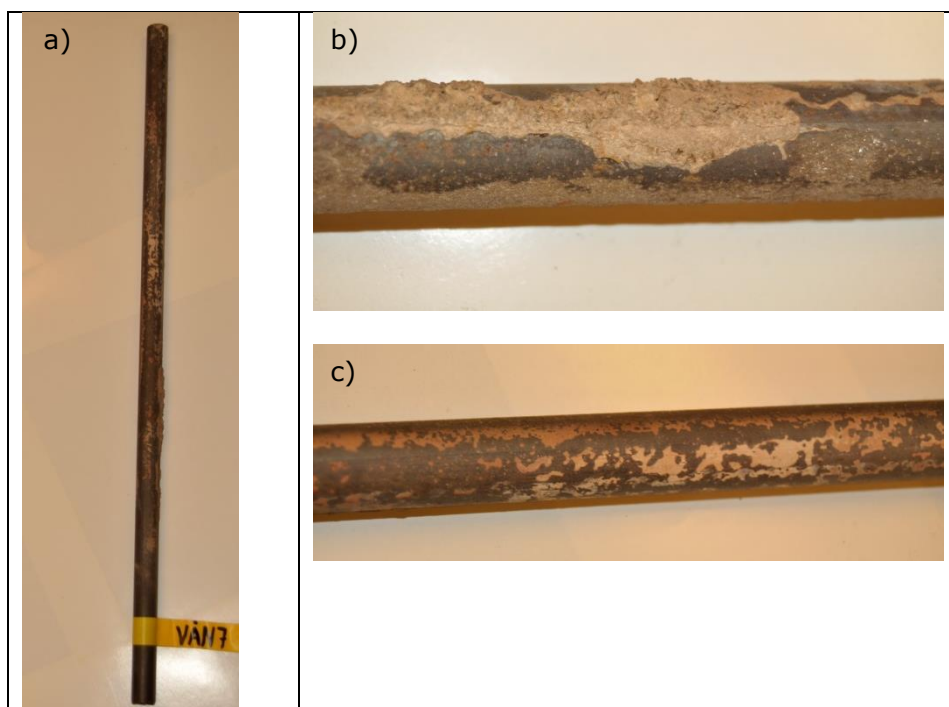
Figure 6-61. Images of the thermal shield tube exposed at position KT037.  
 Figur 6-61. Bilder av termoskyddsroret som exponerats på position KT037.

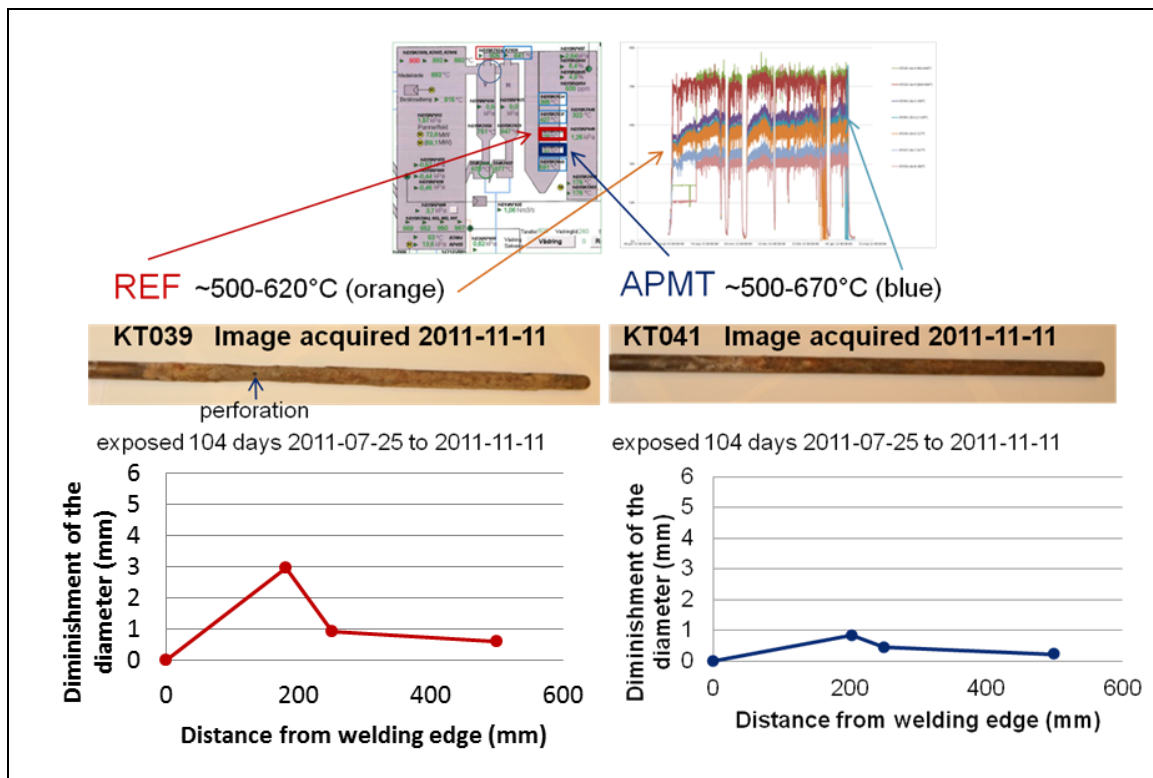
Figure 6-62. Image and material loss diagrams of the thermal shield tubes exposed at the positions KT039:1 and KT041:1, together with illustrations of the positions and temperatures during the exposure.

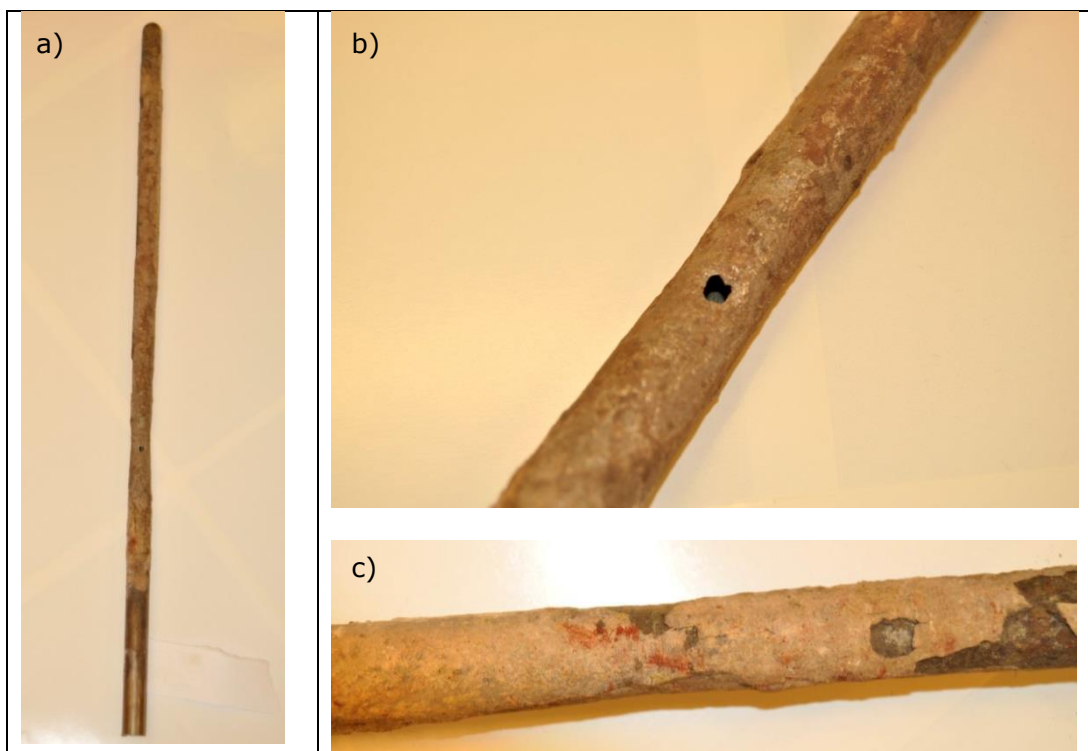
Figure 6-64. Images of the thermal shield tube exposed at position KT039:1.  
Figur 6-64. Bilder av termoskyddsröret som exponerats på position KT039:1.

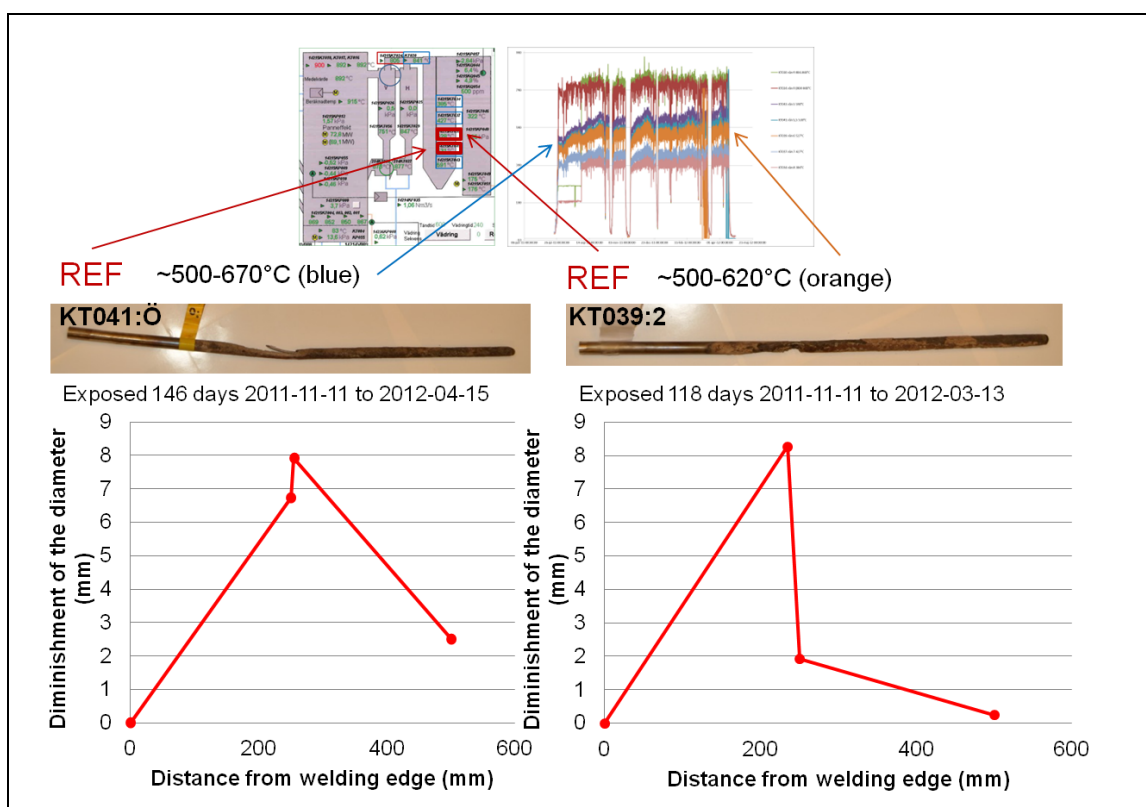
*Figure 6-65. Image and material loss diagrams of the thermal shield tubes exposed at the positions KT039:2 and KT041:Ö, together with illustrations of the positions and temperatures during the exposure.*

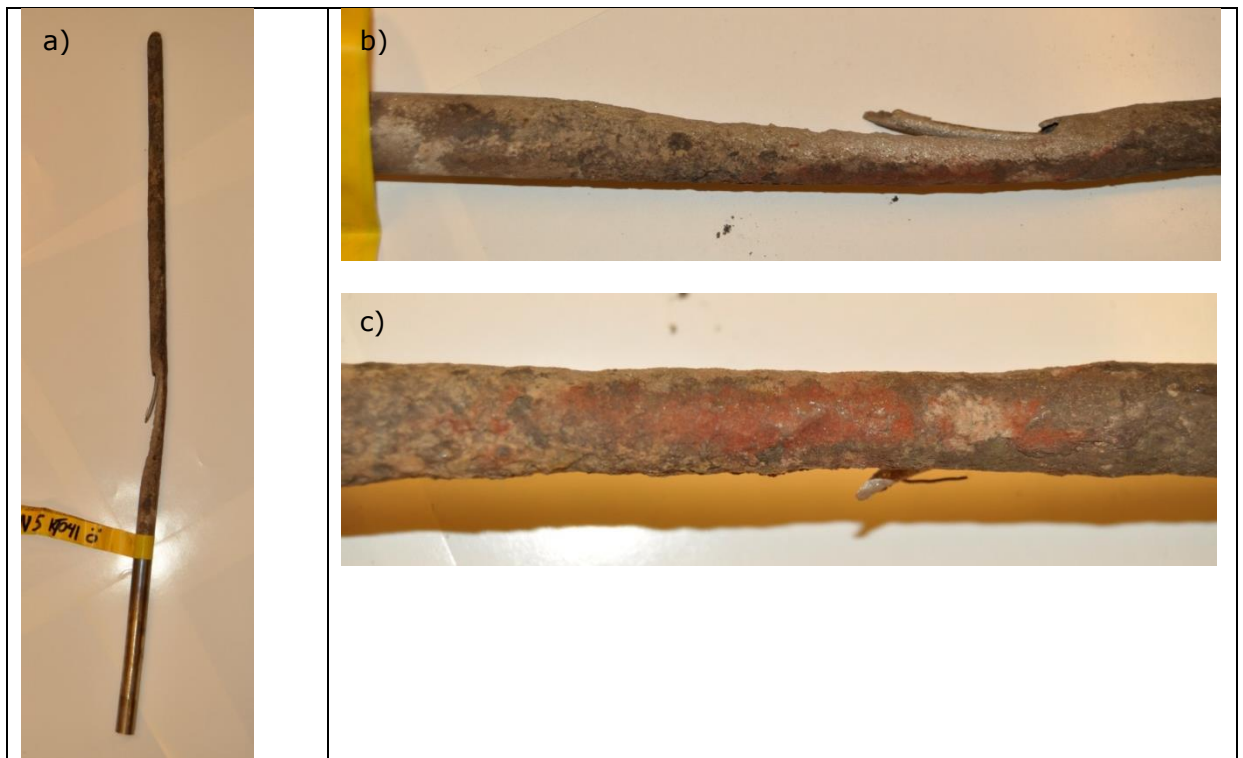
Figure 6-66. Images of the thermal shield tube exposed at position KT041:Ö.

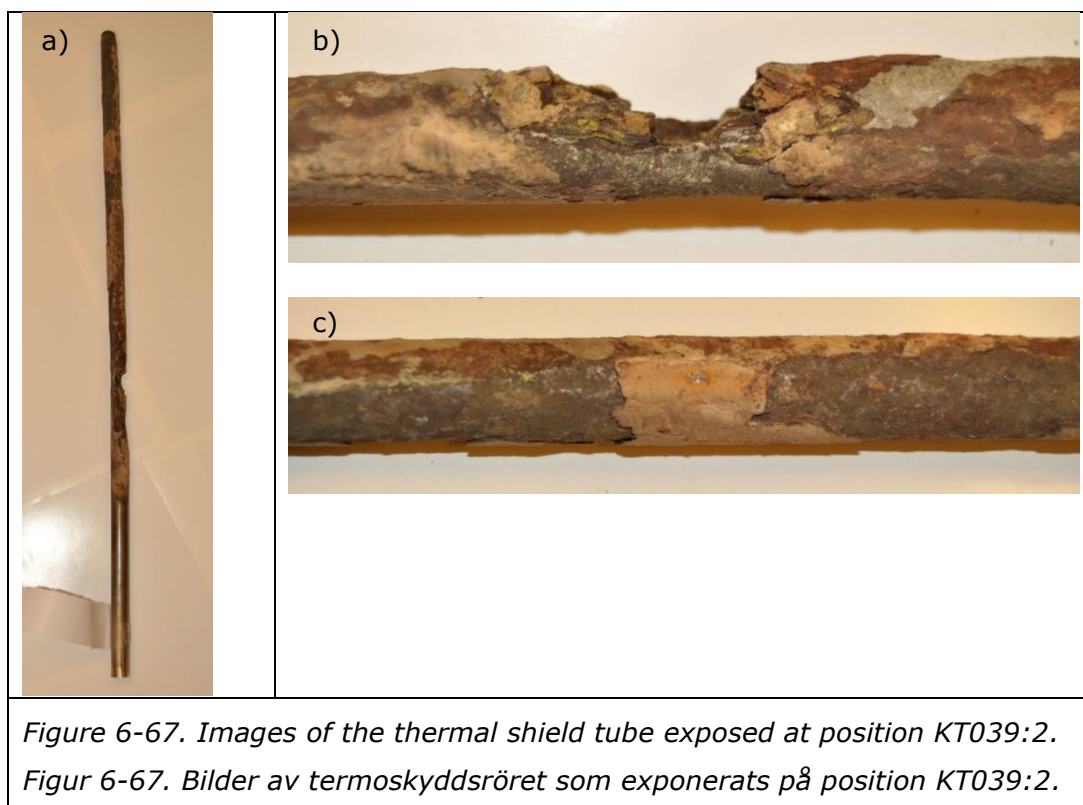
Because the reference appears to brake quite quickly at position KT039, it was decided to test if the lifetime of the thermo shield tube could be increased by using alloy APMT instead. Hence, an APMT tube was put in 2012-04-29 at position KT039 and was taken 2013-10-21 which results in 540 days of exposure. The tube was still intact without any perforation into the thermo couple. Measuring of the tube shows that the maximum diminishment of the diameter is approximately 2.50 mm, which is far less than that of IN 625 (104 days – 3 mm, 118 days – 8 mm).

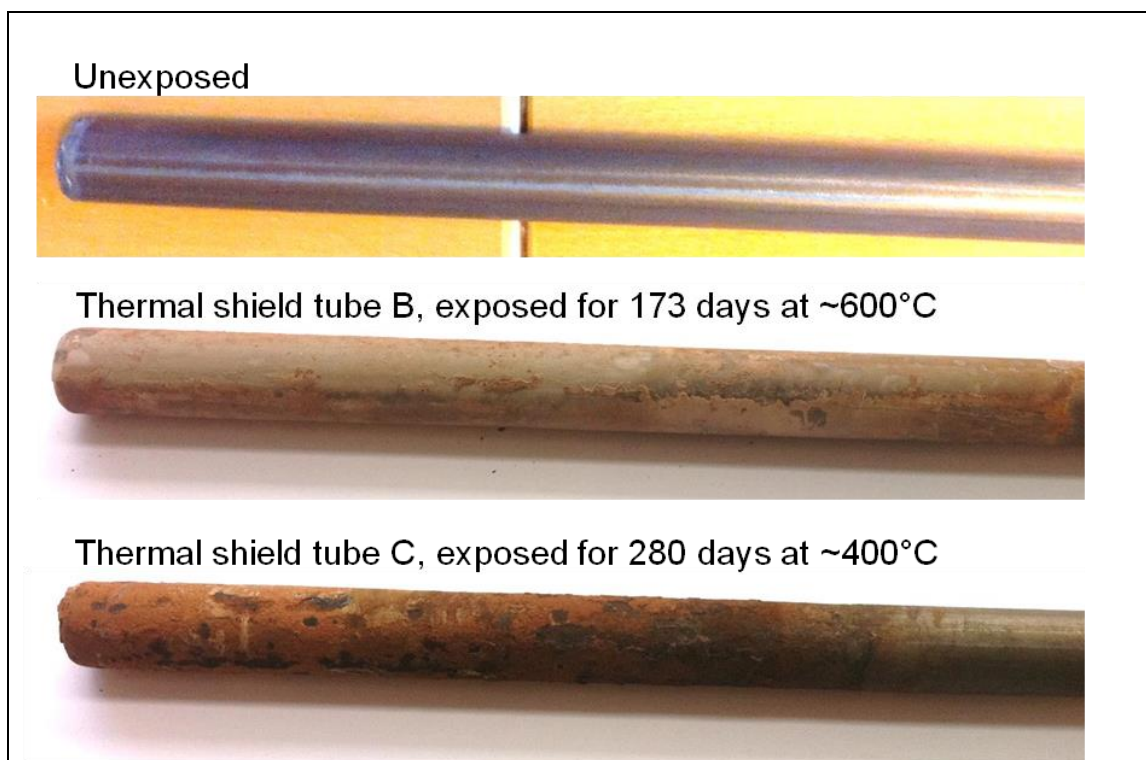
Figure 6-68. Images of thermal shield tubes. The upper one is not exposed. The ones below are exposed at Idbäcken, the middle one for 173 days at  $\sim 600^\circ\text{C}$  and the lower one for 280 days at  $\sim 400^\circ\text{C}$ .

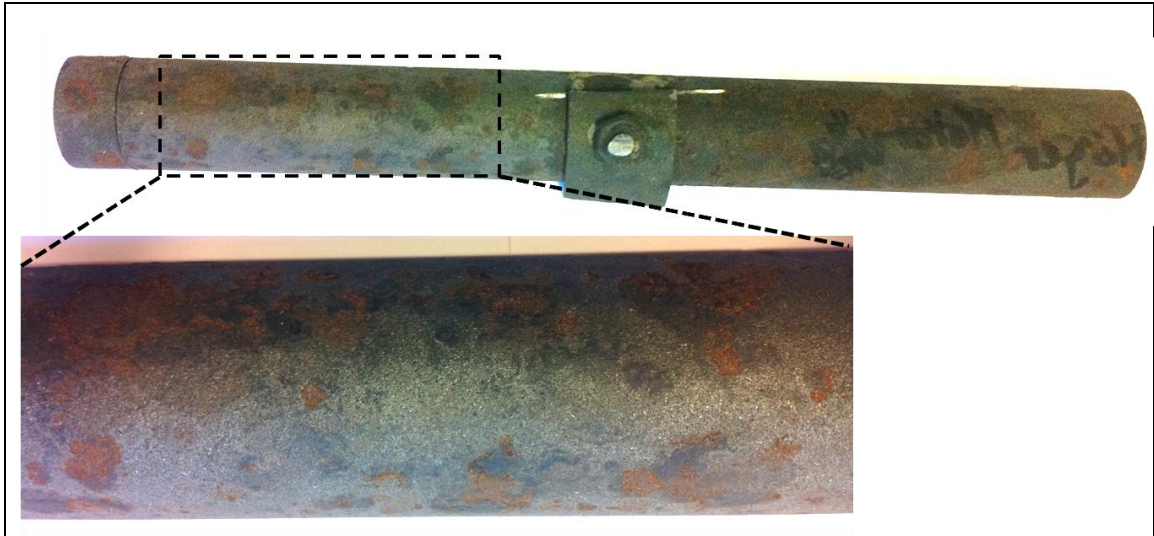
*Figure 6-75. Images of the shield sheet of the tertiary superheater after exposure at Idbäckens facility.*
