# KME 708

## High temperature corrosion in used wood fired boilers 2014-2016

17-03-21 Pamela Henderson, Annika Talus, Mattias Mattsson, Fredrik Niklasson

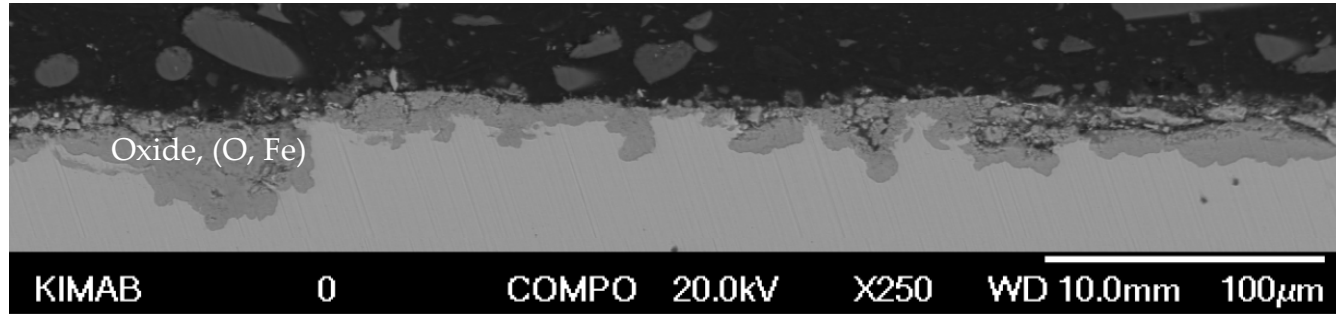
Fuel 1

For all temperatures the corrosion increases with higher Cl/Pb-content in the fuel.

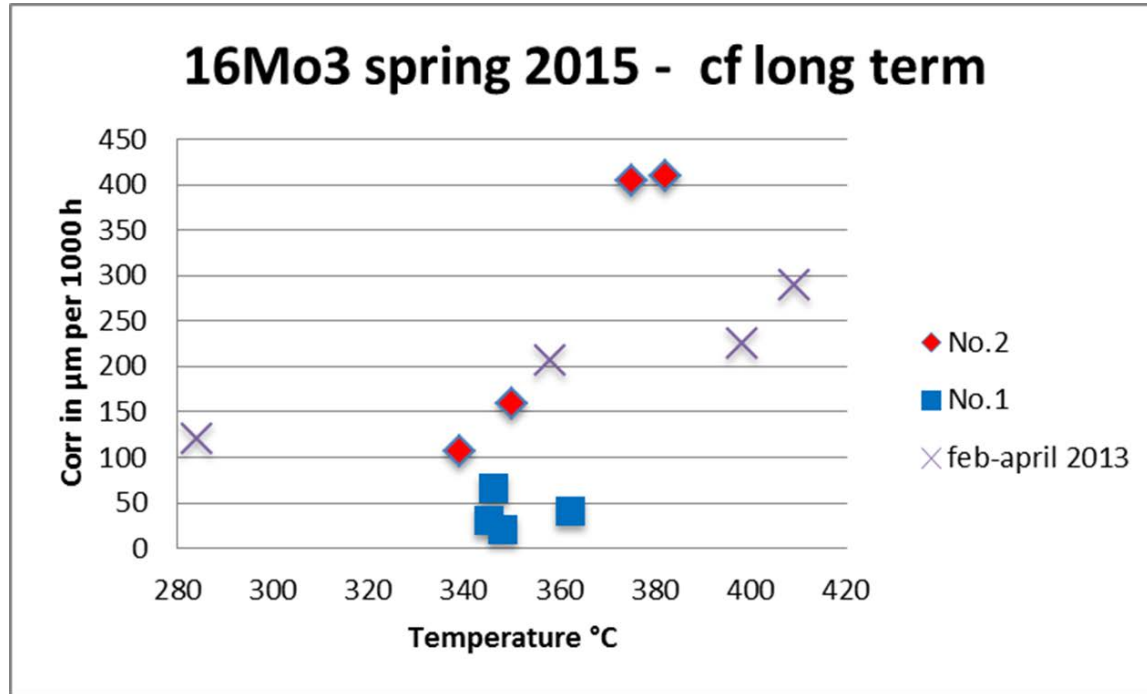
Fuel no. 2 (High Cl and Pb) causes more corrosion on 16Mo3 and is more temperature sensitive.

6 times more corrosion at the highest temperature

Corrosion of 16Mo3 was more sensitive to Cl/Pb content than corrosion of Alloy 625. Corrosion can be reduced by careful control of the fuel composition and by reducing the furnace wall temperature (reducing boiler water pressure).

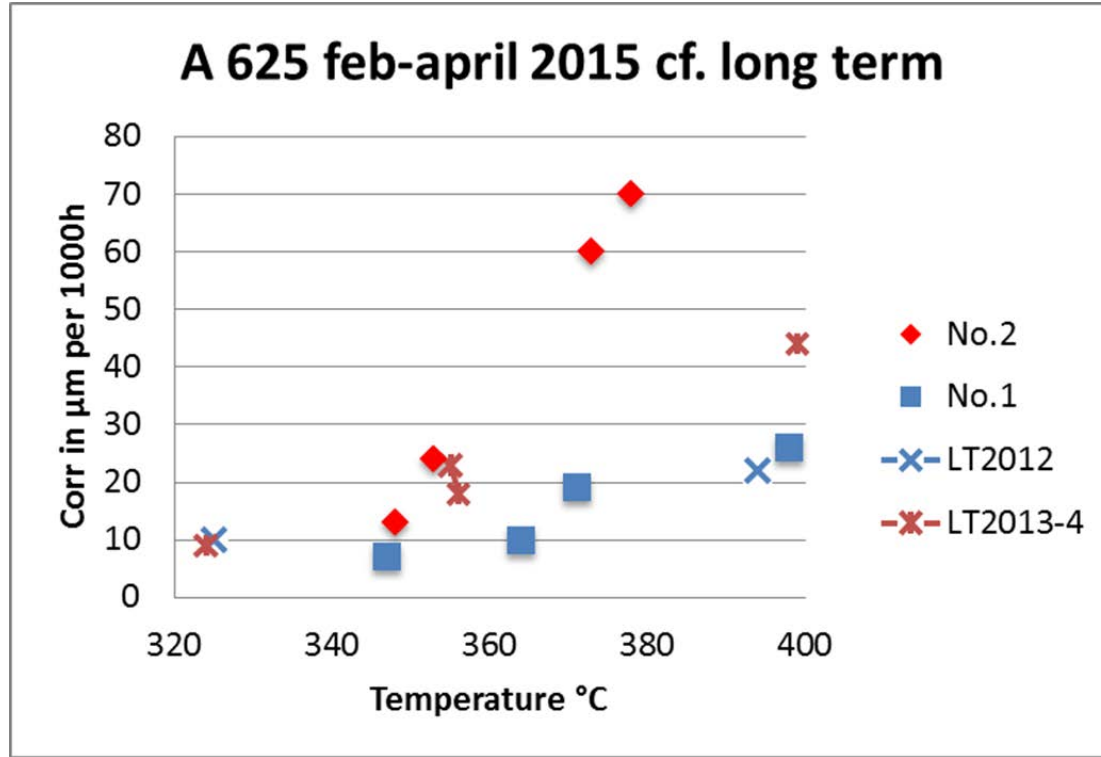
Fuel no. 2 (High Cl and Pb) causes more corrosion on Alloy 625 and is more temperature sensitive.

3 times more corrosion at the highest temperature.

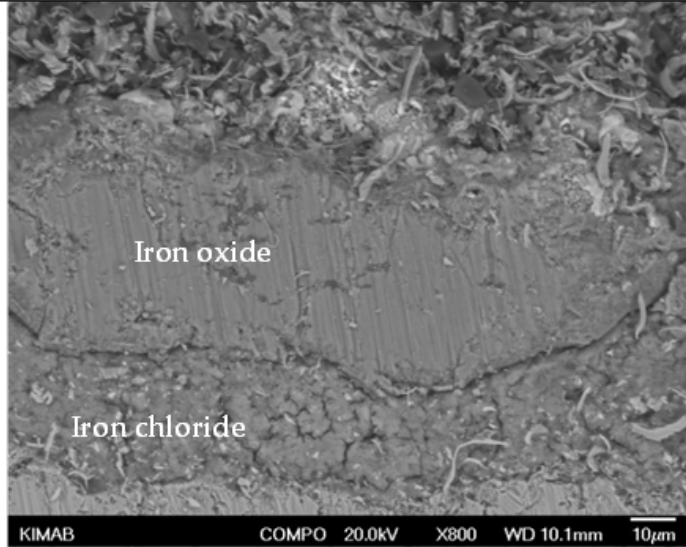
a)

Fuel 1

For 16Mo3, iron oxide and iron chloride were found as corrosion products and **Pb-rich compounds were found in the samples exposed to Fuel 2, but not Fuel 1.**

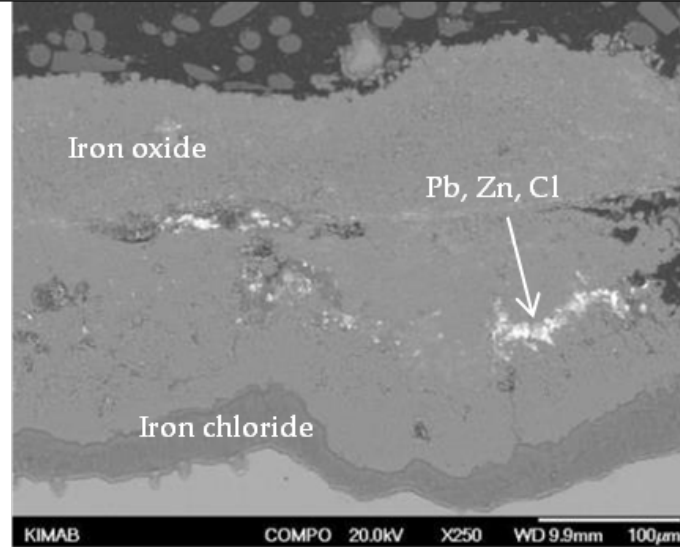
b)

Fuel 2

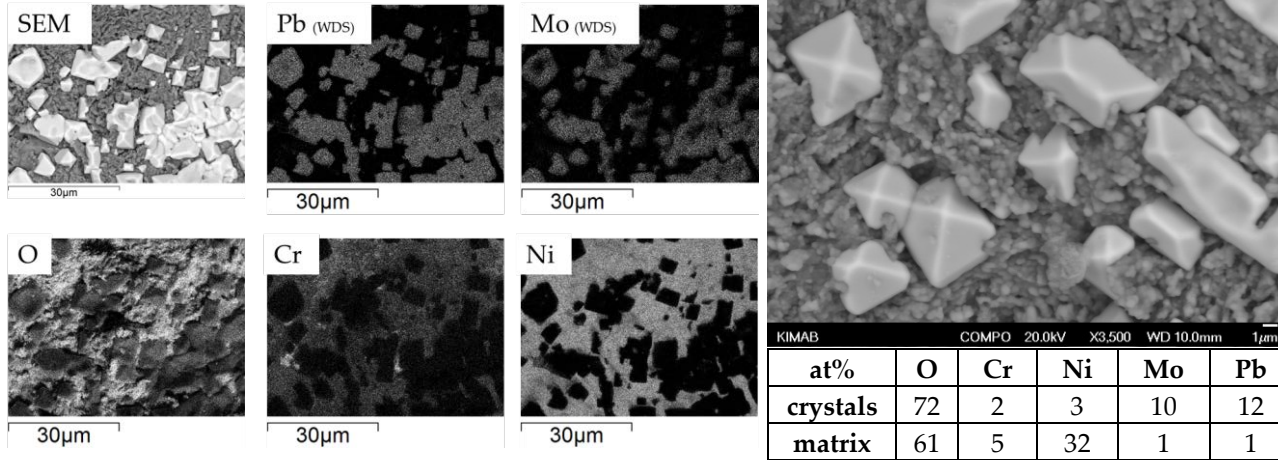
Lead molybdate,  $\text{PbMoO}_4$ , was found on the surface and in the cross sections of Alloy 625 samples exposed in Fuel 2 at temperatures of 370°C and higher.  $\text{PbMoO}_4$  was identified by EDS analysis and X-ray diffraction.

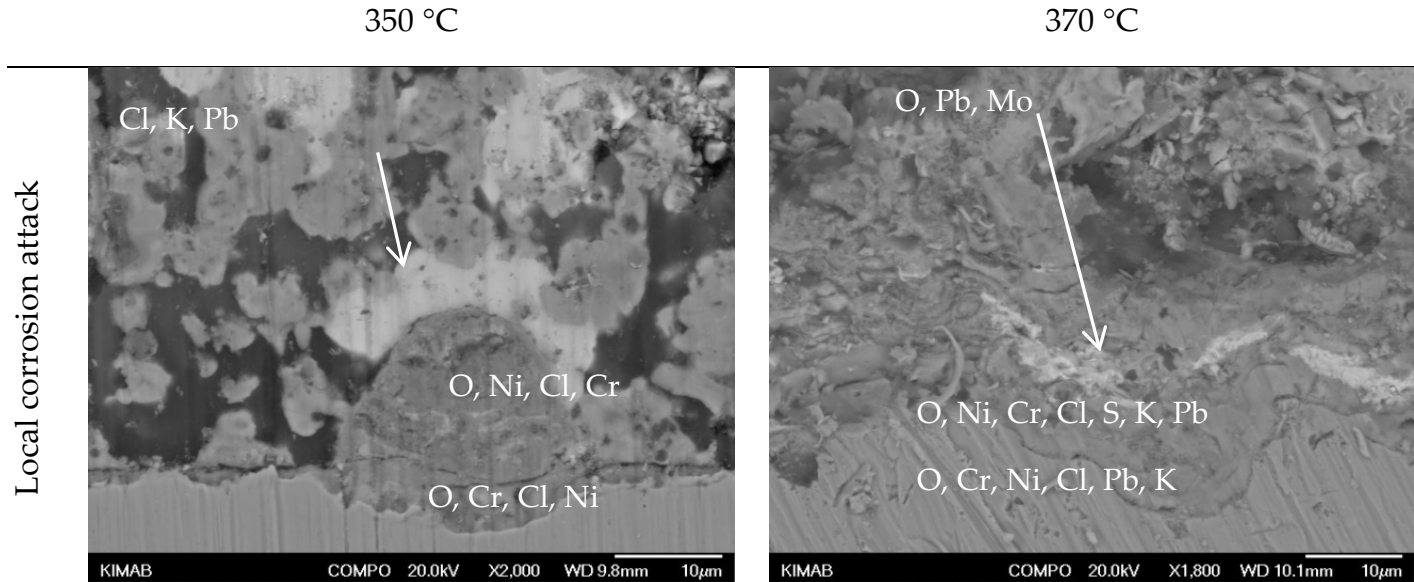
At lower temperatures (350 °C) no lead molybdate  $PbMoO_4$ , was found in the corrosion products but compounds rich in Pb, K and Cl were often found in a deposit -alloy mixture

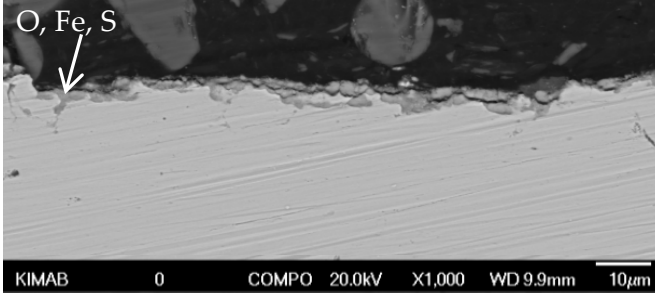
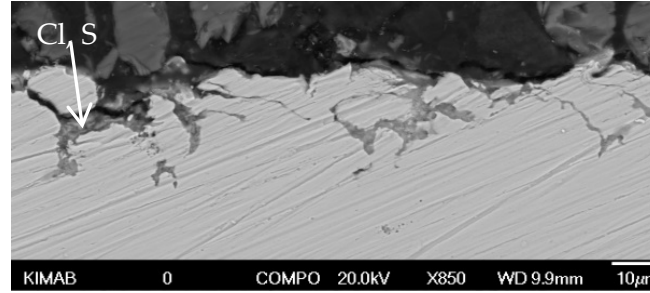
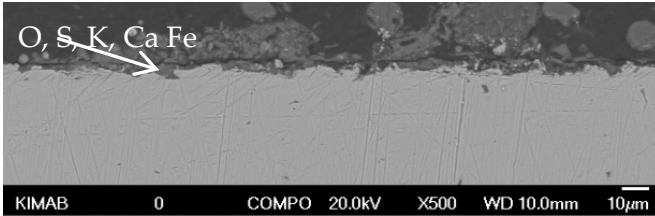
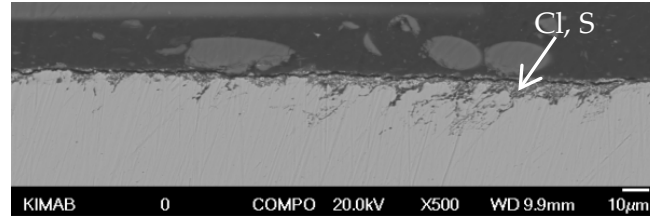
More Cl detected at corrosion front and more internal corrosion with Fuel 2.

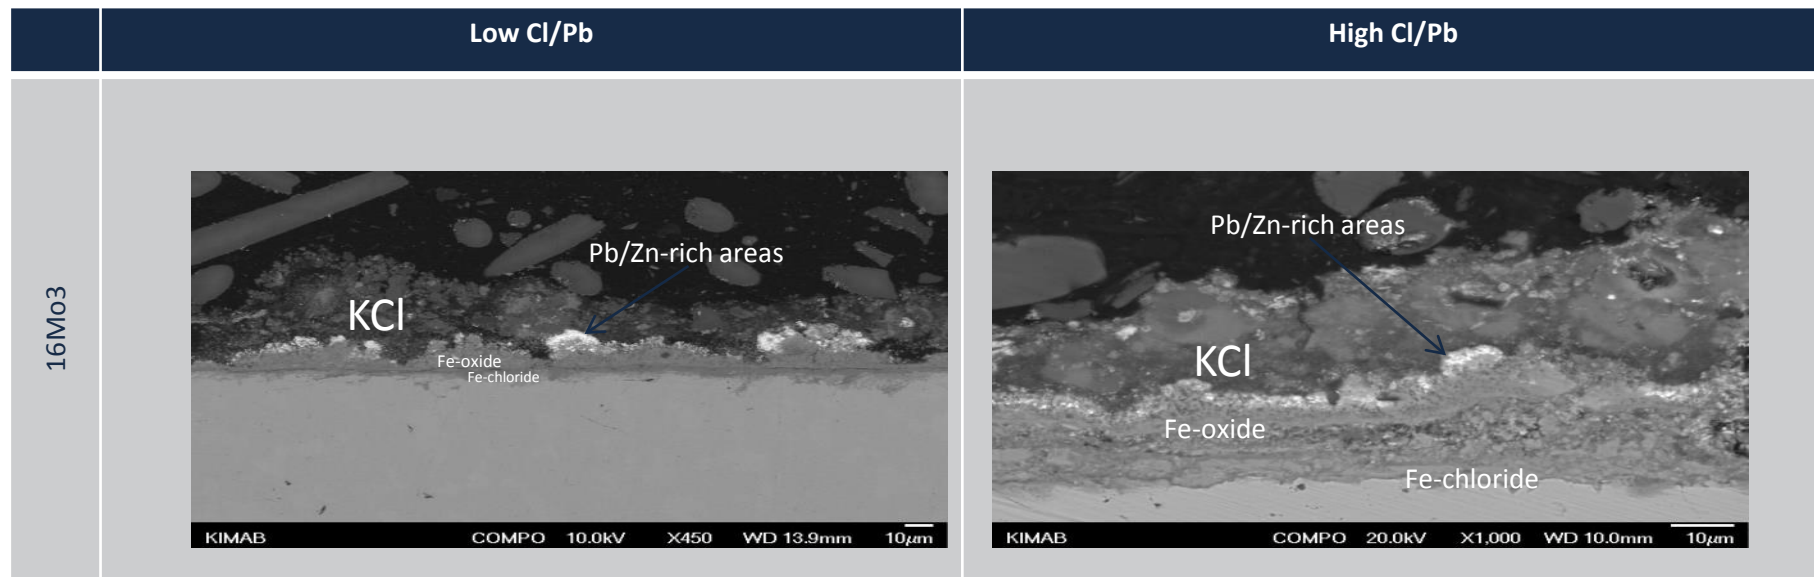
Results show that the corrosion increases when Pb/Cl-content in the fuel increases even though not dramatically after 8 h. Fe-chloride layer is thicker for Fuel 2  
(Note the difference in magnification between the figures)

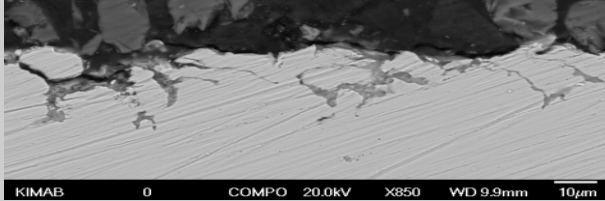
| | Low Cl/Pb | High Cl/Pb |
|---|---|---|
| 2.25Cr | <p>KIMAB 0 COMPO 20.0kV X1,000 WD 10.0mm 10µm</p> | <p>KIMAB 0 COMPO 20.0kV X850 WD 9.9mm 10µm</p> <p>More internal oxidation with Cl in grainboundaries. Spalled samples, according to SP in oxide/metal interface.</p> |

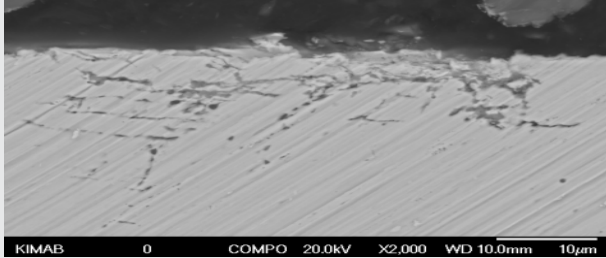
| | Low Cl/Pb | High Cl/Pb |
|---|---|---|
| 304L | <p>KIMAB 0 COMPO 20.0kV X1,500 WD 10.0mm 10µm</p> | <p>KIMAB 0 COMPO 20.0kV X2,000 WD 10.0mm 10µm</p> <p>Cl and internal oxidation</p> |
