# HIGH TEMPERATURE CORROSION IN USED-WOOD FIRED BOILERS

# **High temperature corrosion in used-wood fired boilers**

## **Part 1. KME-708**

ISBN 978-91-7673-089-8 | © 2017 ENERGIFORSK

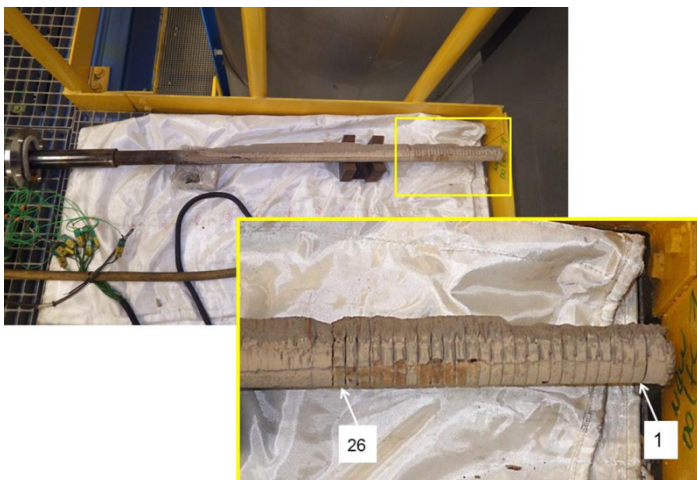
Fig. 2.2.5 . E.ON's superheater probe after 890 hours exposure (close up of probe tip with ring specimens).

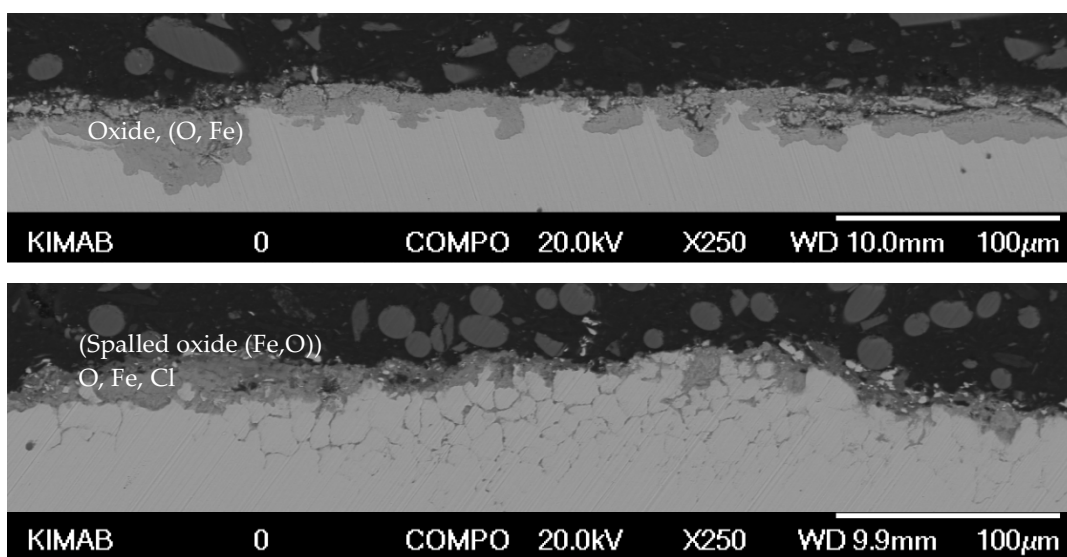
**Fig. 3.1.3** Section through the 13CrMo44 (SS2216) deposit rings exposed for 3h at 350°C. Upper- Fuel 1, Lower-Fuel 2. More corrosion (grain boundary attack) caused by Fuel 2.

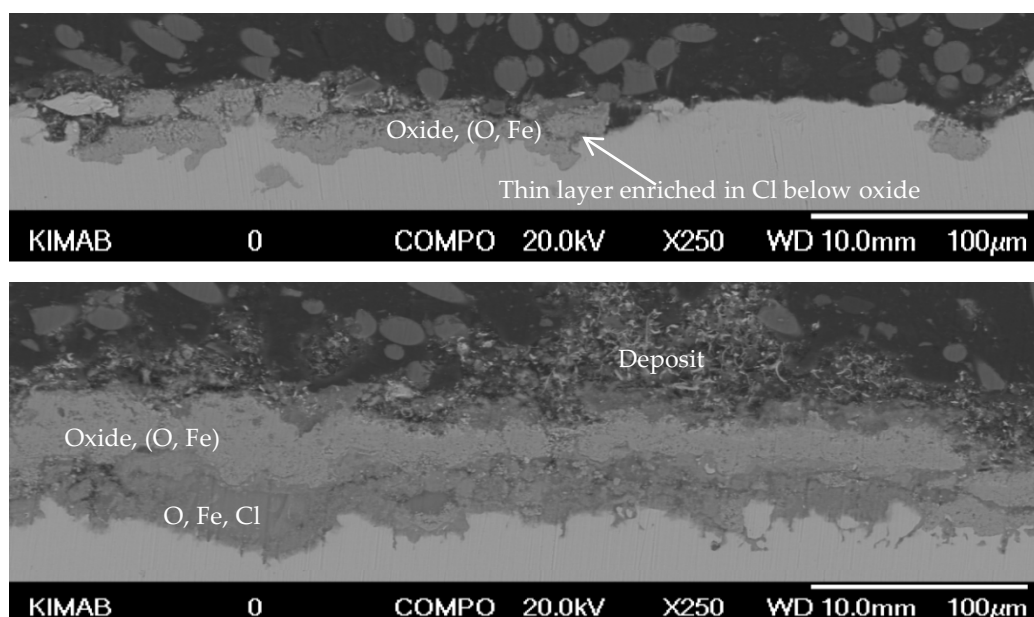
Fig. 3.1.4 Section through the 13CrMo44 (SS2216) deposit rings exposed for 3h at 450°C. Upper- Fuel 1, Lower-Fuel 2. More corrosion and thicker chloride layer caused by Fuel 2.

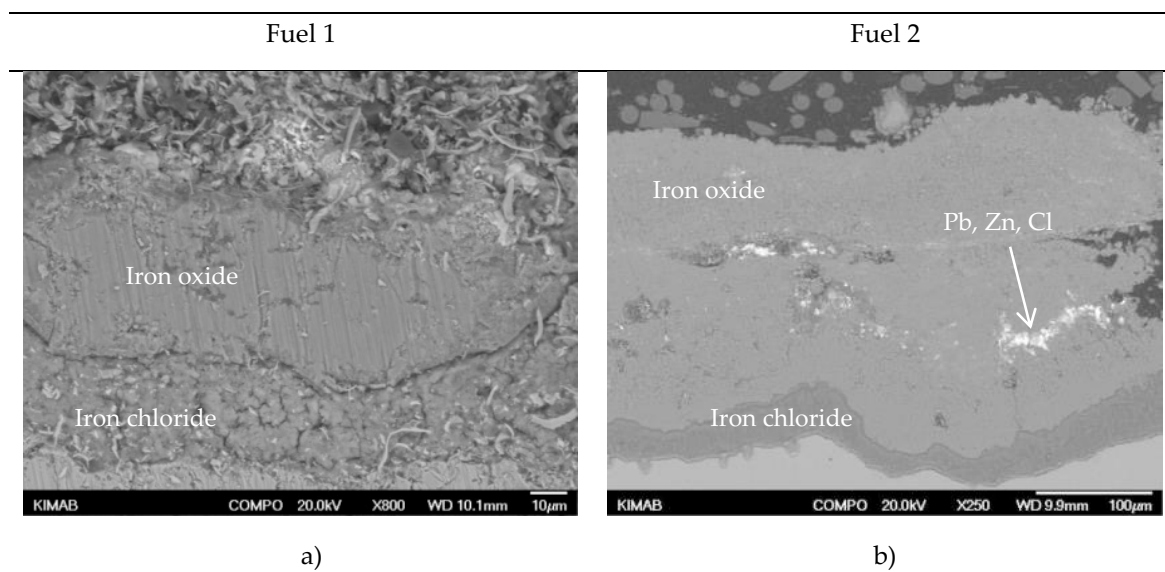
Metallographic analysis confirmed these results. For 16Mo3, iron oxide and iron chloride were found as corrosion products and Pb-rich compounds were found in the samples exposed to Fuel 2, but not Fuel 1, see Fig. 3.1.7

Fig. 3.1.7. Corrosion products on 16Mo3-samples with a metal temperature of 350 °C exposed on the furnace wall probe when firing a) Fuel 1 and b) Fuel 2. (Note: a) is at higher magnification x800 than b) x250.)

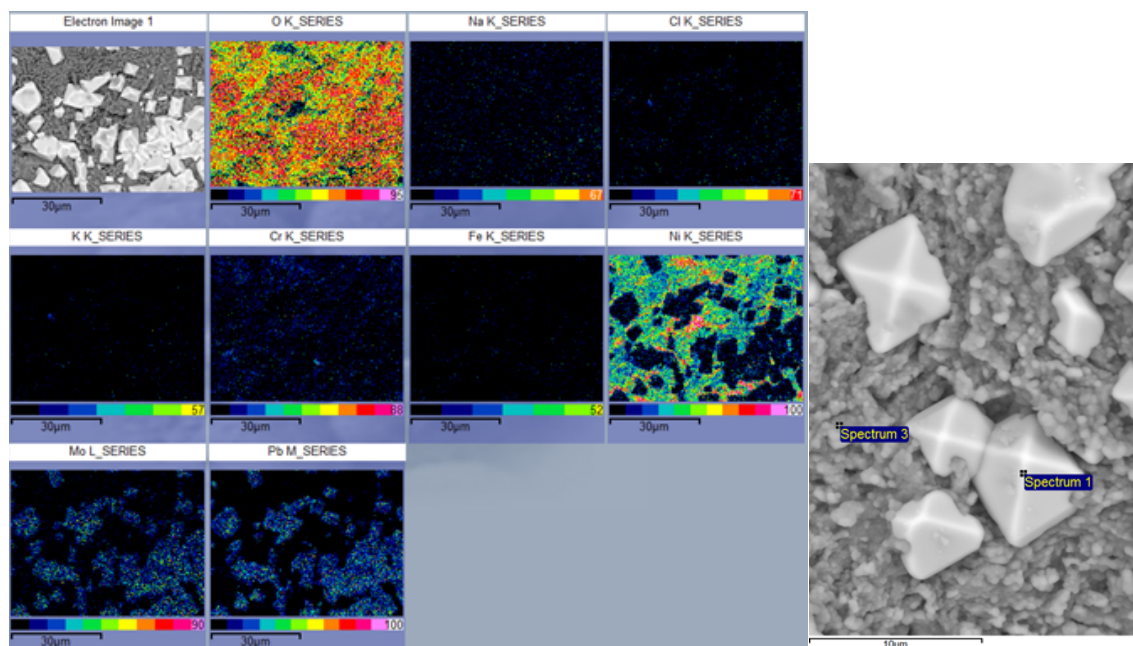
For the Alloy 625 samples local corrosion attack with nickel oxide and chromium oxide was observed and the numbers increased with increasing temperature. In addition lead molybdate,  $\text{PbMoO}_4$ , was found on the surface and in the cross-sections of the Alloy 625 samples exposed in Fuel 2 at temperatures greater than 370°C, see Figure 3.1.8. This compound was identified by EDS analysis and X-ray diffraction. At lower temperatures (350 °C) no lead molybdate was found in the corrosion products.

Fig. 3.1.8. The surface of Alloy 625 after 333 hours exposure at 373°C to Fuel 2 on a furnace wall probe.  
(Left) Mapping diagrams showing the presence of oxygen, molybdenum and lead rich areas.  
(Right) High magnification photo of lead molybdate crystals.

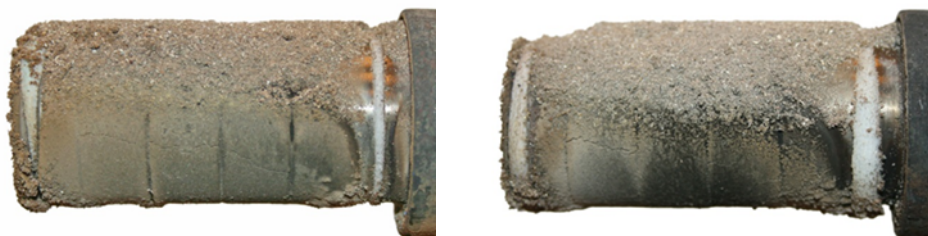
Fig. 3.2.1 Furnace wall probe at 380°C directly after removal from the test rig. Fuel 1 (left); Fuel 2 (right)

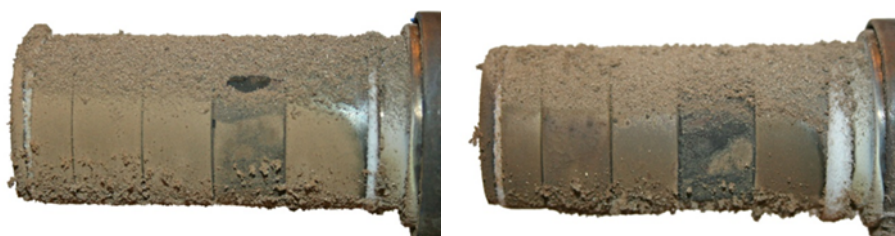
Fig. 3.2.2. Superheater probe at 550°C directly after removal from the test rig. Fuel 1 (left); Fuel 2 (right).

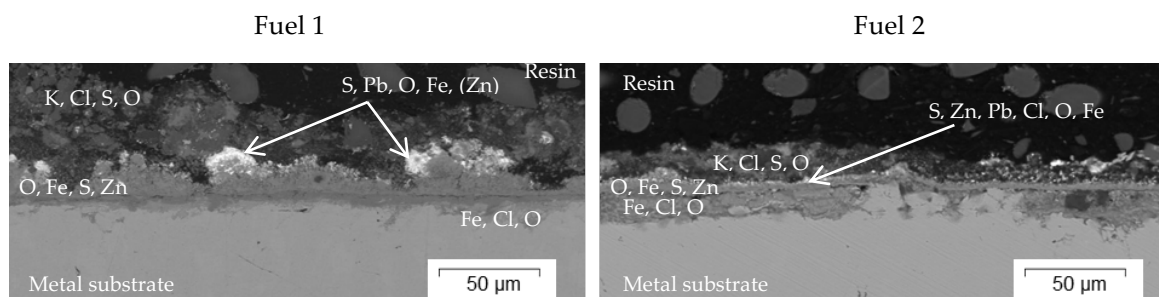
chloride closest to the metal substrate, Figure 3.2.4. Above this a layer rich in iron, sulphur and zinc was observed. On top of these two layers, compounds rich in sulphur and lead are present. Compared to the innermost layers this compound did not show high chlorine concentrations. Outermost a deposit rich in alkali chlorine and sulphur is present. Similar corrosion products were observed for both fuels. However, the sample exposed when firing Fuel 2 show a thicker layer of iron chloride closest to the metal substrate, indicating more corrosion.

Fig. 3.2.4. Cross section appearance for 16Mo3 after exposure at 380°C in the furnace wall position.

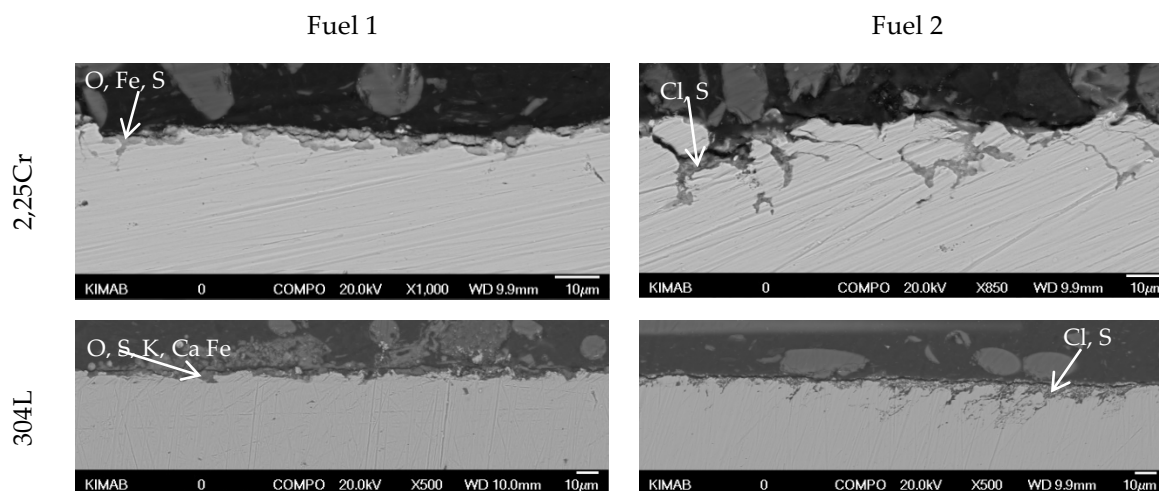
A similar behaviour was observed for the stainless steel 304L, although less corrosion was observed in general. For the sample exposed when firing Fuel 1 not so much corrosion was observed. When firing Fuel 2 internal corrosion with chlorine present in corrosion products increased.

Fig. 3.2.5. Cross section appearance of 2.25Cr and 304L exposed at 550°C in the superheater position.

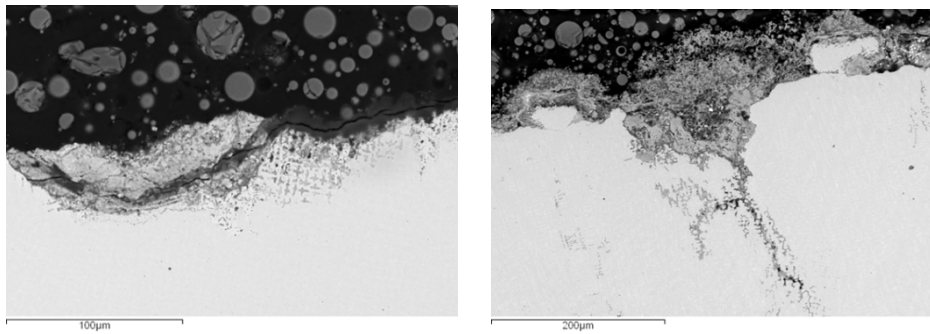
Laser clad IN625 : Surface highly damaged, accumulating Nb-rich slag and deposit. Selective internal oxidation of Cr-rich dendritic phases leading to S/Cl infiltration and localised pitting, (see Fig. 3.4.4)

**Fig. 3.4.4.** Laser clad IN625 after exposure showing selective internal oxidation.

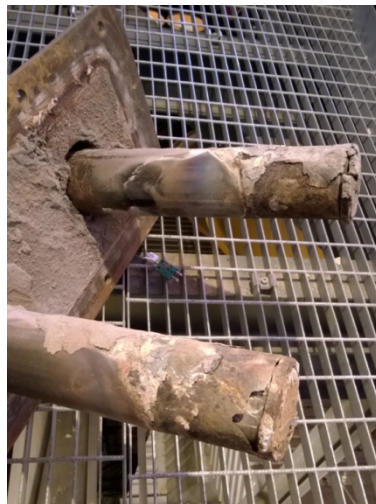
**Fig. 3.4.1** Probes after removal from furnace.

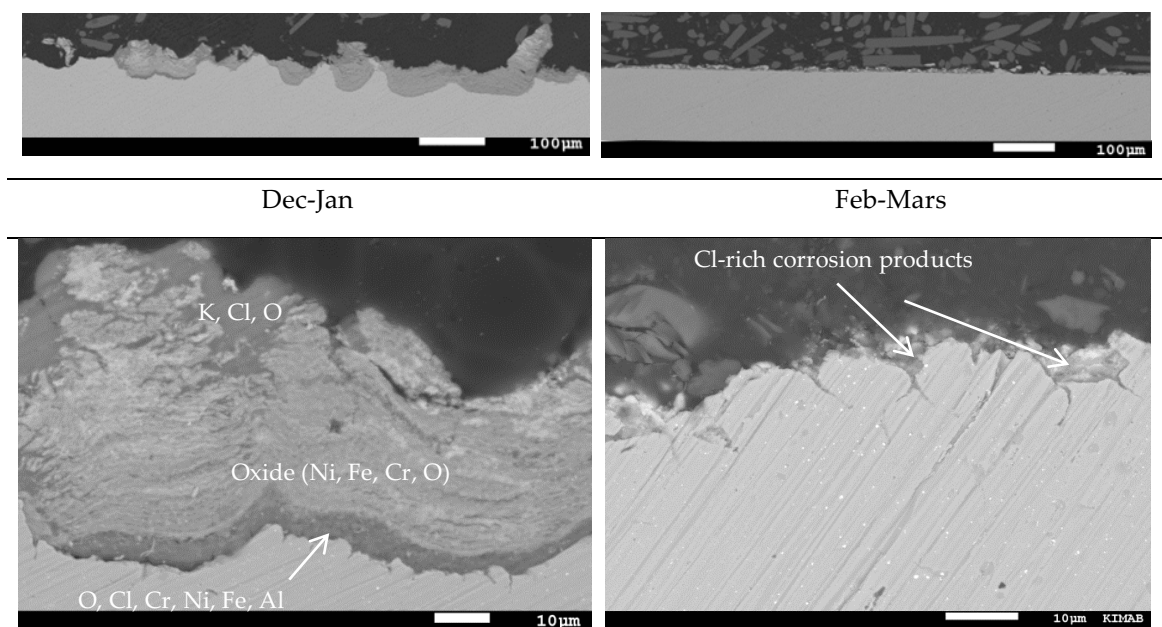
**Fig. 4.4.3** Cross section of Nikrothal PM58 showing local corrosion attacks for samples exposed in dec-jan (left) and feb-mars (right). Upper low magnification, lower high magnification.
