Background – deposits on boiler components

Project aim and content

Field exposures - Västhamnsverket

Field exposures - Avedöre

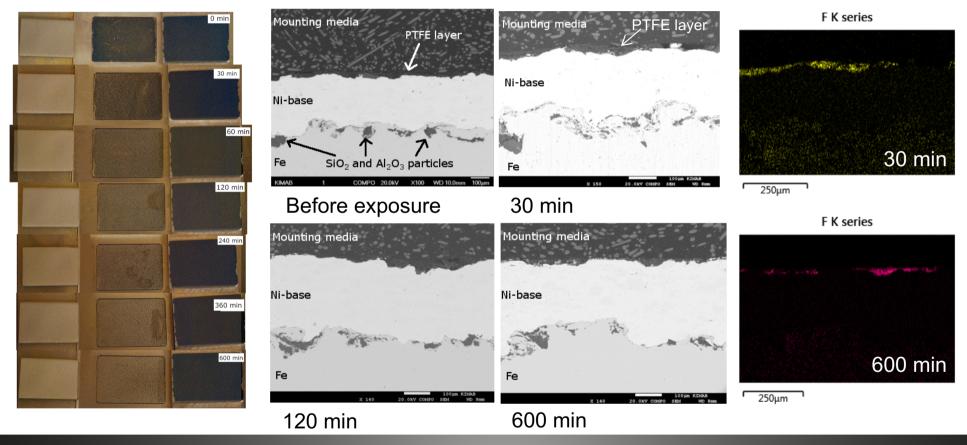
Photographs indicate 25-50 % coverage of top coating after 10 h wear test except for the graphite based material (almost nothing left

after 30 min)

SEM examination for materials with polymeric coatings (#1,6,8) indicate 50-65% coverage after 10 h wear test

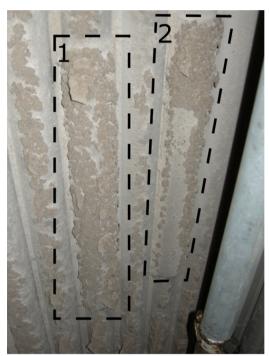
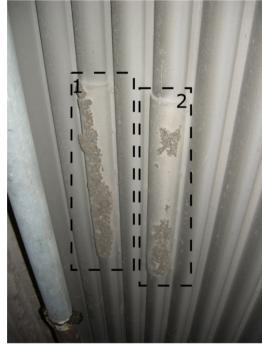
Västhamnsverket - Furnace

- More deposit on the samples
- Gas flow?
- Mounting of samples?
- Larger exposure area?

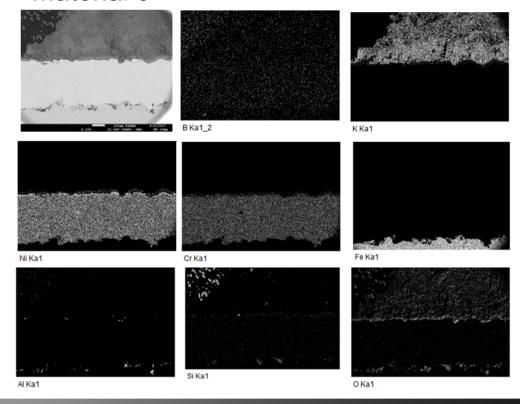
- Material 9 showed a thick deposit layer with slightly increased O signal at the interface CMP/deposit
- No CMP layer could be identified for the exposed materials 5 (Al-phosphate/ BN), 9, 10 after exposure
- Less deposit on material 10, might depend on material handling

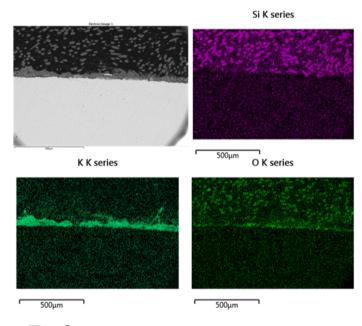
Reference

- Exposed materials: 4(BN-silicate), 9 (BN), 10 (graphite), reference (austenitic steel)
- No clear difference in amount of deposit between reference and samples (visual inspection)

Materials 9 (BN) and 10 (graphite) could not be identified at the metal/deposit interface

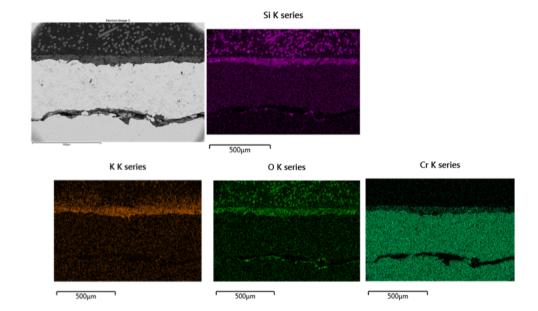
Material 4 – BN Silicate: slightly more explicit Si layer – CMP layer?
