COMBATING HIGH TEMPERATURE CORROSION BY NEW MATERIALS, TESTING PROCEDURES AND IMPROVED MATERIAL SELECTION

- CORROSION EXPOSURES IN THE WASTE FIRED CFB BOILER P15 AT HÄNDELÖ
- THE EFFECT OF INCREASED FRACTIONS OF WASTE WOOD ON WATER WALL- AND SUPERHEATER CORROSION

KME-711 & KME-720

L.PAZ, A.OLIVAS, T.JONSSON, A. PETTERSSON, F. MORADIAN, A.JONASSON, J. ASPEN, P. SCHNEIDER, J. MAHANEN, K. VÄNSKÄ, V. BARIŠIĆ, B.JÖNSSON, J. HERNBLOM, M. HUHTAKANGAS, J. LISKE

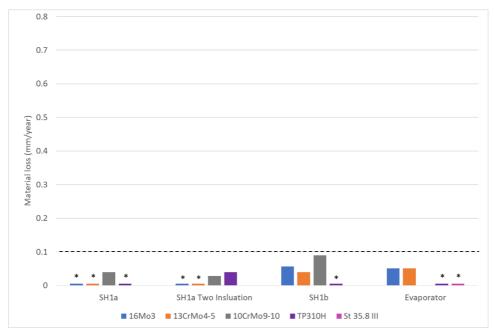
Figure 28. Material loss of the clamps removed from the P15 boiler in Händelö after 4 895 hours. The material temperature has been 360-380 °C. * No noticeable corrosion

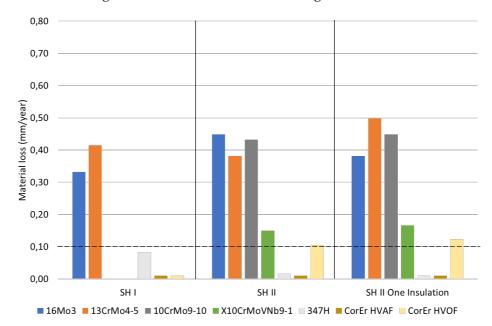
Figure 29. Material loss of the clamps exposed for 5277 hours with 40% waste wood in Örtoftaverket. The material temperature of the clamps has been about 450 °C (SH II), 475 °C (SH II) and 505 °C (SH II One Insulation), respectively.

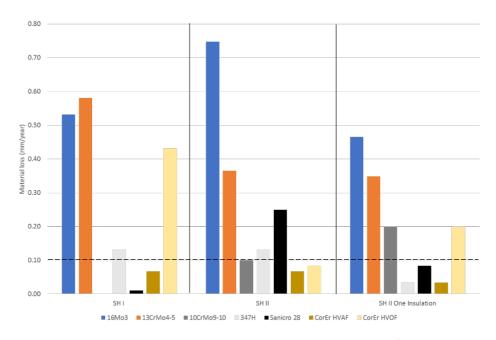
Figure 30. Material loss of the clamps exposed for 5265 hours with 45% waste wood in Örtoftaverket. The material temperature of the clamps has been about 450 °C (SH II), 475 °C (SH II) and 505 °C (SH II One Insulation), respectively.

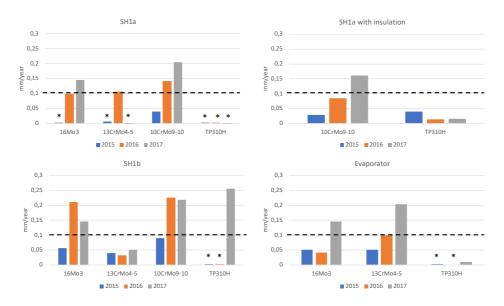
Figure 31. Material loss of the clamps exposed on several positions in the superheater region in the waste fired boiler P15 Händelö. The years refers to time for outtake from the boiler. * No noticeable corrosion

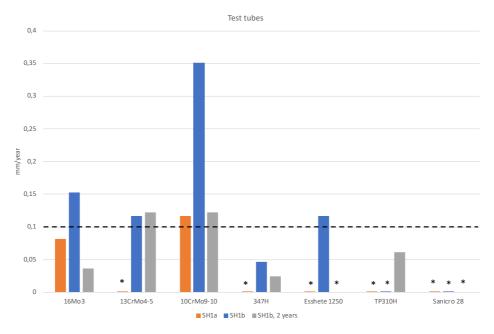
Figure 39. Material loss of the test tubes exposed on several positions in the superheater region in the waste fired boiler P15 Händelö. The years refers to time for outtake from the boiler. * No noticeable corrosion

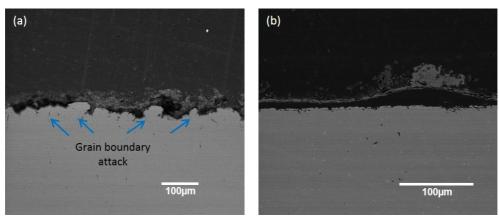
Figure 56. Pre-oxidized 347H reference exposure after 24 hours, a) an area where the corrosion attack has been initiated b) an area where the pre-formed oxide still has withstand the corrosion attack.

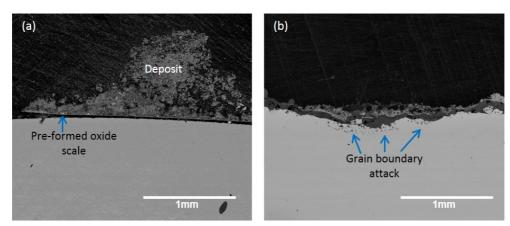
Figure 60. Pre-oxidized 347H reference exposure after 144 hours a) an area where where the pre-formed oxide still has withstand the corrosion attack. b) an area where an accelerated corrosion attack is seen. Steel grain boundary attack is observed as well as the formation of metal chlorides.

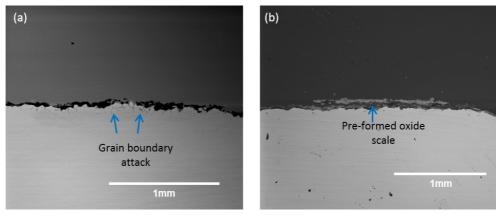
Figure 64. Pre-oxidized 347H exposure with ammonium sulphate addition after 24 hours, a) an area where the corrosion attack has been initiated b) an area where the pre-formed oxide still has withstand the corrosion attack.

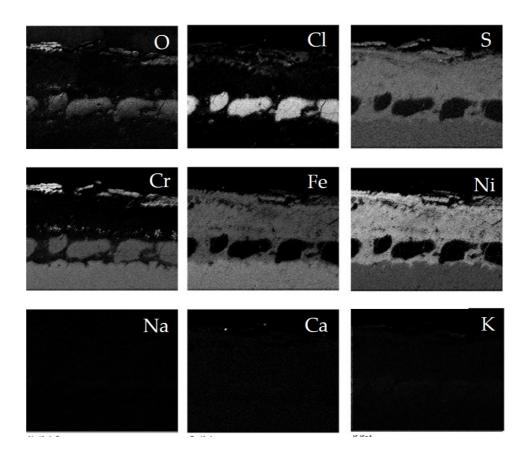
Figure 87. EDX mapping analysis of the Sanicro 33 sample after 144 hours exposure in the reference exposure. The thickness of the sample was measured before and after the exposure. The results are presented in Figure 88. The sample presents a maximum material loss of 0.22 mm in the flue gas side. The material loss is close to zero on the lee side of the sample.

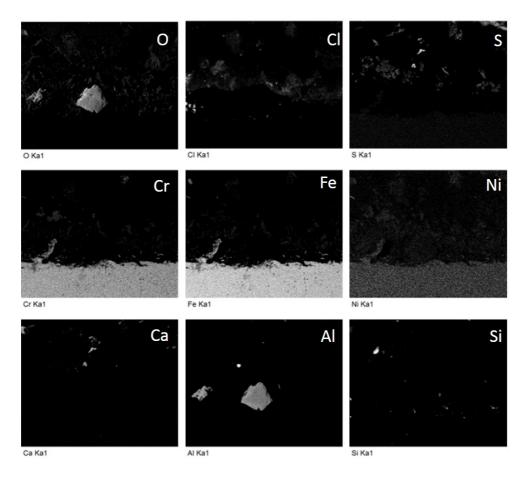
Figure 110. EDX mapping analysis of the APMT sample after 144 exposure with ammonium sulphate addition. The thickness of the sample was measured before and after the exposure. The results are presented in Figure 111. No or very little material loss was observed.

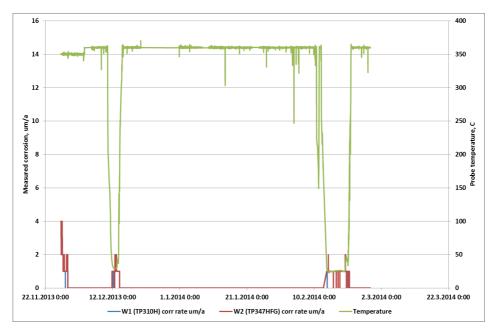
Figure 116. Measured corrosion rates were very low during the whole test campaign 1 in the horizontal pass of Händelö P15.

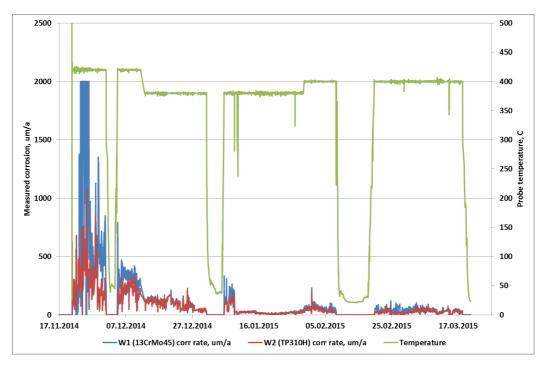
Figure 119. Very high corrosion rate values were measured in the beginning of the test campaign 2 in the empty pass of Händelö P15 - gaps in the data are due to malfunctions in remote connection.

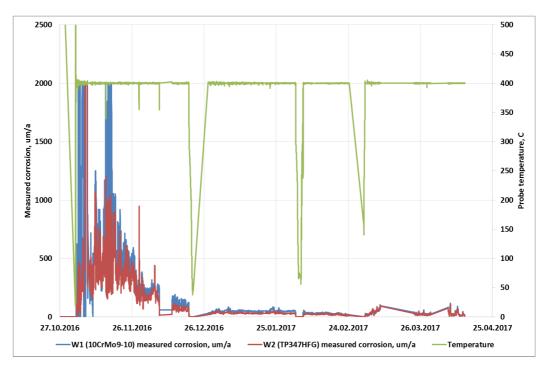
Figure 122. Very high corrosion rate values were measured in the beginning of the test campaign 3 in the empty pass of Händelö P15 - gaps in the data are due to malfunctions in remote connection.
