COMPOSITE METAL POLYMER (CMP) FOR NON-STICK IMPROVEMENTS IN CHP PLANTS

KME-715

MATTI HUHTAKANGAS, MH ENGINEERING AB

RAGNA ELGER, SWEREA KIMAB AB LEYLA WICKSTRÖM, SWEREA KIMAB AB RIKARD NORLING, SWEREA KIMAB AB

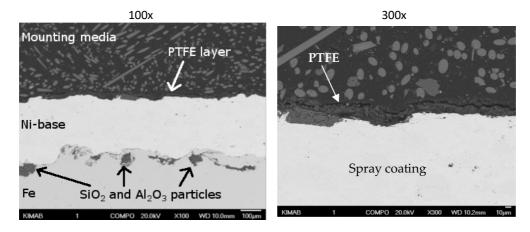
Figure 8. SEM images of as received material 1 (Alu-Releco, PTFE) in cross section at two different magnifications. Base material (carbon steel), spray coating (nickel base) and top coating (PTFE layer) are indicated in the figures. Scale bar is 100 μm at 100x magnification and 10 μm at 300x.

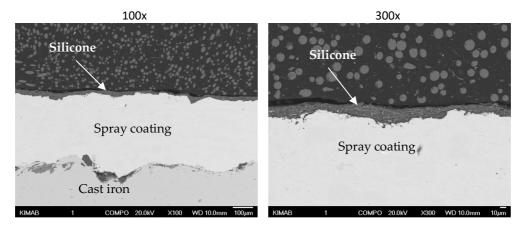
Figure 10. SEM images of as received material 8 (Aremco, Silicone) in cross section at two different magnifications. Base material (carbon steel), spray coating and top coating are indicated in the figures. Scale bar is $100 \, \mu m$ at $100 \, \mu m$

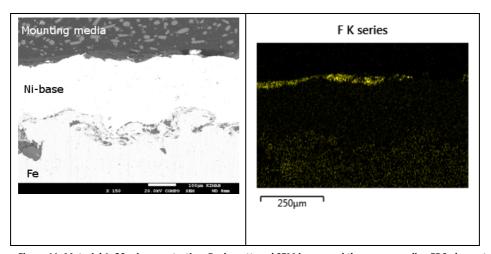
Figure 11. Material 1, 30 min wear testing: Back-scattered SEM image and the corresponding EDS elemental map of F at 150x magnification. F is clearly observed on top of the nickel coating. The fluorine signal in the base material is an artefact. The scale bar in the SEM image is $100 \, \mu m$.

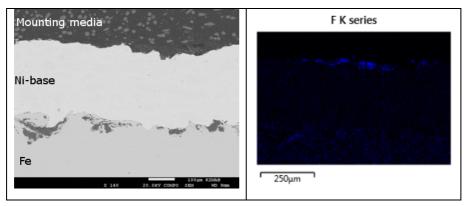
Figure 12. Material 1 after 2 h wear testing: Back-scattered SEM image and the corresponding EDS elemental map of F at 140x magnification. A distinct F-layer was detected on top of the nickel-base material, indicating presence of PTFE polymer. The scale bar in the SEM image is $100 \, \mu m$.

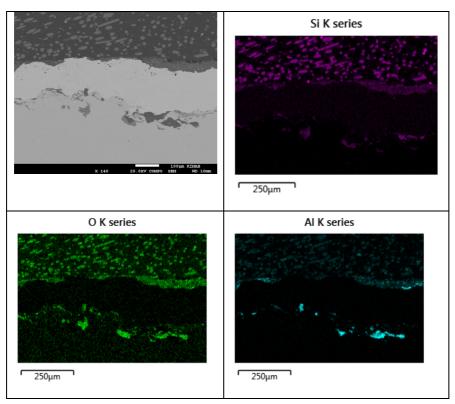
After 30 min wear testing of material 8, generally very good adhesion (\approx 90%) of the coating (silicone) was noted. There was occasional crevice formation between the sample and mounting media, which did not appear to have influenced the attachment of the top coating. After 2 h wear testing, material 8 showed app. 70% adhesion of top coating (silicone). Occasional crevice formation was observed between the sample and mount. In these locations, no top coating was observed, but it was not clear whether this was due to the mounting procedure or a consequence of the wear test. After 10 h wear testing of material 8, approximately half the examined surface (\approx 50%) exhibited top coating. Hardly any crevice between the sample and mount was observed. In Figure 18 - Figure 20, the backscattered image of material 8 after 30 min, 2 h and 10 h wear test is shown along with corresponding elemental maps of Si, Al and O.

Figure 18. Back-scattered SEM image of material 8 after 30 min wear testing. Al, Si and O are detected on the surface. Scale bar in SEM image is $100~\mu m$ at 140x magnification

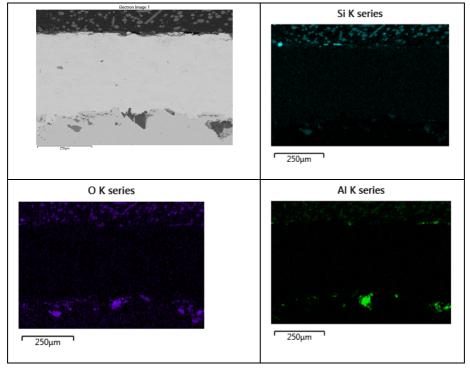
Figure 19. Back-scattered image of material 8 after 2 h wear testing. The scale bar in SEM image is 250µm at 140x magnification. Hardly any Si layer was detected, indicating little presence of the silicone top coating. The scale bar in SEM image is 250 µm.

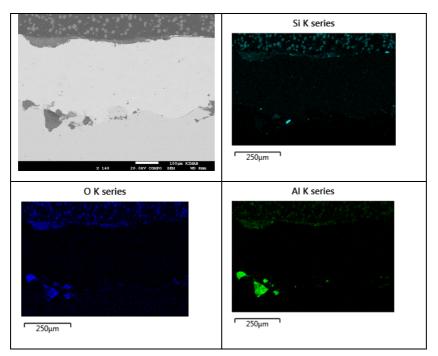
Figure 20. Back-scattered image of material 8 after 10 h wear testing. The SEM scale bar is 100μm at 140x magnification. In the corresponding elemental maps, a layer enriched in Si and O is observed.

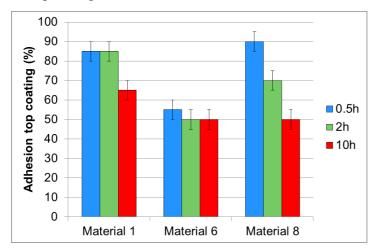
As shown, all examined materials (1, 6, 8) show some coverage of the top coating after the wear test for 10 h. A qualitative estimation in terms of surface coverage/adhesion of the top coating over the examined surface was carried out for each material (Figure 21).

Figure 21. Qualitative estimation of top coating coverage (polymer) of examined surface for material 1, 6 and 8 after wear testing for 0.5, 2 and 10h.

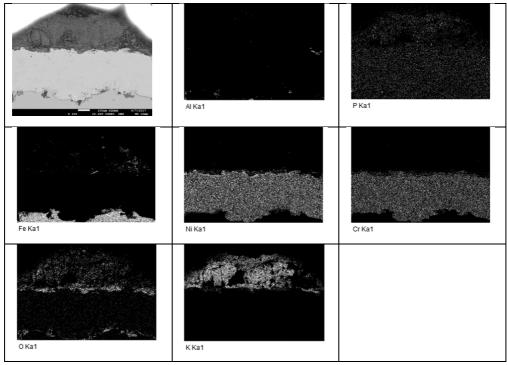
Cross-sections of material 5 are shown in Figure 28-Figure 29. The top coating of Alphosphate could not be observed in the analysis. Instead, a thick deposit layer with somewhat elevated level of oxygen close to the metal surface is shown. In Figure 29, it is shown that nickel and chromium is observed with oxygen in a band close to the metal surface. This could indicate a non-protective oxide layer on the nickel-base layer of the CMP.

Figure 28. EDS analysis results of material 5 after exposure at Västhamnsverket in the superheater (SH-HT). Sample removed from site in 2017. Scale bar in the SEM image is 100 μ m.

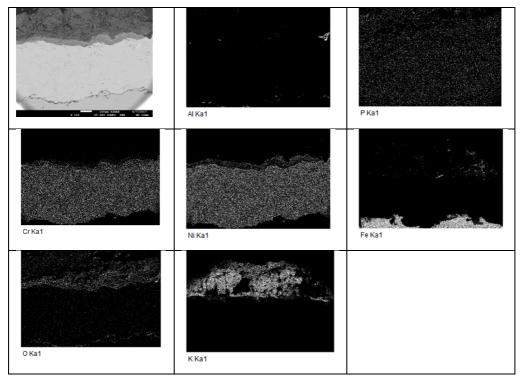
Figure 29. EDS analysis results of material 5 after exposure at Västhamnsverket in the superheater (SH-HT). Sample removed from site in 2017. Scale bar in the SEM image is 100 µm.

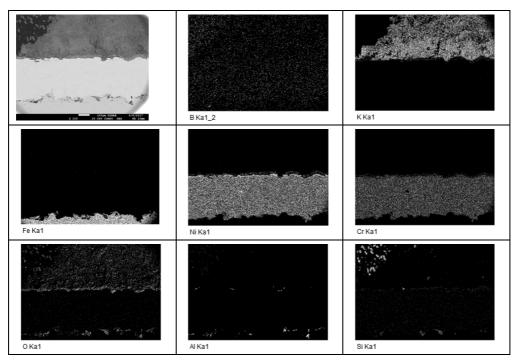
Material 9 also showed a thick deposit layer (Figure 30-Figure 32). In some instances, the CMP layer had detached from the base material. No increased signal for boron or nitrogen could be detected at the CMP surface. A slight increase in the oxygen signal was observed at the CMP surface, indicating an oxide layer. At the base-metal/CMP interface, areas with elevated oxygen content were observed together with Al or Si and are probably a result of the initial surface treatment of the base metal. Interesting to note is the increase in oxygen signal in the interface between CMP and base metal in Figure 32. Even though particles of SiO₂ and Al₂O₃ are expected in the interface, the signal from Al and Si do not form a continuous layer as the oxygen signal. This might indicate an initial corrosion attack and initiation of CMP detachment. Material 9 was not examined before exposure.

Figure 30. EDS analysis results of material 9 after exposure at Västhamnsverket in the superheater (SH-HT). Sample removed from site in 2017. Scale bar in the SEM image is $100~\mu m$.

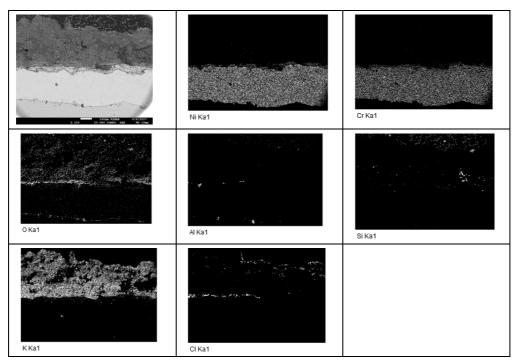
Figure 32. EDS analysis results of material 9 after exposure at Västhamnsverket in the superheater (SH-HT). Sample removed from site in 2017. Scale bar in the SEM image is $100 \, \mu m$.

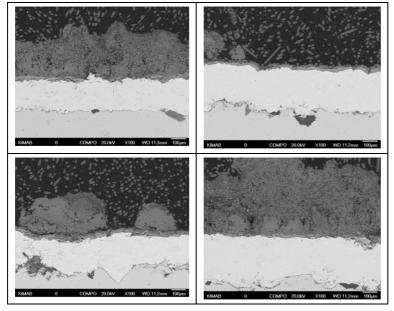
Figure 33. SEM images of material 10 after exposure at Västhamnsverket in the superheater (SH-HT). Sample removed from site in 2017. Scale bar is 100 μ m at 100x magnification.

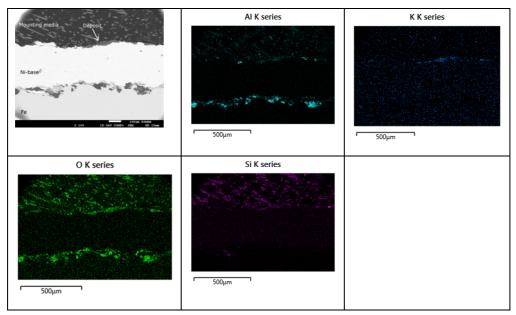
Figure 35. Back-scattered SEM image of material 8 after exposure in the superheater region (SH-LT). Sample removed 2016. Scale bar in the SEM image is $100\mu m$ at 100x magnification.

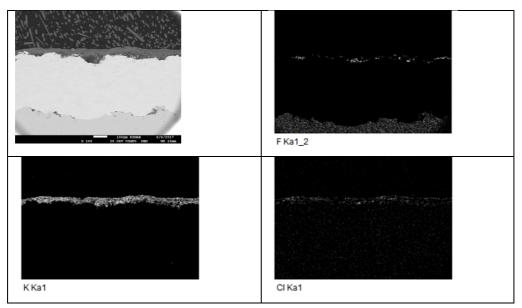
Figure 41. EDS analysis results of material 1 after exposure at Västhamnsverket in the economizer. Sample removed from site in 2017. Scale bar in SEM image is 100 μ m. The fluorine signal in the carbon steel is an artefact.

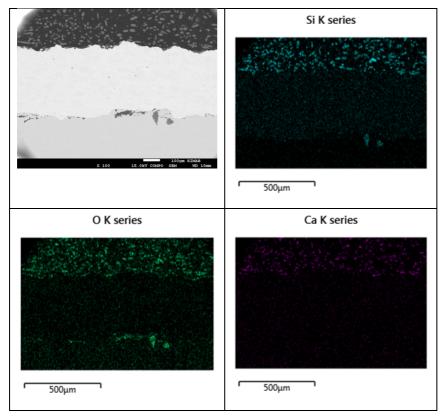
Figure 42. SEM images of material 6 after exposure at Västhamnsverket in the economizer. Sample removed from site in 2016. Scale bar at 100x magnification is 100 μ m. EDS analysis for O and Si included to image that the coating is absent. Ca included as reference for deposit originating from exposure.

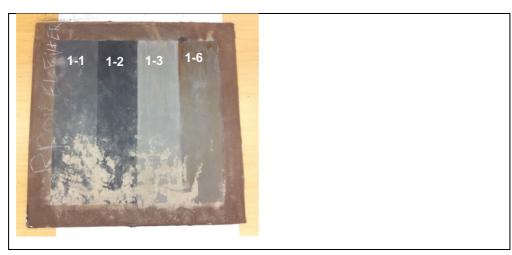
Figure 47. Material (from left) 1, 2, 3 and 6 after exposure in the ESP cone. Plate removed from site in 2017. For material 1 removed in 2016, good adherence of the PTFE layer was detected (Figure 48-Figure 49). Similarly good adhesion of the top coating was observed for the material removed in 2017, although it was missing in some regions (Figure 50-Figure 51). The amount of deposit was very low on the samples as discussed above.

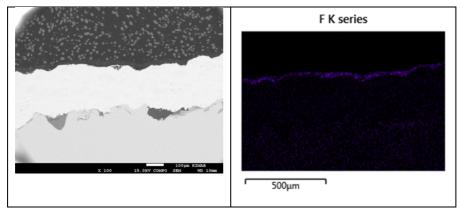
Figure 48. SEM images of material 1 after exposure at Västhamnsverket in the ESP cone. Sample removed from site in 2016. Scale bar at 100x magnification is 100 μ m. EDS analysis of fluorine included to the right.

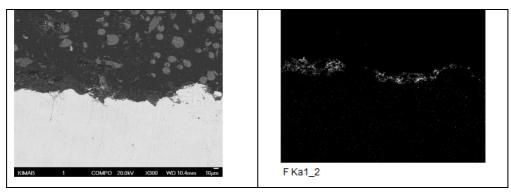
Figure 51. SEM image at 300x magnification and EDS analysis of F of material 1 after exposure at Västhamnsverket in the ESP cone. Sample removed from site in 2017. Scale bar in SEM image is 10 µm.

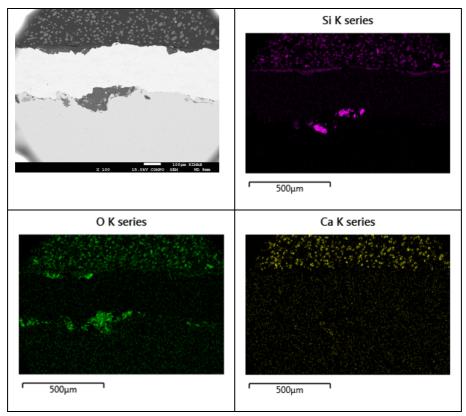
Figure 52. EDS analysis of material 6 exposed in the ESP Cone at Västhamnsverket. Sample removed from site in 2016. Scale bar in SEM image 100 μ m.

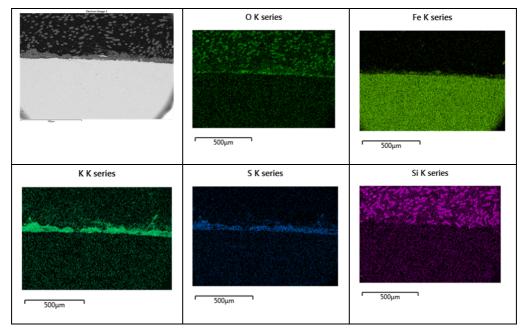
Figure 61. EDS analysis results of carbon steel reference sample after exposure at Ørsted /Avedöre in position A (SH-HT). Sample removed from site in 2017. Scale bar in SEM image is $500 \, \mu m$.

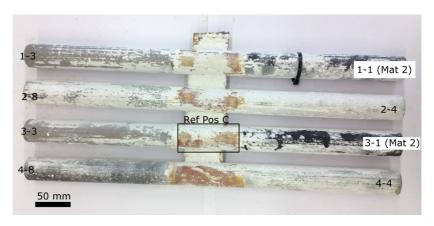
Figure 69. Photograph of the coated tubes with sample ID noted in the image after exposure at Ørsted /Avedöre in position C. The tubes were removed from the site in 2017. The reference sample was taken from the indicated area. Note that material 2 was exposed as samples 3.1 and 1.1

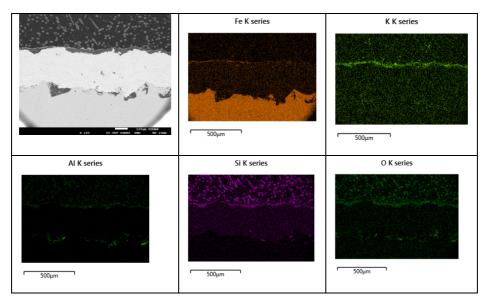
Figure 70. Back-scattered image and EDS analysis of material 8 after exposure in Position C in Avedöre. The scale bar in the SEM image is $100\mu m$.

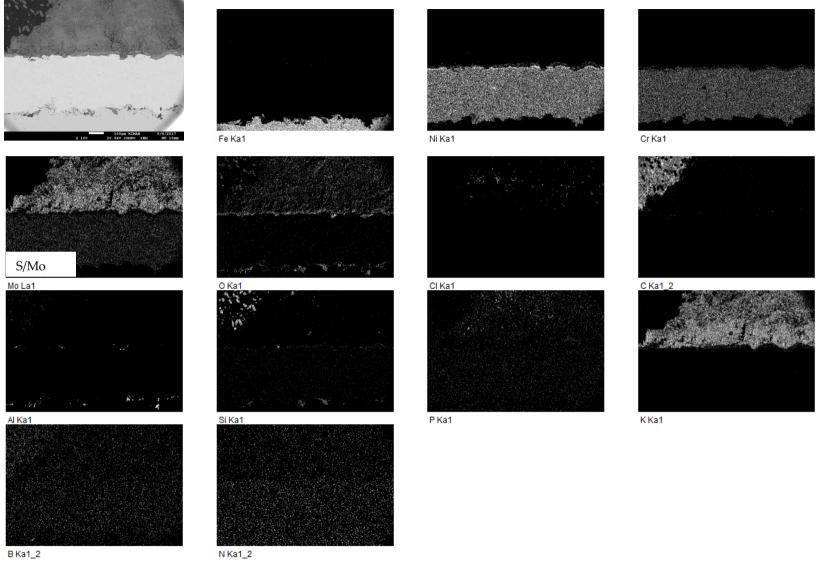
Figure 98. EDS analysis results of material 9 after exposure at Västhamnsverket in the superheater (SH-HT). Sample removed from site in 2017. Scale bar in the SEM image is 100 μm. The S and Mo maps were identical due to an overlap.

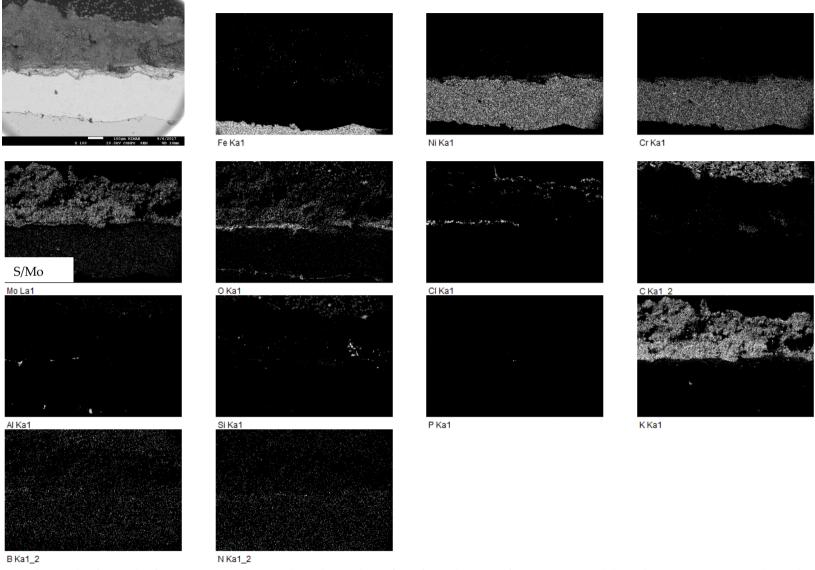
Figure 100. EDS analysis results of material 9 after exposure at Västhamnsverket in the superheater (SH-HT). Sample removed from site in 2017. Scale bar in the SEM image is 100 µm. The S and Mo maps were identical due to an overlap.

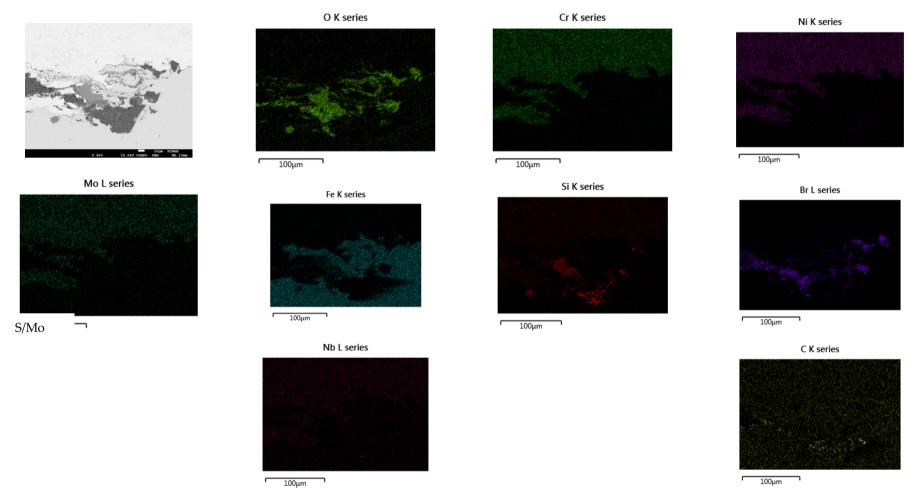
Figure 105. EDS analysis results of material 8 after exposure at Västhamnsverket in the superheater (SH-LT). Sample removed from site in 2016. Scale bar in the SEM image is 10 μm. The S and Mo maps were identical due to an overlap.

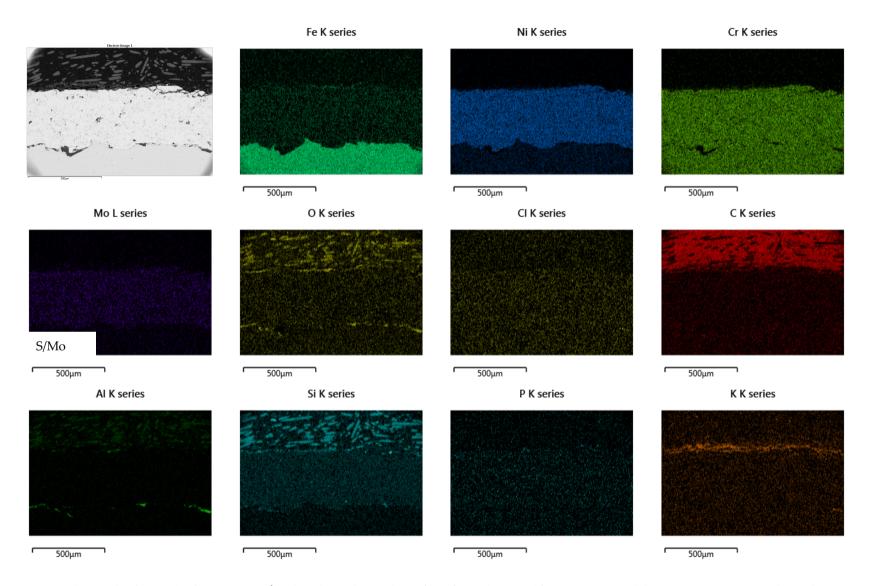
Figure 119. EDS analysis results of material 7 after exposure at Ørsted Avedøre in the superheater (SH-HT). Sample removed from site in 2017. Scale bar in SEM image is 500 μm. The S and Mo maps were identical due to overlap.

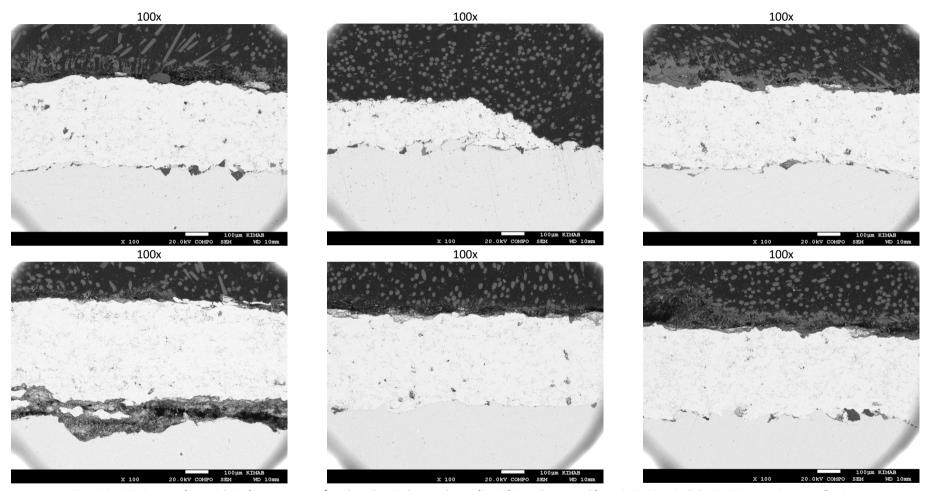
Figure 124. SEM images of material 10 after exposure at Ørsted Avedøre in the superheater (SH-HT). Sample removed from site in 2017. Scale bar is 100 µm at 100x magnification.

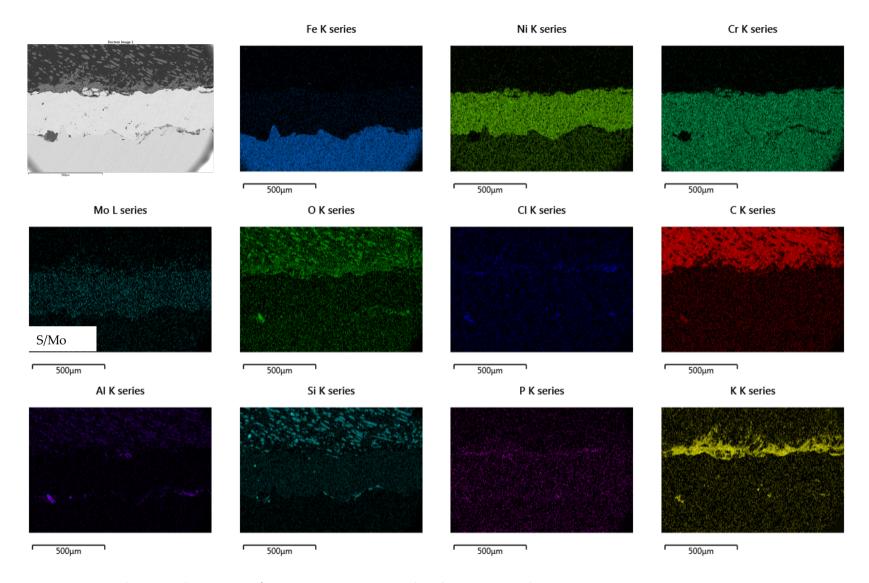
Figure 129. EDS analysis results of material 3 after exposure at Ørsted Avedøre in the superheater (SH-LT). Sample removed from site in 2017. Scale bar in SEM image is 500 μm. S and Mo maps were identical due to overlap and only the Mo map is shown

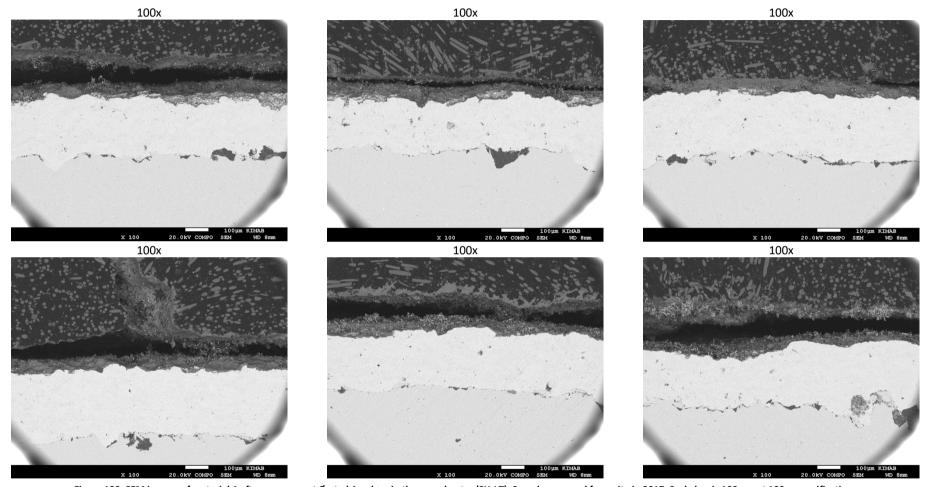
Figure 130. SEM images of material 4 after exposure at Ørsted Avedøre in the superheater (SH-LT). Sample removed from site in 2017. Scale bar is 100 µm at 100x magnification.

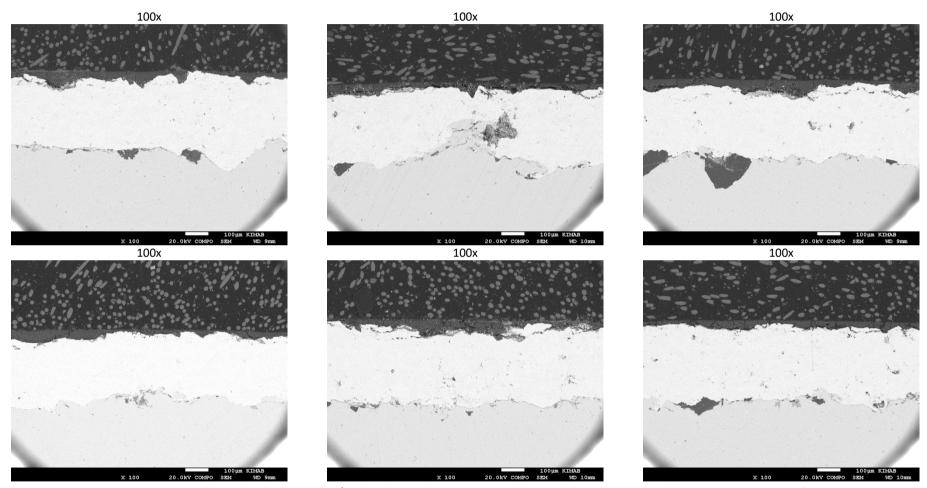
Figure 136. SEM images of material 3 after exposure at Ørsted Avedøre in the economizer. Sample removed from site in 2017. Scale bar is 100 µm at 100x magnification.

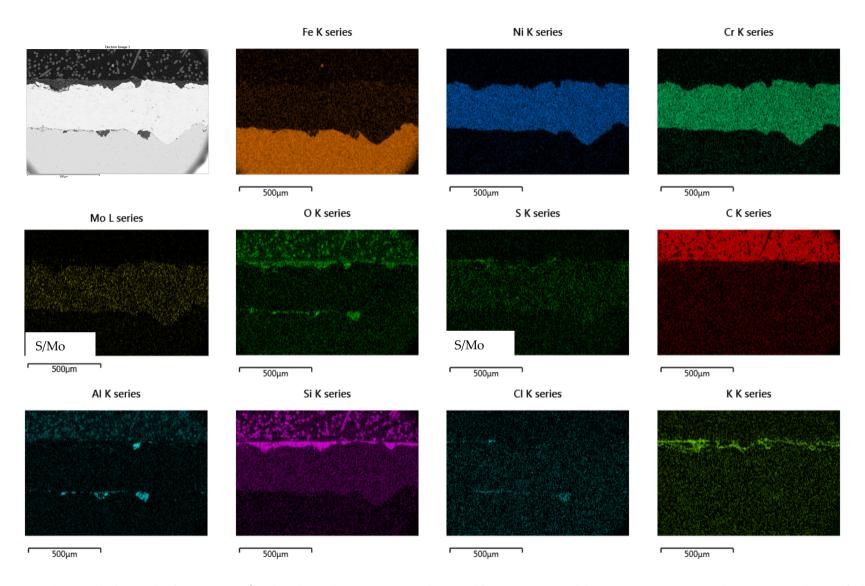
Figure 137. EDS analysis results of material 3 after exposure at Ørsted Avedøre in the economizer. Sample removed from site in 2017. Scale bar in SEM image is 500 μm. . The maps are an indication of sulphur in the deposit layer and Mo in the nickel-base layer, but S and Mo do overlap as indicated.

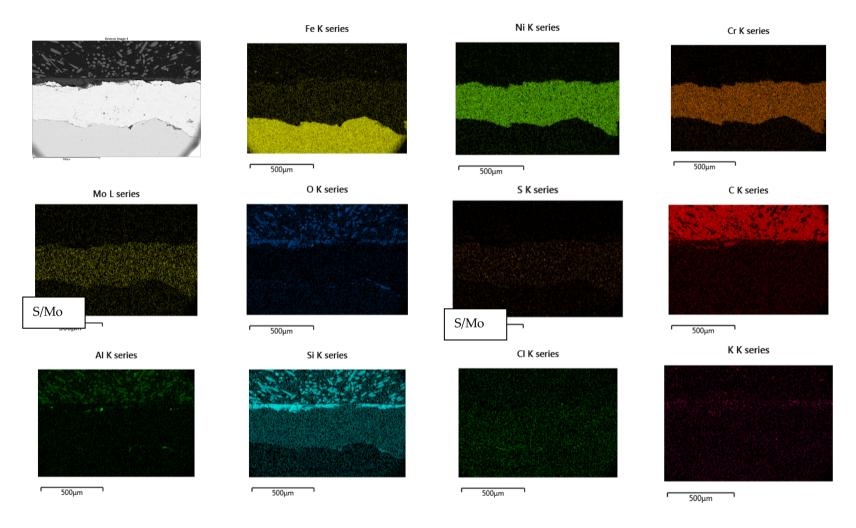
Figure 138. EDS analysis results of material 3 after exposure at Ørsted Avedøre in the economizer. Sample removed from site in 2017. Scale bar in SEM image is 500 µm. S and Mo overlap as indicated.
