Investigation of converter failure in wind turbines

A pre-study

Elforsk report 12:58

November 2012

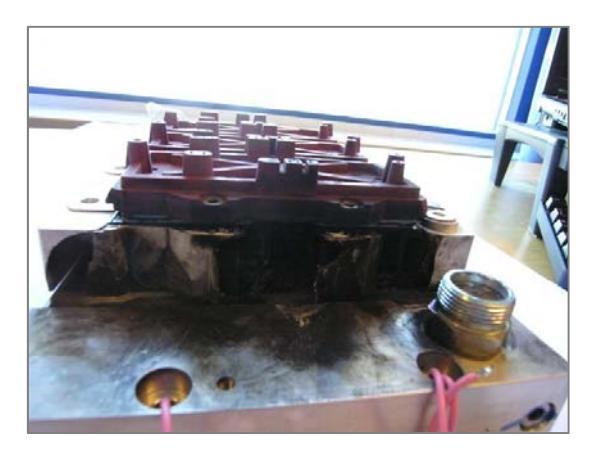
Fig. 44: Destructed converter module

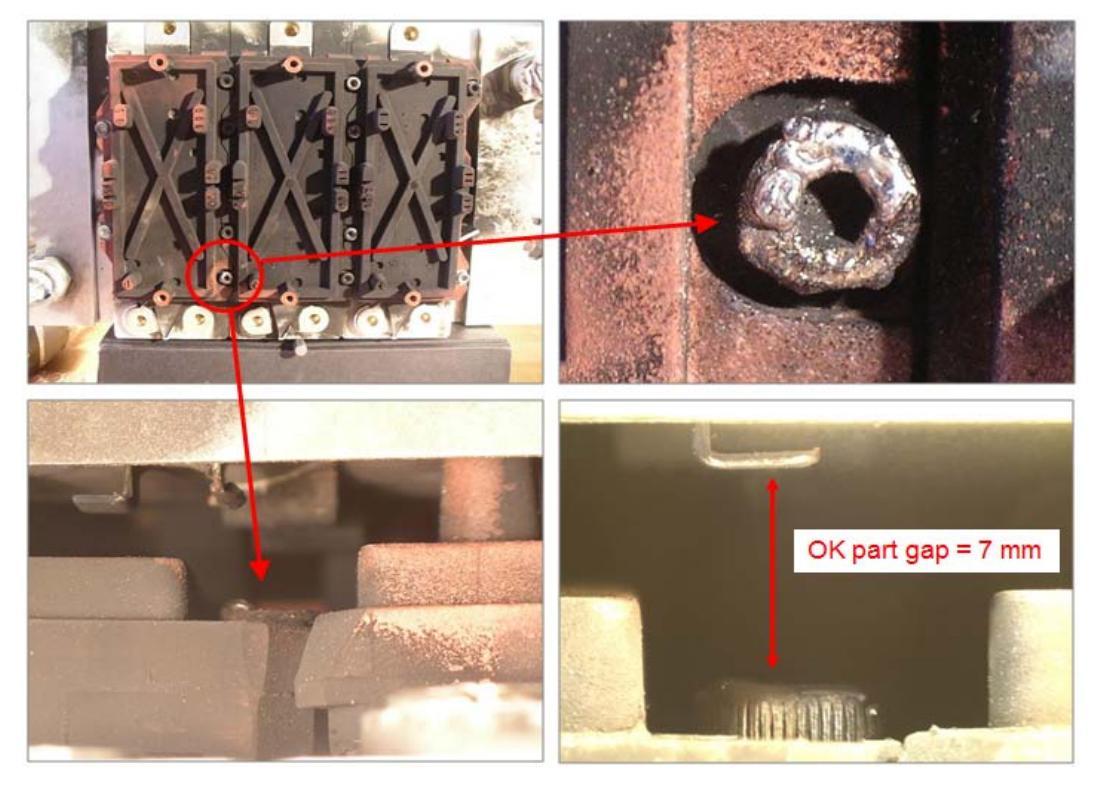
A strong correlation between lightning strikes and converter failure was observed. This was supported by the results of the forensic analysis, in which converter modules showed signs of electrical overstress. Dead insects were discovered inside the converter cabinets. Although there is some uncertainty how these can cause flashover, it is recommended to take countermeasures in turbines with large amounts of insects.

Fig. 45: Evidence of high-voltage sparkover between a PCB cooling fin and a screw reaching into the heat sink

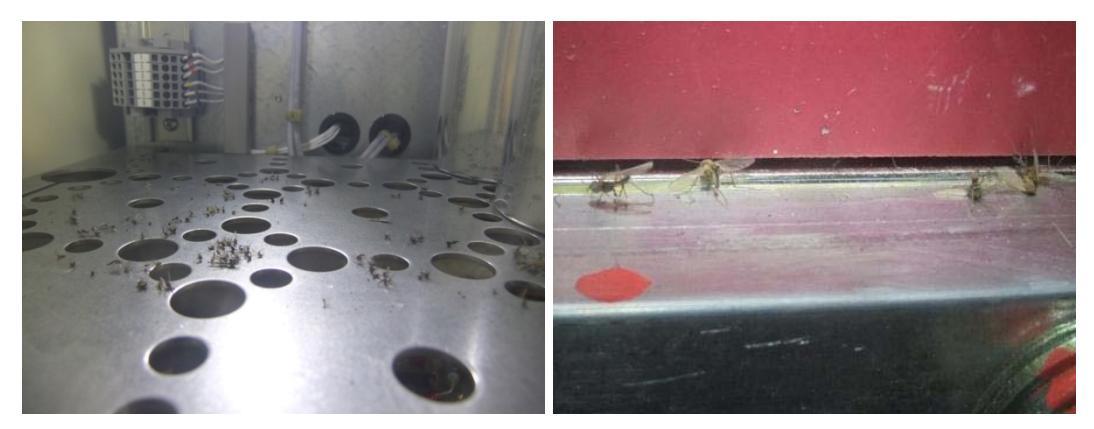
Fig. 46: Dead insects found inside wind turbines at offshore site D, confirming the presence of insects also at larger distances from the coast

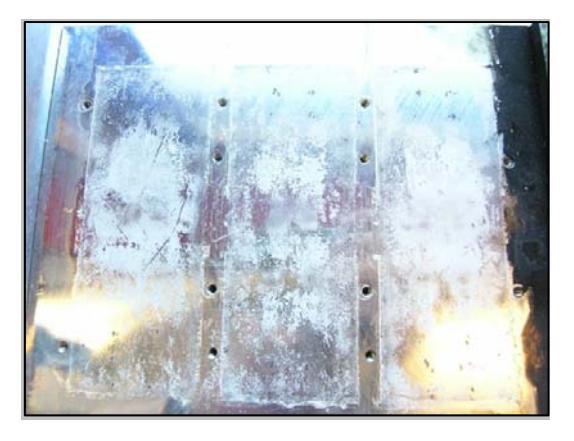
Fig. 48: Degraded thermal grease between DCB and heat sink

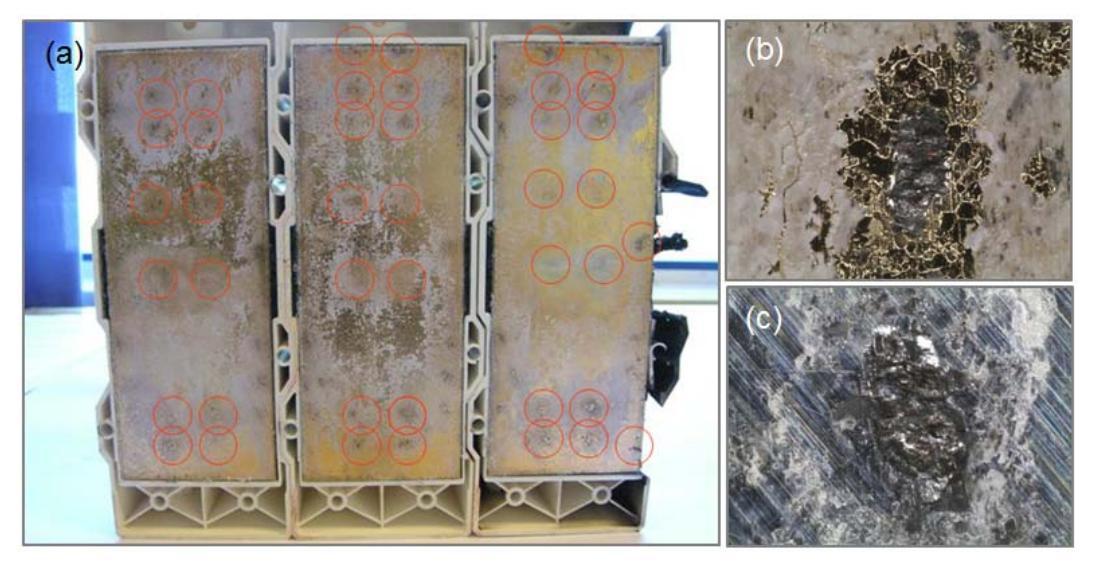
Fig. 49: Spots on the bottom side of the DCB and on top of the heat sink

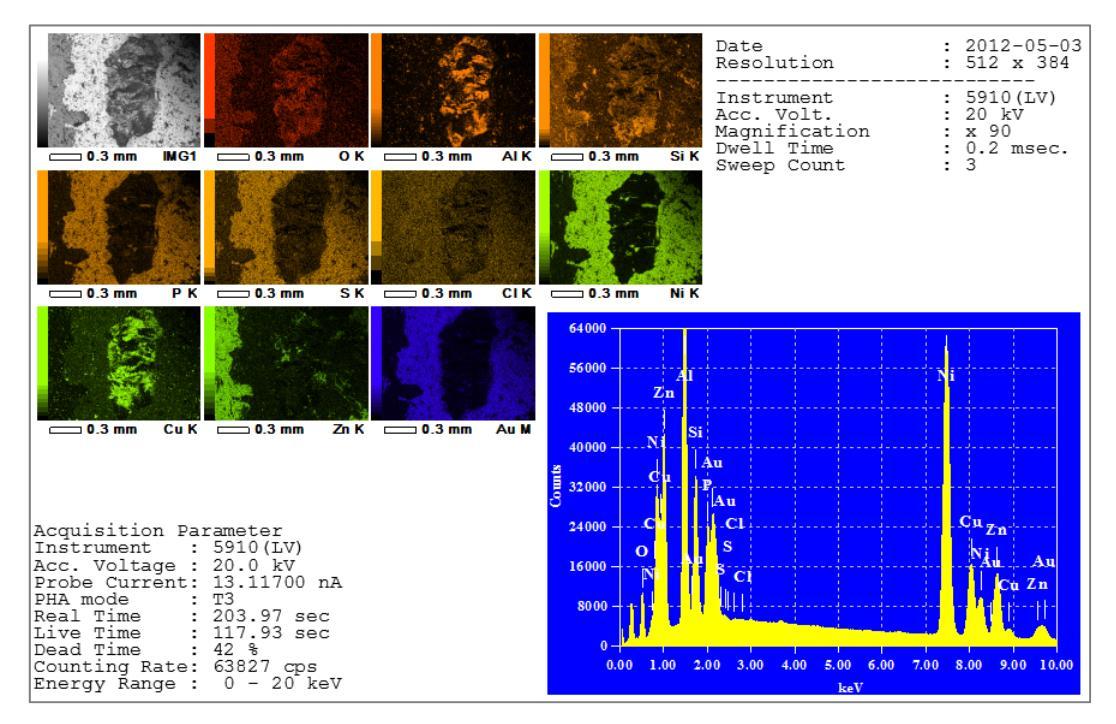
Fig. 50: Scanning-electron microscopy analysis of spots on the bottom-side of the DCB

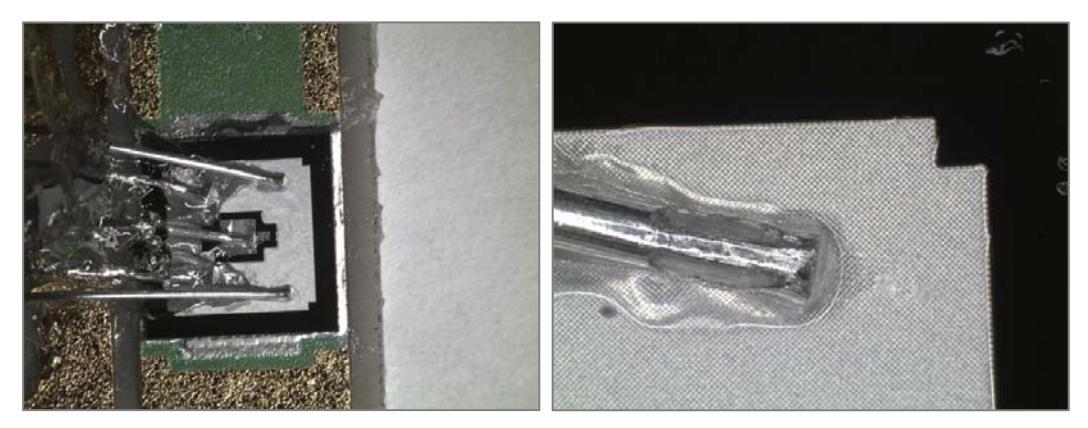
Fig. 51: Microscopy inspection of the bond-wires and die attach

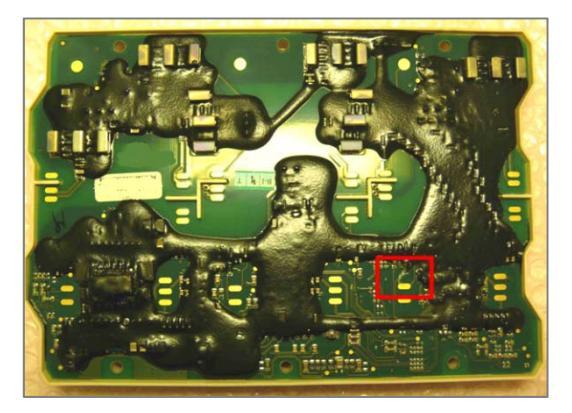
Fig. 52: Driver board of converter-module #1 after dismantling (bottom side) with marked location of observed contamination and likely corrosion products

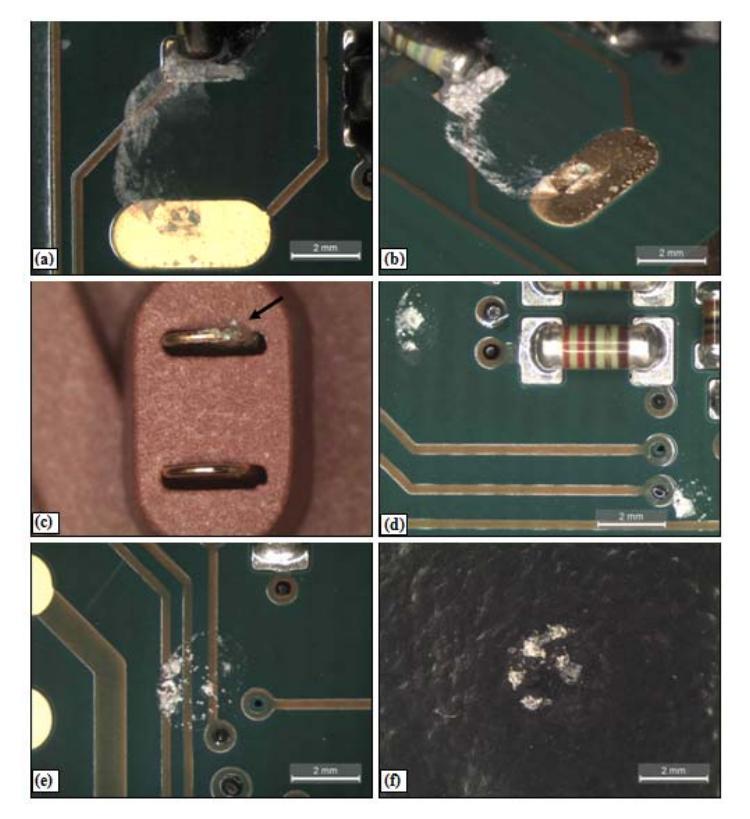
Fig. 53: Optical inspection images of converter module #1, (a, b) contamination/corrosion products on driver board between component pad and connector pad, (c) corresponding pin connector, (d-f) contamination spots observed at several positions on the driver board A SEM/EDS analysis of the contamination revealed the presence of sodium (Na) and chloride (Cl), indicating impact from the sea based environment, i.e. moisture and salt. The SEM/EDS analysis of the contamination/corrosion products observed between component pad and connector pad (see Fig. 54) showed a dominant content of tin (Sn) and chloride (Cl) in addition to oxygen (O) indicating corrosion products. These form a possible path for electrical (ionic) conduction during field operation.

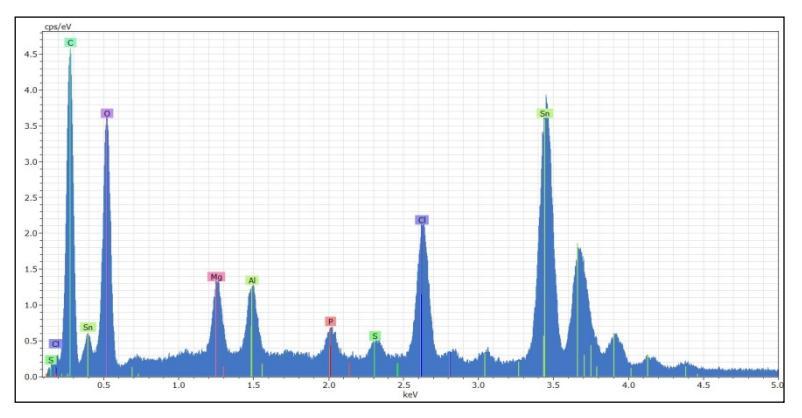
Fig. 54: SEM/EDS analysis of contamination / corrosion products

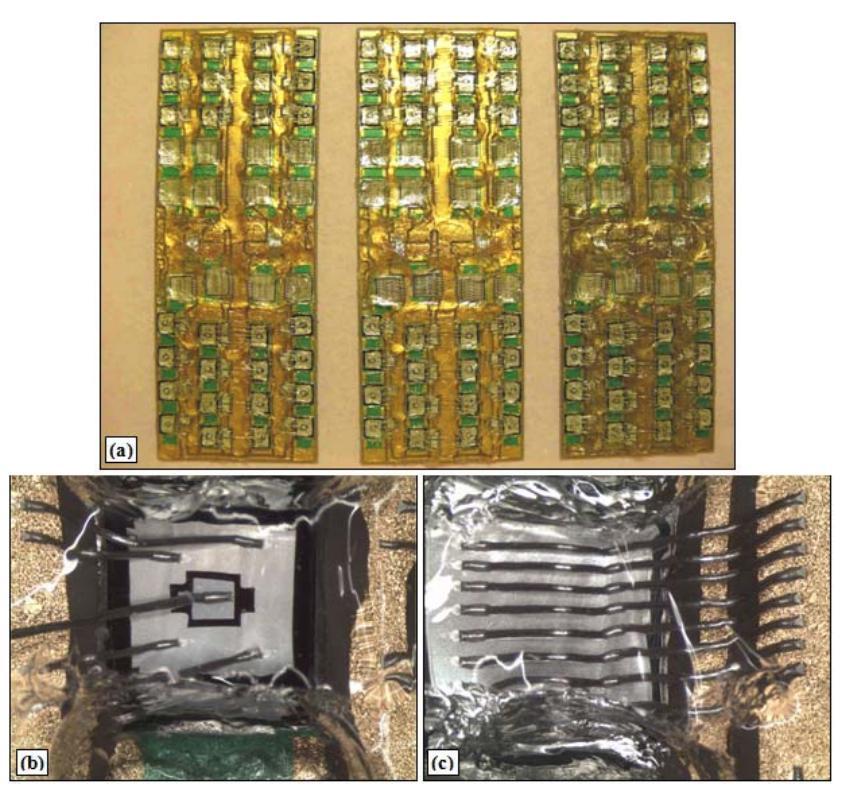
Fig. 57: Optical images of uncovered half-bridges in converter module #1,
(a) overview of the three half-bridges with chips visible under a silicone layer (partly removed), (b, c) detailed images of chips and bond wires

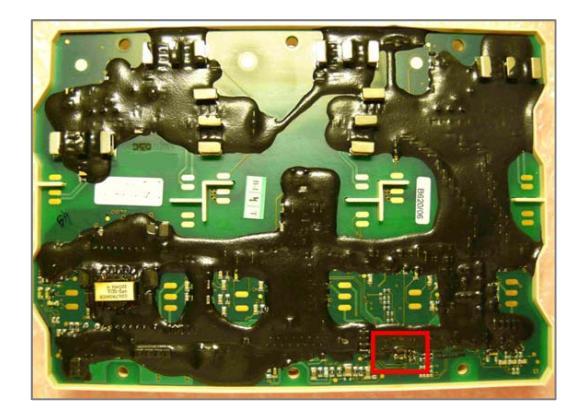
Fig. 59: Driver board of converter-module #2 after dismantling, with marked location of re-melted solder joints and "burned" components

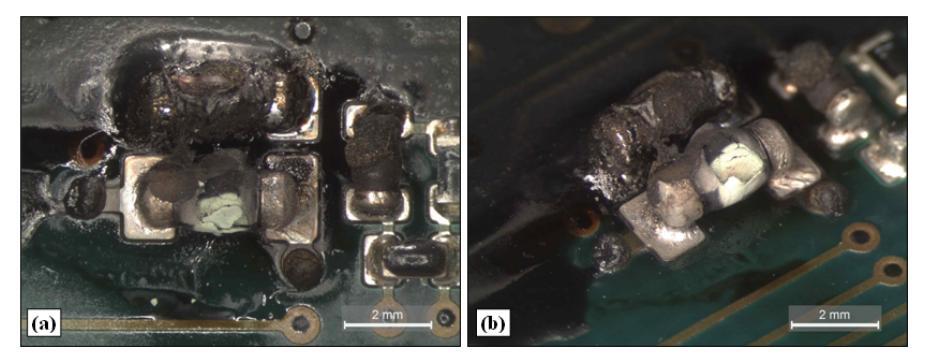
Fig. 60: Optical inspection images of converter module #2, top and oblique view of two resistors showing re-melted solder joints and damaged component package

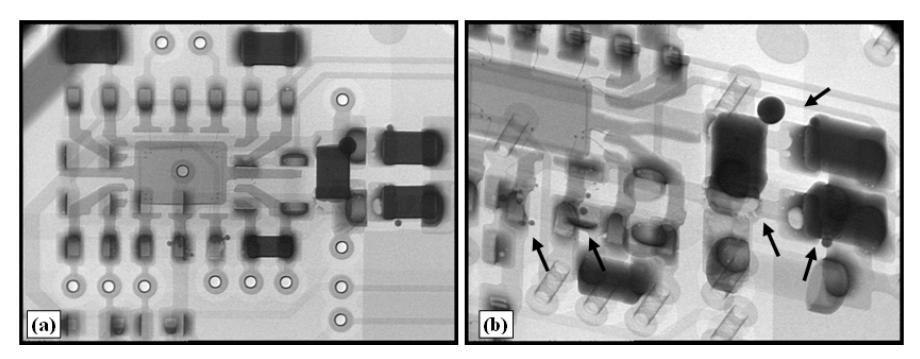
Fig. 61: X-ray image of driver board in converter module #2, top and oblique views revealing re-melted and broken solder joints at the resistors shown in Fig. 60, in addition to re-melted solder joints on the over-moulded side of the board

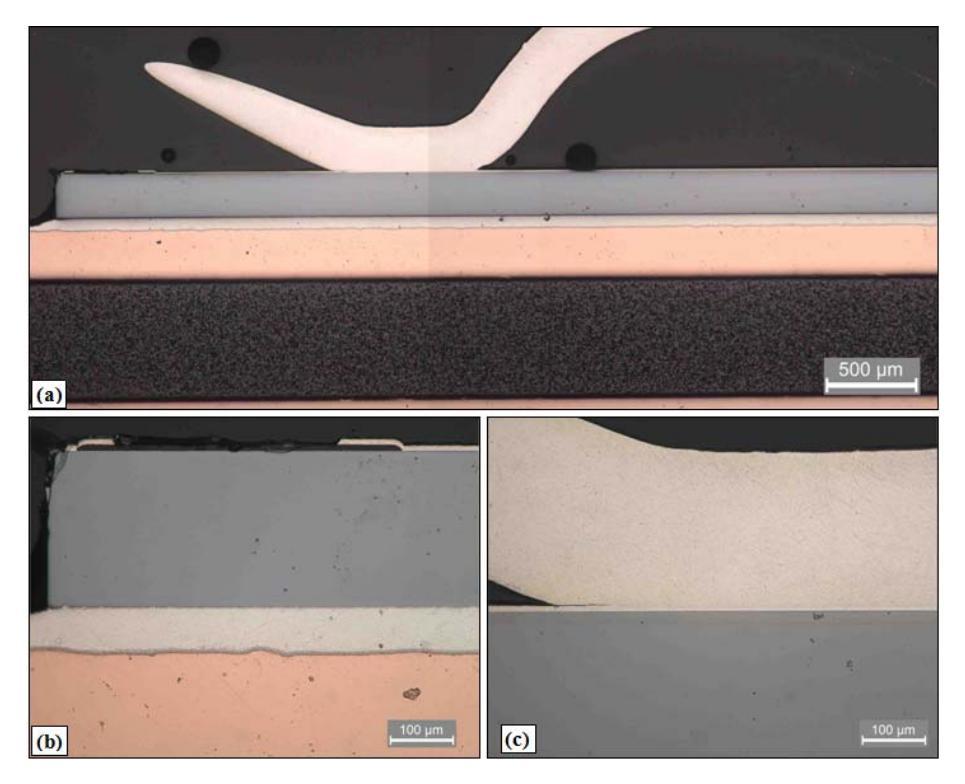
Fig. 62: Optical-microscopy cross-section images of a chip from converter module #2, (a) overview of part of the IGBT chip with wedge-bonded aluminium bond wire to the chip, (b) detailed view showing intact die attach solder, (c) magnified view of bond-wire connection to the chip metallization
