FUSE PLUG BREACH TESTS

REPORT 2018:465

Can a laboratory scale test replace a field test?

JOHAN LAGERLUND

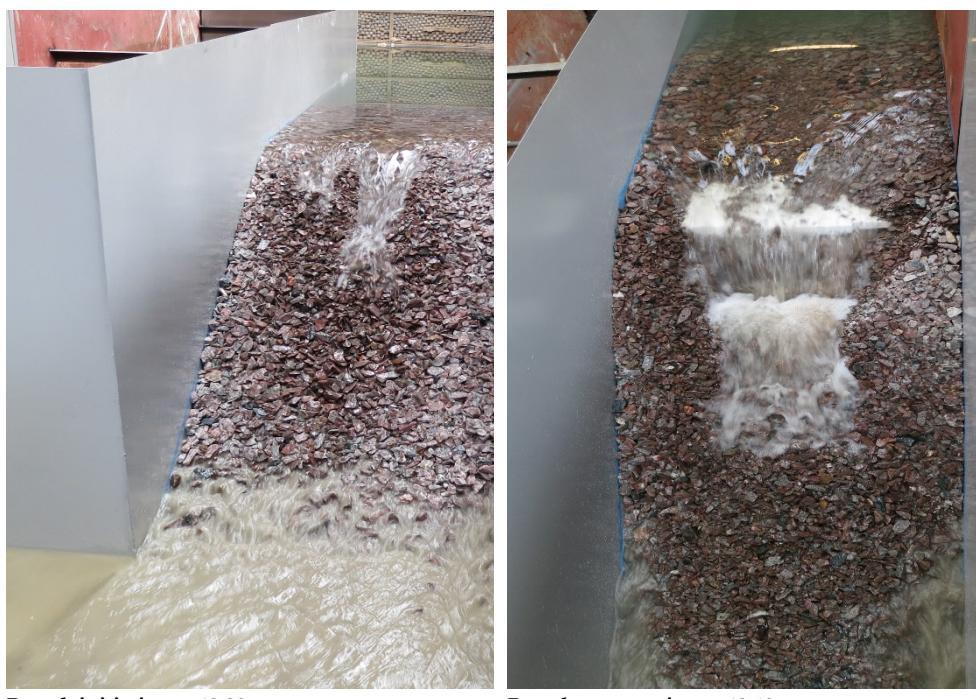
Breach initiation at 12:08 pm Breach propagation at 12:10 pm Figure 10. Breach formation and propagation during the 1:3 scale test.

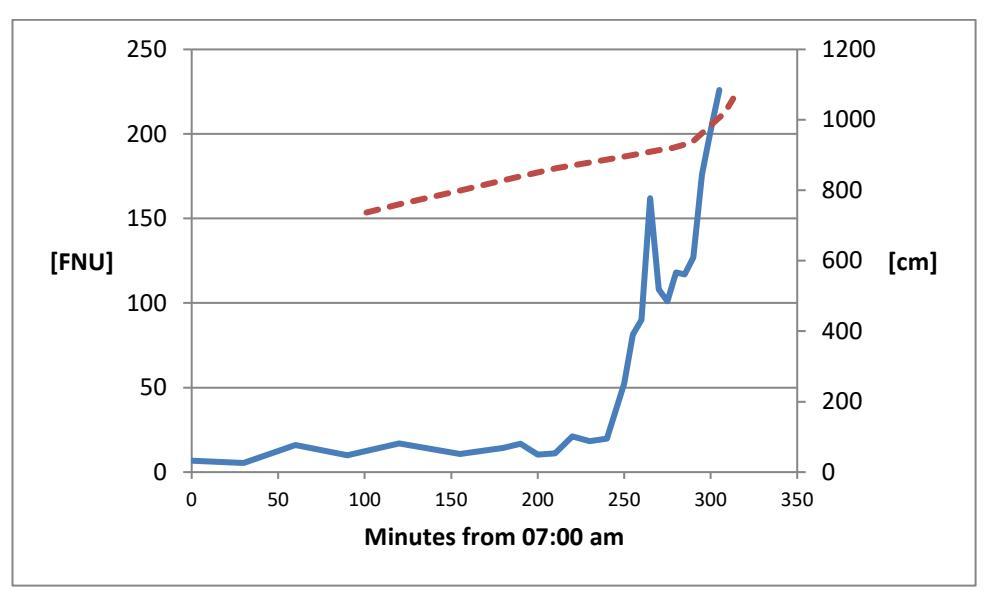
the turbidity increased significantly. At 10:50 am the water level in the reservoir was at a height of 88 cm, which corresponded to the height of the core crest (at 85 cm) plus the height of the insulation foam boards (3 cm thickness). At 11:30 am the turbidity dipped but started to increase immediately. A visual inspection of the turbidity in the water (Figure 15) revealed that the turbidity was mainly from the filter and downstream structural fill. This indicated internal erosion occurring in the filter and not in the core.

Figure 14. Turbidity (full line) compared to the water level (dashed line) during the 1:3 scale test. Test started at 07:00 am.

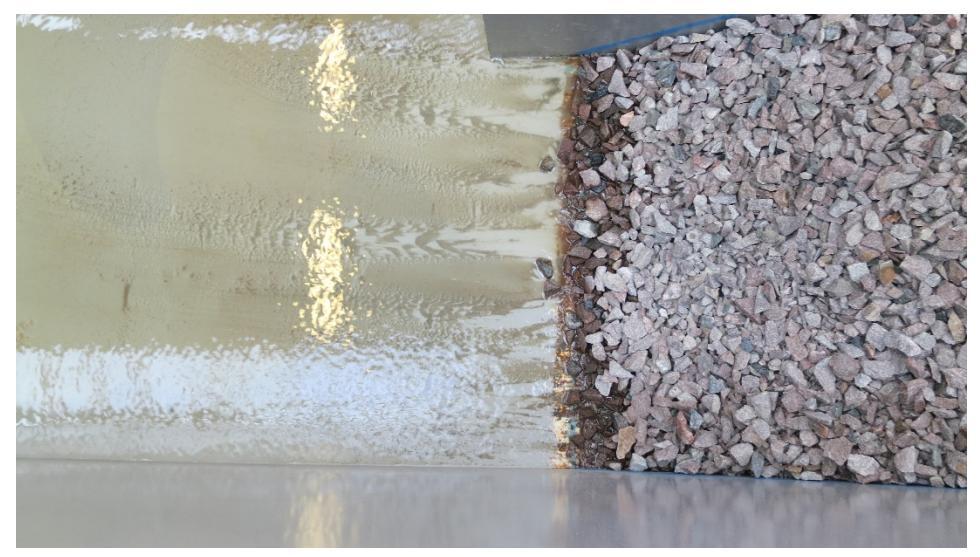
Figure 15. Turbidity coming out from the dam toe at 11:58 am

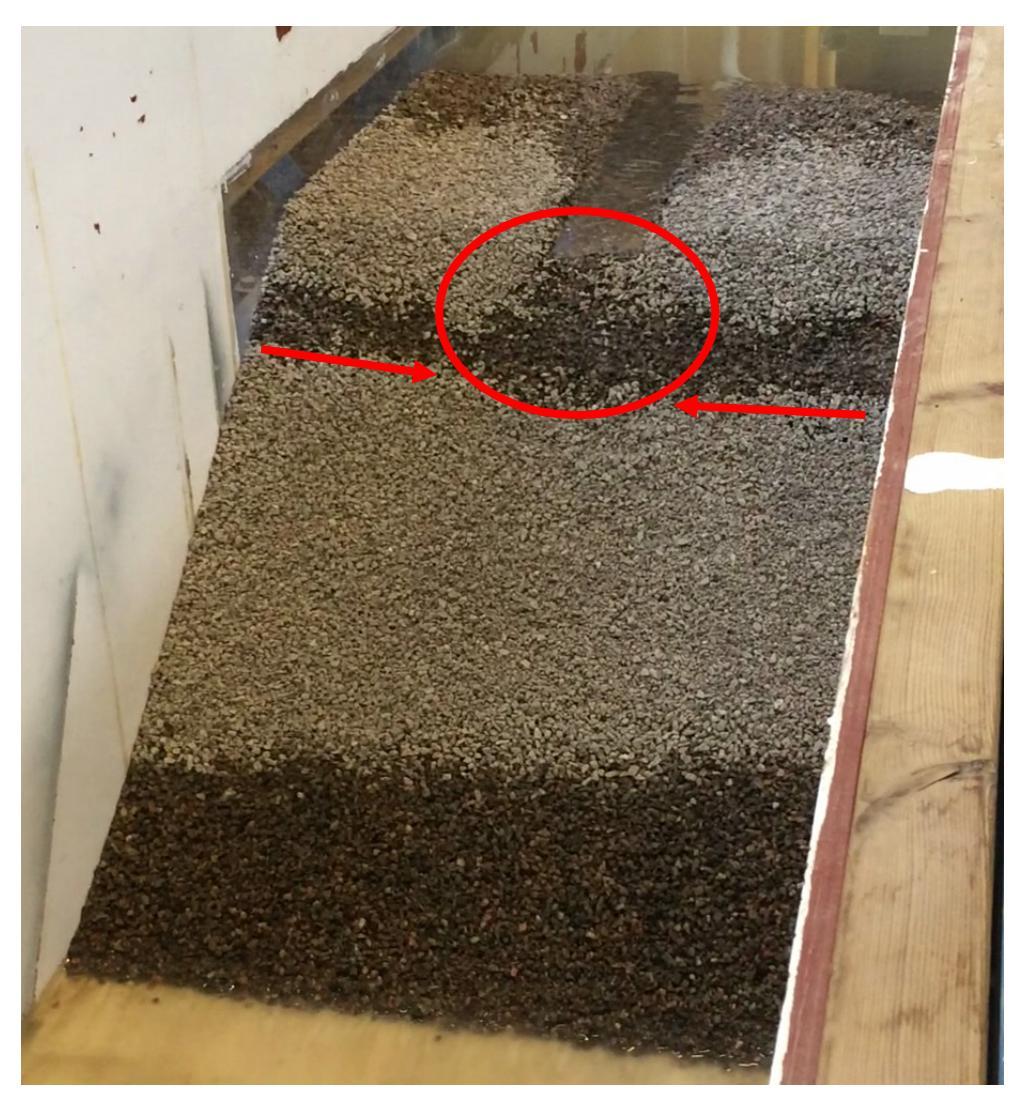
Prior to the breach, a line of seeping water could be observed in the downstream shoulder 0.07 m below the crest at the boundary of insulation foam boards and core. This water line appeared first at both abutments and as the water level increased, it moved towards the centre of the fuse plug. Prior to the breach of the fuse plug, seepage with turbidity could be clearly seen on the downstream slope below the pilot channel like a spring indicating internal erosion. At the toe of the fuse plug, water with high turbidity appeared and in particular as soon as the water level exceeded the core.

Figure 16. Seeping water line with arrows marking their propagation and breach initiation (circle), where the sudden collapse of the structural fill took place.

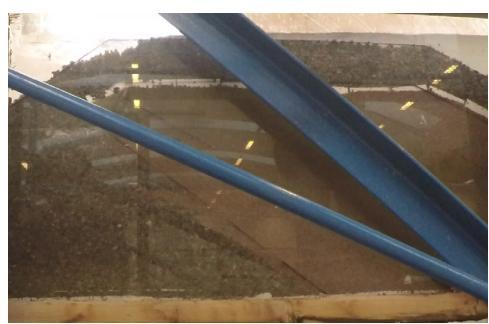
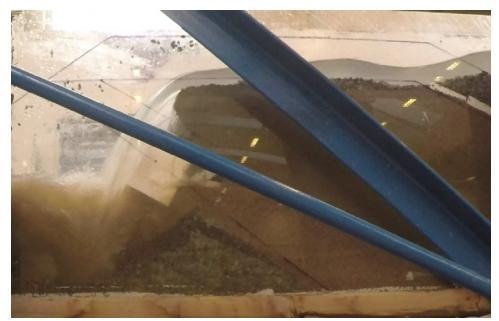
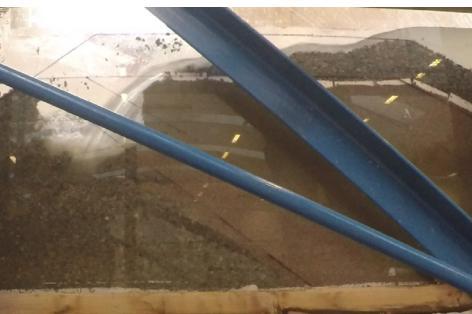
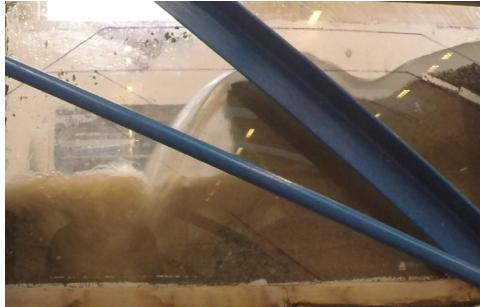
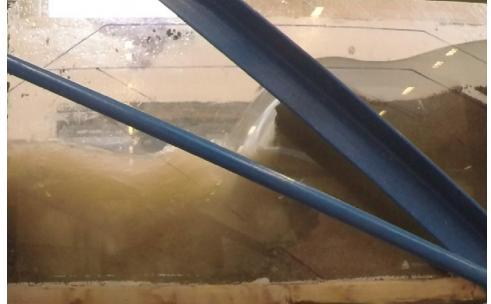
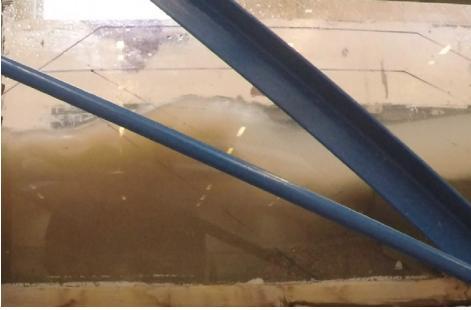
Figure 18. Propagation of the erosion process of the fuse plug.

The side view of the 1:6 scale fuse plug revealed in detail how the breach progressed (Figure 18). Heavy undercutting of the core due to erosion of the downstream structural fill/filter took place and the core was "shaved off" layer by layer during the breach phase. The side view furthermore revealed how seepage from the boundary layer between the core /insulation foam boards/structural fill was focused and entered the downstream filter sand. Even though the core was undercut, it did not break.

Breach initiation. A small portion of the structural fill has been eroded

Water has begun undercutting the core

Erosion of core has begun on its downstream front edge

Erosion progresses backwards

Downstream filter material is almost completely eroded. Note that the insulation foam boards on the right side slowed down the erosion process.

Fuse plug almost completely eroded

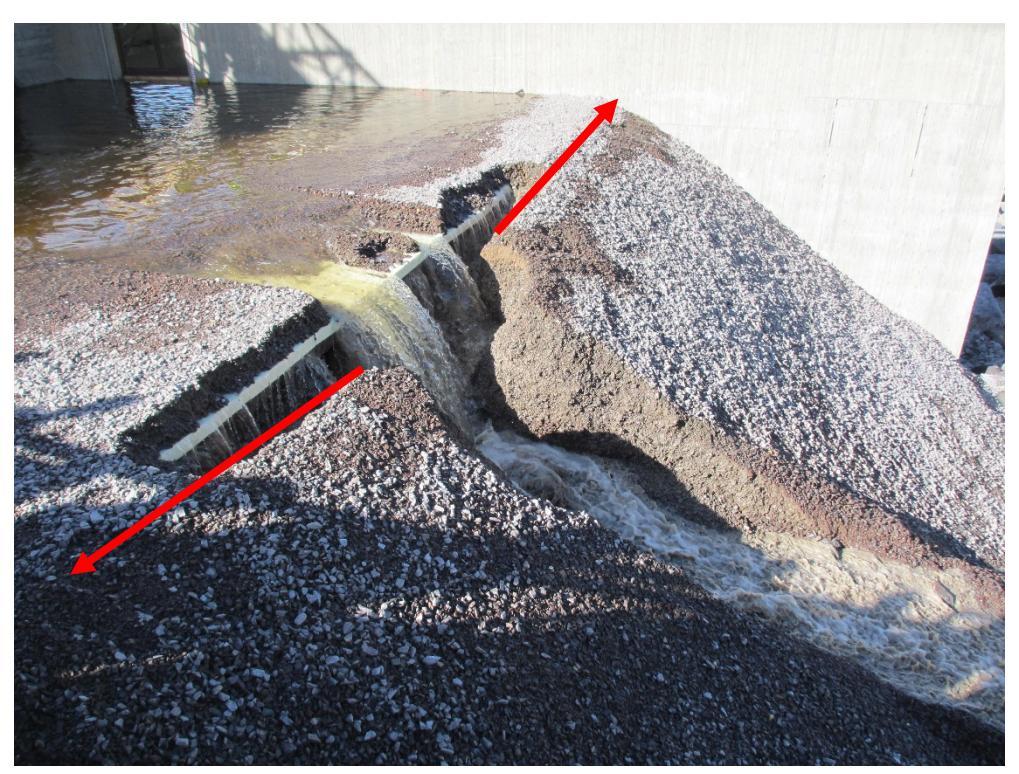
As soon as the reservoir level exceeded the core crest, internal erosion started. The design of the fuse plug allowed the overtopping water to pass through the intersection core crest/insulation foam boards down to the unprotected downstream filter sand, initiating its erosion. This affected the fuse plug at all points sideways, a fact that became evident due to the propagation of the breach from the center of the pilot channel and outwards towards the abutments (Figure 22). The breach was concentrated to the center of the fuse plug because of the pilot channel. If there was no pilot channel the breach initiation would have occurred at a random or several random locations in the crest but at the same height as the breach formation in the field test.

Figure 22. Propagation of breach sideways from the center of the fuse plug and outwards toward the abutments (red arrows). Photo is taken from the field test.

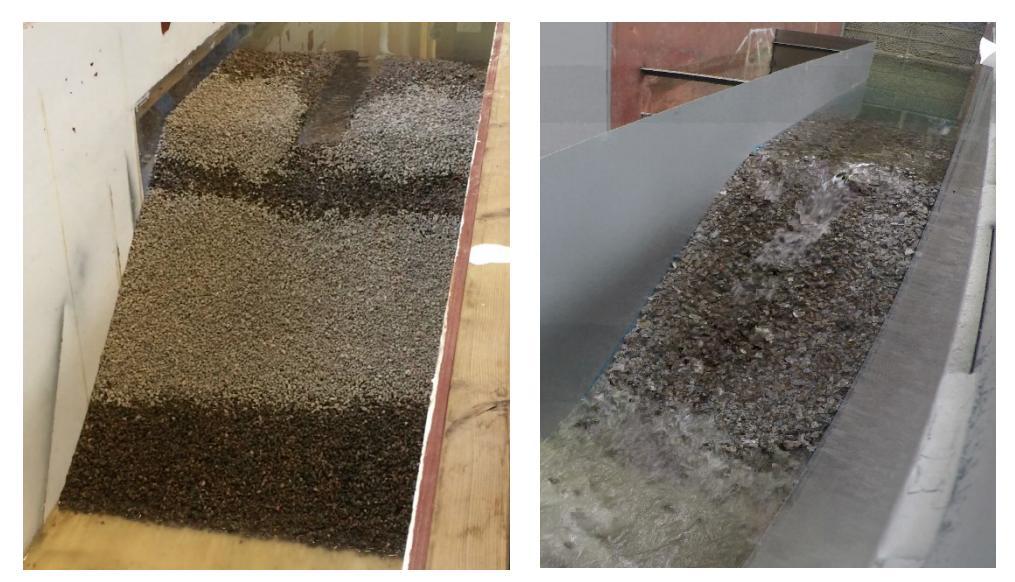
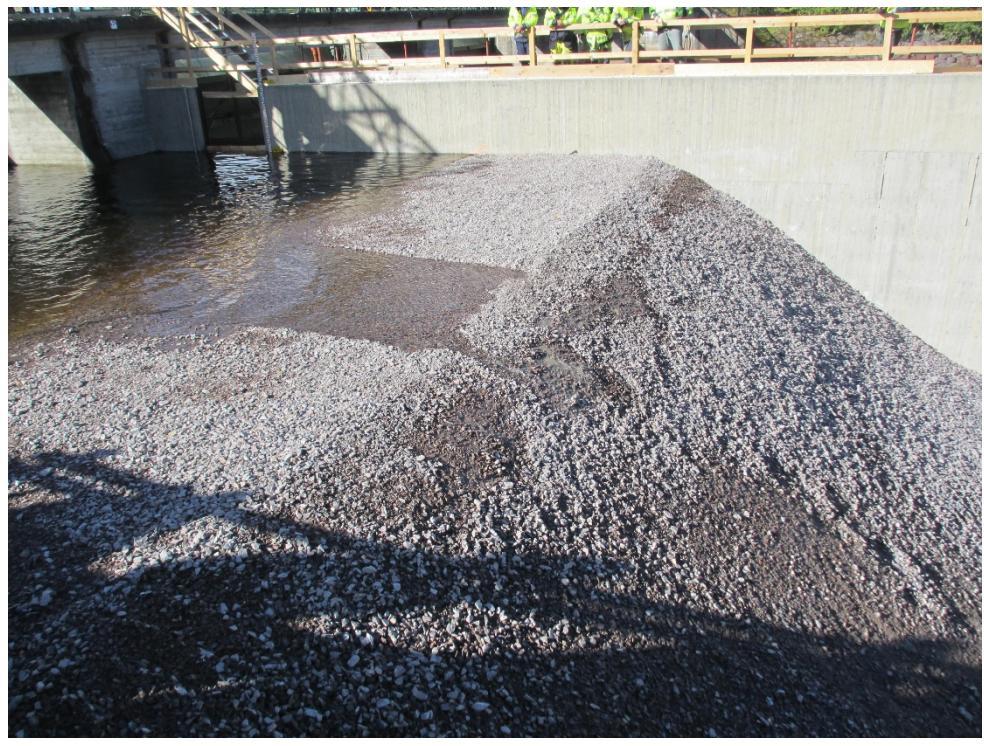
In the field test and in the 1:6 scale test the breach initiation was very similar, see Figure 23. In these two different tests a pipe was formed below the pilot channel in the downstream slope at a corresponding height to the core/insulation foam board interface. After the formation of this pipe, the structural fill caved in at the downstream side of the pilot channel, thus opening up the breach. In the 1:3 scale test this was not the case. The fuse plug crest in the 1:3 scale test was completely overtopped by water before the crest imploded, followed by a pushing action of

the water on the structural fill. After this, the breach propagation in the 1:3 scale test was however similar to the field and 1:6 scale test. The amount of seepage through the 1:3 scale model was higher than during the other two tests prior to the breach initiation.

Moment of breach 1:6 scale test

Moment of breach 1:3 scale test

Moment of breach field test

Figure 23. Moment of breach initiation for the two model tests compared to the field test. Note the difference between the 1:3 scale test compared to the other.

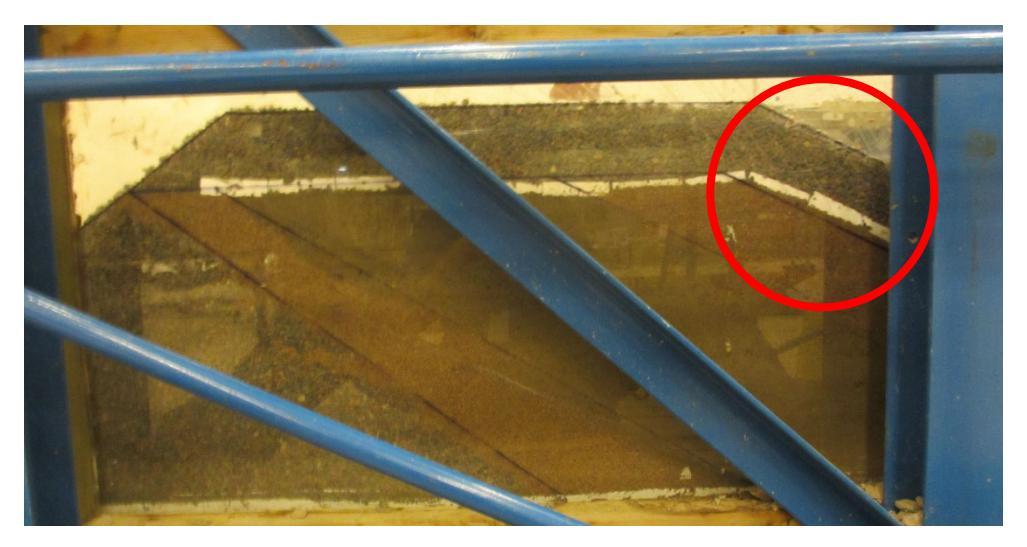
The insulation foam boards decreased the erosion rate of the fuse plug, and in particular the insulation foam boards in the upstream slope (Figure 24). As soon as the insulation foam boards in the upstream slope was washed away, the erosion rate increased and the total collapse of the fuse plug was imminent. The insulation foam boards are not expected to delay the breach initiation, only to delay the total collapse of the fuse plug.

Figure 24. Insulation foam boards seen from the left abutment in the 1:6 scale test. The insulation foam boards on the upstream slope inside the red circle were in particular slowing down the erosion rate of the fuse plug.

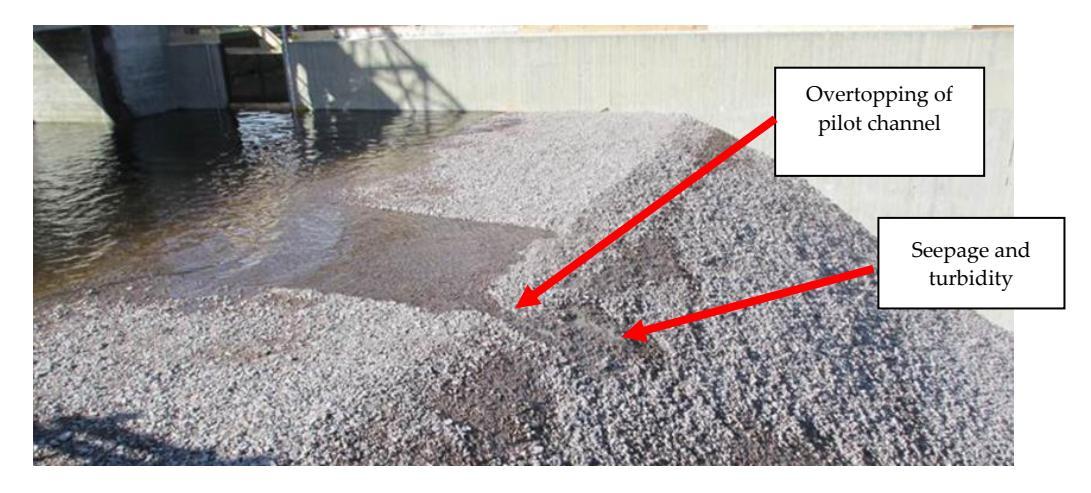
The fuse plug failed due to overtopping at 11:41 am, 25 minutes after the reservoir level exceeded the upstream side of the pilot channel, as shown in Figure 25. However, the assessment of the breach mechanism and test observations indicated that the top part of the shoulder fill may have developed internal erosion at 11:16 am.

Figure 25. Field test fuse plug at 11:41 am, upstream water level +84.99 m.

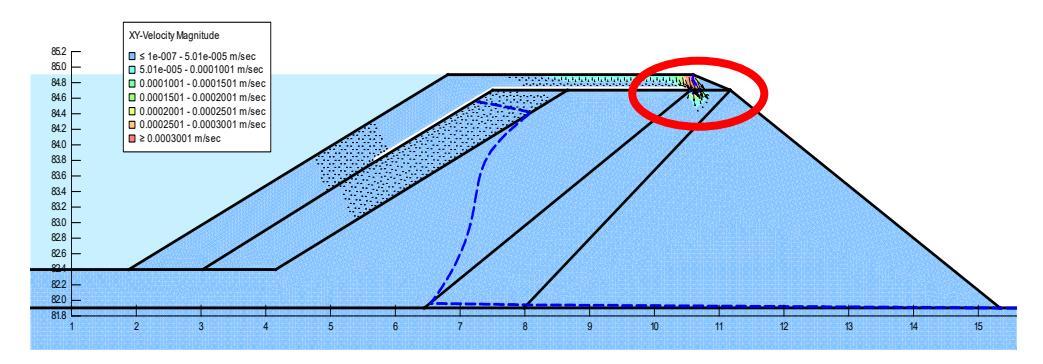
Three main factors that control the internal erosion are: material, hydraulic gradient and shear stress ratio. Grain size, specific gravity and elastic properties represent material parameters, whereas the hydraulic gradient represents the height of the water column in the saturated part of the fuse plug.

Figure 26. Seepage velocity at 11:16 am.

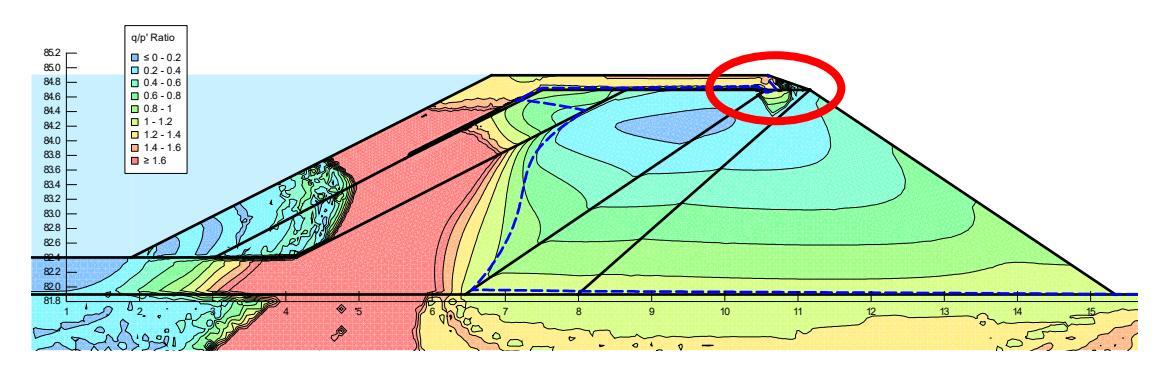
Figure 27. Shear stress ratio (q/p') at 11:16 am.

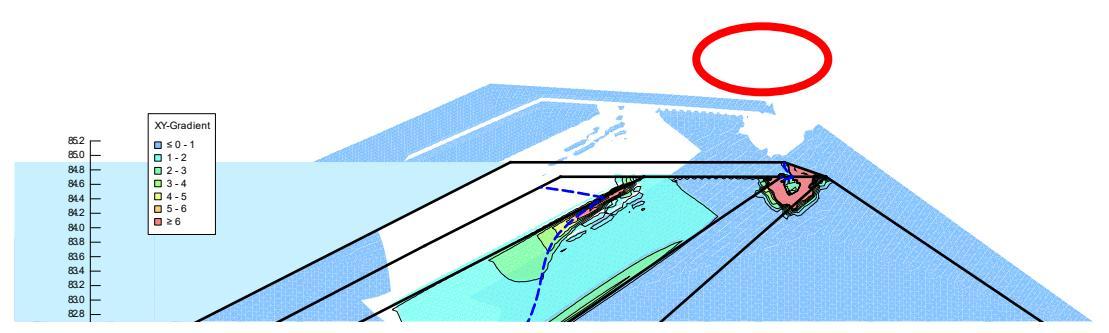
If given enough time, this effect should have led to water breakthrough given the hydraulic gradients were high enough within the core of the fuse plug (Figure 28). It is evident that horizontal fractures will be opened at shallow depth when the principal horizontal stress becomes higher than the principal vertical stress as demonstrated in Äspö HRL (Talbot & Sirat, 2001). This can probably explain the mechanism of internal erosion, which is also consistent with the results obtained by Chang and Zhang (2012), where the shear stress ratio and hydraulic gradients in their test were within this range. Hence, by time, piping could likely occur at any point of the crest if the reservoir level was kept between the top of the core and dam crest.

Figure 28. Hydraulic gradients at 11:16 am.

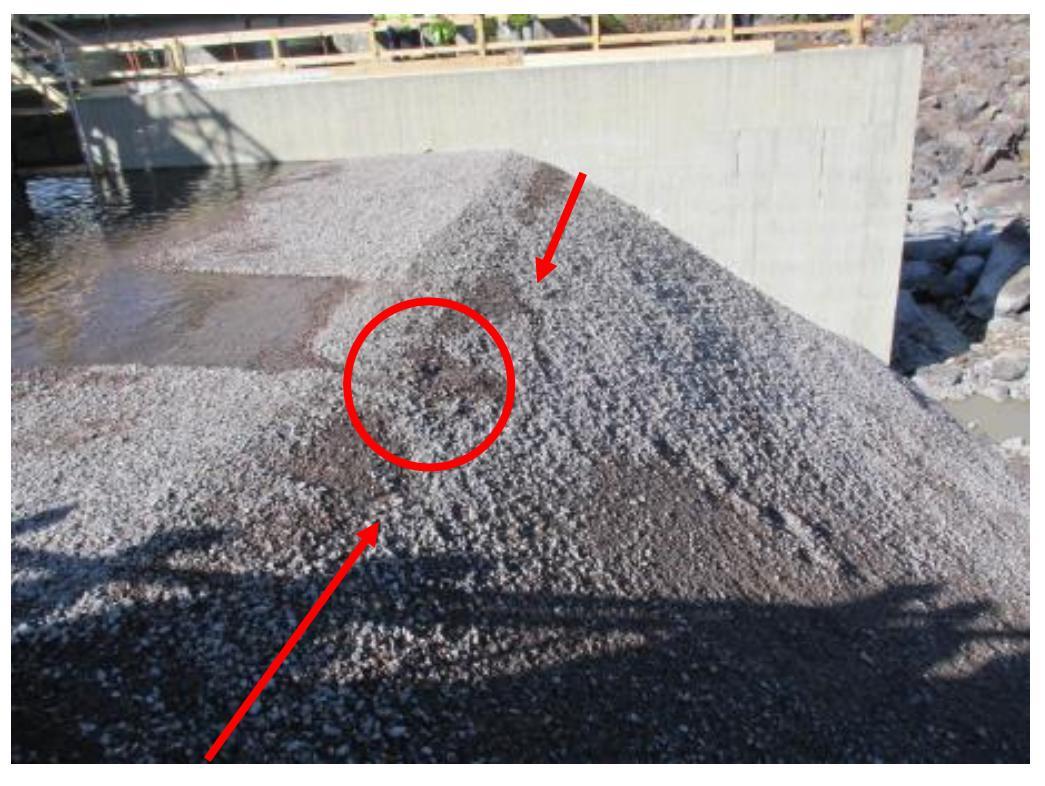
The impounding of water was started at 5:02 am and the order of events throughout the test can be seen in Table 10. The velocity at which the reservoir level increased was ~0.2 m/h. Prior to the breach, a line of seeping water could be observed in the downstream shoulder 0.4 m below the crest at the boundary of insulation foam boards and core (Figure 30). This water line first appeared simultaneously at both abutments but as the reservoir level increased, it moved towards the center of the fuse plug. Prior to the breach of the downstream side of the crest, seepage with turbidity could be seen on the downstream slope below the pilot channel like a spring, indicating internal erosion. The breach initiation

Figure 30. Orientation and movement of seeping line of water (arrows) and breach initiation (circle)

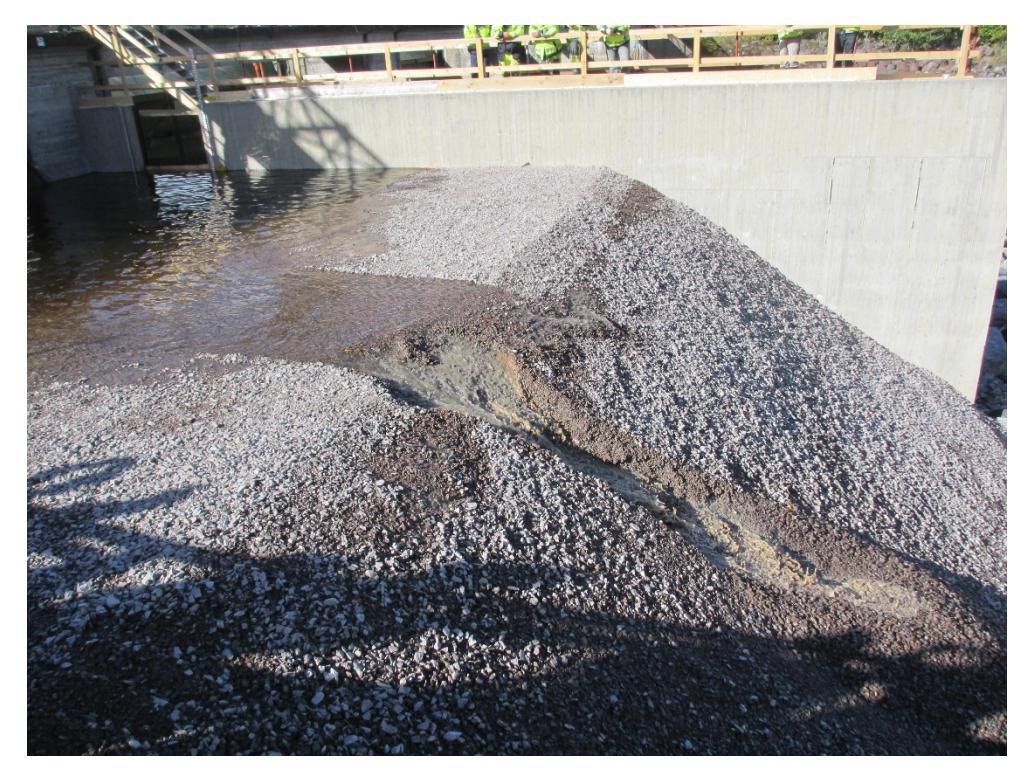
The breach progressed in the center of the fuse plug (Figure 31) in a "pushing action" caused by the water on the structural fill. The erosion then gradually spread sideways all along the crest of the fuse plug as the reservoir level slowly continued to rise (Figure 32). The structural fill on top of the insulation foam boards was quickly washed away. The insulation foam boards slowed down the erosion process of the core beneath them. The insulation foam boards were washed away one by one, gradually leaving the core exposed to the passing water. The insulation foam boards that were placed on the upstream side of the inclined filter sand were in particular responsible for protecting the core against erosion (Figure 33 left). As soon as these insulation foam boards were washed away the core was quickly eroded. The core in the beginning of the erosion process was "shaved off" layer by layer. After some progression of the erosion rate was increased (Figure 33 right).

Figure 31. Progression of breach just after initiation.

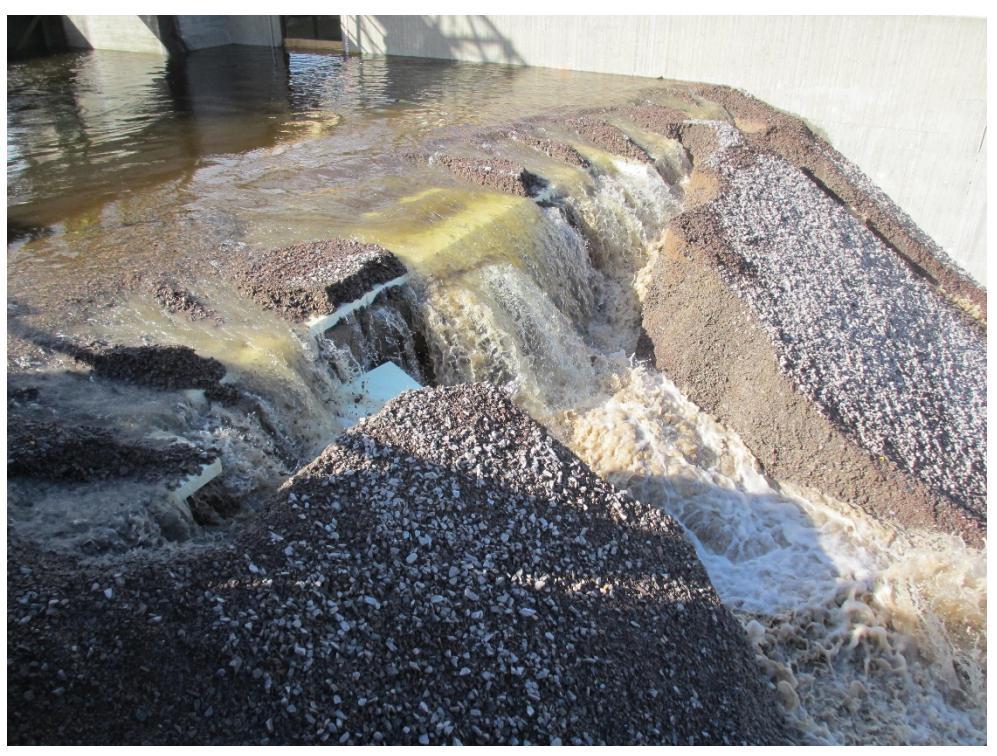
Figure 32. Breach initiation and propagation. Note the more excessive erosion at the center due to the pilot channel.
