# INCREASED STEAM TEMPERATURE IN GRATE FIRED BOILERS - STEAMBOOST

KME-709

## Increased steam temperature in grate fired boilers - Steamboost

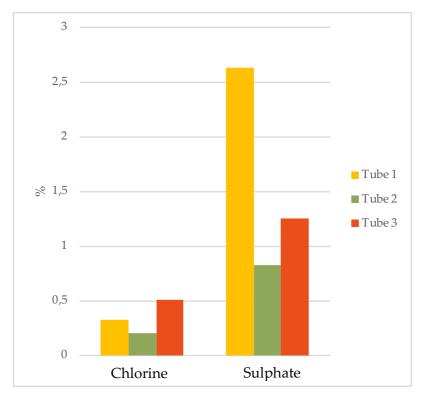
The deposit taken from the fixed installed Steamboost tubes (first installation) was analysed by using Ion Chromatography and the results are shown in Figure 39.

Figure 39. Ion Chromatography results show the percentage of chlorine and sulphate in the deposit of the three different tubes.

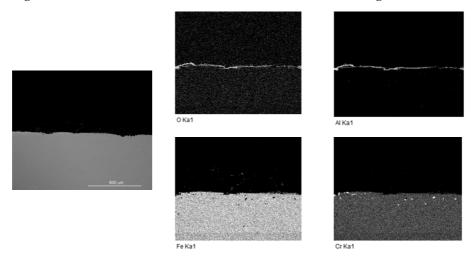
After 4500h a part of the tip from the FeCrAl tube was cut and analysed with SEM. The investigation showed that approximately 50% of the tube still had the pre-oxide formed protective alumina oxide remaining (Figure 40). The scale thickness is in thickness is in the  $\mu$ m range thick and aluminium rich. In the bulk, some inner Cr rich regions could be observed.

**Figure 40.** Backscattered SEM image and EDX analysis of the FeCrAl tube placed at Steamboost area 4500h. This area represents the 50% of the tube where the protective alumina was not damaged

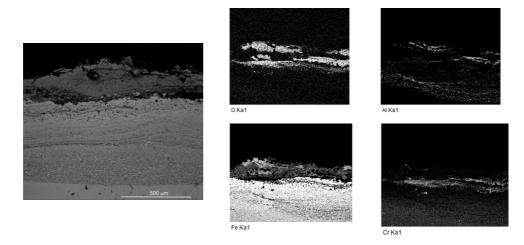
However, in the remaining 50% of the tube the alumina layer was damaged/absent and the material is covered by thick iron and chromium oxide scales. Indications of nitrides inside the bulk material could also be observed (Figure 41).

**Figure 41.** Backscattered SEM image and EDX analysis of the FeCrAl tube placed at Steamboost area 4500h. This area represents the 50% of the tube where the protective alumina was cracked and corrosion occurred

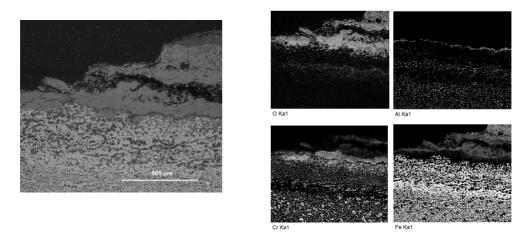
Figure 42 shows a SEM/BSE images of the top part of the tube. The sample was very corroded and indications of nitrides could be found all the through the sample, see EDX analysis. No traces of an alumina scale were observed on any part of the sample. Figure 43 shows the bottom part of the tube which had a similar microstructure and corrosion attack.

Figure 42. Backscattered SEM image and EDX analysis of the top of the FeCrAl tube

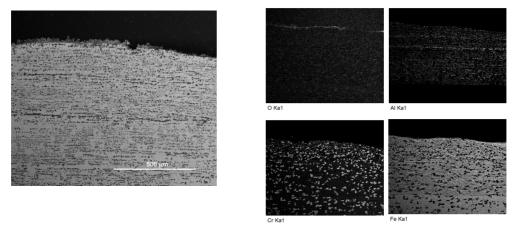
Figure 43. Backscattered SEM image and EDX analysis of the bottom of the FeCrAl tube

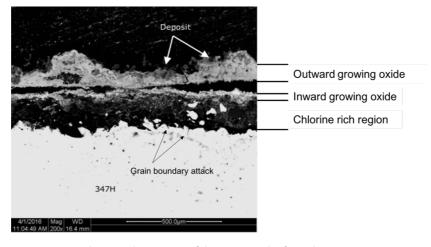
The SEM/EDX investigation of the cross-section shows that only small amounts of deposit are left on the sample, see Figure 45. The remaining deposit consist of K, Ca, Na and S while very little/no chlorine could be found in the deposit. The oxide scale is approximately 250  $\mu m$  and composed of an outward growing Fe rich oxide of about 100  $\mu m$ , and an inward growing FeCr-Ni oxide. In the inner part of the oxide scale chlorine could be detected indicating the presence of metal chlorides, see Figure 46. Indications of alloy grain boundary attack could be observed on some positions.

Figure 45. Backscattered SEM image of the 347H sample after 24h exposure

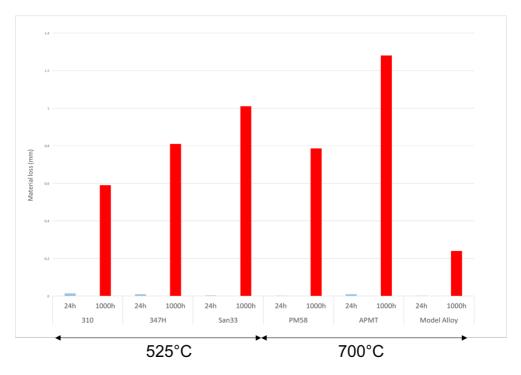
Figure 52 shows the material loss calculated for the materials exposed 1000h in the Steamboost region compared to the 24h exposure. The analyses were carried out as described in 3.2.6.3. The over welded materials were not included in the material loss measurements due to the high error that the shape of the weld seam introduces. It should be pointed out that the temperature control of the 700  $^{\circ}$ C temperature zone was lost for about 100h of the exposure. The corrosion rates are high and in line with the fast-initial corrosion attack observed on the 24 h samples. The two alumina forming alloys represent the highest material loss (Kanthal APMT) and the lowest material loss (Model alloy).

Figure 52. Material loss of the different materials exposed 24h and 1000h in the Steamboost region.

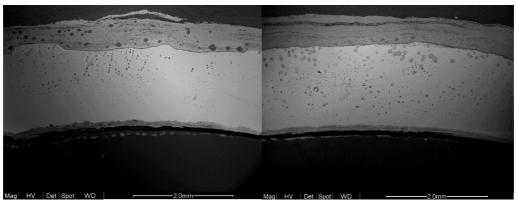
Figure 61 shows two different cross section images of alloy 1. As can be seen, the material loss is roughly the same all over the ring. Figure 62 shows SEM cross sections of the alloy 3 sample ring which is the sample that performed the best. In the left image a cross section from the least corroded area is shown. Barely any oxide is visible and the material loss is close to zero. This is the case for the majority of the sample ring surface. The exception is the part of the ring that was on the flue gas side which has corroded much more severely. This can be seen in the left image of Figure 62 as the oxide is reaching into the material.

Figure 61: SEM cross section images of two different points of the alloy 1 sample ring.

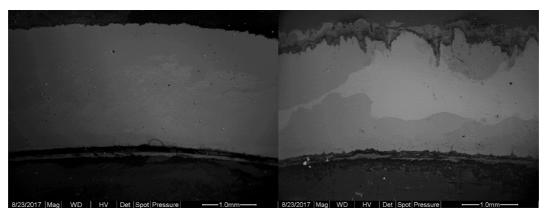
**Figure 62:** SEM cross section images of the least severely corroded (left) and the most severely corroded (right, flue gas side) point on the **alloy 3** sample ring.

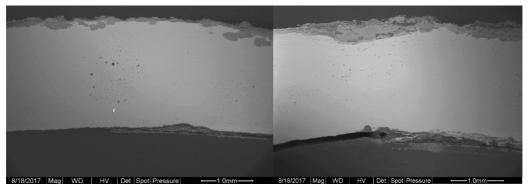
**Figure 63:** SEM cross section images of the least severely corroded (left) and the most severely corroded (right, flue gas side) point on the **alloy 2** sample ring.

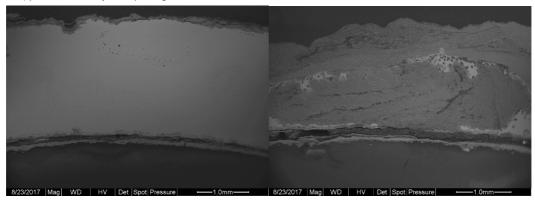
**Figure 64:** SEM cross section images of the least severely corroded (left) and the most severely corroded (right, flue gas side) point on the **alloy 5** sample ring.

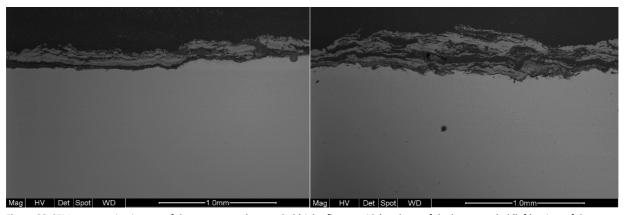
Figure 66: SEM cross section images of the most severely corroded (right, flue gas side) and one of the less corroded (left) points of the Inconel overweld sample ring.

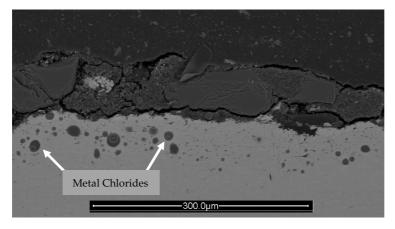
Figure 67: SEM cross section image of Inconel 625 overweld sample ring showing the formation of metal chlorides.

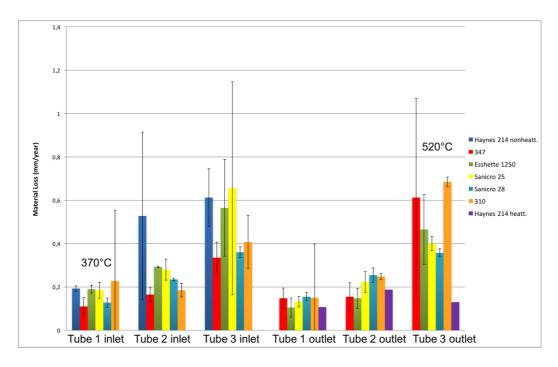
Figure 68: Material loss of the different material of the Steamboost for the different tubes (2015)

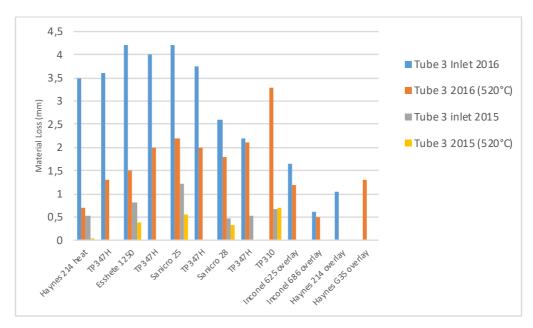
Figure 69. Material loss of the different materials in the tube 3 (520°C) 2016
