# KME 708 High temperature corrosion in used wood fired boilers

## Part 1 2014-16

# Scope and goals

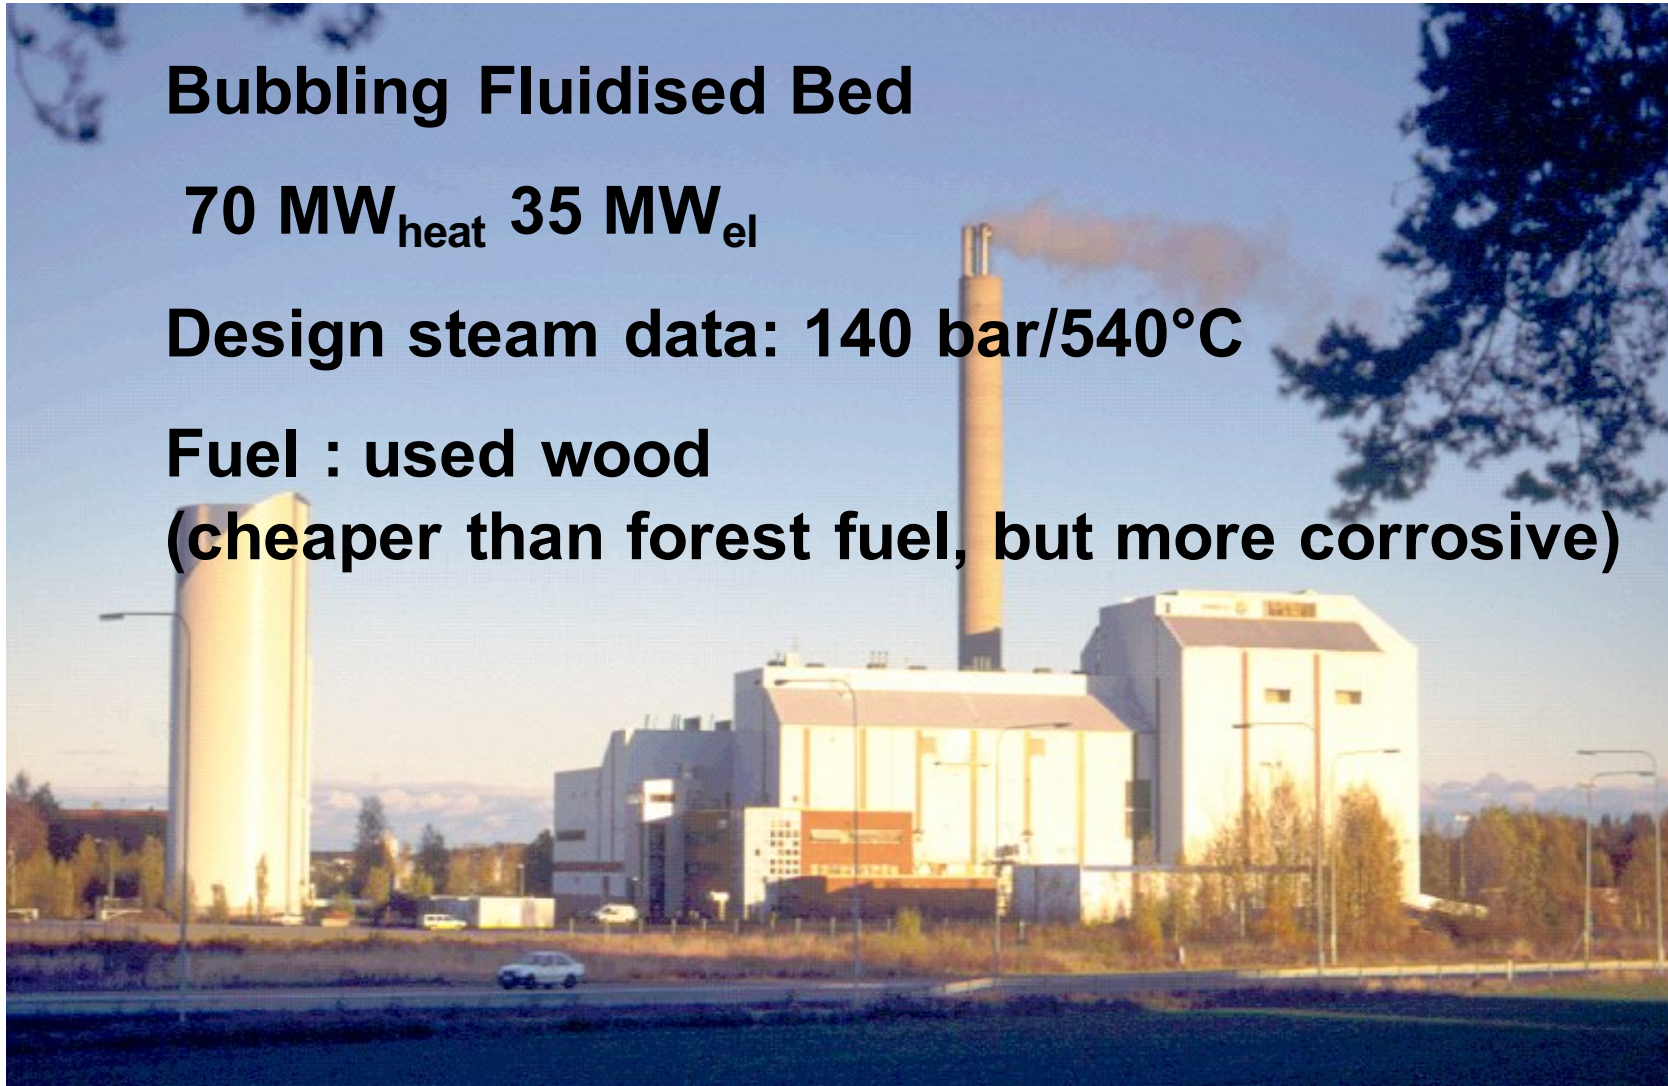
## Testing performed in Idbäcken line 3 (CHP) in Nyköping

**Bubbling Fluidised Bed**

**70 MW<sub>heat</sub> 35 MW<sub>el</sub>**

**Design steam data: 140 bar/540°C**

**Fuel : used wood**

**(cheaper than forest fuel, but more corrosive)**

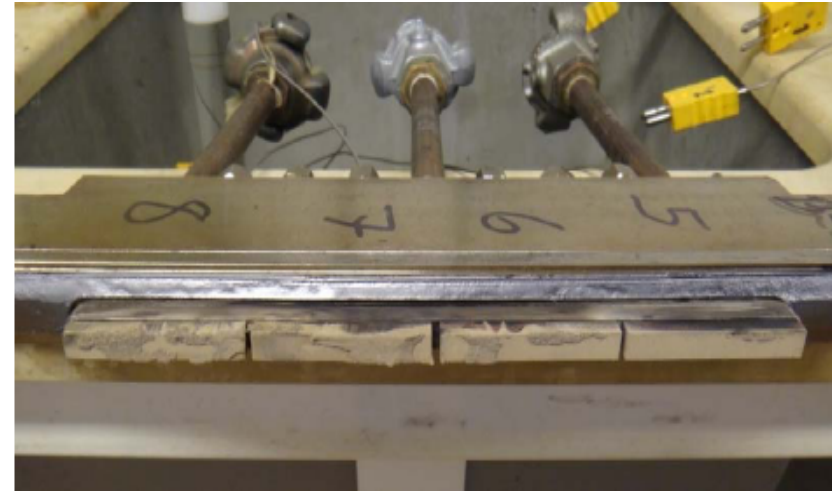
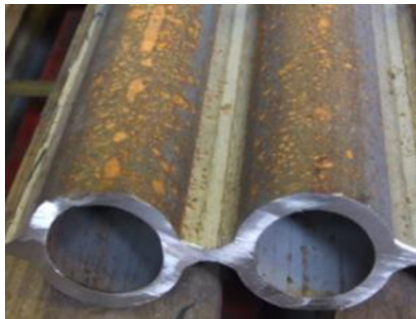
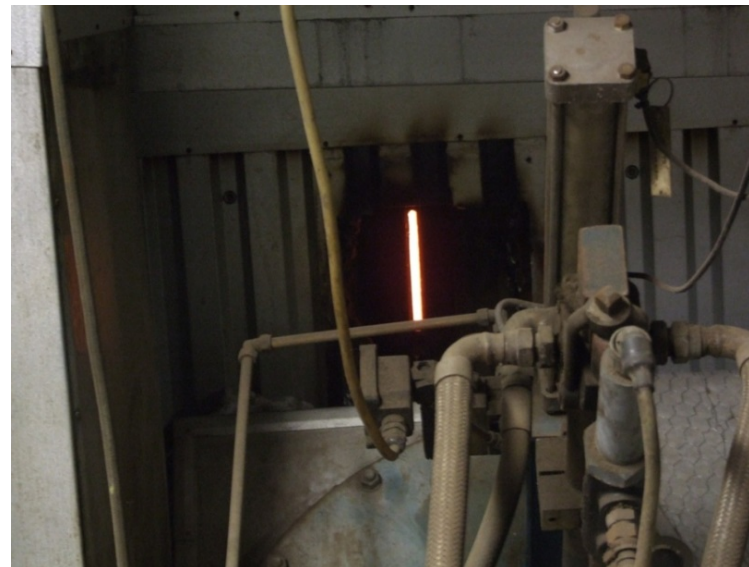
# Corrosion probe testing – air-cooled furnace wall probe

Vattenfall's in-house probe. Sits between the tubes in the furnace wall. 4 specimens on each probe. Thermocouple in each specimen for individual temperature measurement. Control temp 350 and 400°C

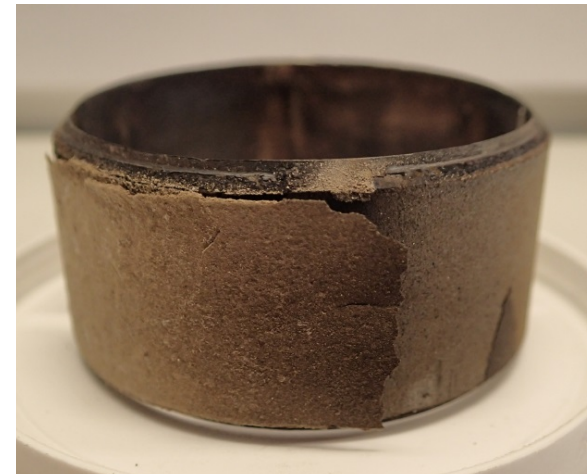
## Air cooled probe

Three rings at temperatures 350, 450, 550°C  
(equivalent to steam temp ~520°C)

- Weigh ring before and after exposure for deposit growth rates.
- Analyse deposit with SEM for info on corrosion risk

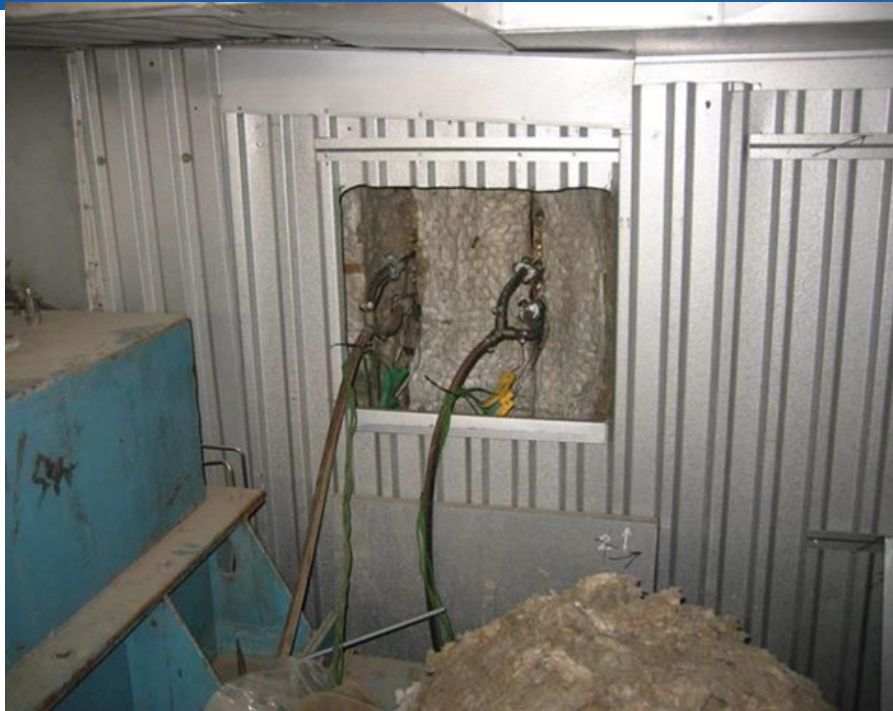
# Corrosion testing on back wall

Corrosion testing previously made in centre position A on back wall. This hole is not easily accessible on outside of boiler. Safety issues. Two new testing holes made between A and J on back wall.
