**Experiences from Hydraulic Model Tests in Dam
Rebuilding Projects**

Elforsk rapport 10:95

James Yang, Vattenfall R & D

April 2009

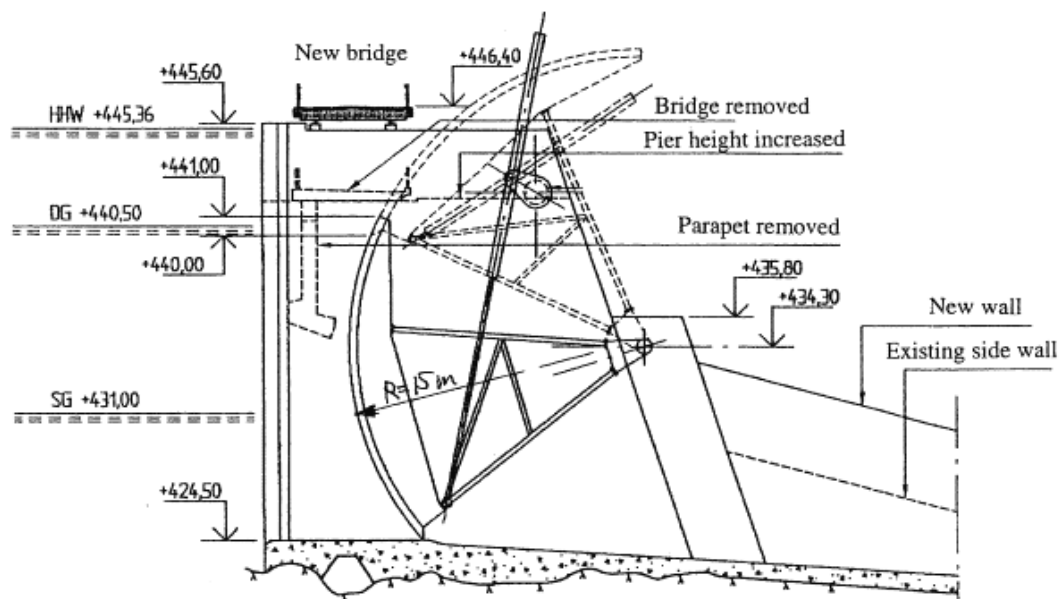
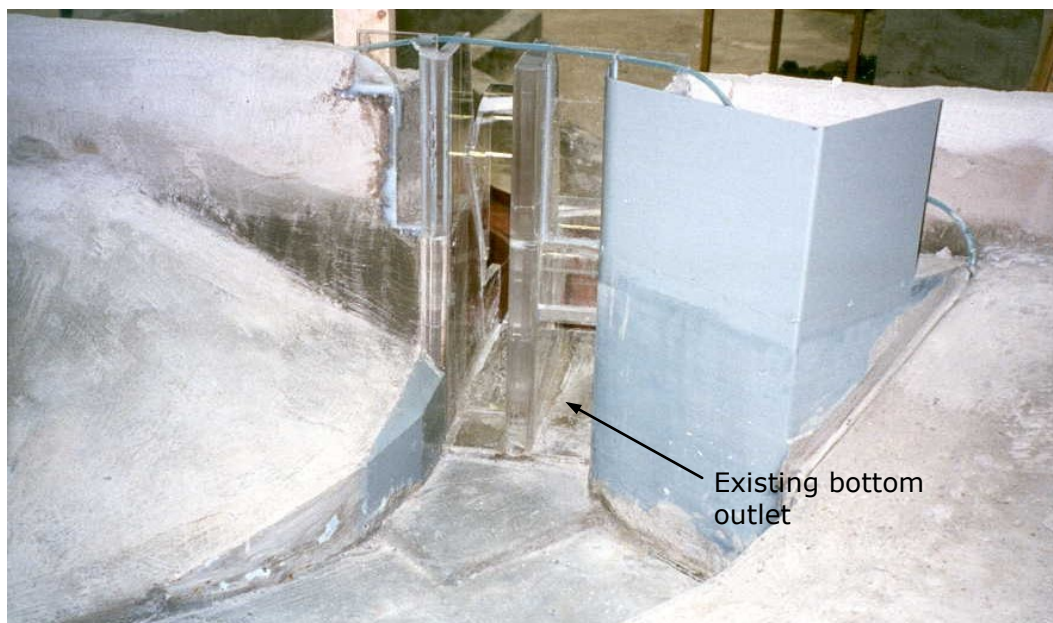
Figure 2.4 Modification of left bottom outlet to gated open spillway

It was suggested that one of the two bottom outlets, i.e. the left outlet, was modified to an open spillway (gated), Figure 2.4. In so doing, the reservoir water stage would increase much slower with increasing inflow discharge. The main reason why the left bottom outlet was chosen was that the radial gate in the right outlet had been, due to leakage, renovated a couple of years ago. The modification implied that the parapet wall in the left outlet was removed; the existing radial gate was replaced, and a larger, new one was installed. The sill elevation and width of the opening remained however unchanged.

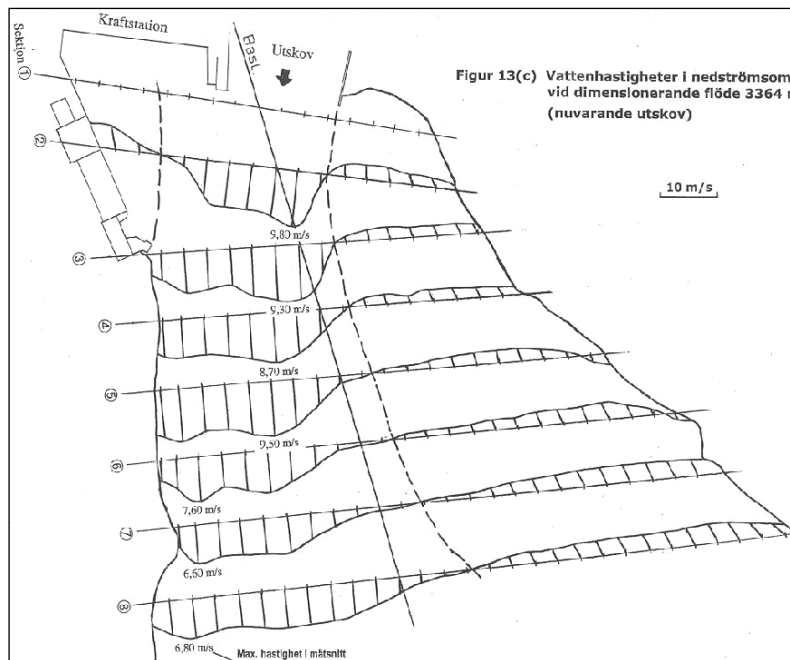
Figure 3.7 Flow velocity downstream at the discharge $3350 \text{ m}^3/\text{s}$

Figure 3.7 showed the velocity distribution at the discharge $\sim 3350 \text{ m}^3/\text{s}$. Due to the oblique dam location in relation to the river valley, back flow was created and it took up roughly half width of the river. The back-flow velocity was as high as 2–3 m/s, depending on the discharge. Measures must be taken to protect the left bank immediately downstream the dam from erosion. It could be seen that the velocity along the riverbank is very high, up to 7–8 m/s. Due to flow unsteadiness, irregular wave motions hit the bank and the breeding station. The spillway discharge scheme was therefore investigated to obtain the most favorable flow pattern at high floods, so that the risk for erosion was minimized.

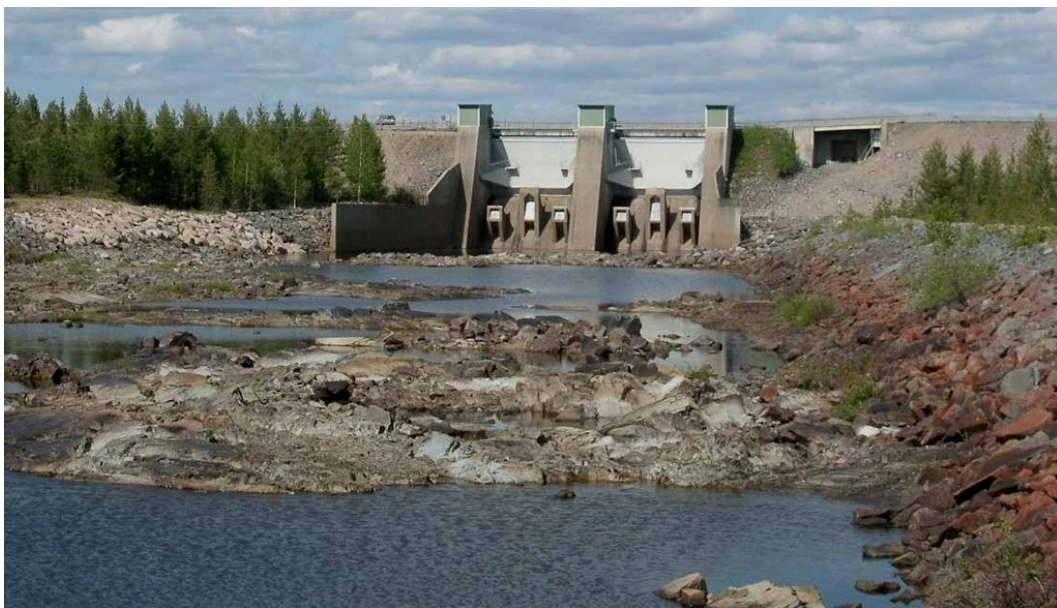
Figure 4.1 Gallejaur dam with gated spillway openings

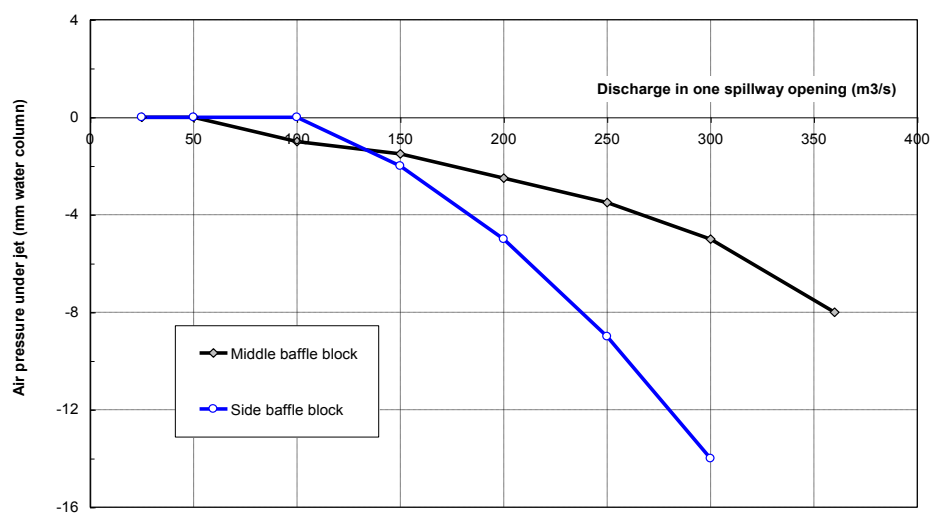
Figure 4.4 Measured under-pressure beneath nappe in the model

Aeration of flow - Figure 4.4 shows the under-pressure measured under the jets over the middle (upper) baffle and the side (lower) baffles. Neglecting the model scale effect, the flow should be obviously aerated at discharges higher than about 50 m³/s for the middle baffle and 100 m³/s for the side ones. To seal the aerating channels is not advisable above the limits.

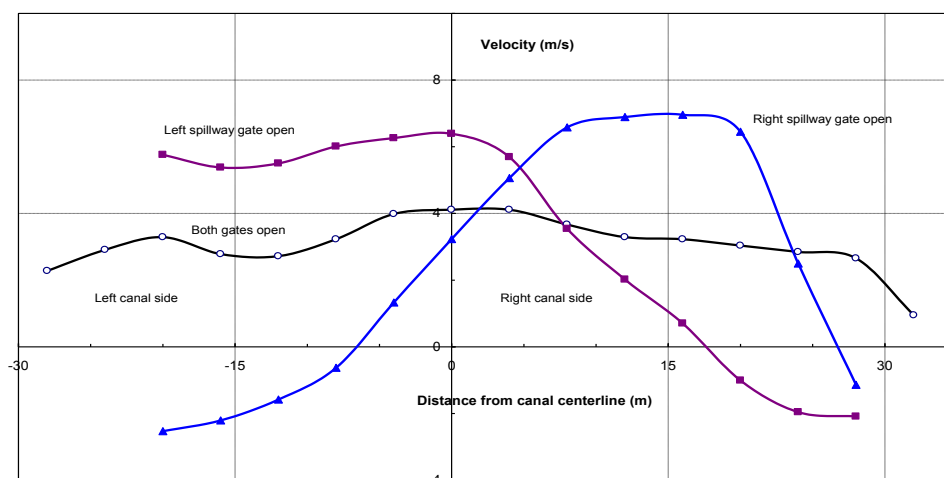
Figure 4.5 Flow velocity distribution in the canal, only one gate open $360 \text{ m}^3/\text{s}$ and both gates open $840 \text{ m}^3/\text{s}$

Figure 4.5 illustrates the velocity distribution in the canal at a location 80 m from the dam. The resulting velocity with only one spillway gate in operation, irrespective of left or right, was much higher than that with both gates opened at the same time. Besides, due to the fact that a lower discharge corresponds to a lower water level in the canal, the waves acted on lower position of the erosion protection when only one spillway was open.

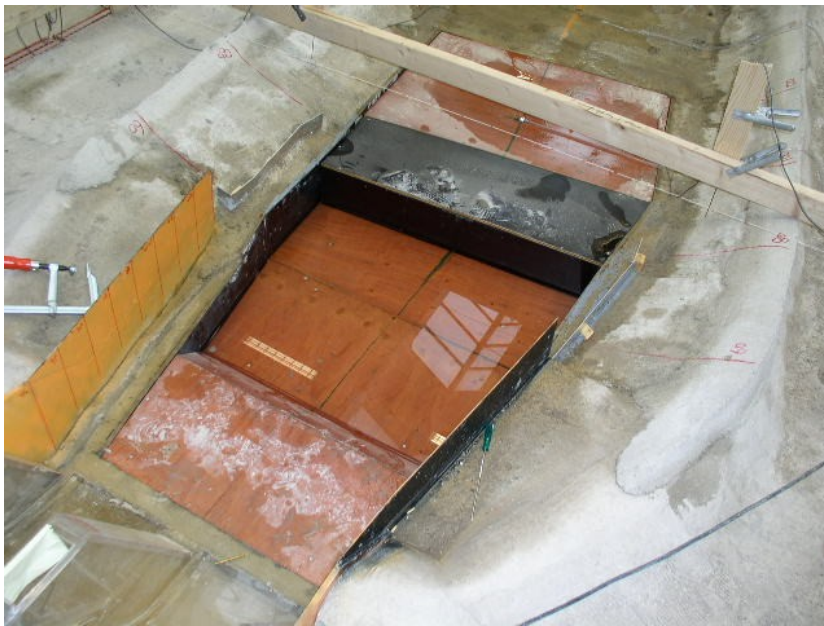
Figure 4.7 Use of stilling basin to improve energy dissipation

To improve the flow conditions in the canal, excavation of a stilling basin was proposed. The basin tested in the model was given different layouts, corresponding to a length of 25 – 80 m and a depth of 6.0 – 8.0 m below the exiting canal bottom. Depending on the canal width, the basin width varied between 25 - 40 m, Figure 4.7.

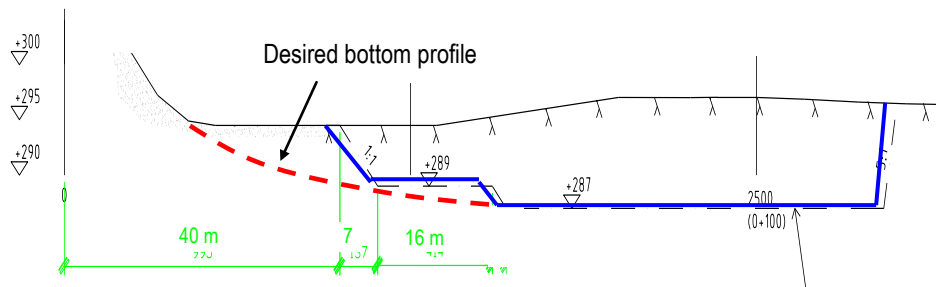
Figure 4.8 Excavation of stilling basin – longitudinal profile

Tests indicated that the jets over the three baffle blocks plunged unexpectedly on the horizontal chute, i.e. outside the basin, where the water depth was very limited. Besides, conditioned by the horizontal chute, very strong surface currents prevailed in the basin area. As a result, strong waves were generated, propagating further downstream in the canal. The flow velocity along the basin bottom was very low, implying that the basin depth did not play much role in the energy dissipation. Despite a larger basin length, the flow pattern was not affected.

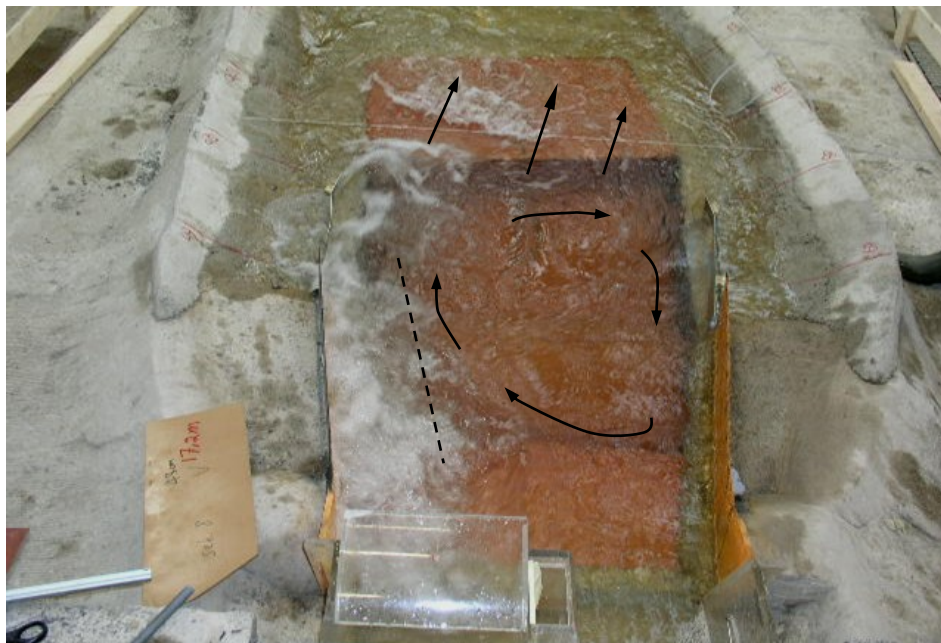
Figure 4.10 Removal of ski-jump baffles - highly concentrated flow with large circulating zone generated in canal

Conditioned by the geometry of the canal and the stilling basin, a highly concentrated flow, accounting for only 20–25% of the canal width, built up downstream the spillway if only one gate, either left or right, was in use, Figure 4.10. The flow was characterised by a large back-flow area and considerable water-level difference. Tests demonstrated that, if the middle spillway pier was extended downstream in form of a partition wall, the flow pattern could be avoided and relatively even flow was achieved in the canal.

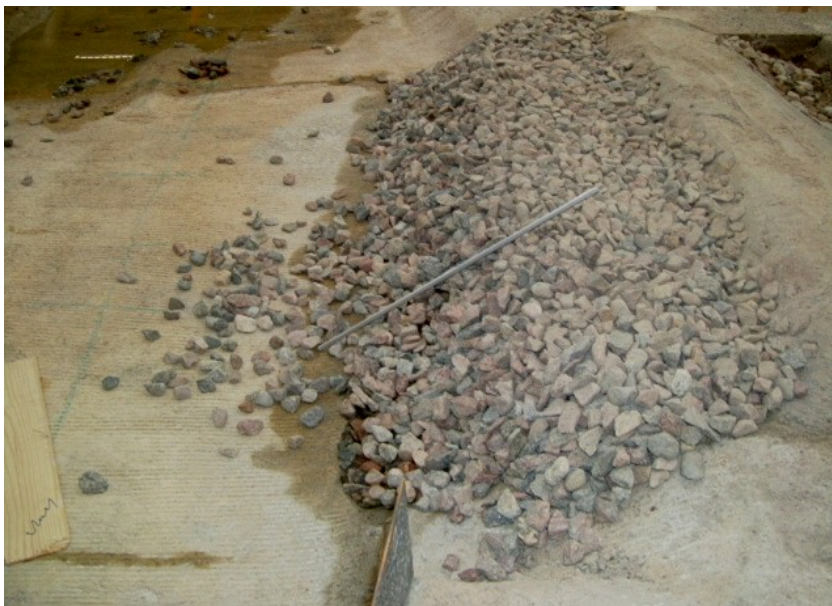
Figure 4.11 Spillway canal subjected to with high velocity and strong waves - collapse of riprap-slope protection whose size was only based upon flow velocity

In the model, a section of the canal sidewall immediately downstream the spillway chute was removed. It was replaced by blasted stones whose size D_{50} was based upon those often used formulas at a given canal discharge. The stone slope was built with the same angle as in the prototype. Repeated tests showed that the slope collapsed easily, Figure 4.11. To guarantee its stability, a large safety factor was a must. To use rock riprap as erosion protection in close vicinity of a stilling basin was probably not a good engineering practice.

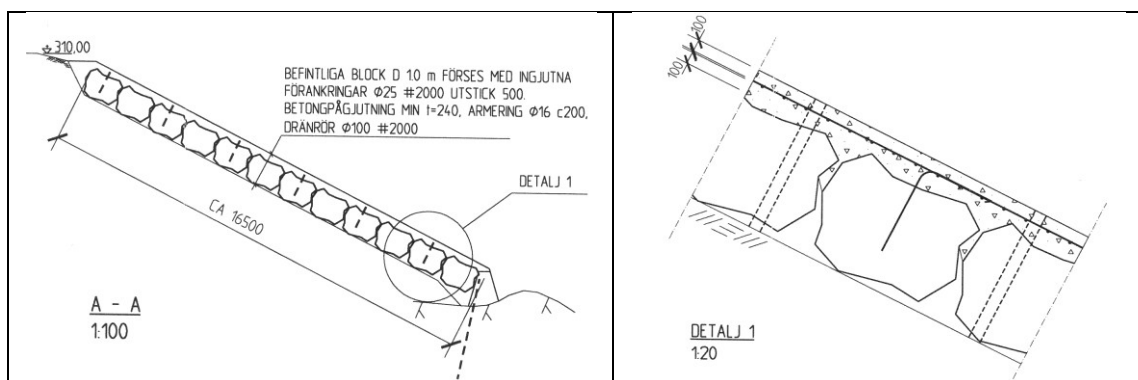
Figure 4.12 Illustration of concrete grouting of stones in exiting erosion protection (stone size 1.0 m, min. concrete thickness above stones $t = 240$ mm; reinforcement bar $\phi 25$, #2000, $L=1500$; drainage hole $\phi 100$, #2000)

Even if one could estimate the requisite stone size, it wouldn't be realistic to replace the riprap in an existing canal because large engineering costs were usually involved. The rebuilding measure suggested for Gallejaur was to have the voids filled with concrete grout, so that the stones were joined together to form a layer of rigid, monolithic armour, Figure 4.12. Grouted rock can resist larger hydraulic forces than the riprap itself. Proper drainage should be arranged to avoid the uplift pressure behind it when the water level in the canal drops. The loss of the supporting bank material should be also avoided, as the grouted rock was particularly susceptible to failure from undermining.

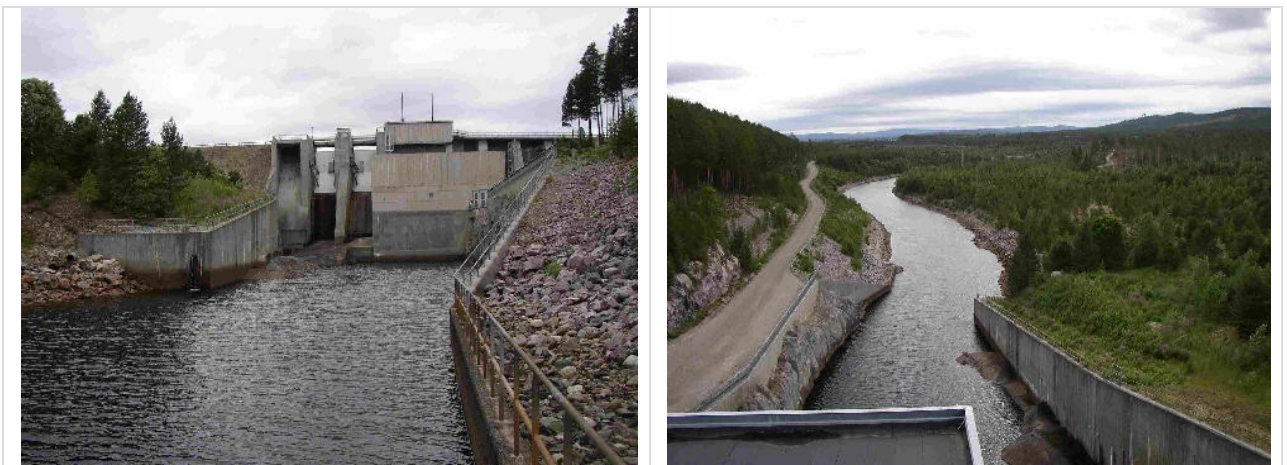
Figure 5.1 Halvfari dam - spillway section and channel downstream

The spillway water is discharged into a plunge pool excavated in rock. Sidewalls exist on both sides to prevent overtopping at high spillway discharges. Downstream of the plunge pool, the right riverbank consists of easily erodible material.

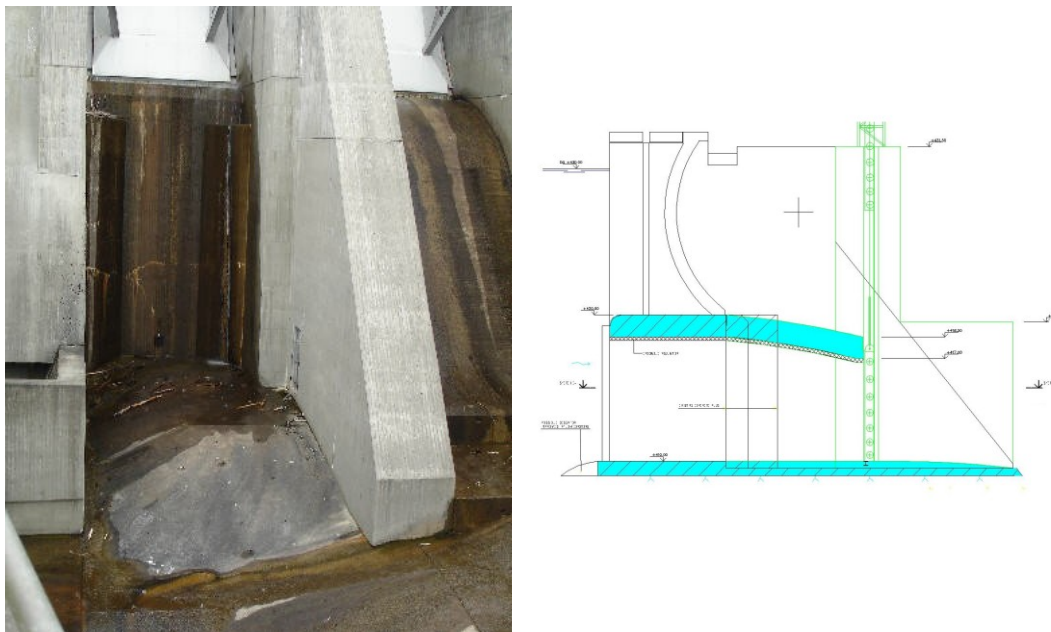
Figure 5.2 Rebuilding of sealed passage to bottom outlet

The spillway between the Ogee and siphon spillway is a free-drop type of opening. The passage below it is at present sealed with a vertical concrete plug. Another rebuilding proposal is to remove this plug and modify the passage into a bottom outlet, Figure 5.2. This means that the plug is dismantled and the horizontal crest of the overflow opening is extended downstream and bent somewhat downwards. At the end of the extension, a bulkhead gate is installed for closure of the outlet. The outlet has the same width as the free-drop spillway at its upper part, 5.0 m, and reduces to 4.5 m towards the bulkhead gate. The outlet height is 8.5 m and reduced to 7.0 m at the bulkhead gate. As a technically feasible solution, this proposal is chosen for further investigation.

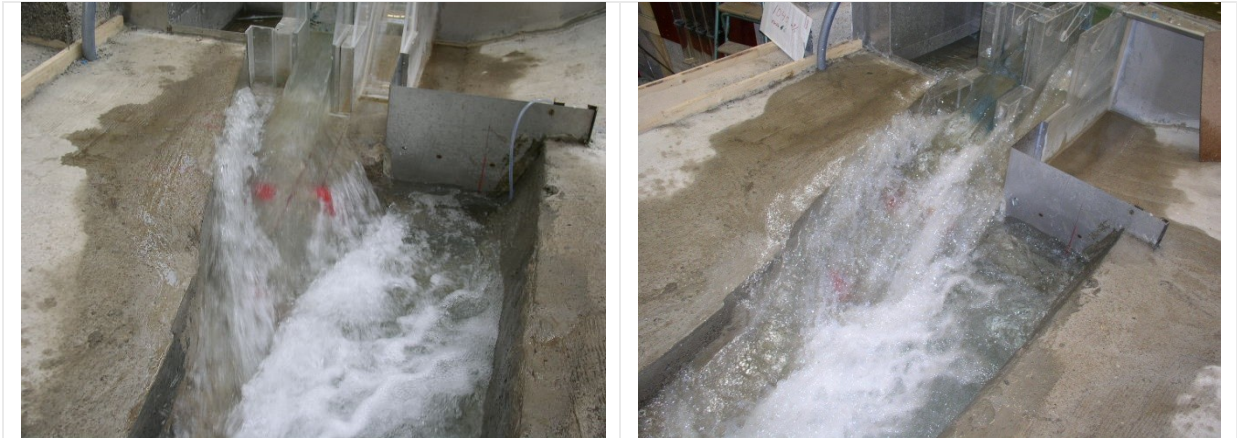
Figure 5.7 Existing energy dissipation, ~500 m³/s only from bottom outlet (left) and ~1300 m³/s from all three openings (right)

Structural modifications are an absolute necessity to improve the energy dissipation and mitigate the turbulent flow situation in the pool.

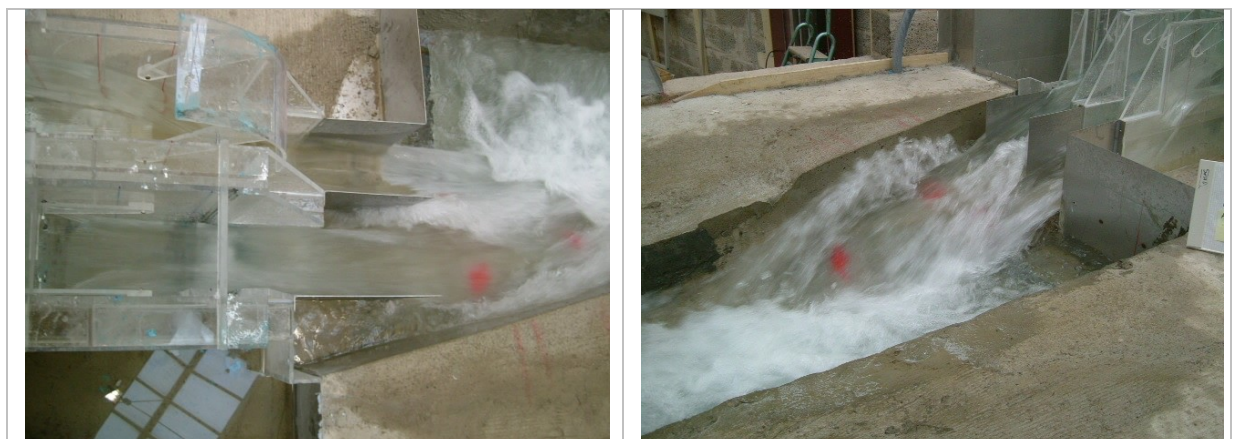
Figure 5.8 Improvement through extension of spillway piers, at the flow discharge ~1300 m³/s

The existing spillway piers end too early upstream, the water from both sides interrupts each other. A large portion of the spillway water runs directly onto the right sidewall. By trial and error, it has been found that if the middle and right spillway piers are extended, the flow situations immediately downstream of the spillway gates are improved, which provides prerequisite of further improvements (Figure 5.8).

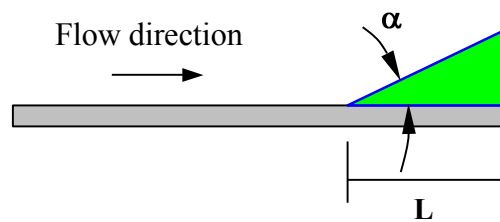
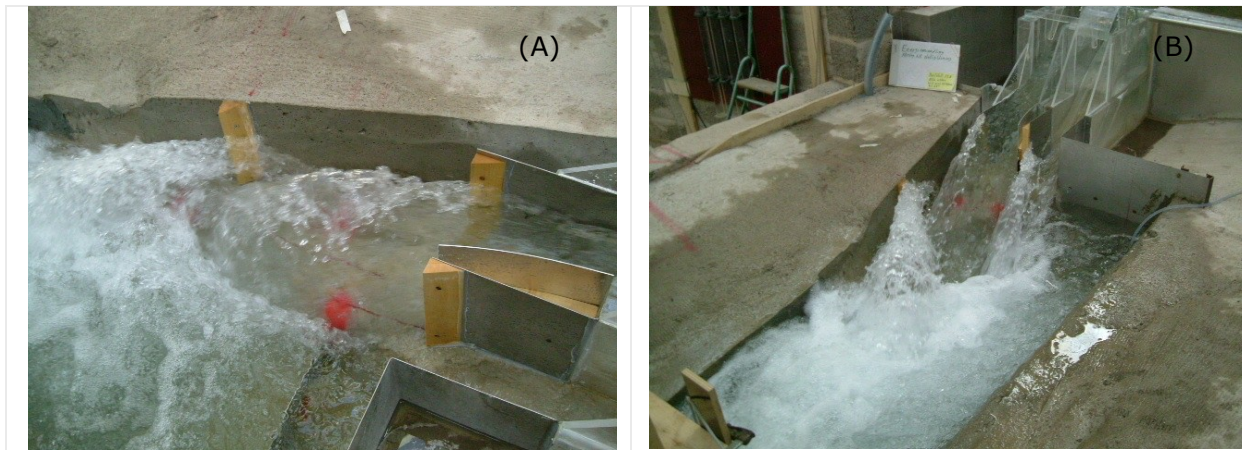
Figure 5.9 Finalized modification by installation of vertical deflectors at the end of extended piers and on the right sidewall, (A) discharge in bottom outlet and (B) discharge in all openings

From the energy dissipating point of view, the plunge pool has a very limited volume and water-surface area. To achieve effective energy dissipation, a concentrated flow jet into it should be avoided if possible. With the extended spillway piers, the flow conditions and energy dissipation in the plunge pool can be further improved by adding vertical deflectors at the end of the piers, Figure 5.9. Tests show that deflectors are needed in both spillway openings. The reasonable angle, measured in the flow direction, is $\alpha_L = 30^\circ$ for the left deflector and $\alpha_R = 25^\circ$ for the right one. The suitable length of both deflectors is $L_L = L_R = 2$ m.

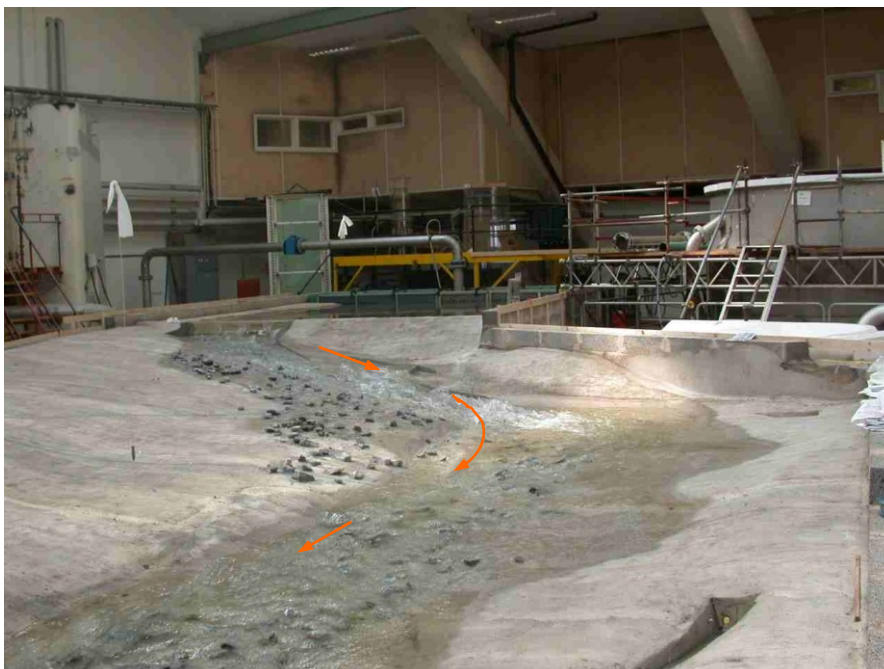
Figure 6.3a Model of Harsprånget, 1:60, seen from downstream

In order to in an approximate way reproduce the rock-surface condition, the model was in its downstream area provided with macadam, 40–60 mm, and some gravel, 70–120 mm, Figure 6.3b.

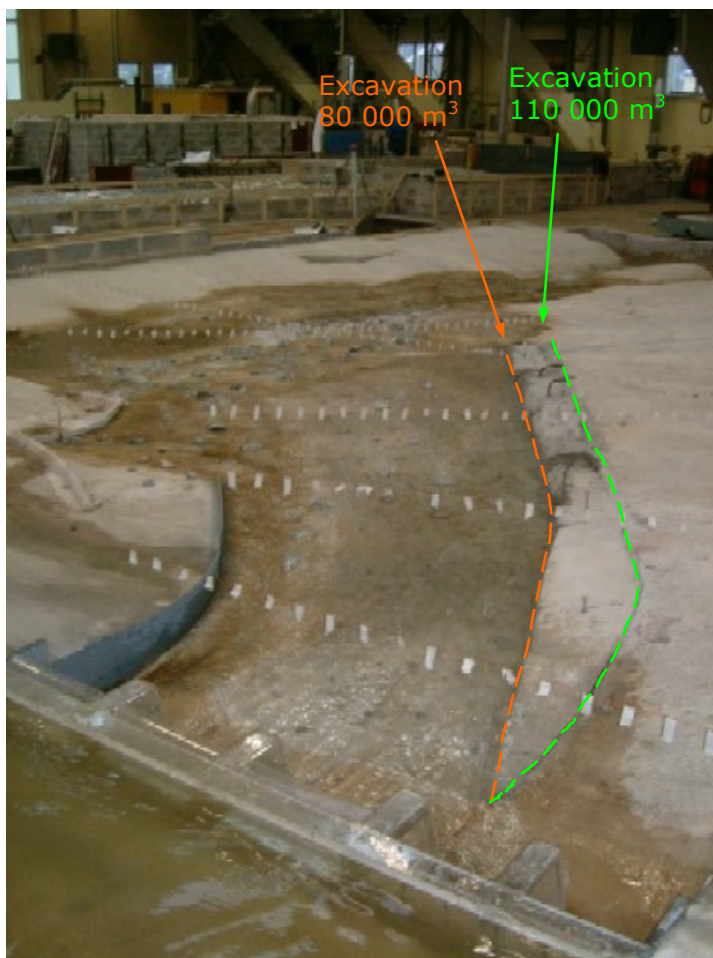
Figure 6.4 Rock excavation downstream of the spillway worked out through model tests

The spillway channel, following basically the exiting curvature, was re-shaped by excavation; several layouts were tested. On a trial-and-error basis, a total of 80 000 m³ rock was removed over a length of 200 m from the spillways and downstream. The water was thus diverted away from the guide walls and the thresholds to the tunnels. The channel surface was made as smooth as possible; the water was thus distributed over a wider area, which also reduced the loads acting on the rock. The excavated rock mass would be used for improvement of the erosion protection at both upstream and downstream side of the dam. The new channel shaping is shown in Figure 6.4.

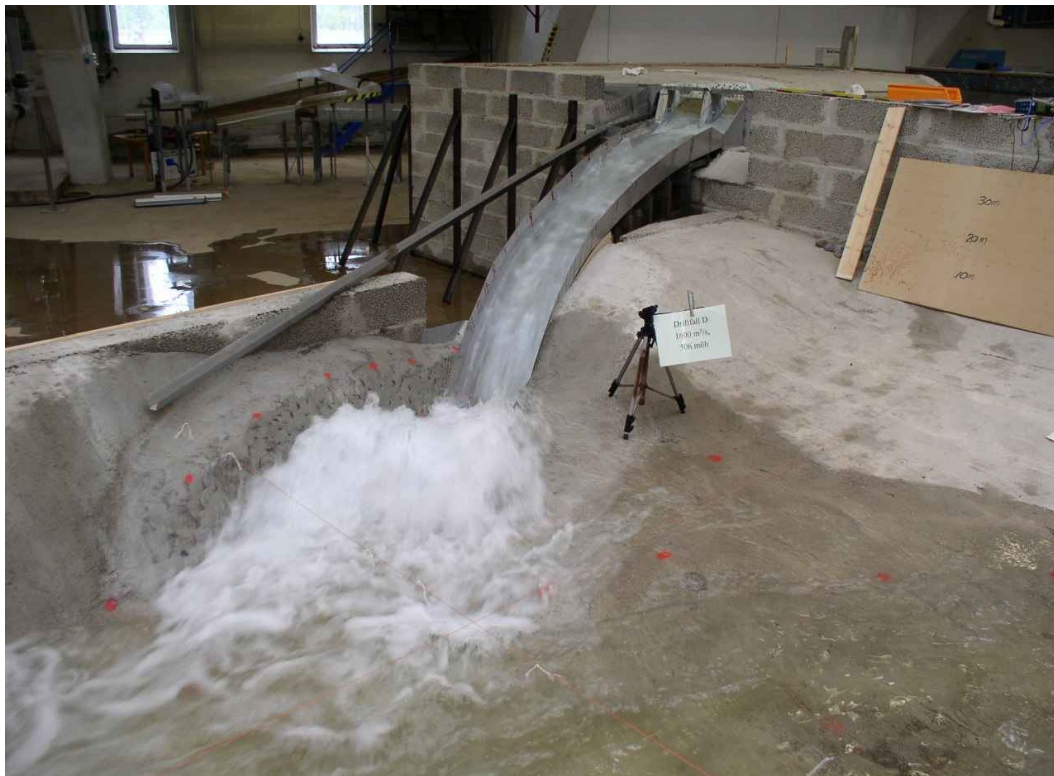
Figure 7.8 Flood discharge in existing energy dissipator, $1600 \text{ m}^3/\text{s}$

The outflow into the river from the basin was characterized by large water level differences and high-intensity turbulence. The flow velocity along the right river bank downstream of the stilling basin was as high as 10-12 m/s and strong wave motions occurred along the erosion sensitive left bank.

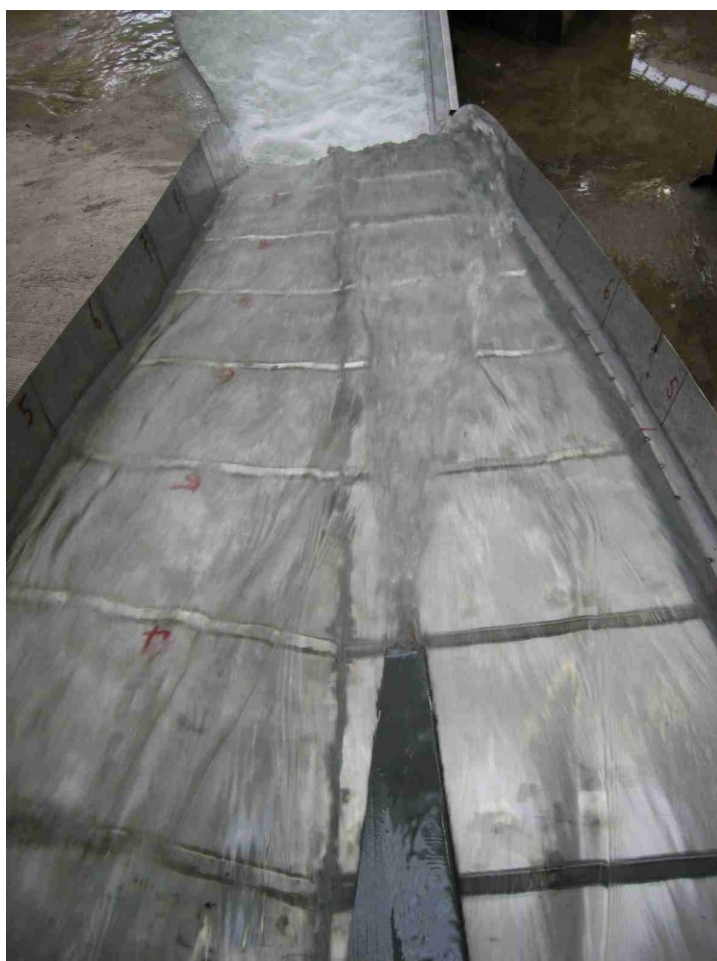
Figure 7.12 Alternative B2 – Non-uniform flow with cross-wave if the channel bottom given the same cross-sectional elevation.

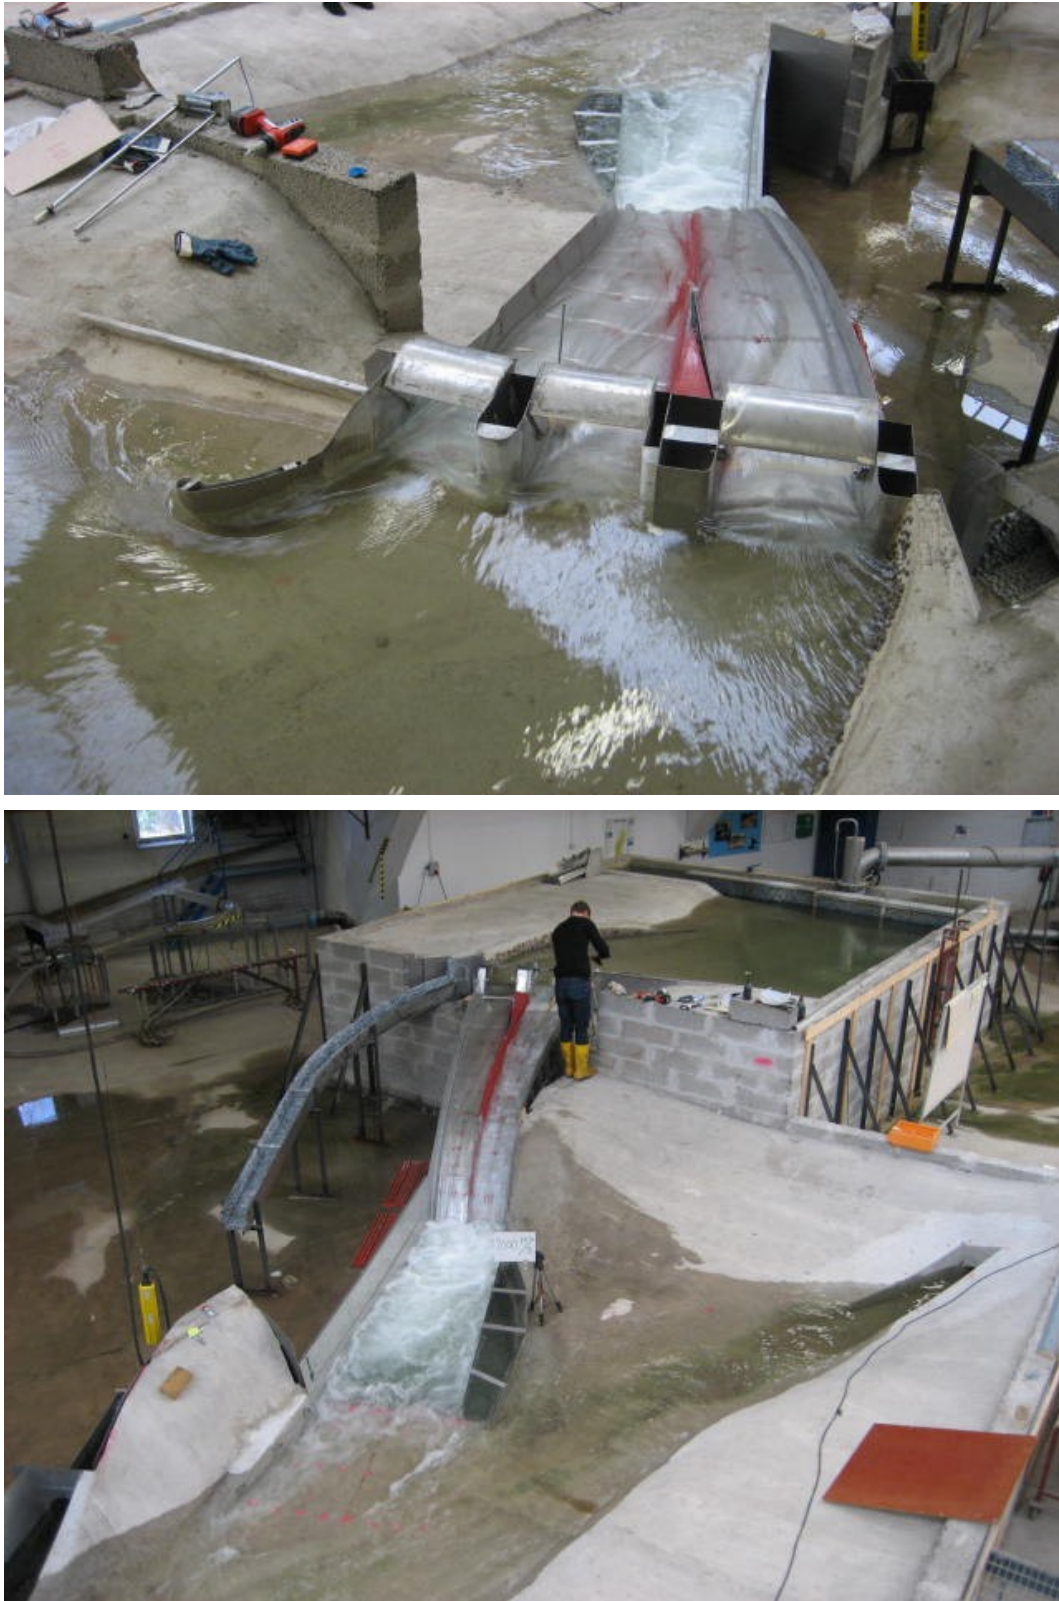
Figure 7.14 Alternative B2 – Flow in the final worked-out layout

At the design flood, the approaching flow conditions at the spillway and the energy dissipation for the final chosen layout for alternative B2 are shown in Figure 7.14.

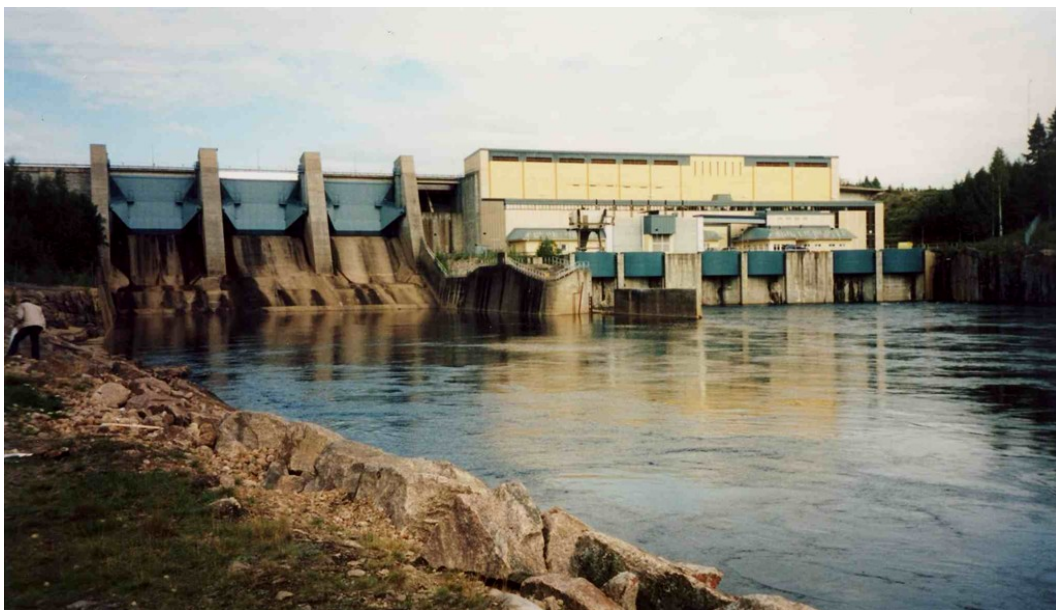
Figure 8.1 Laxede dam, with spillway located to the right of the power plant

The spillway section is located to the right of the power station and consists of three gated overflow openings of 15 m wide each. The total discharge capacity corresponds to $\sim 2800 \text{ m}^3/\text{s}$ at the FRRL. The updated design flood amounts to some $3200 \text{ m}^3/\text{s}$.

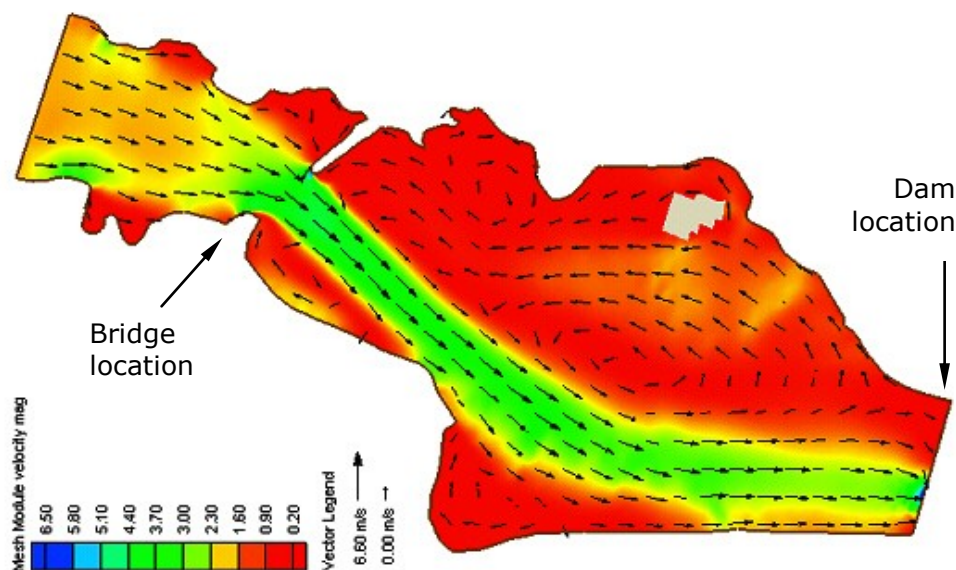
Figure 8.4 Flow pattern in Laxede at spillway discharge $Q = 3200 \text{ m}^3/\text{s}$

The possibility of using debris booms in Laxede is first investigated. Figure 8.4 shows the flow pattern in the Laxede reservoir at the design flood (results from the program Surfacewater Modeling System (SMS), based on shallow-water equations). Different locations of placing a debris boom were tested, including anchorage from the riverbanks and from a buoy in the middle of the main stream. The narrow bridge opening caused a flow velocity amounting to 2 – 4 m/s throughout the reservoir. Debris temporarily stopped by the boom would be dragged down by the water and pass the boom from underneath. Due to the concentrated high flow velocity in the reservoir, the use of shear booms proved to be unsuitable.

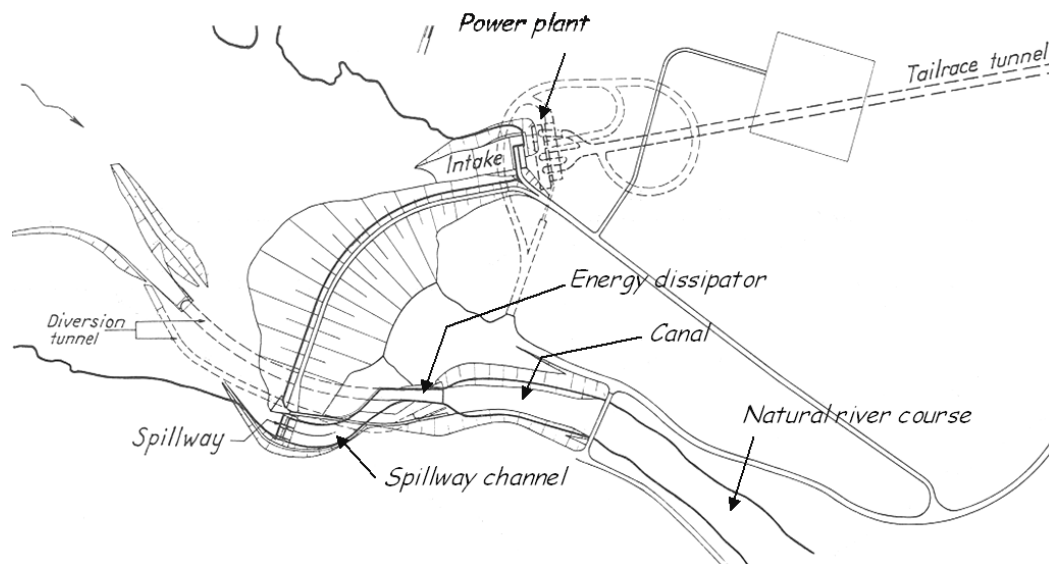
Figure 9.1 Layout of Letsi before rebuilding

The dam is of rock-fill type, having a max. height of 85 m and a crest length of $\sim 550 \text{ m}$, Figure 9.1. It is grounded on solid rock and has a conventionally formed vertical impervious core of moraine, surrounded by filter and rock fill. The dam axis is given a slightly convex form in the upstream direction.

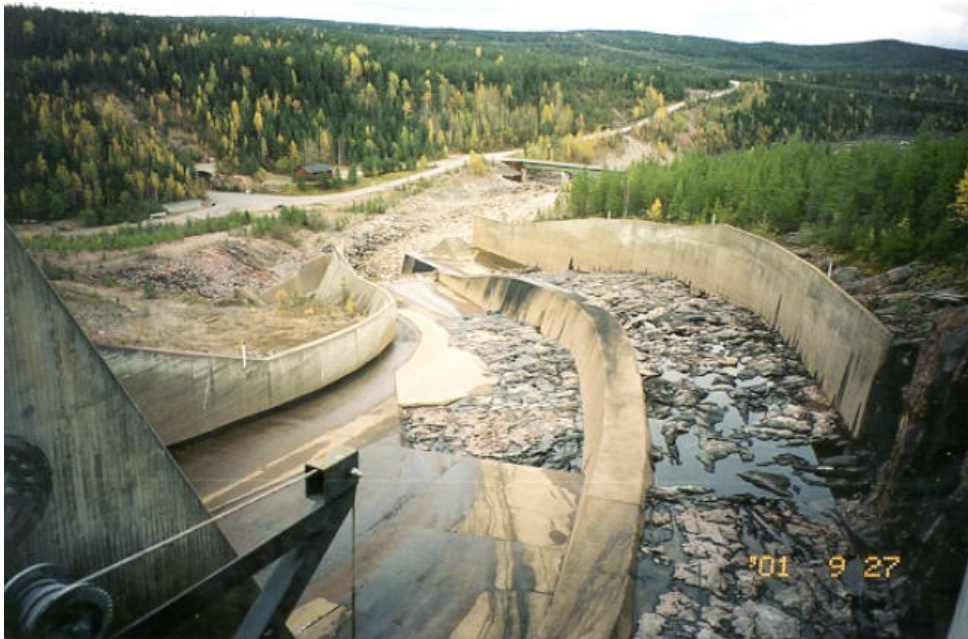
Figure 9.2 Spillway channel before rebuilding

The spillway channel is bent to the left in plan and is about 120 m in length. The channel bottom is partially in rock and partially in concrete, Figure 9.2. From the channel, the spillway water is discharged into an energy dissipator that is some 40 m lower in elevation. The dissipator runs almost perpendicular with the dam axis. It is $\sim 100 \text{ m}$ long and 20 m wide. The water is then conveyed to the natural river through an artificial canal paved with stone.

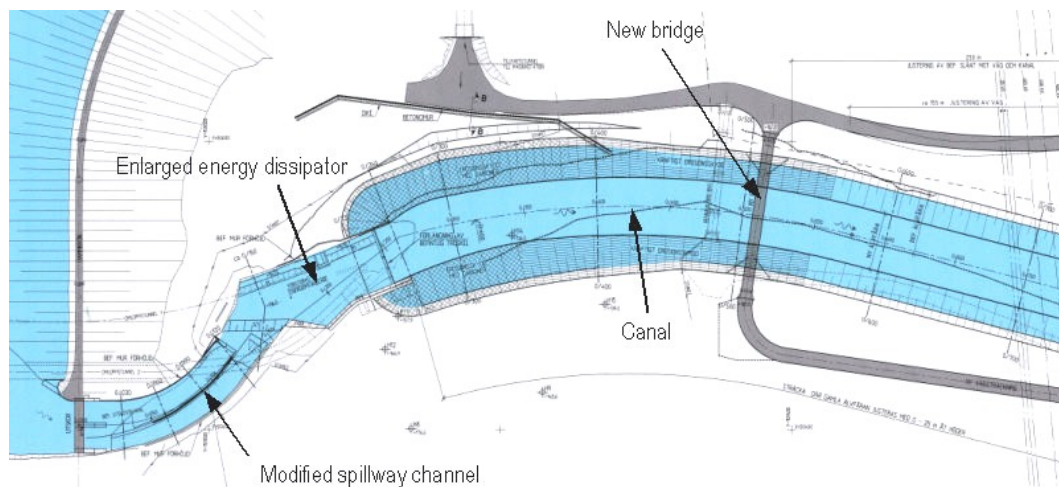
Figure 9.5 Layout B – rebuilding of the existing waterway

Layout B, shown in Figure 9.5, refers to rebuilding of the existing spillway waterway, which consists of the following aspects.

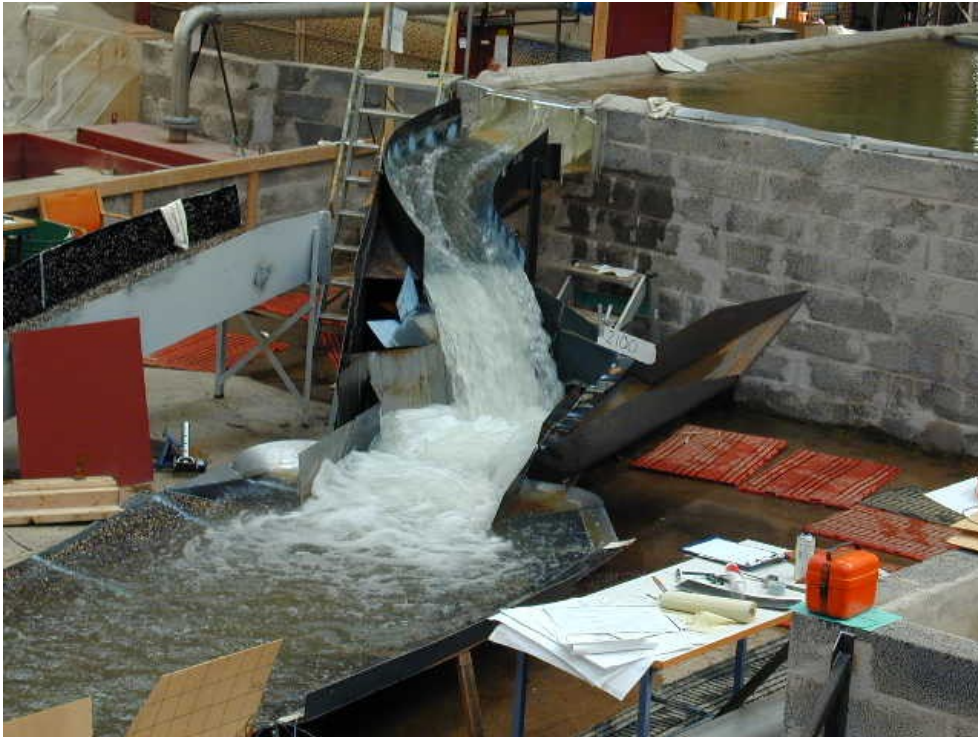
Figure 9.10 Modified existing spillway channel with partition wall, flow behavior at the design flood

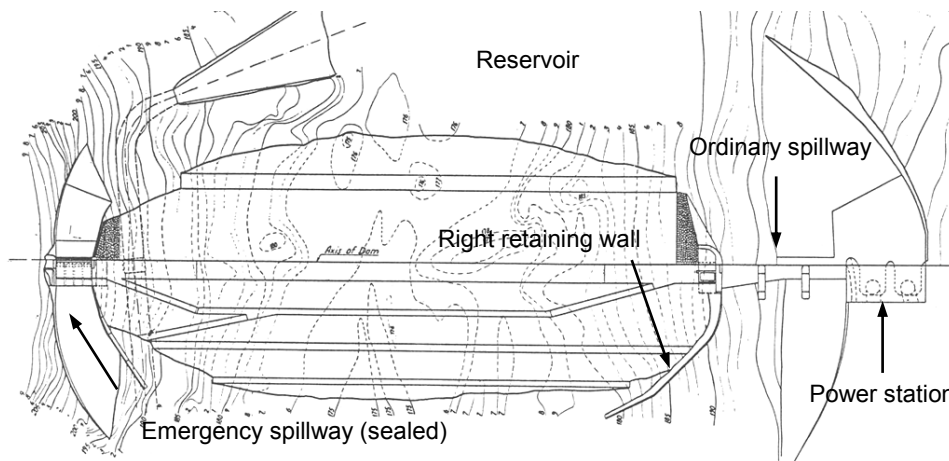
Figure 10.1 Ligga dam, layout

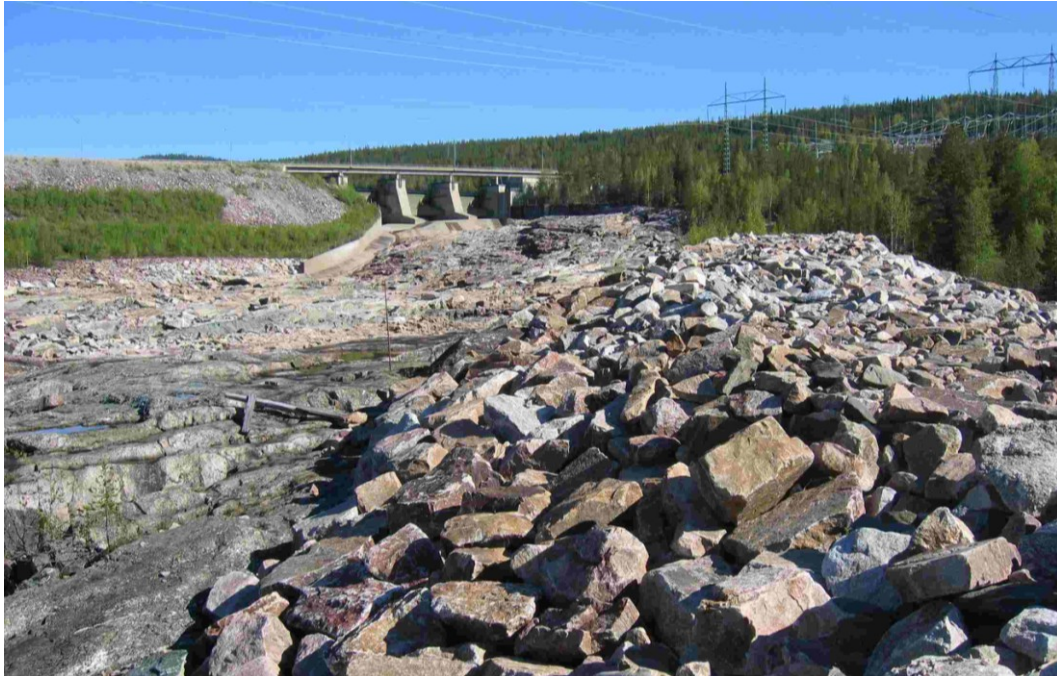
Figure 10.2 Spillway channel is bounded by bedrock of coarse-grained granite

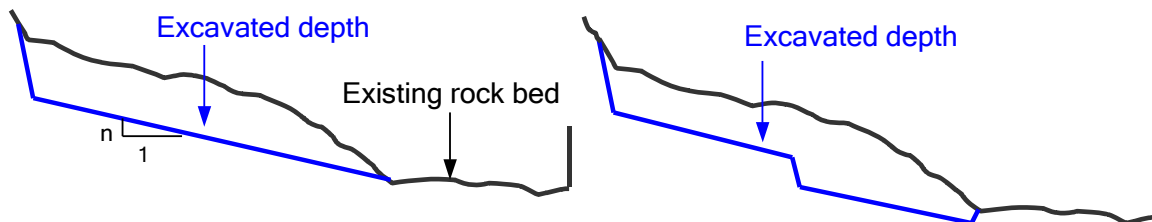
Figure 10.4 Two basic ways of excavation, option A and B

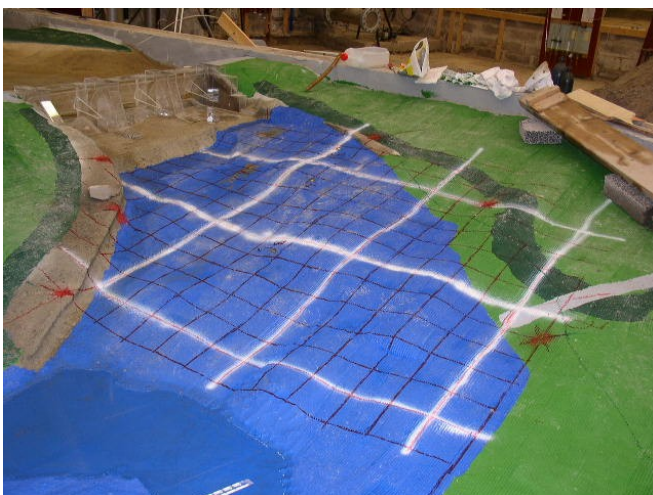
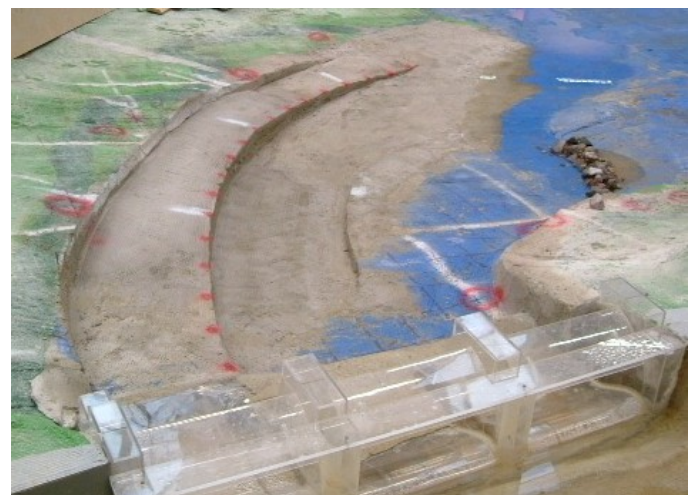
Figure 10.5 Spillway channel – before and after excavation
