**Experiences from Hydraulic Model Tests in Dam
Rebuilding Projects**

Elforsk rapport 10:95

James Yang, Vattenfall R & D

April 2009

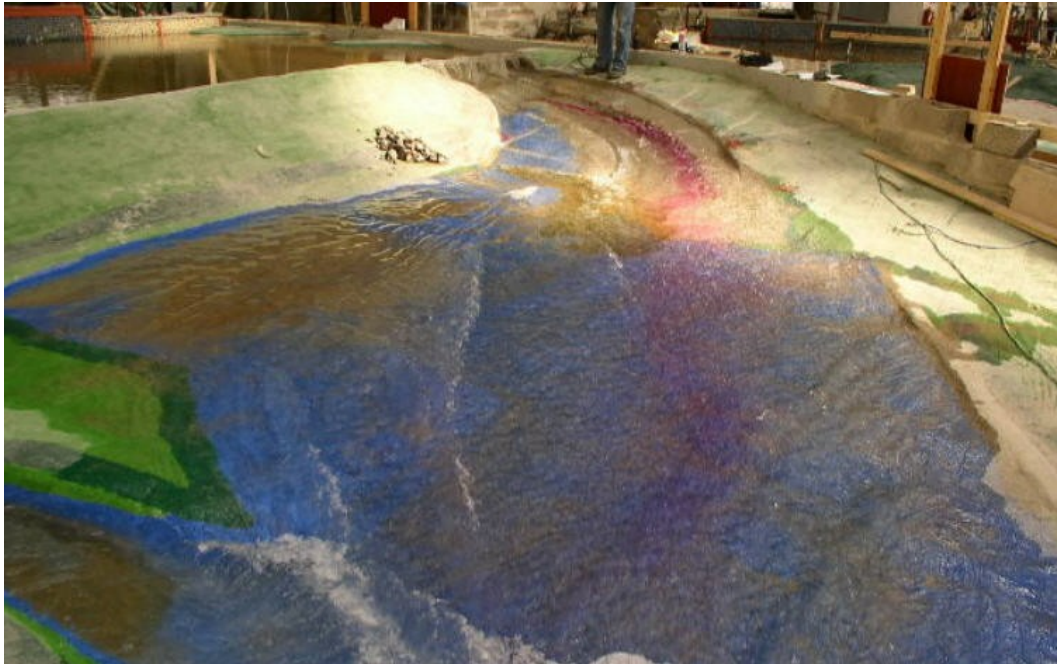
Figure 10.6 Flow conditions in the modified spillway channel (option B)

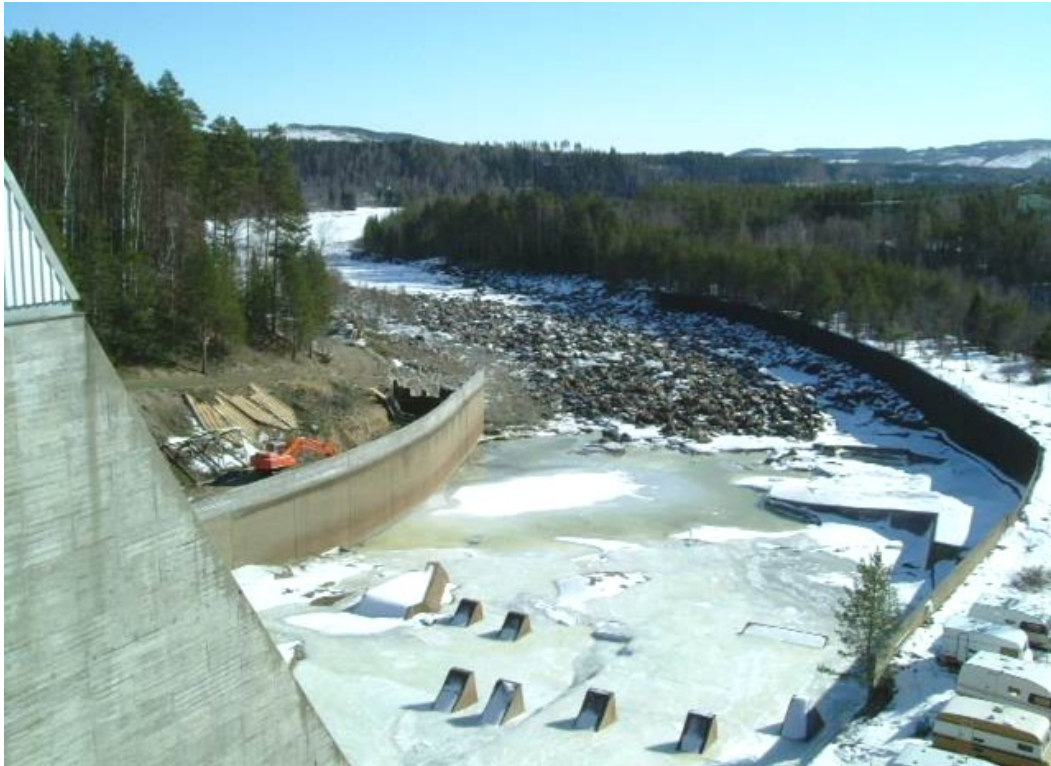
Figure 11.2 Spillway channel and energy dissipator in Långbjörn

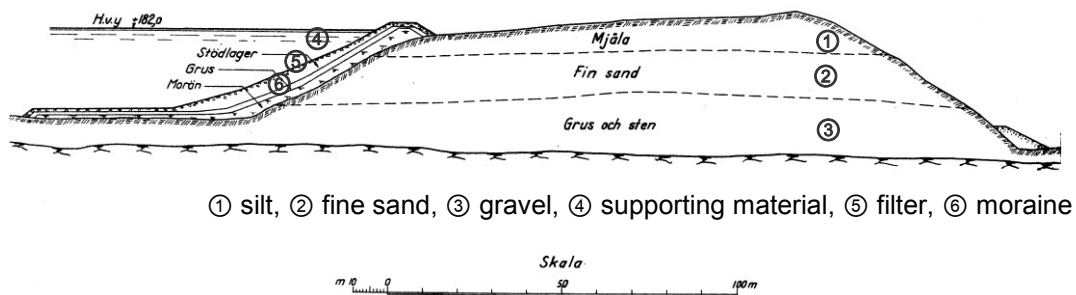
Figure 11.3 Left embankment leaning on a riverbank revetment

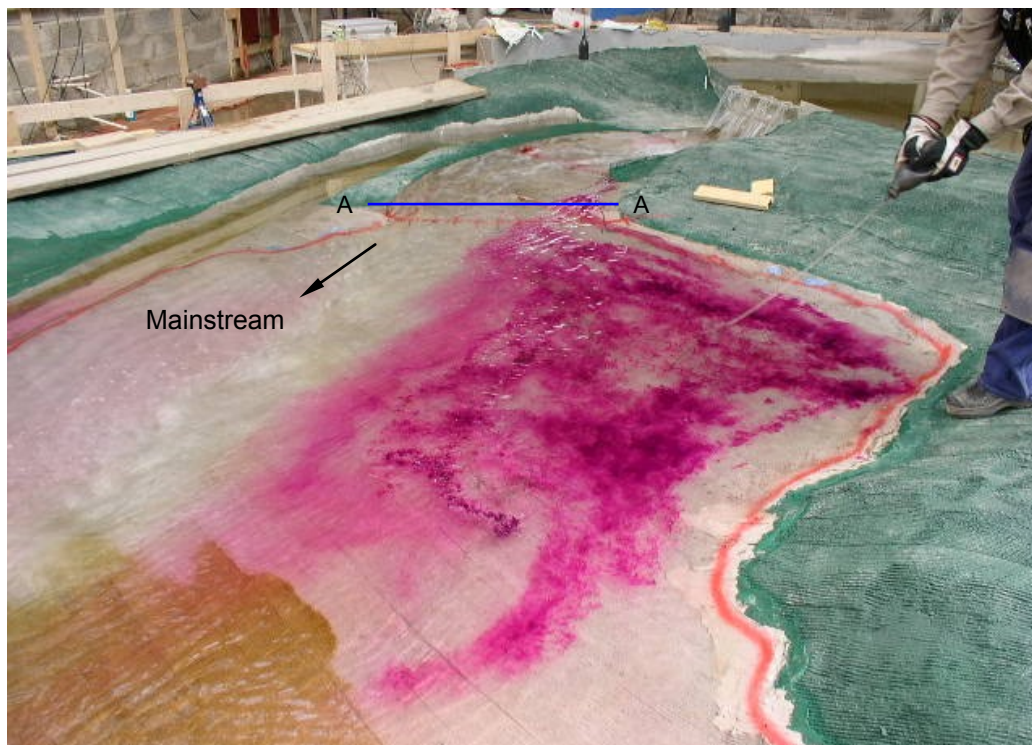
Figure 11.4 Fixed-bed model for Långbjörn dam

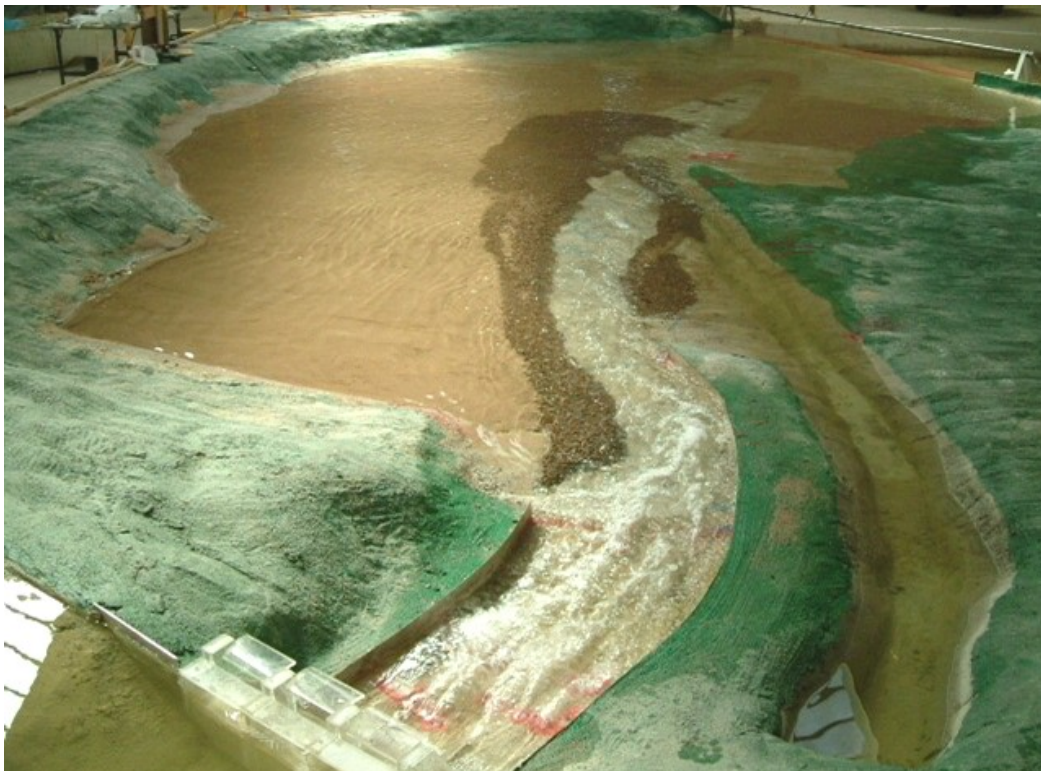
Figure 11.5 Impact of river erosion on flow pattern downstream, movable bed conditions

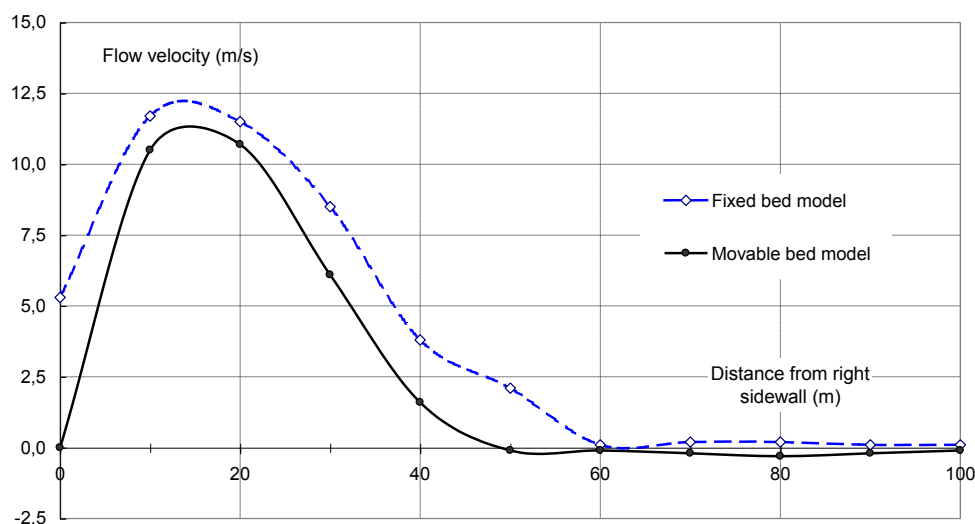
Figure 11.6 Flow velocity at the downstream end of the spillway channel

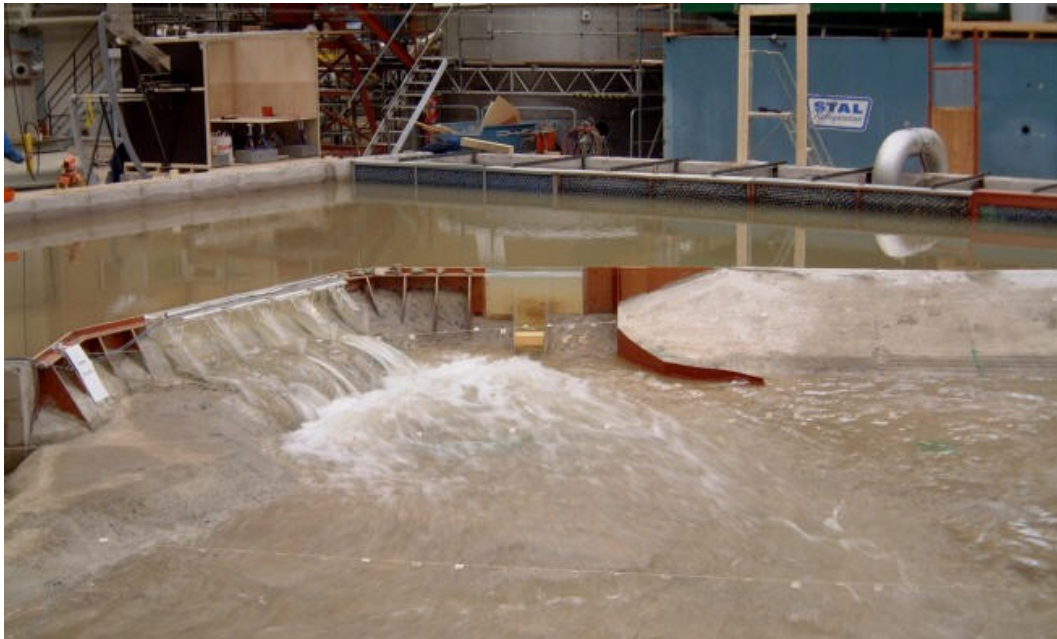
Figure 12.2 Model of Midskog dam, 1:50

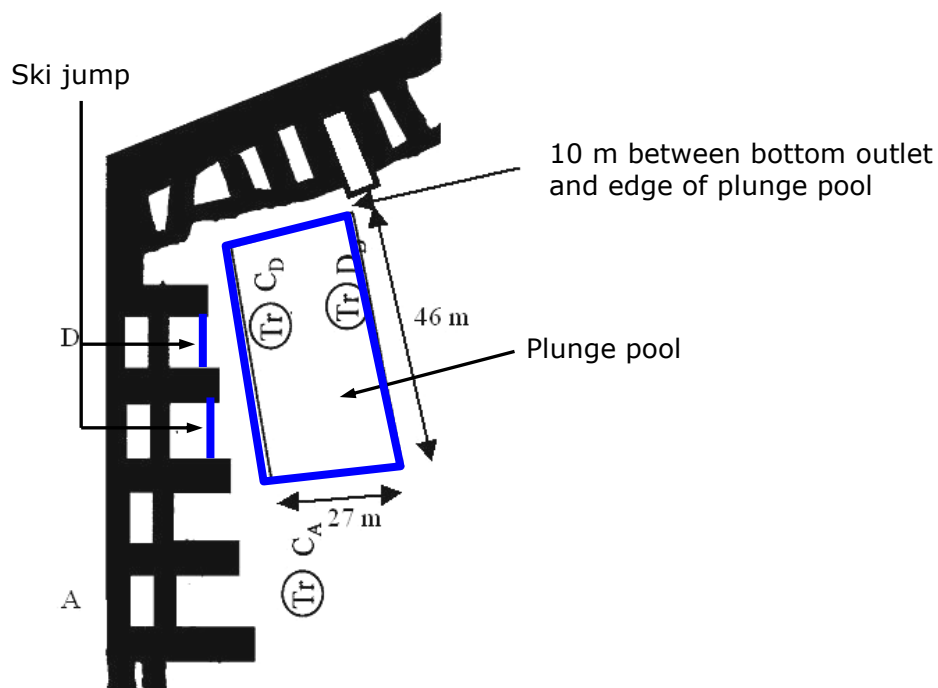
Figure 12.3 Layout of recommended plunge pool

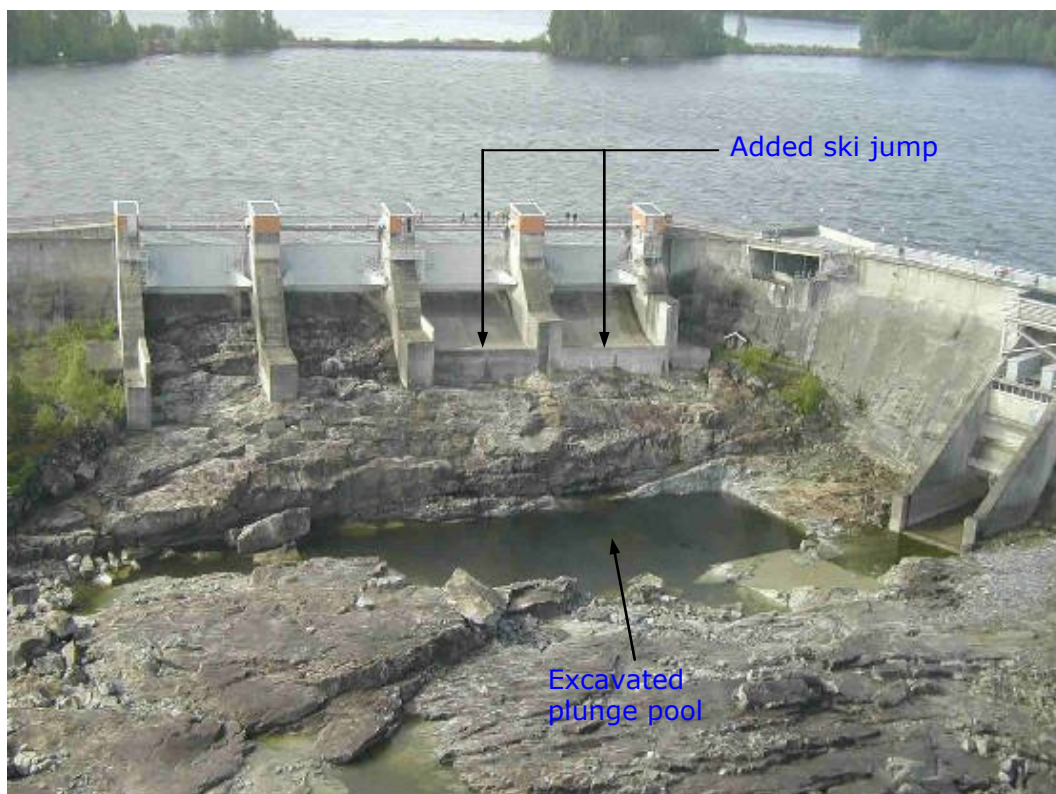
Figure 12.4 Plunge pool after completion

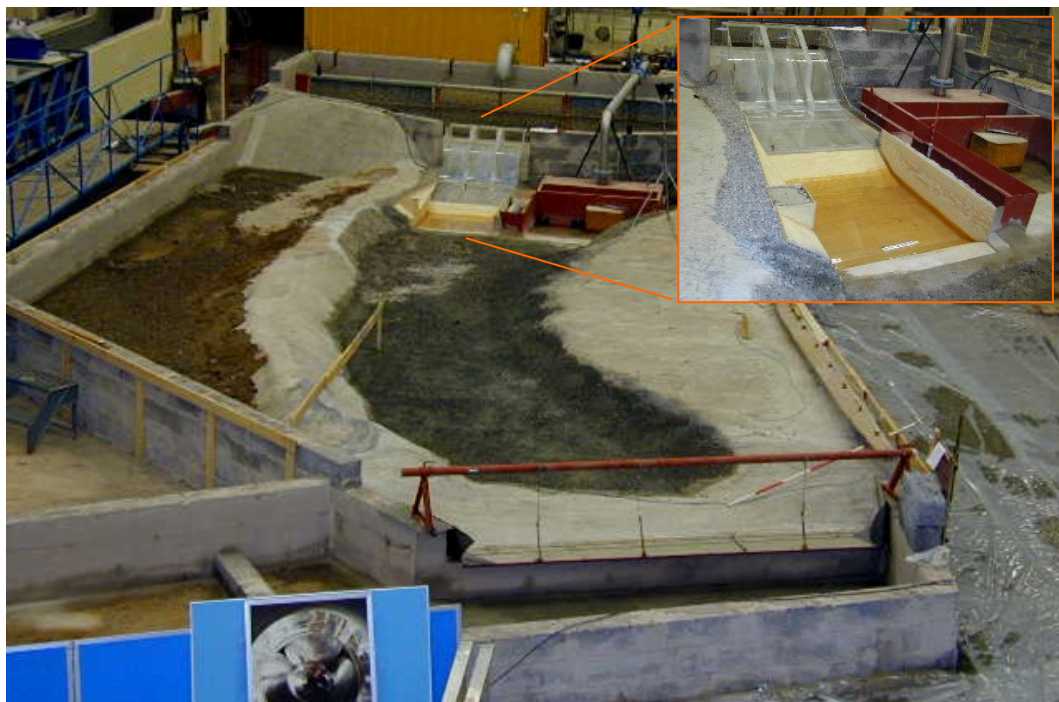
Figure 13.3 Fixed-bed model of Porsi dam, scale 1:50

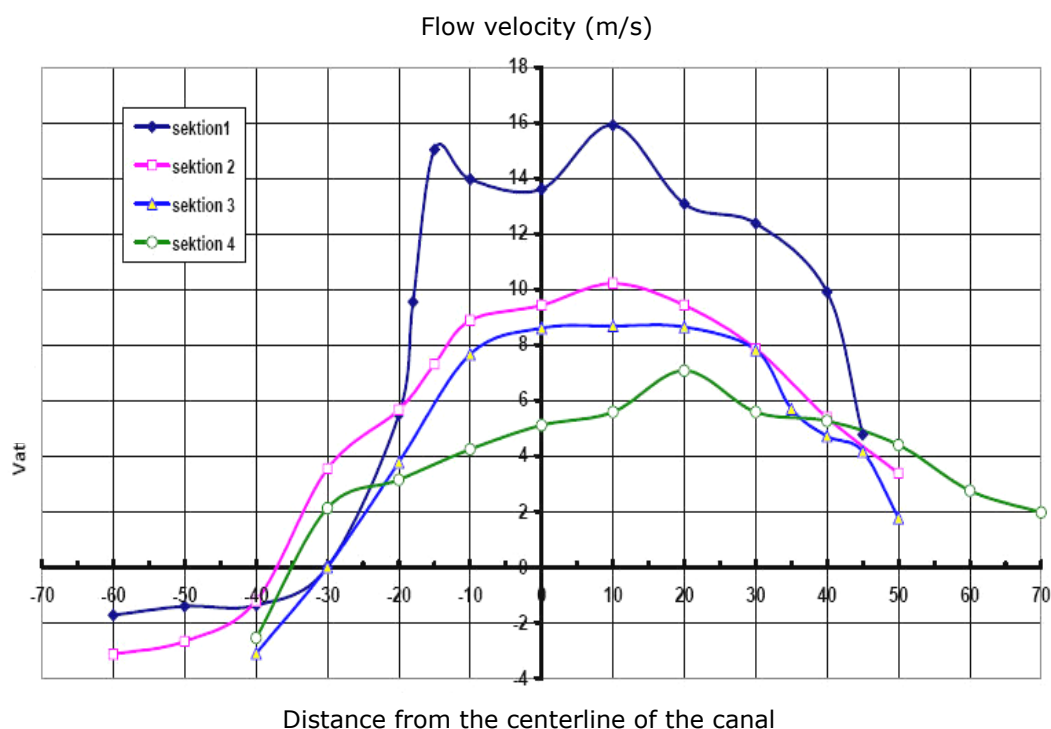
Figure 13.6 Flow velocity downstream of energy dissipator at 1 m lower than normal tailrace water level (section 1, 2, 3 and 4 were located at about 20, 80, 180 and 330 m downstream from the basin end)

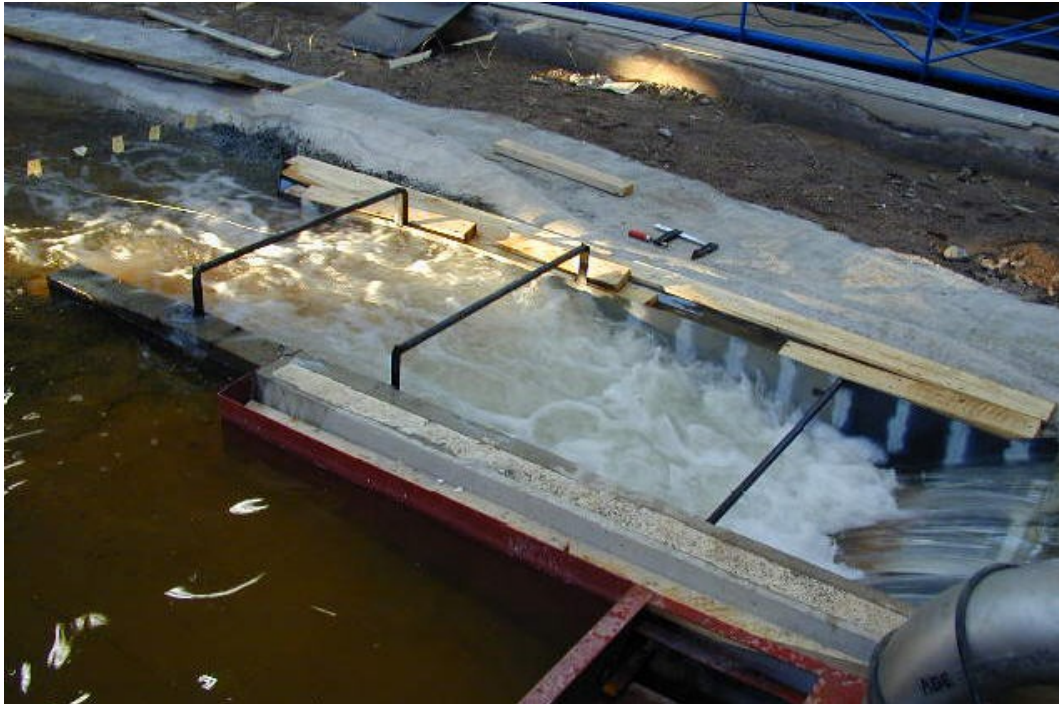
Figure 13.10 Finalized layout of the dissipator at the design flood and normal downstream water stage

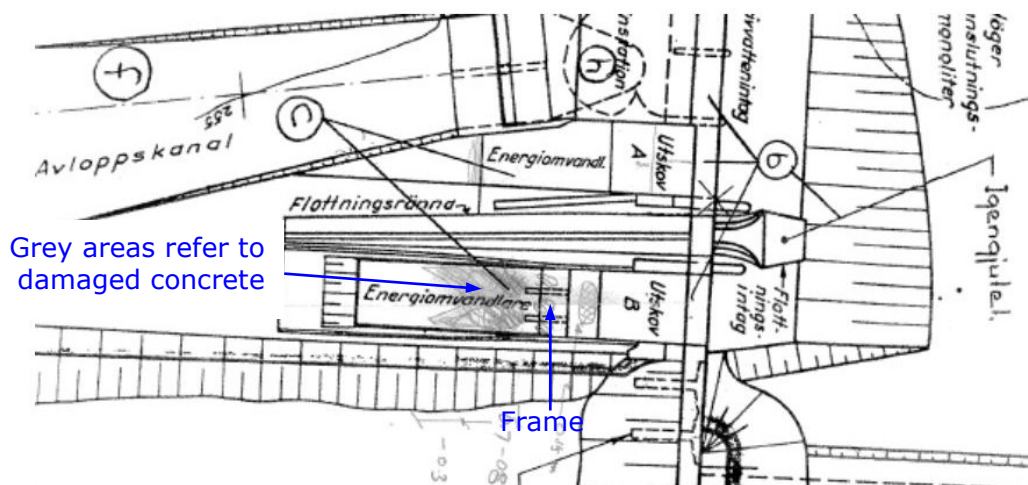
Figure 14.2 Damages in the left spillway opening at Rusfors

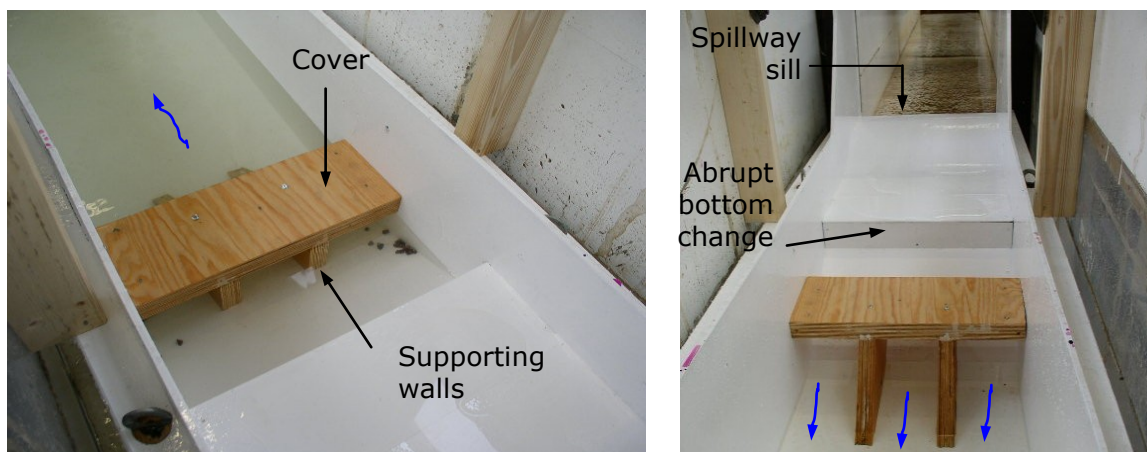
Figure 14.4 Rusfors model of energy dissipator in a flume

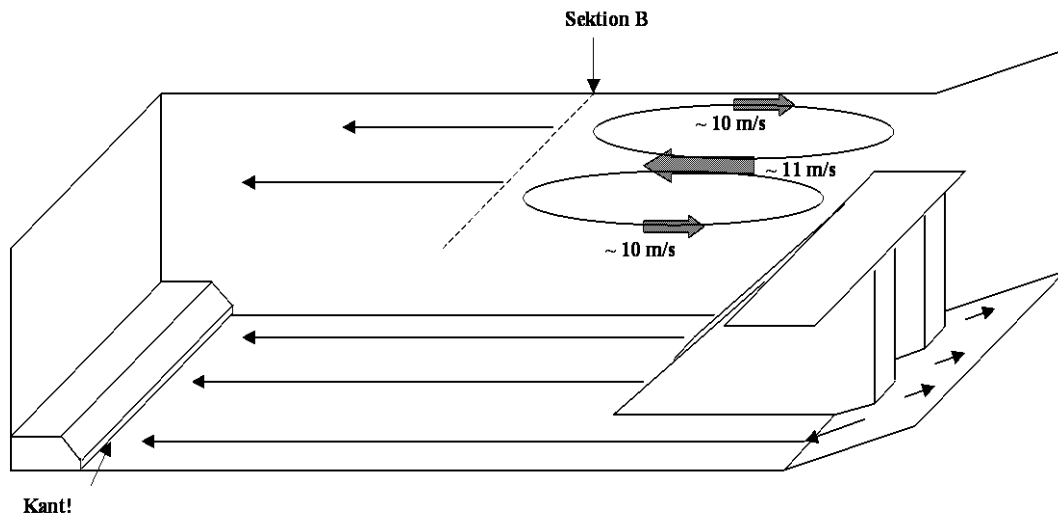
Figure 14.5 Circulations of surface flow with high velocity and waves featured the existing layout

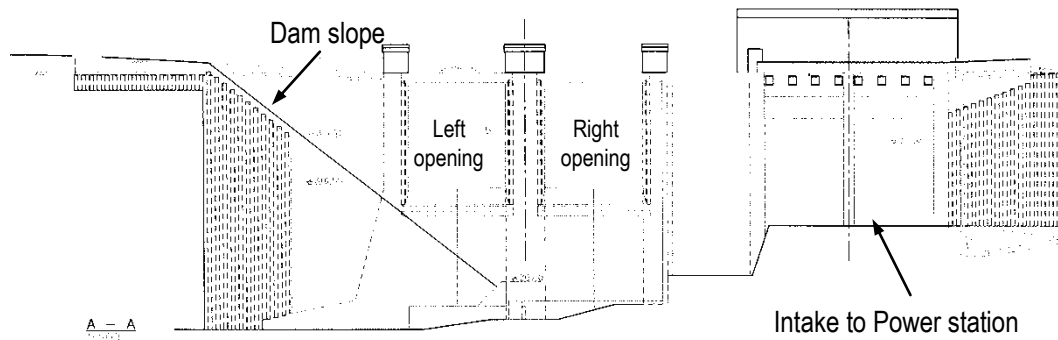
Figure 16.3 Existing spillway layout, looking downstream

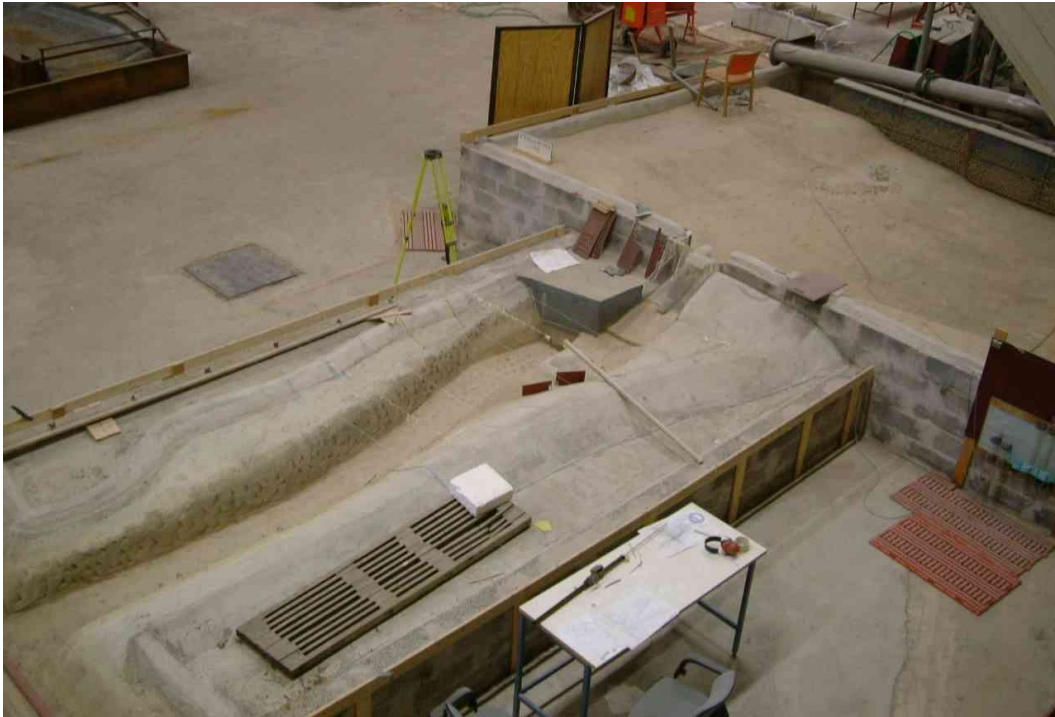
Figure 16.4 Model of Stenkullafors, scale 1:50

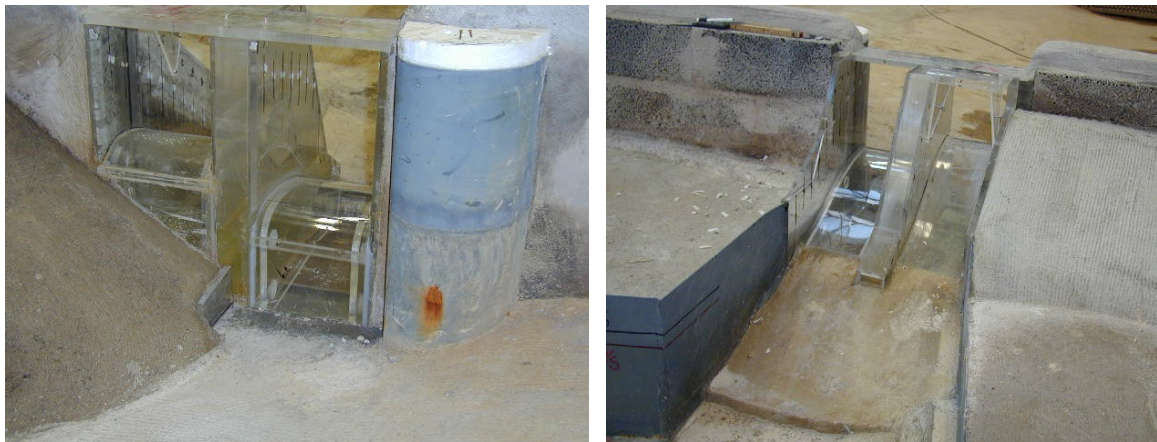
Figure 16.7 Spillway modification - crest lowering and optimization through model tests

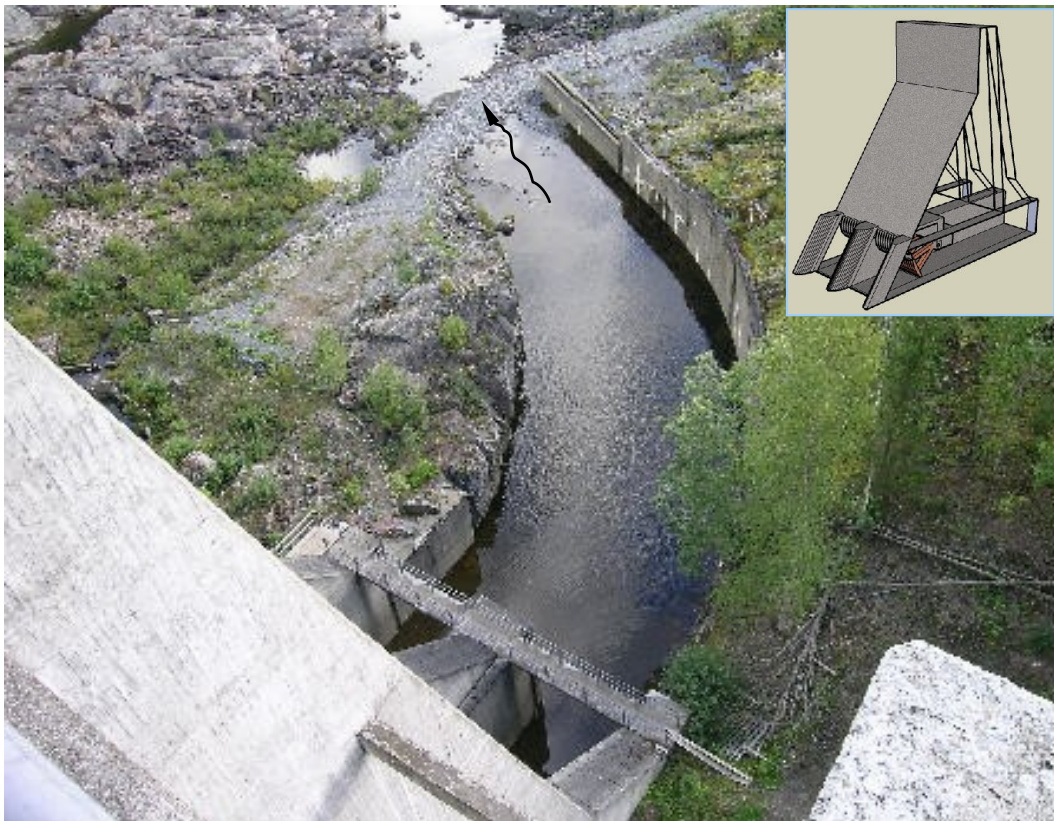
Figure 17.2 Discharge channel downstream of the bottom outlets

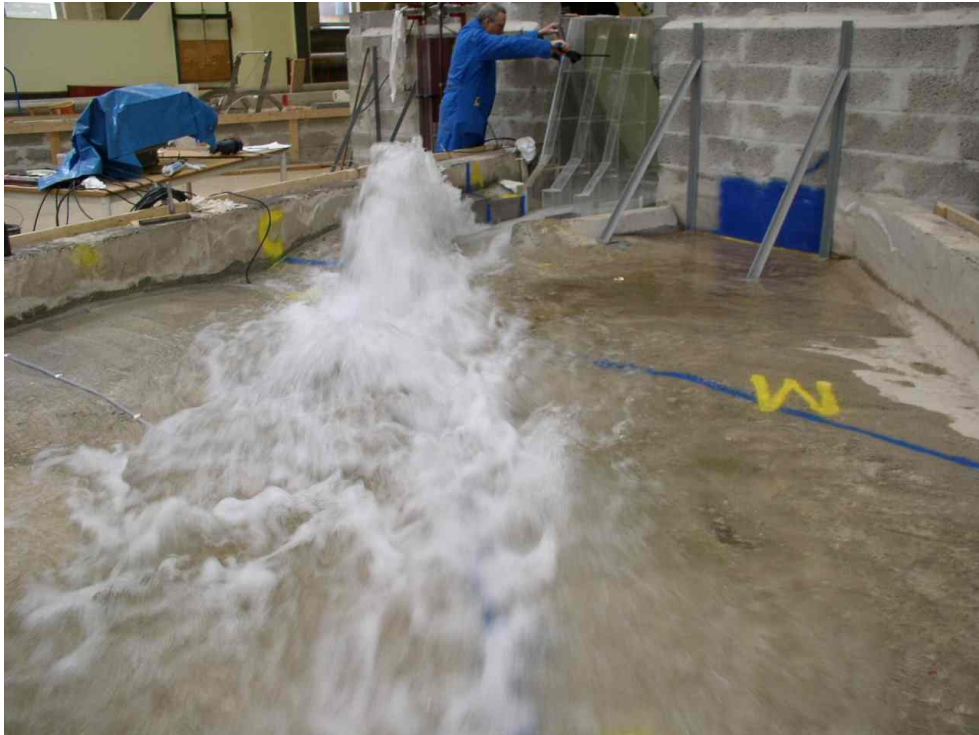
Figure 17.8 Flow discharge only from the left outlet

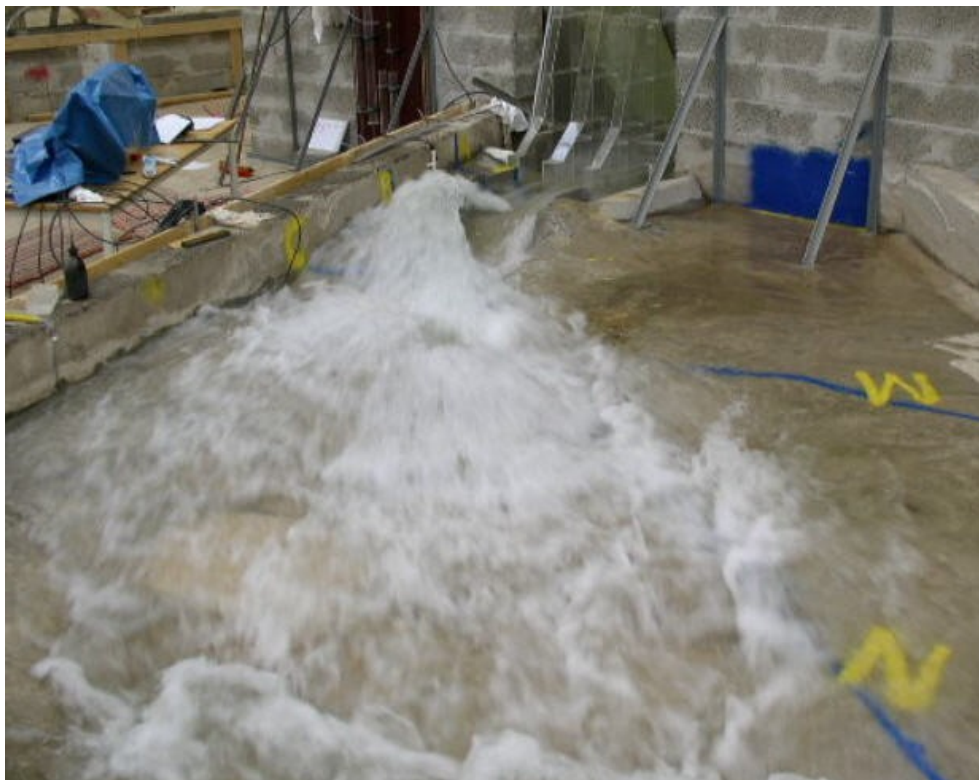
Figure 17.9 Flow discharge from both bottom outlets

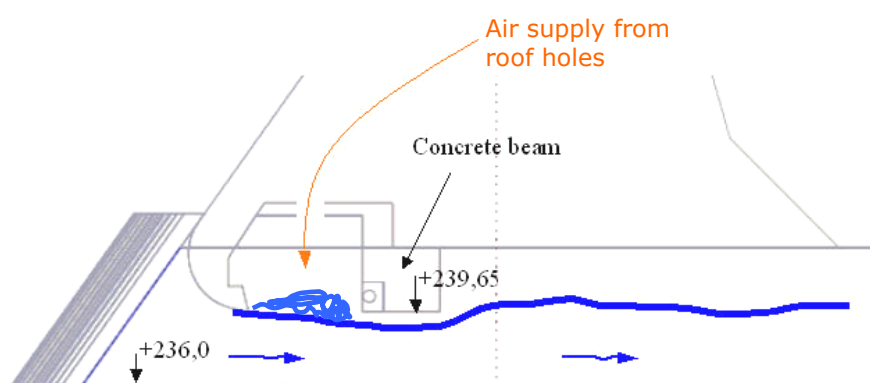
Figure 17.10 Need of air supply through openings above the gate to the flow

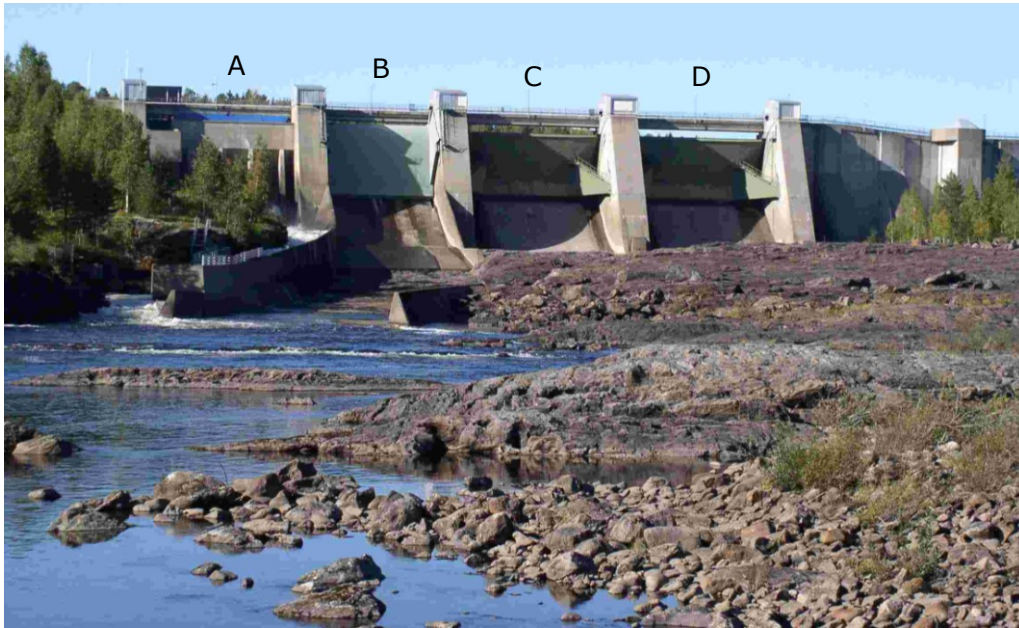
Figure 18.2 Spillway at Stornorrfors. Opening A is sealed with a concrete wall and partly occupied by the salmon ladder

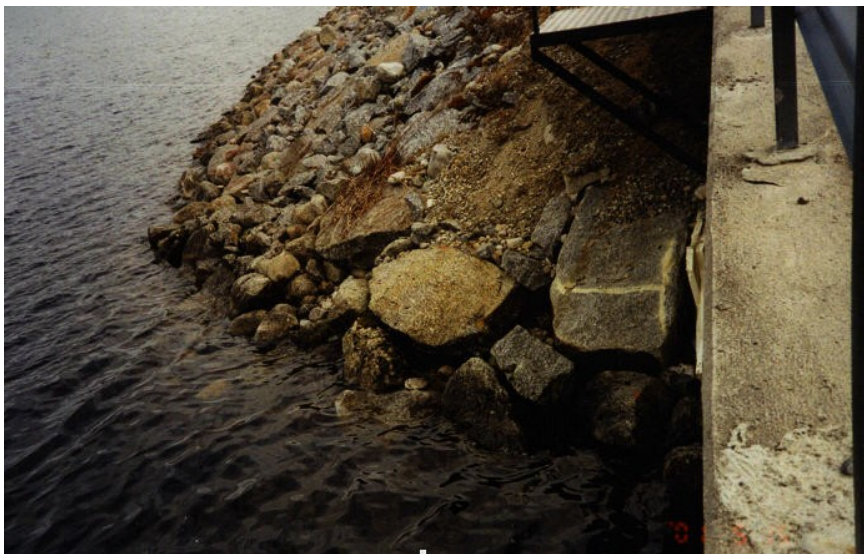
Figure 19.1 Erosion in dam slope near spillway

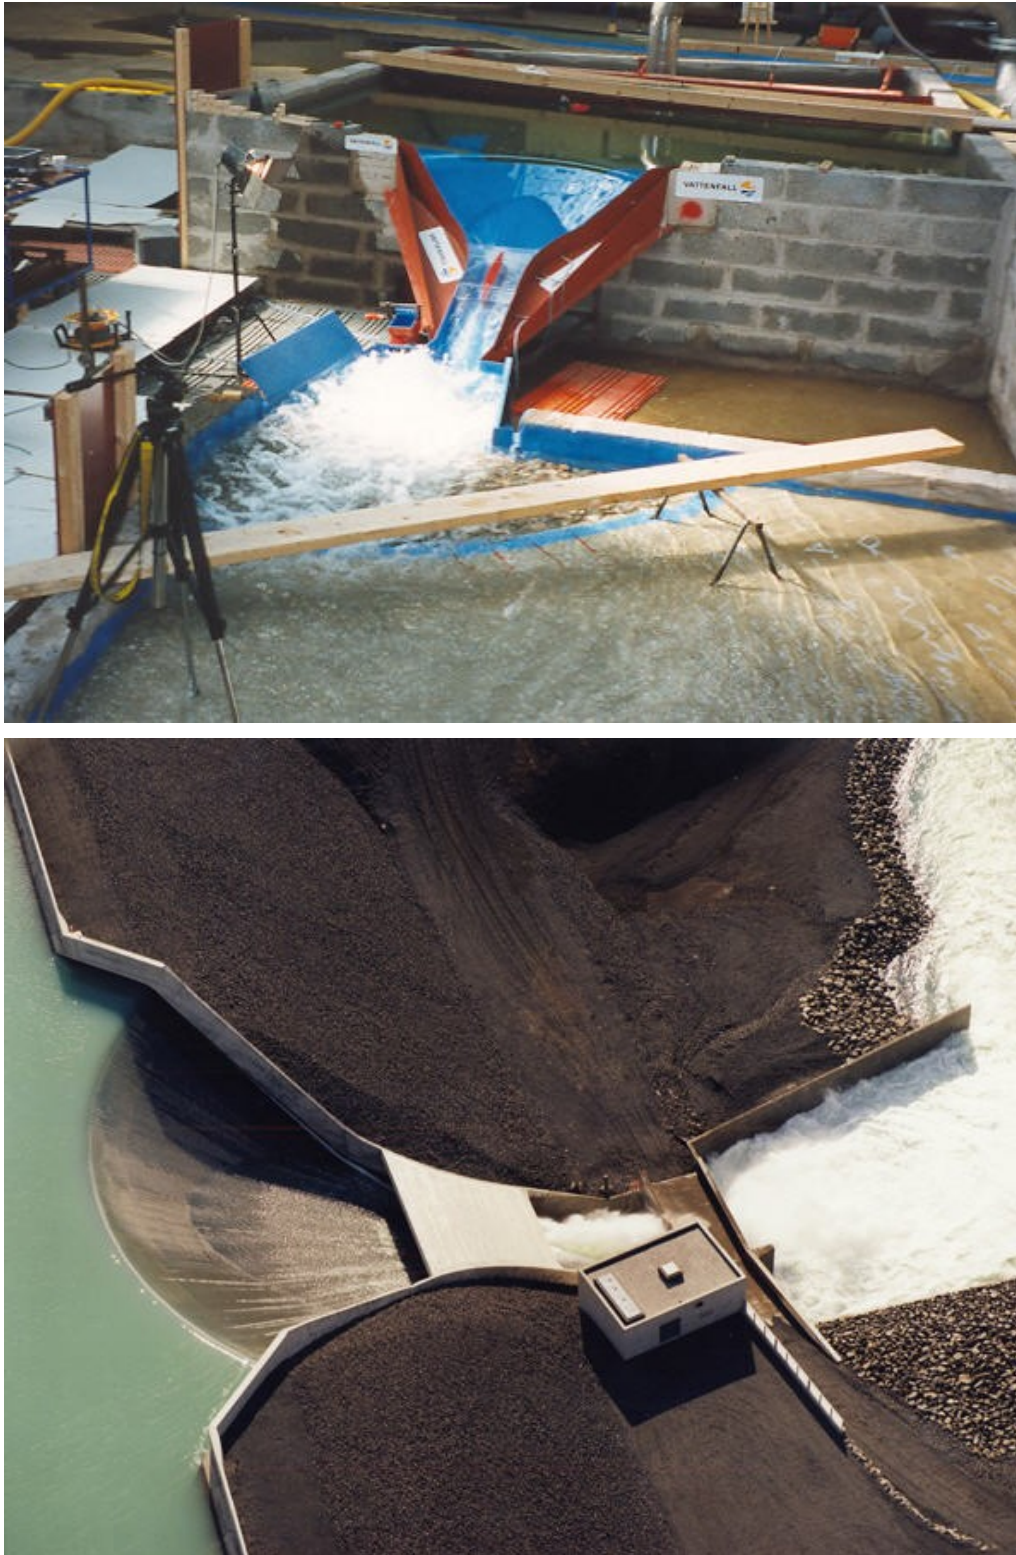
Figure 20.4 Model (above) and prototype (below) of Vatnsfell flood discharge structures
