Performance of old PV modules

Measurement of 25 years old crystalline
silicone modules

Elforsk rapport 06:71

October 2006

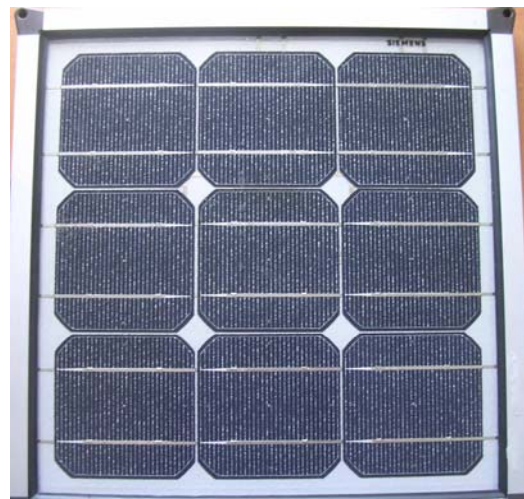
A Siemens reference module that was assumed to be stable was used for measuring irradiance and cell temperature (Figure 2). It consists of nine cells, where the centre cell is the actual reference cell. The surrounding dummies are there to eliminate edge effects on the reference cell. A Pt100 temperature sensor is glued to the backside of the centre cell. The Pt100 sensor returns a resistance value that has to be converted to a temperature value. From a datasheet of the Pt100 [6] it can be read that each Ω over 100 Ω corresponds to approximately 2,56 °C over zero degrees

Figure 2. The Siemens reference cell that was used for measuring irradiance and cell temperature.

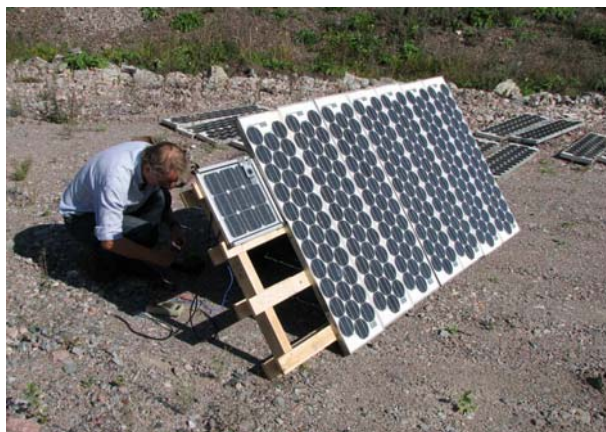
The arrangement for measuring the modules was quite simple. Two wooden pallets nailed together with a suitable angle (approx. 50°) were used as stand for the modules and the reference cell. The inclination is necessary in order to give perpendicular irradiance on the modules. The stand was too small for all modules to fit. The modules that were waiting to be measured were distributed on the ground without any shading. This was a way to ensure that the modules reached a steady temperature. The picture below shows the measuring arrangement.

Figure 4. The arrangement for measuring the modules.

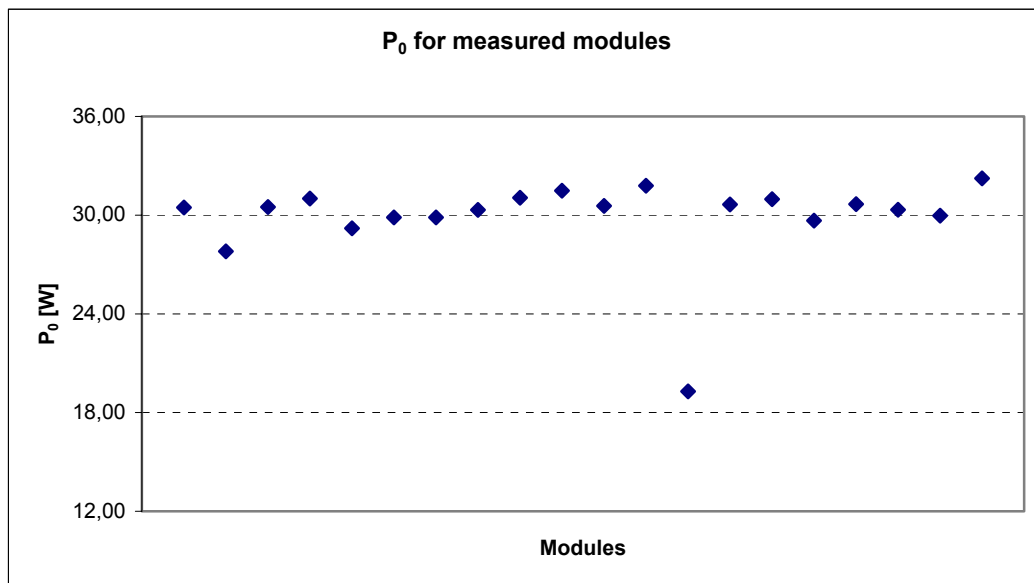
The mean value of the measured power from all modules is 29.9 W. The figure below shows nicely how only one module diverges from the others. The rest is gathered around the 30 W line.

Figure 5. Power from the measured modules.

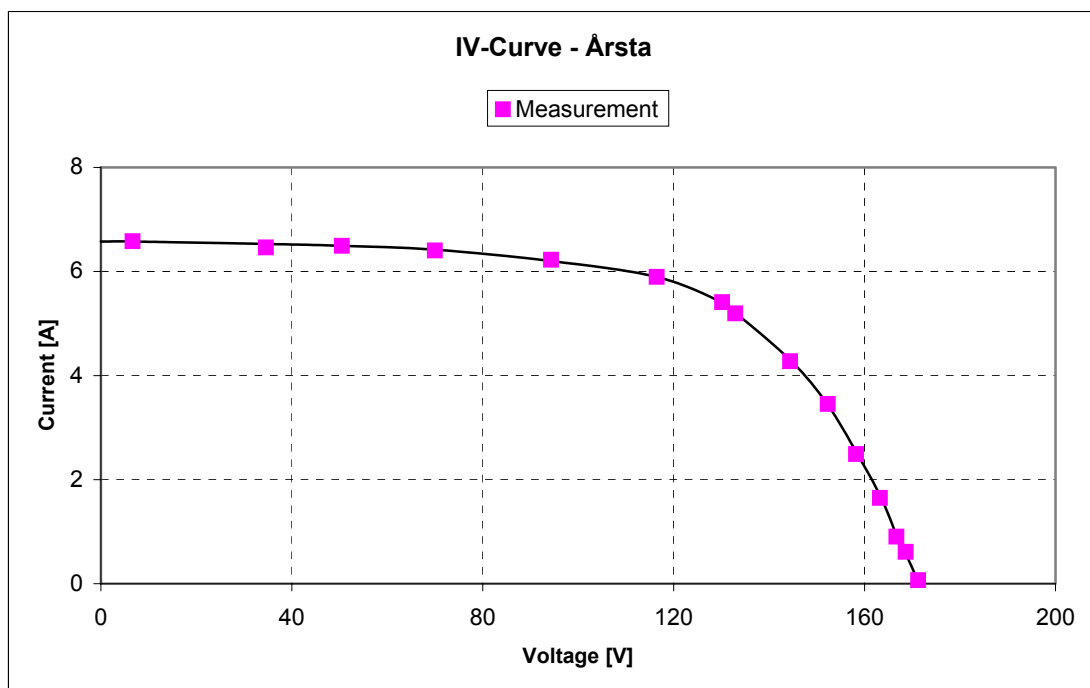
In 1985 a study was carried out to measure the performance of these modules after the installation in Årsta [3]. The modules were not measured separately, but an IV-curve for the whole string was obtained. The figure below shows the result of the measurement in Årsta.

Figure 10. IV-Curve from measurement of the Årsta installation, measured in July 1985 at $G_I = 868 \text{ W/m}^2$ and $T_A = 56 \text{ }^\circ\text{C}$.

A mean value of the power of the modules can be calculated from this, knowing that the modules were connected ten modules in serial in three parallel strings.

$$P_M \approx 130.2/10 * 5.41/3 = 23.47 \text{ W.}$$
