DAM SAFETY
DISTRIBUTED STRAIN MEASUREMENTS FOR
EMBANKMENT DAMS – Field tests at Ajaure Dam
2004-05

Rapport 05:32

Sam Johansson
HydroResearch
Sam Johansson AB

Dan Watley
Sensornet Ltd

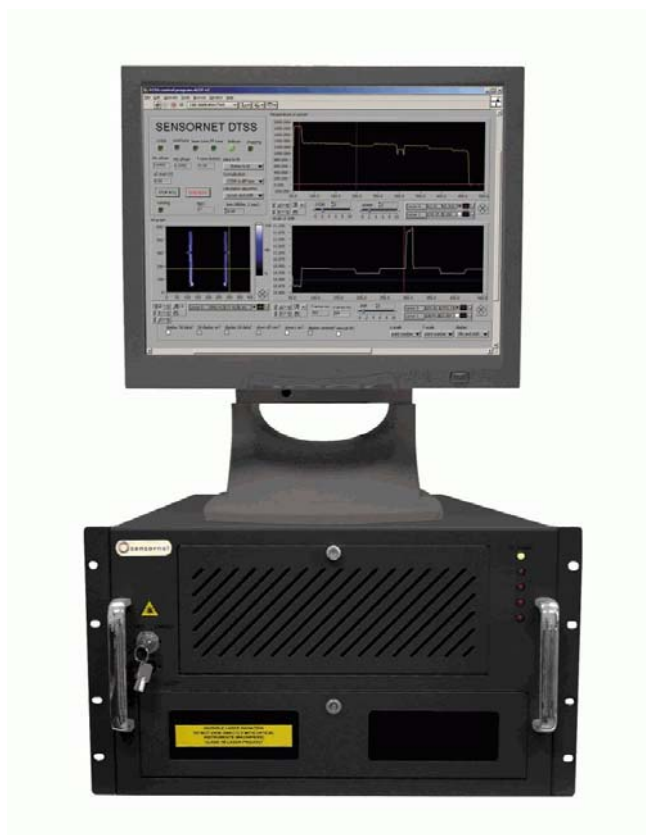
Figure 1 - Sensornet DTSS

The DTSS, or Distributed Temperature and Strain Sensor, is a prototype instrument developed by Sensornet, which measures the entire Brillouin spectrum (the Brillouin shift and power for both the Stokes and anti-Stokes light) at every 1m along the fibre (Parker et al 1997). Analysis of this data allows the strain and temperature to be measured simultaneously and independently at all points along the fibre. This independent measurement of strain and temperature (which allows strain to be measured without temperature cross-sensitivity) requires the full Brillouin spectrum to be captured – a feature that is unique to Sensornet’s DTSS (Farhadiroushan and Parker 1996).

The DTSS used in these tests was configured to give a 1°C temperature resolution and a $20\mu\epsilon$ strain resolution for a spatial resolution of 1m and a measurement time of around 20mins. Sensornet’s DTSS is housed in a single field-transportable 6U rack mountable box with an inbuilt PC (there is no need for a separate control or interface PC). Although these tests only required a short sensing length (a few hundred metres) the DTSS is designed to be able to operate over lengths of up to 10km.

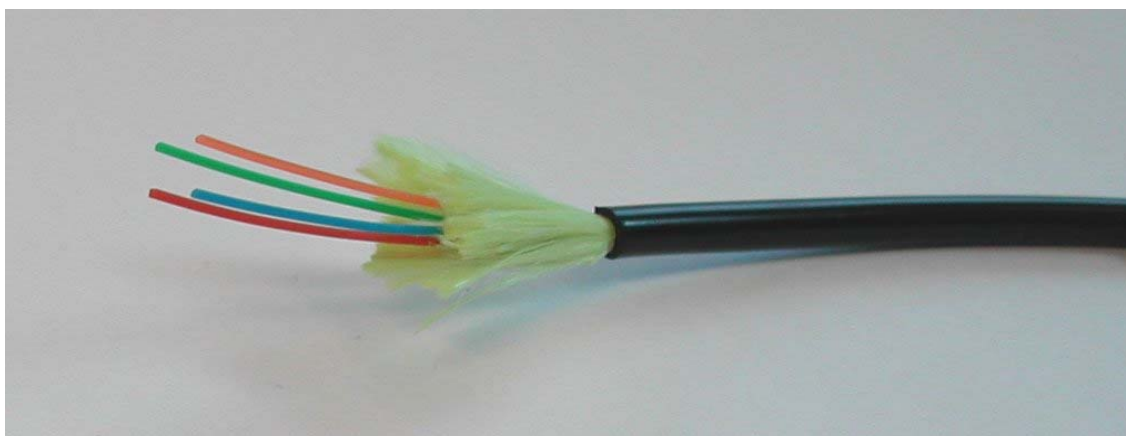
Figure 2 - DTSS cable breakout.

The cable (Figure 2), installed in Ajaure was designed for dam monitoring and has the following product code: DC-DTSS02S.4MC/3MD-DTS02A3GB/1GC/900. It contains two single mode fibres for use with the DTSS system, and two multimode fibres for use with the Sensornet DTS system (which measures only temperature along a length of fibre), if the user should wish to use a DTS system at some time. Each system only requires one fibre (they take single-ended measurements) – the second fibre was added for redundancy. The specifications for the cable and the fibres are shown in Table 1 and Table 2.

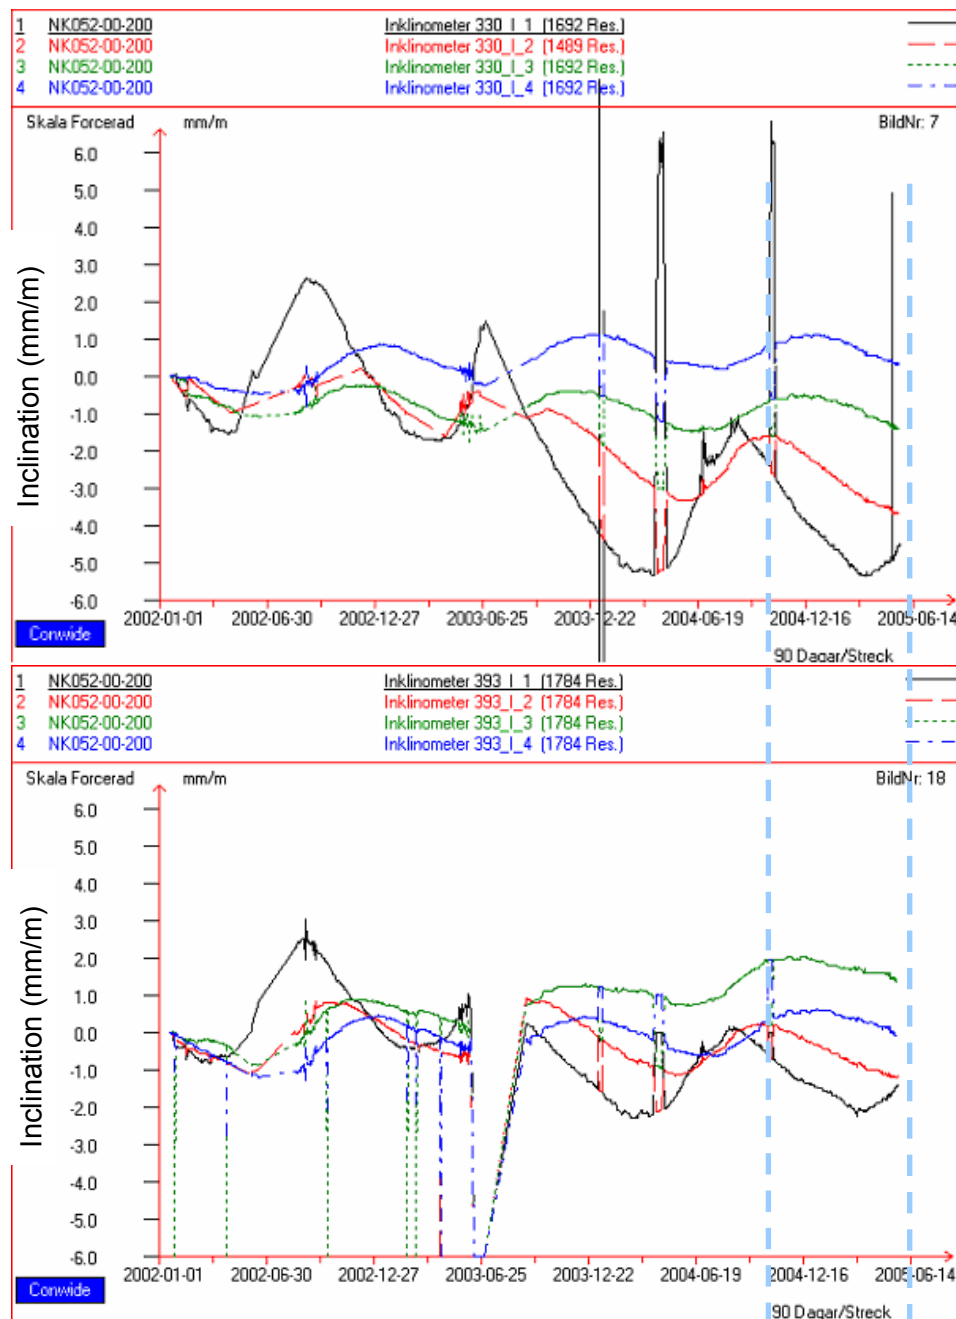
There are two inclinometers for continuous monitoring in the dam, placed at chainage 0+330 and 0+393. Measurements are performed at 2m height intervals from the bedrock, to which the inclinometers are fixed. The most upper sensors (330I_1 and 393I_1, the black curves in Figure 7) are placed at 442.7m (i.e. similar to the level of

the lower cable). The largest variation of the inclination is found at the most upper level, where the annual inclination is about 4mm/m at inclinometer 330 I_1, and 2mm/m at 330 I_1. The variation between the two measurements was 3mm/m at 330 I_1 and 1mm/m at 393 I-1.

Figure 7 – Inclinometer results from the four upper levels. Data obtained from Swedpower AB. The blue dotted lines indicate the date for the measurements (Sept 29, 2004 and May 17, 2005).

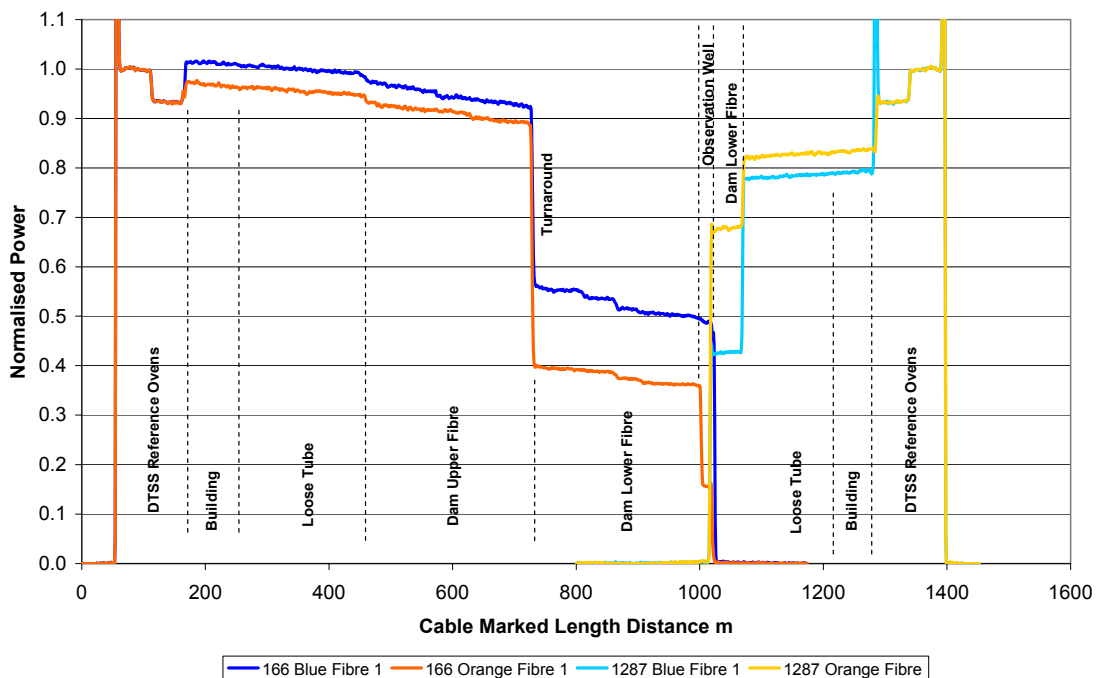
Figure 8 – Optical loss measurements of Ajaure Dam

Figure 8 shows four different loss measurements. Although the cable was originally installed in a loop configuration, damaged at a position in the lower path of the cable means that the loop is effectively broken. Hence, to measure both paths in their entirety, measurements must be undertaken from both ends of the loop i.e. 166m marking and 1287m marking. Additionally, there are two fibres included in the cable for these measurements; the blue and the orange fibres. Figure 8 shows the measured losses and provides annotations of various features in the cable path along the dam.

Important features are the large point loss (>3dB two way loss) experienced at the turnaround point at the far end of the dam. Also of particular importance are the losses in the region of the observation well. At this position the cable was bought into the

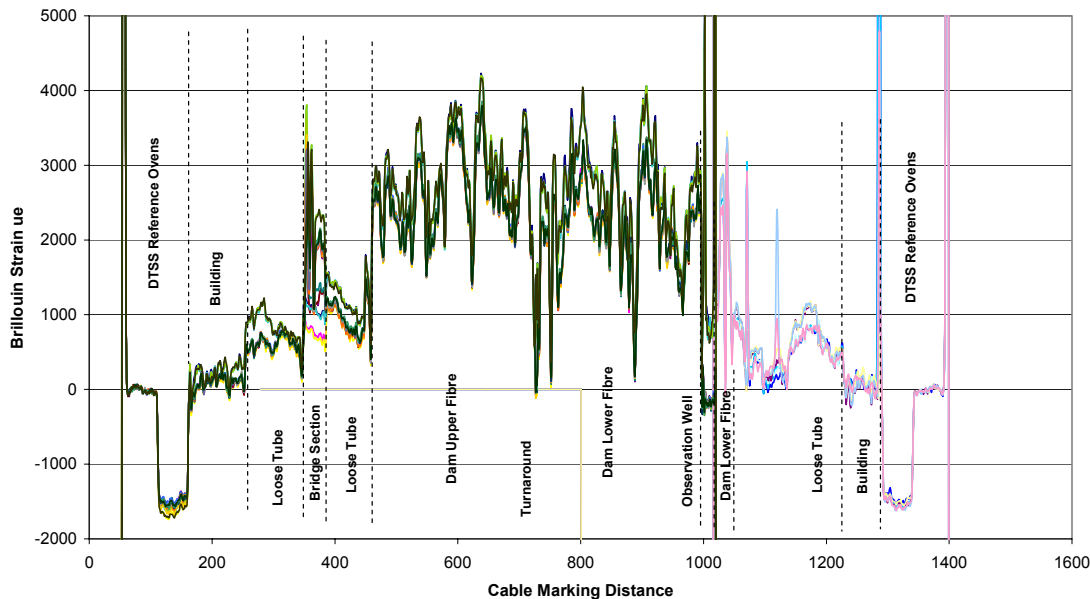
Figure 10 – September strain measurement overview

An overview of the first strain measurements taken during September are shown in Figure 10. Again the figure has been annotated to highlight the various features of the cable path along the dam. The sections of cable within the control building and the loose tube out to the dam show reasonably low strain levels. The sections actually within the dam crest show much greater strain and a lot of variation. This is associated with compaction during construction of the dam crest. Variations in the strain may also be seen at the bridge section above the spillway. These variations arise from the deflection tests undertaken during the visit which are presented later in this report.

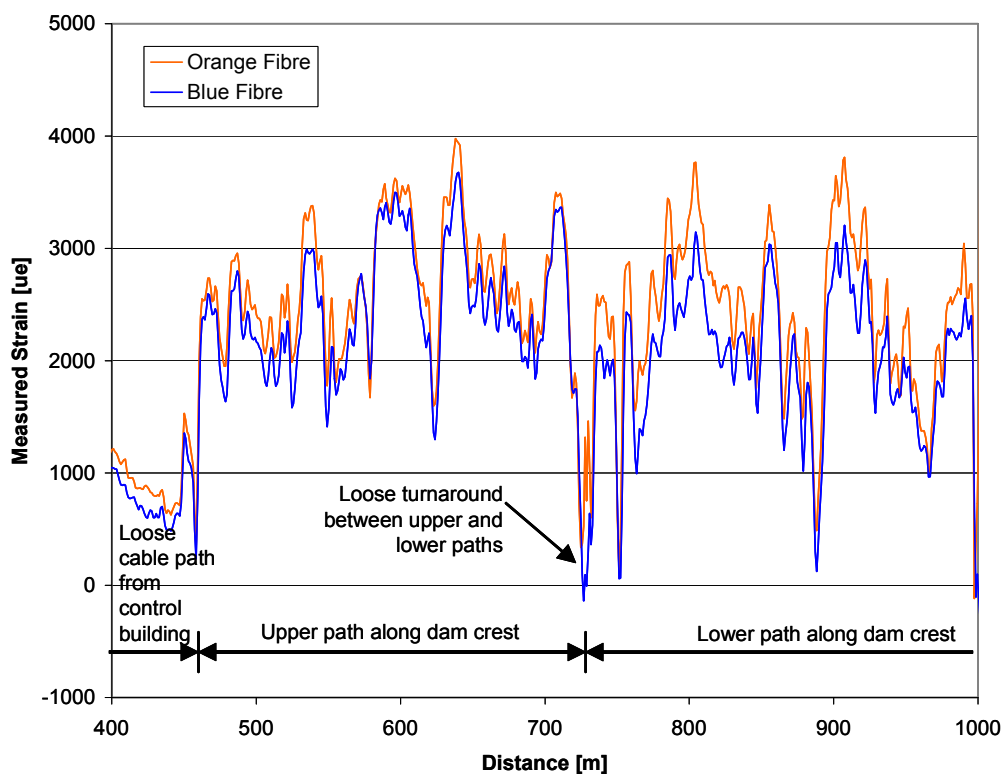
Figure 11 - September measured strain along dam sections of cable

Figure 11 shows an average of four measurements taken in each of the fibres within the cable. The figure is focused on the main area of interest, the dam. It is clear that the two fibres within the cable are closely correlated, tracking the significant variations caused by the compaction of the dam after installation. There is a small difference measured by each of the fibres most likely arising from differences during fibre manufacture. These differences are not significant since we are looking for relative changes in the strain over time. Another feature to note is the strain level of the turnaround at the far end of the dam, which is relatively unstrained. It is important to realise that few detailed interpretations of the state of the dam can be made at this stage, given the variations in strain arising from the installation process. A second measurement is necessary to look at differential changes.

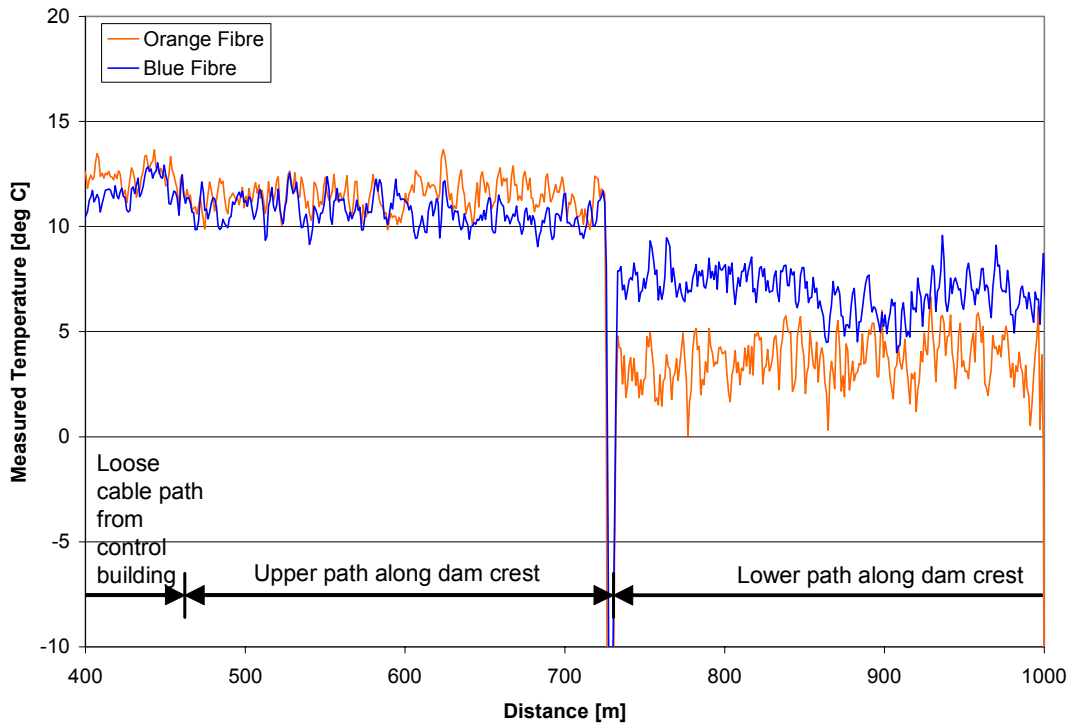
Figure 12 – September measurements of temperature

A unique feature of the Sensornet DTSS is the ability to measure both temperature and strain independently. This allows the instrument to provide measurements of strain with no temperature cross sensitivity, a common problem for other optical technologies. Figure 12 shows the measured temperature in the dam during September. The temperature measured in the upper section shows a reasonably stable profile, as is expected, and the measurement from both fibres agrees well. However, the temperature measured in the lower section does not agree between the two fibres. It should be remembered that there will be a natural difference in temperature between the upper and lower cables, of a few degrees for that time of year.

The lack of agreement between the two co-located fibres highlights a problem arising from the installation. The incorrect absolute temperature arises as a consequence of the excessive point losses at the turnaround. Figure 8 showed that the orange fibre suffered a greater loss at this point than the blue fibre. The magnitude of the loss is equivalent to an additional 9km of cable at that position. The nature of the loss, arising from a severe bend, or similar, at that location is likely to have exacerbated the temperature error which can be seen in Figure 12. Ideally the DTSS would correct for this, but bending losses cause a temperature inaccuracy which cannot be resolved when the losses are of such large magnitude. Despite this, the relative measured temperature in the two dam

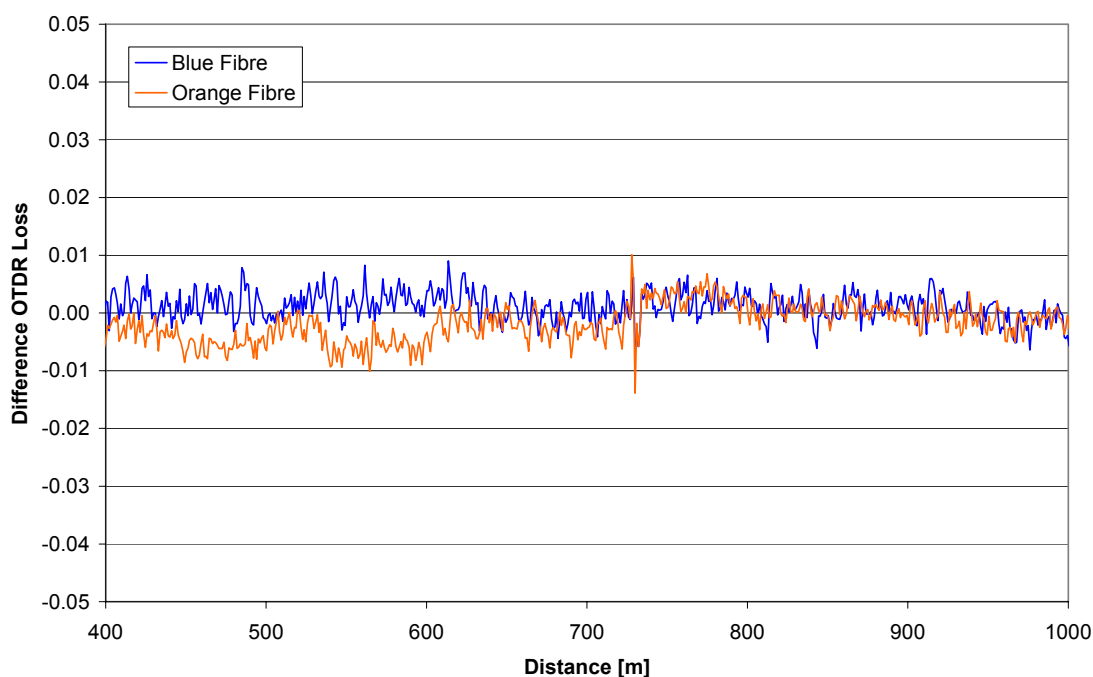
Figure 17 – Difference in optical loss between September 2004 and May 2005

The excessive losses induced during installation have been highlighted earlier in this report. Optical loss measurements were repeated as part of the strain measurement process upon returning to Ajaure during May 2005. Figure 17 shows the difference in measured loss from May 2005 to September 2004. The figure shows clearly that there have been no significant changes in the measured loss along the cable route.

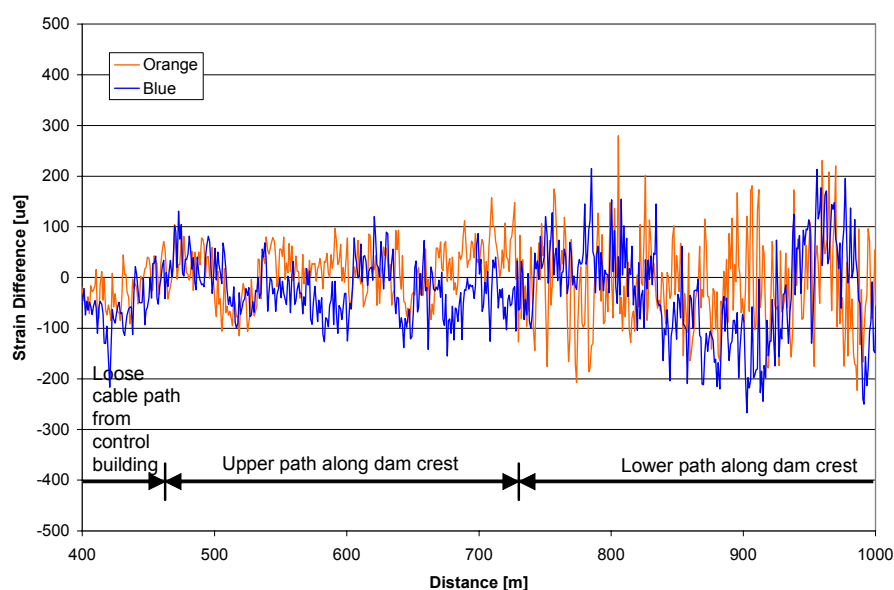
Figure 20 – Strain difference between separate measurements during May

Strain measurements taken at different times during May have been compared again to assess the accuracy of the DTSS instrument. Figure 20 shows the results of this comparison, where two sets of measurements from each of the two fibres have been subtracted from each other to highlight any differences in the measured strain.

Once again the results indicate good repeatability, with the measurements being centred around a zero difference in strain. There is a noticeable increase in measurement noise after the turnaround resulting from excessive losses at that position.

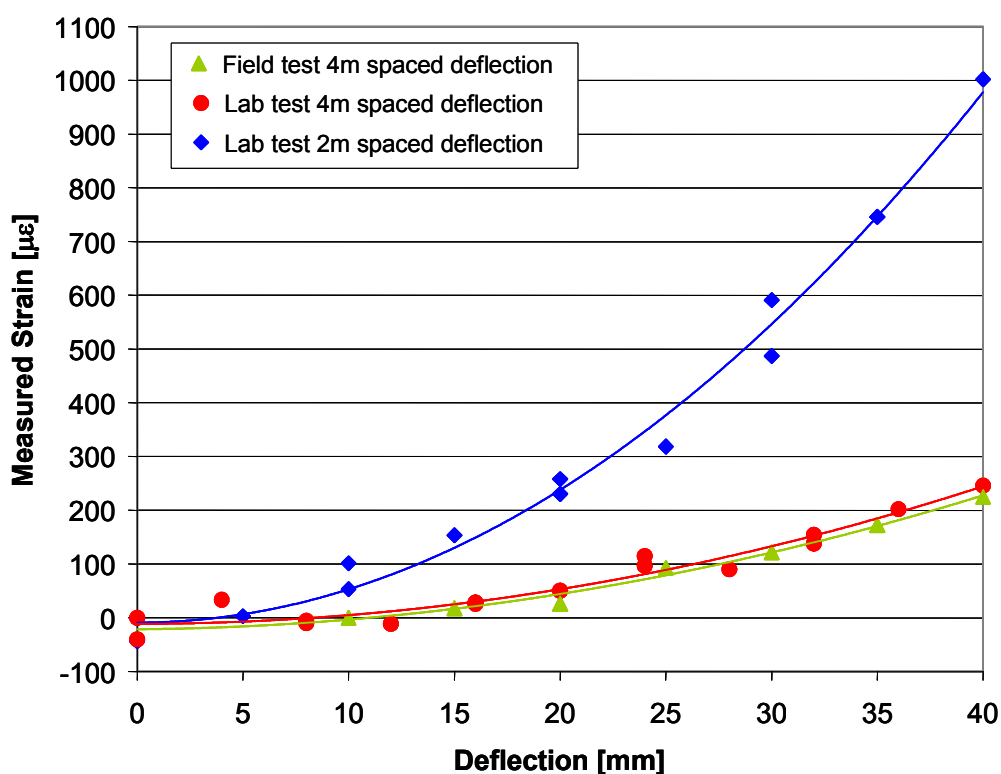
Figure 22 - Measurement results for deflection tests in the field and laboratory.

The results of all three tests are shown in Figure 22 for deflections up to 40mm. A quadratic trendline has been fitted to each data set, showing excellent agreement between the field and laboratory measurement for 4m spacing between the cable clamps. The 2m spacing data points show a good quadratic fit and a magnitude four times that of the 4m spacing data sets, agreeing well with theory. The 2m clamping interval is a closer representation of the behaviour of the cable installed in the dam, since the dam cable is effectively clamped at infinitely small intervals due to the surrounding material of the dam.

The measurements were carried out for deflections up to a distance of 40mm. The results of this test are shown in Figure 22.
