# Metso Power Chalmers

# KME-509

# Improved determination of service life of superheaters in boilers burning biomass and waste

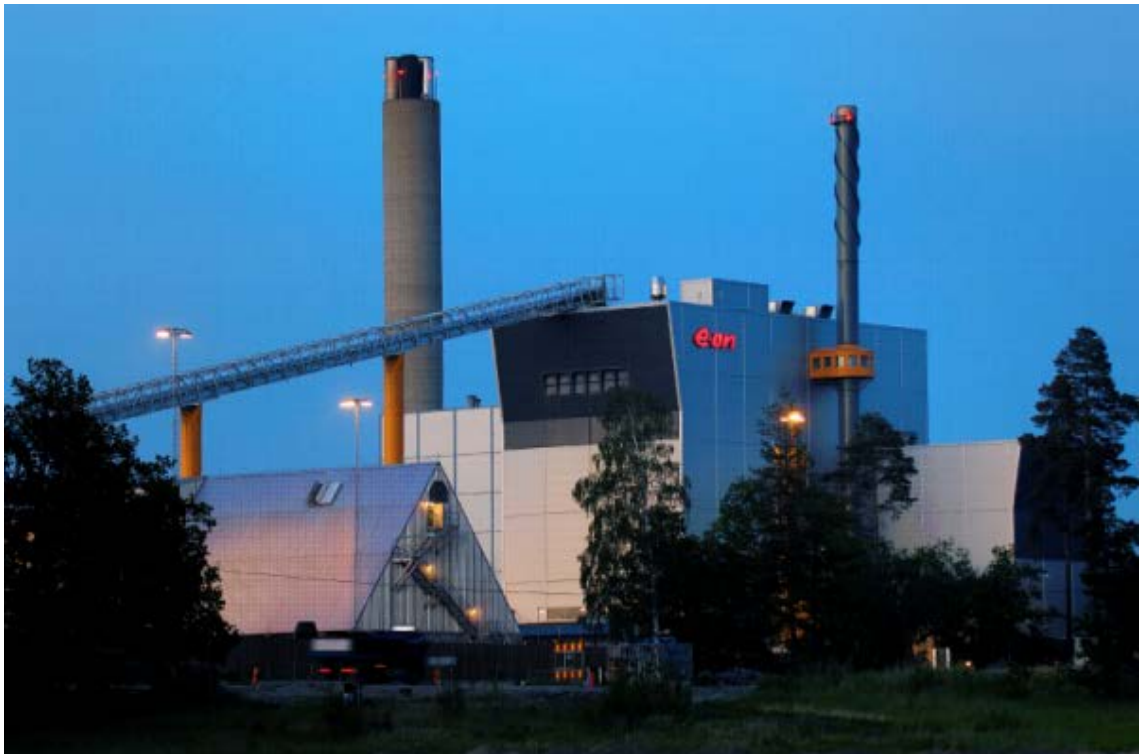
**Figur 1. Den avfallseldade förbränningsanläggningen P14 vid Händelöverket**

*Figure 1. The waste incinerator plant P14 at Händelöverket*

The waste fired plant P14 at Händelö has a capacity of 200 000 metric tonnes/year. The plant is a modern Energy-from-Waste plant with great fuel flexibility. The waste burned is household waste and industrial waste. It is also possible to burn 20% sewage sludge from sewage water treatment plants. The plant consists of a boiler, steam turbine, flue gas cleaning and fuel preparation.

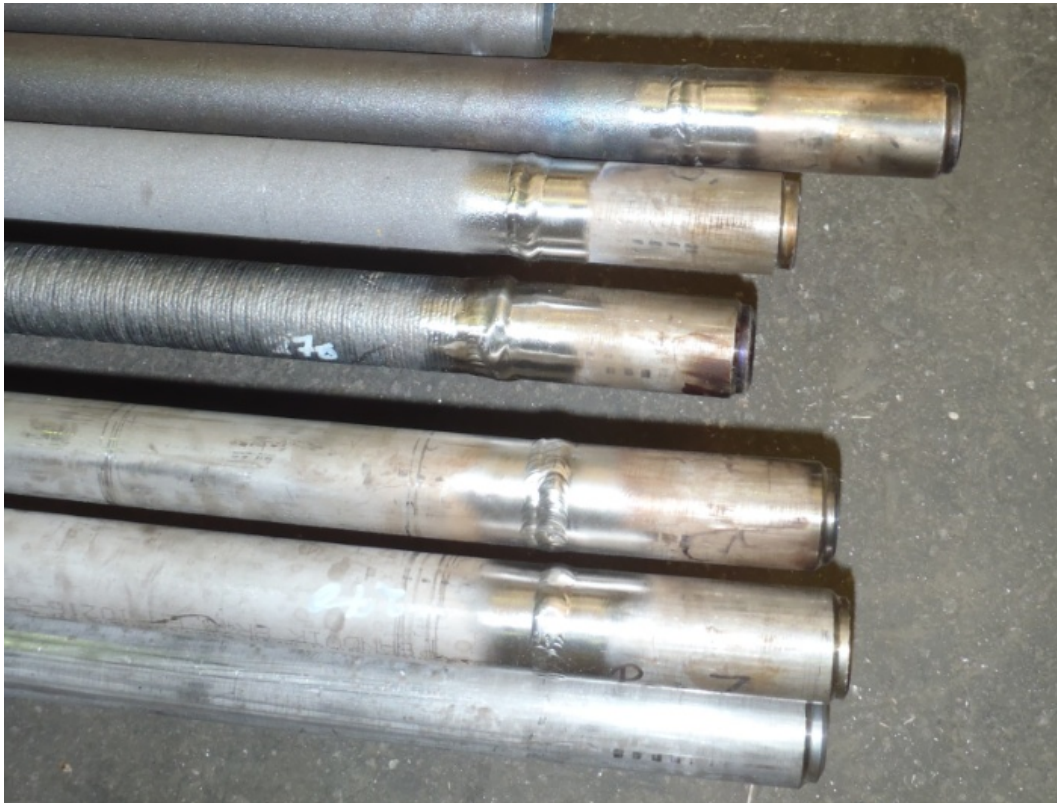
**Figur 9. Testtuber med svetsändar. Nerifrån och upp i bilden: Sanicro28/St48-8, TP347H, TP310HCbN, Inconel625/St48-8, FeCrAl/13CrMo4-5, and 13CrMo4-5.**

Six test tubes were prepared, 2 m long, welding ends made of Sanicro28/St45-8 (except for Sanicro28/St 48-8 tube) were pre-welded on both ends of the test tubes in the workshop to simplify the welding procedure during the revision, see Figure 9. The test tubes were placed on second row from bottom, due to tube shield on the first row tubes, see Figure 6.

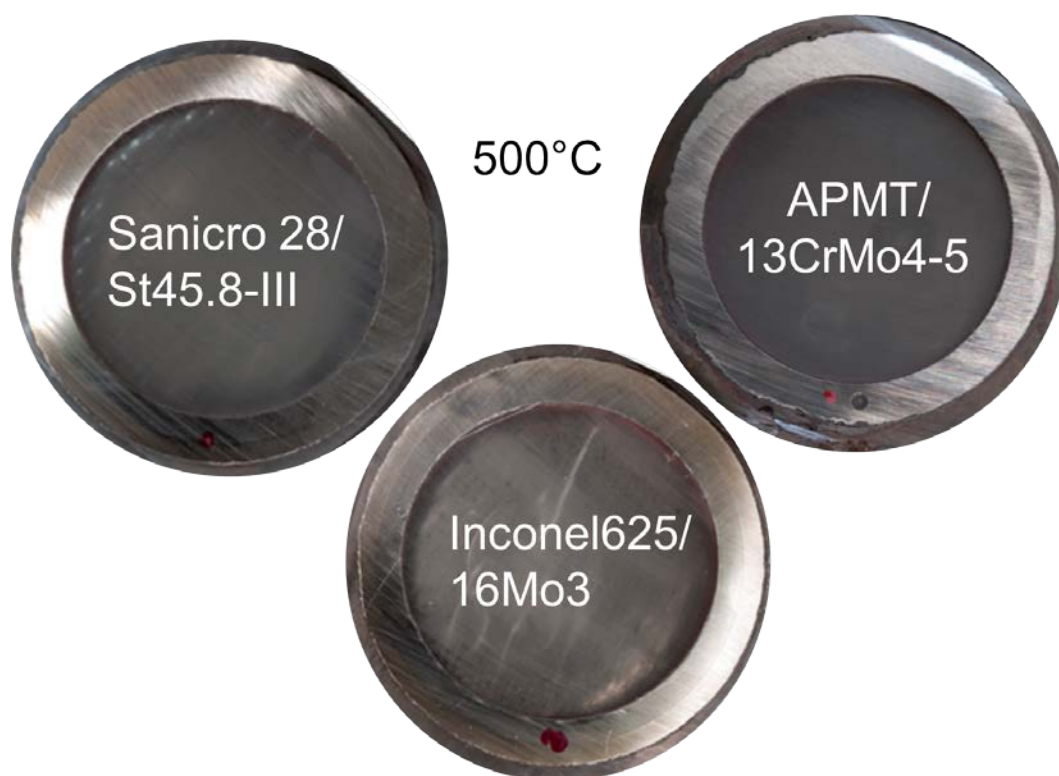
**Figur 21.** Optiska bilder av tvärsnittet av provringarna exponerade vid 500 °C i 5600 timmar. Den röda pricken markerar vindsida.

Three materials (i.e. Sanicro28, KanthalAPMT and Inconel625) were tested at the higher material temperature (i.e. 500 °C). These samples exposed at 500 °C for 5600 hours are shown in Figure 21. Of these three samples, it is clear that the 13CrMo4-5 sample sprayed with KanthalAPMT performed worst. On this sample black/dark grey oxide layers could be seen and the circumference of the steel ring appears nugget and uneven. However, there is a remarkable difference between left and right side of the sample, where the left side is much more corroded. This could also be seen on the Sanicro28 and Inconel625 samples. However, the difference between the two sides was not equally pronounced as for the APMT sample. The more corroded side of the sample rings has been subject towards the nearby soot blower, see Figure 18.

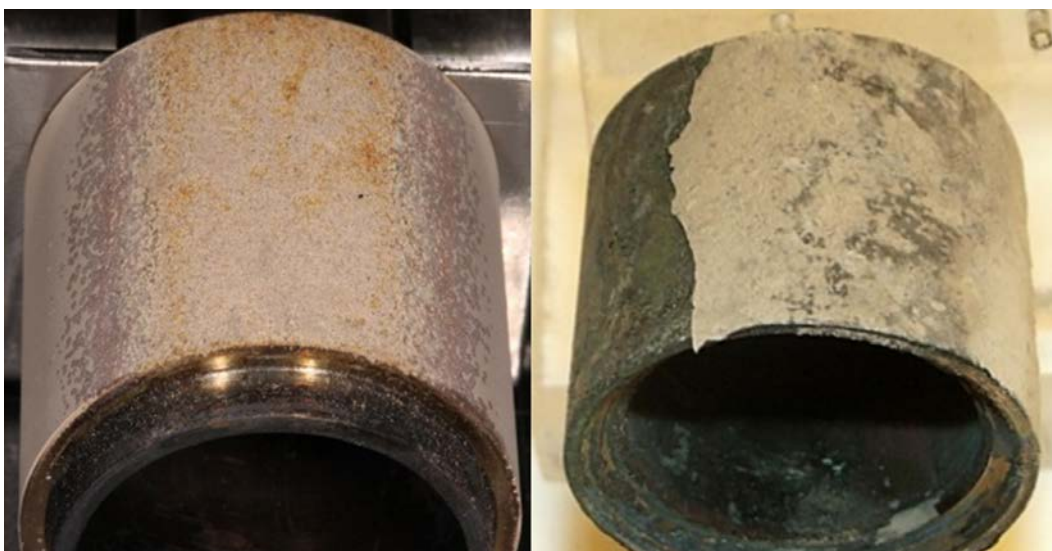
**Figur 32.** Optiska bilder av vindsidan av Sanicro28 exponerade med korrosionssond vid 500 °C. Till vänster: Långsam start (start från kall panna, ~72 timmar med oljeeldning innan 24 timmar med avfallsförbränning) Till höger: Snabb start (24 timmar med avfallsförbränning, kall sond installerades direkt in i en varm panna).

Corrosion rate measurements are usually performed by means of exposing corrosion probes for various times, materials and temperatures. The exposure is often performed in such way that the cold probe is put into the boiler, through some type of measurement hole, during operation. Hence, the cold probe experiences directly the hot flue gases and plausibly intense condensation of various species is occurring during the initial stages. The ramping period can take up to 30 minutes until the desired material temperature is achieved. The right images in Figure 32 and Figure 33 are showing Sanicro28 exposed for 24 hours at 500 °C according to this type of startup (from KME411 [18]). The left images in Figure 32 and Figure 33 are also showing Sanicro28 exposed at 500 °C. However, the exposure history for this sample is different. The corrosion probe was mounted into the boiler during revision, i.e. into a cold boiler. During startup the boiler was fired with oil during 72 hours in order to dry out all new brick work installed during the revision. After this initial time, the fuel gradually changed to waste and the corrosion probe was exposed for an additional 24 hours after that the fuel-mix was 100% waste.

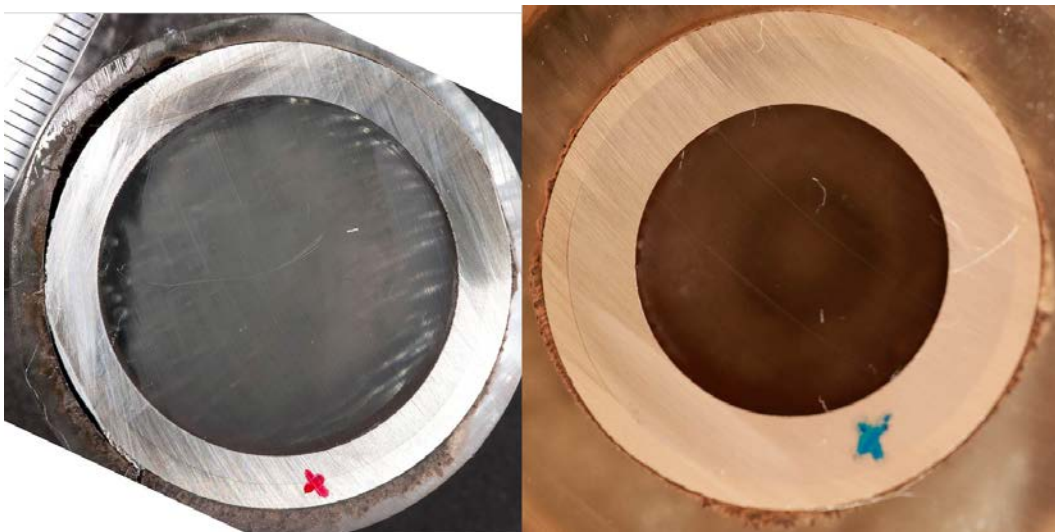
**Figur 36. Tvärsnitt av Sanicro28 exponerad vid 420°C i 5600 timmar. Till vänster: sondprov. Till höger: Tubprov**

The comparison between the probe and tube exposures is shown in Figure 34 - Figure 36. In general, there were little or no difference between the samples exposed on a probe and the samples installed in the superheater tube bundle. There is a tendency of slightly thicker deposit layer on the probe samples compared to the tube samples. However, this may be an effect of the probes being mounted upstream the tube samples. Furthermore, the tube samples were mounted in row 2 and some shielding from row 1 is expected.
