Maria Dolores Paz, Torbjörn Jonsson,  
Jesper Liske, Sofia Karlsson, Colin Davis,  
Anna Jonasson, Tom Sandberg

# **Study of corrosion memory in boiler heat surfaces by field tests with biomass fuel mixes including sulphur and refuse fractions**

## Abstract

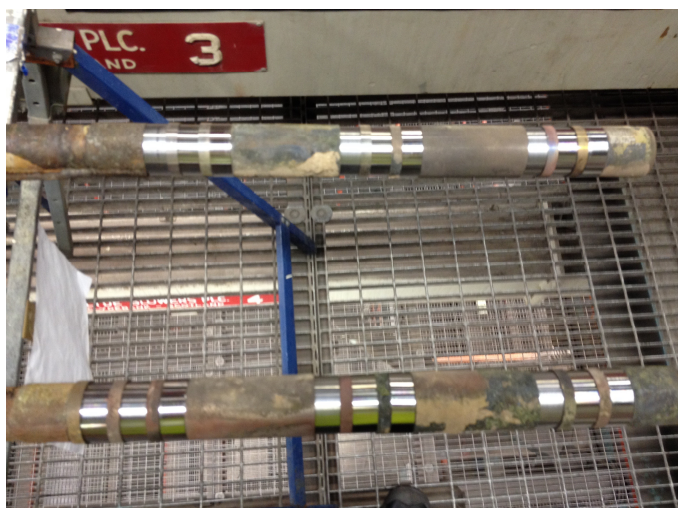
The probes used for both main study and pre-study are cooled probes, which hold 3x3 samples in three temperature zones, as it is presented in Figure 6. A PID controller controlled each temperature zone individually, and pressurized air was used as cooling agent. The probes were exposed in P13 boiler (moderate corrosive environment) and P14 boiler (fuel mix of household and industrial waste).

*Figure 6. Detail of the samples placed in the probes and temperature zones*

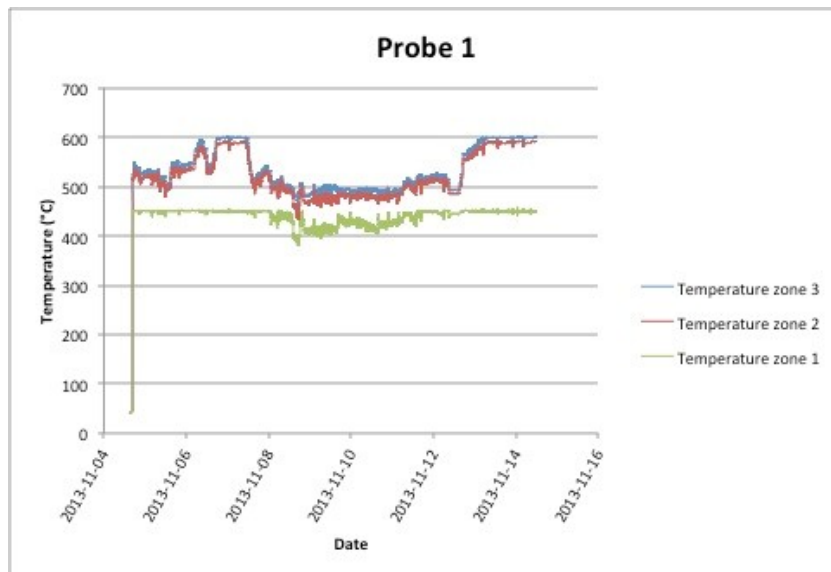
During the second exposure probe 1 was exposed in P13 while probe 2 was exposed in P14. Both probes were handled the same way to be able to compare the results. The temperature of the samples in P14 was very stable during the whole exposure while this was not the case for the samples in P13 where it was impossible to reach the highest target temperatures due to how the boiler was run, see Figure 12 and Figure 13.

Figure 12. Evolution of the temperature in the P13 boiler during the step 2

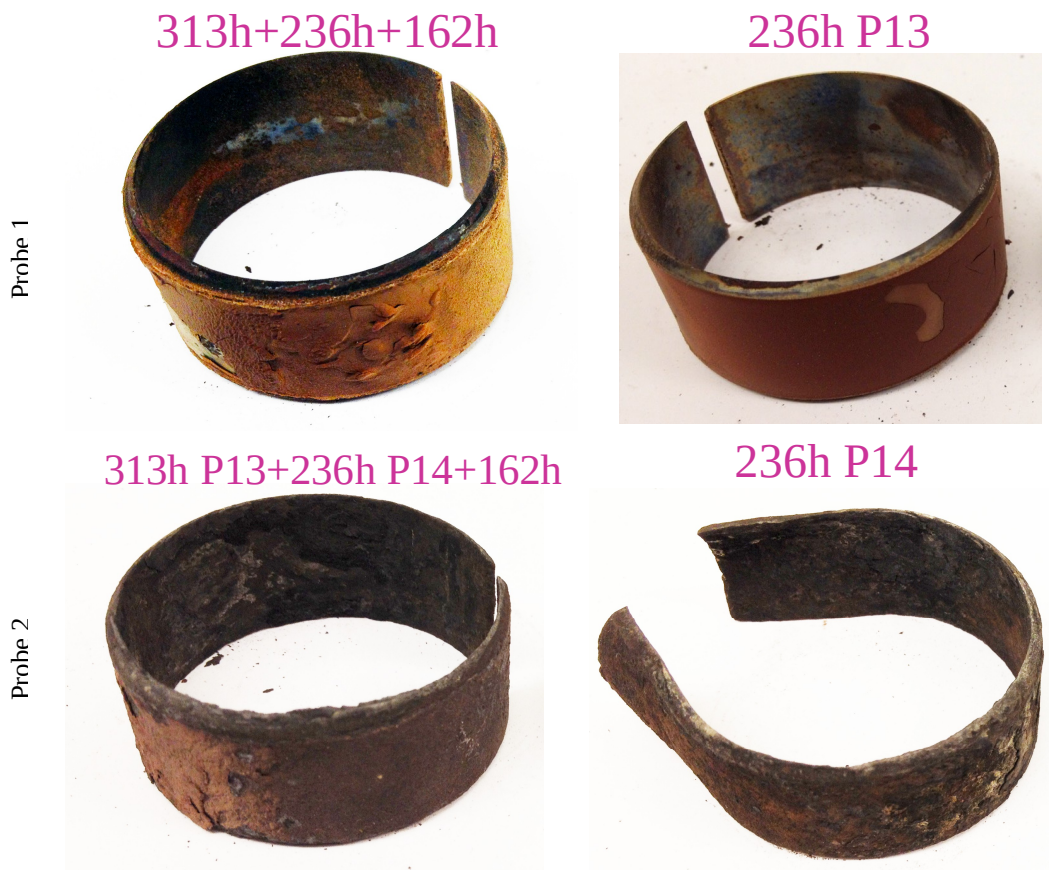
During all exposures three different materials (Sanicro28, 304L and T22) were inserted at both temperatures. However, the first investigation showed that most of the low-alloyed steel (T22) samples were extremely corroded and it was decided together with the project group to further investigate only the 304L and San28 samples. It was in addition decided to focus the detailed investigation on the samples exposed at the high temperature (600°C).

Figure 32. Investigated 304L samples

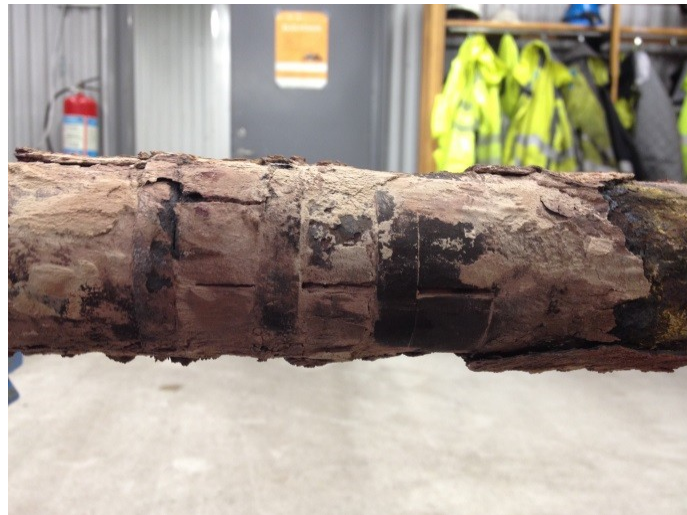
*Figure 48. The thick deposit formed in P14*

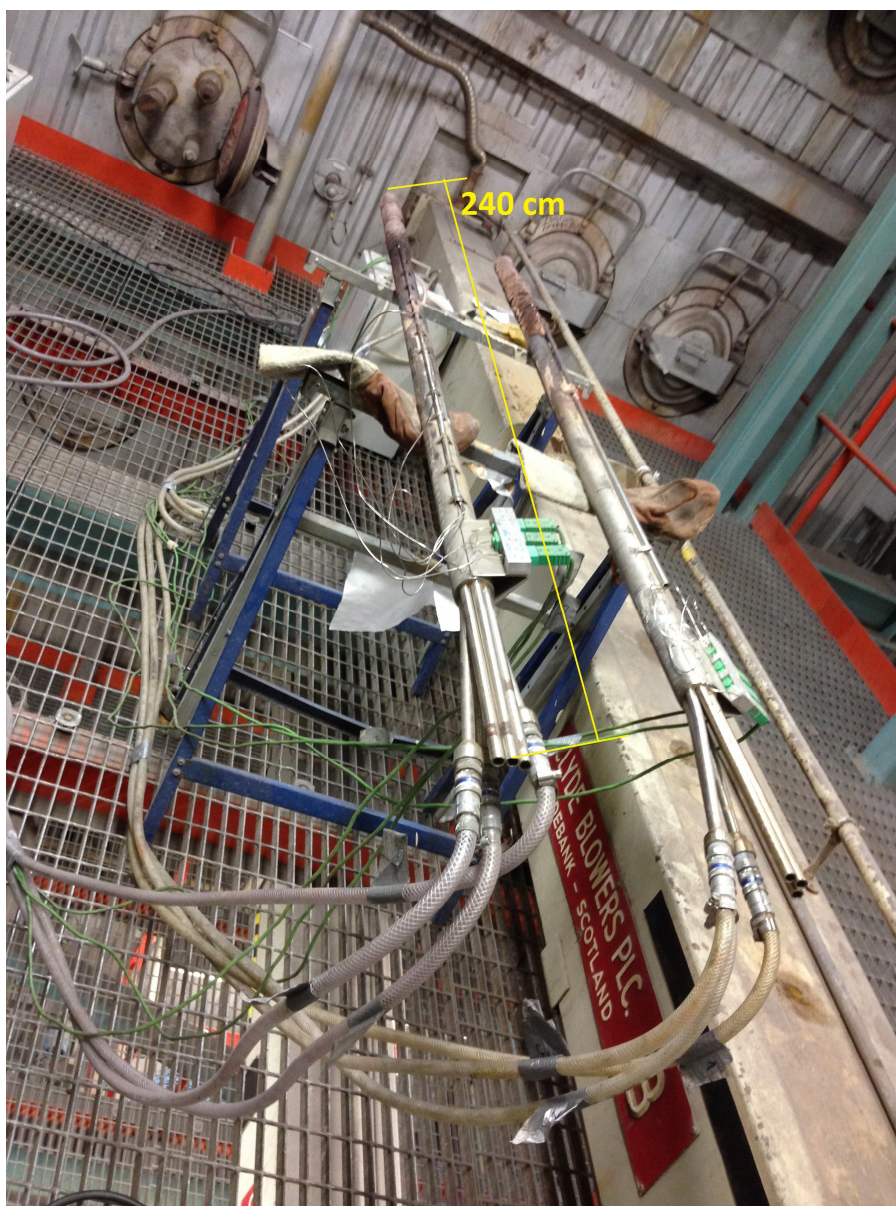
Figure 50. Probe 1 and probe 2 after the exposures in P13

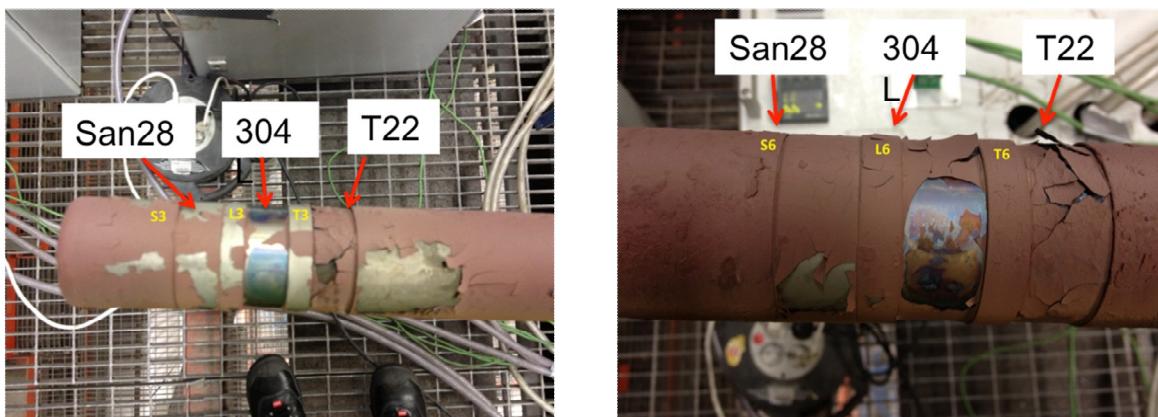
Figure 53. Samples placed in probe 1 (left) and probe two (right) after step 1 temperature zone 3

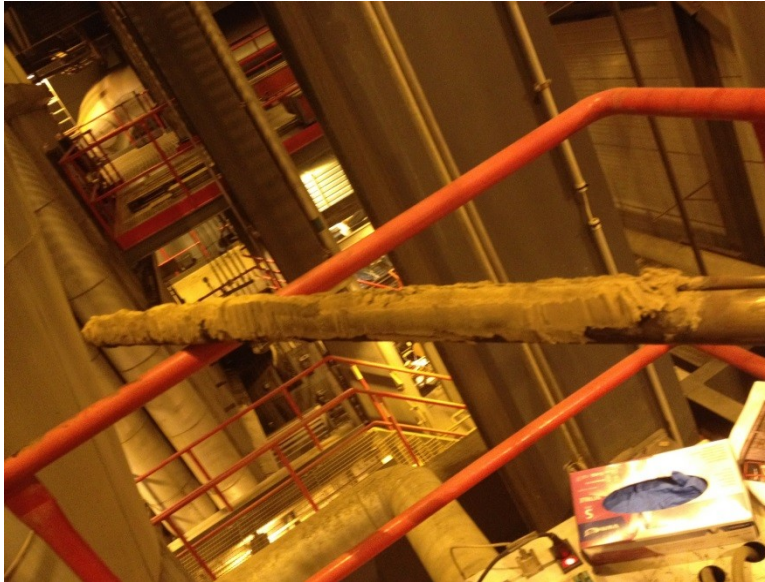
*Figure 55. Probe 2 after the step 2*

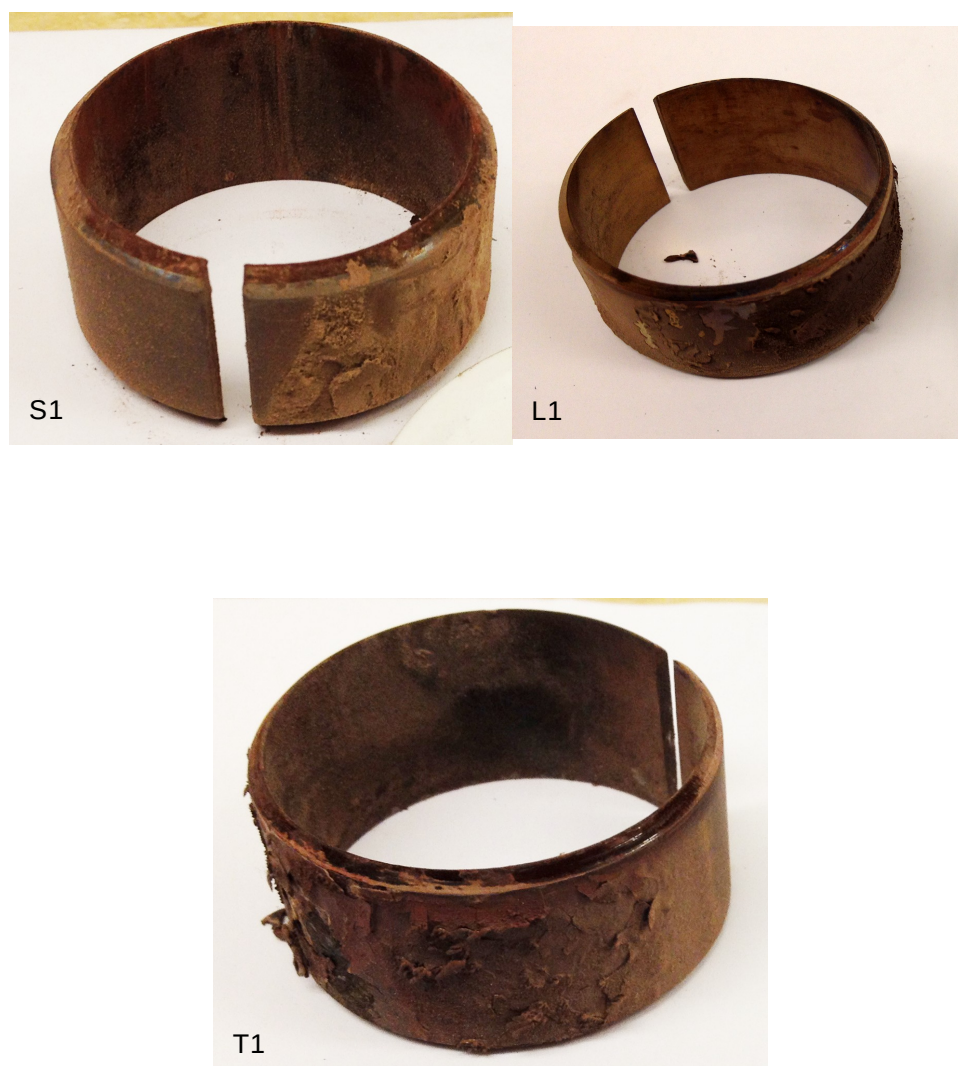
Figure 60. **Probe 1** – temperature zone 1 (450 °C) – S1, L1, T1 (313 h P13 + 236 h P13+ 162 h P13)

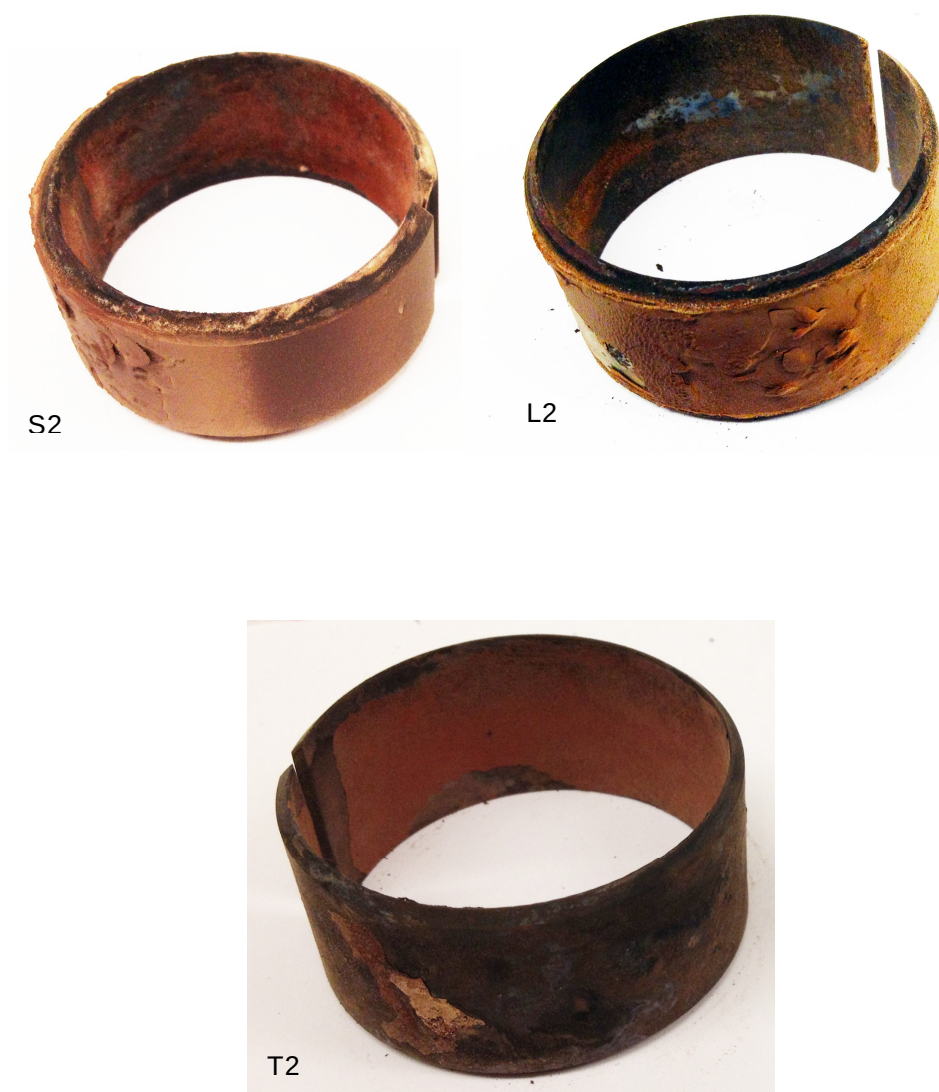
Figure 61. **Probe 1** – temperature zone 2 (600 °C) – S2, L2, T2 (313 h P13 + 236 h P13+ 162 h P13)

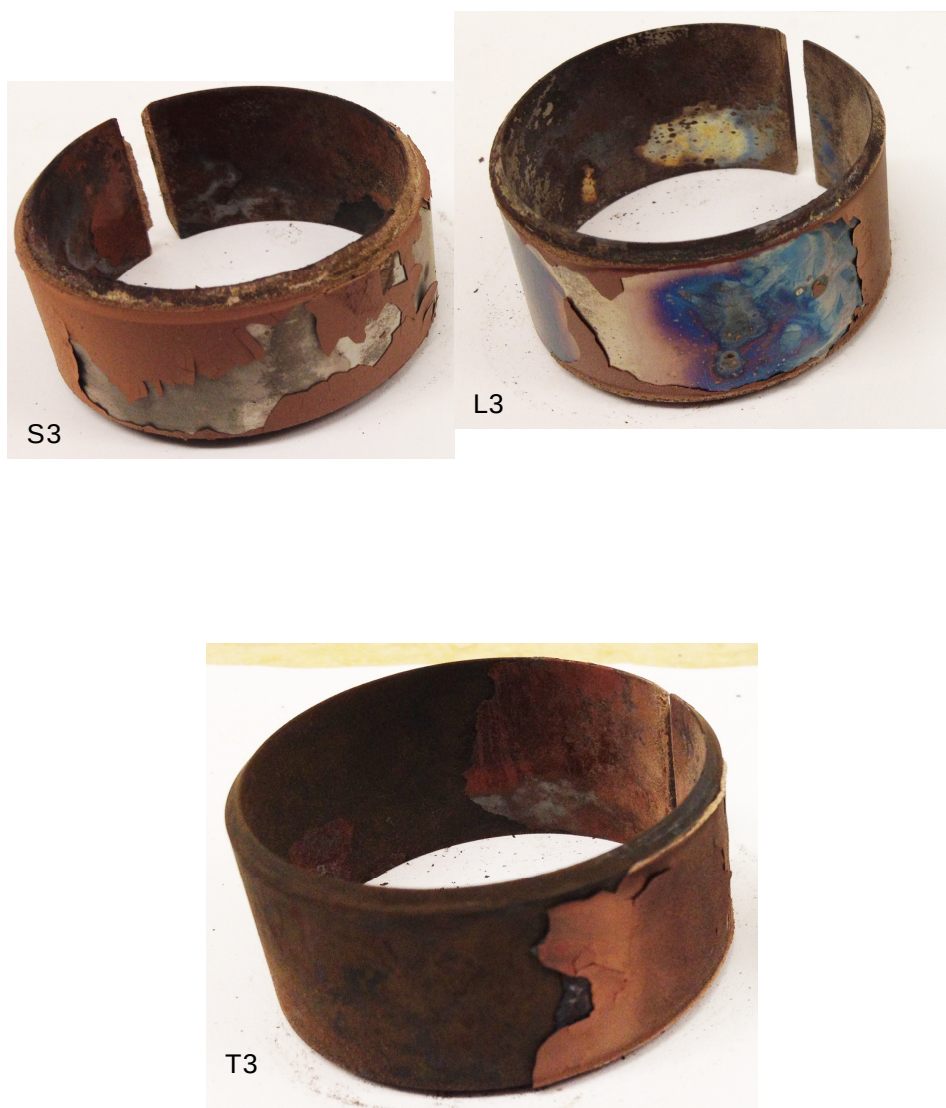
Figure 62. **Probe 1** – temperature zone 3 (600 °C) – S3, L3, T3 (313 h P13)

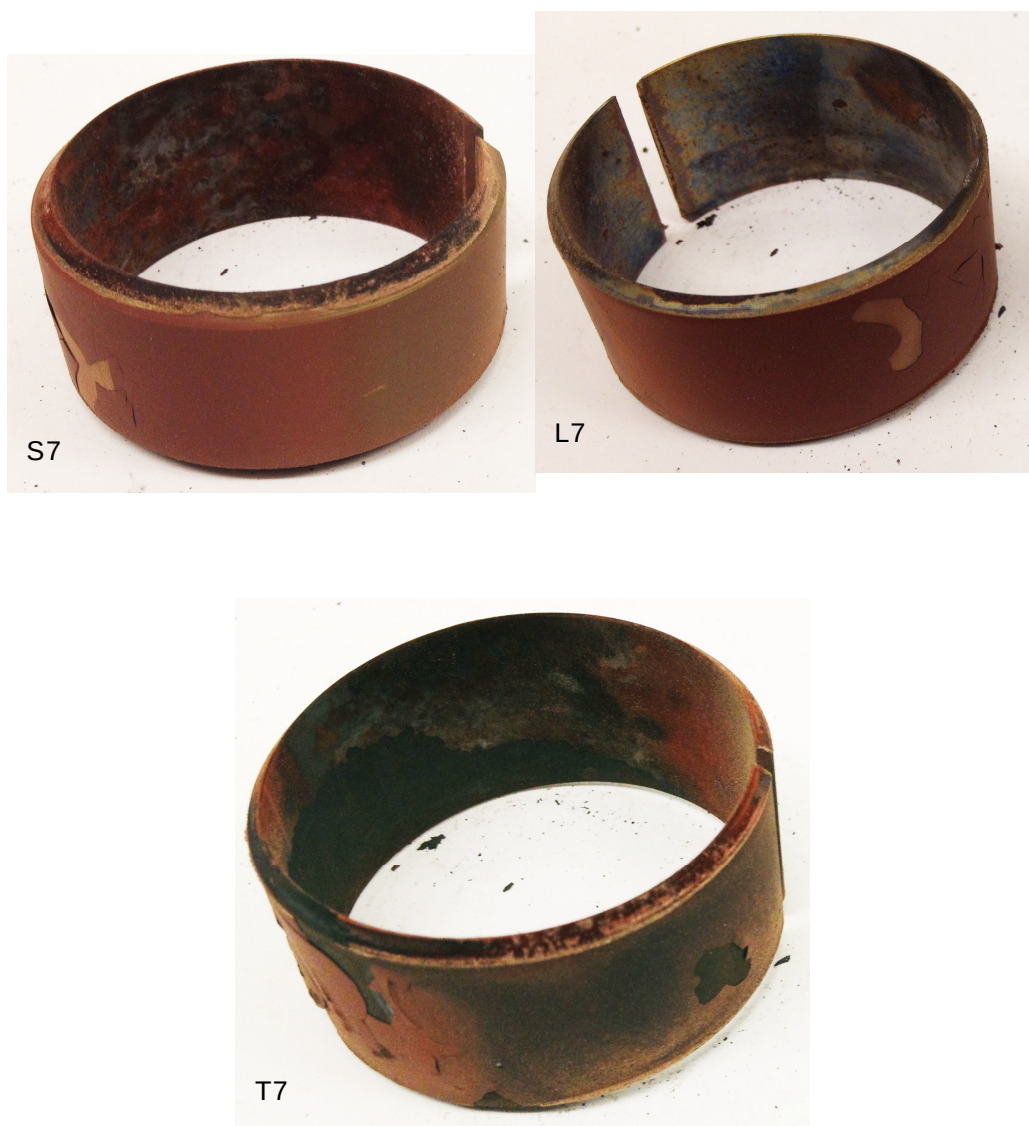
Figure 63. **Probe 1** – temperature zone 3 (600 °C) – S7, L7, T7 (236 h P13)

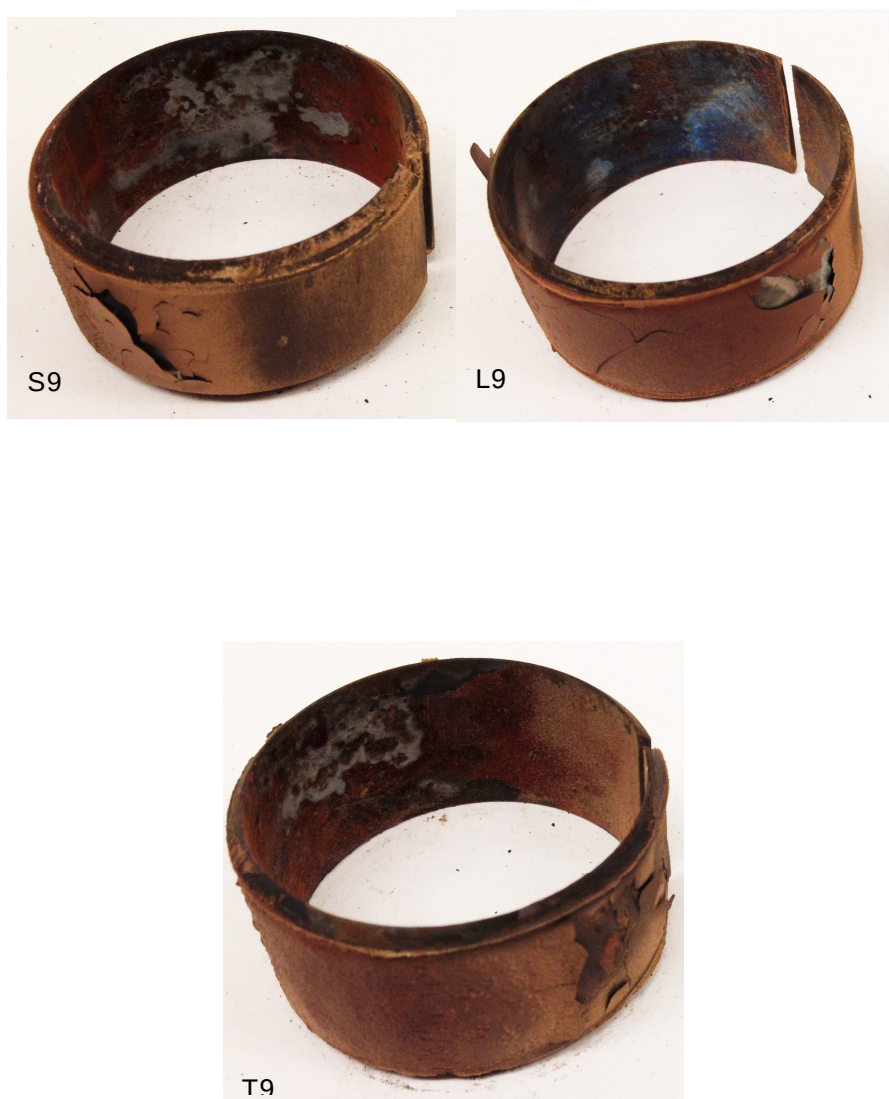
Figure 64. **Probe 1** – temperature zone 3 (600 °C) – S9, L9, T9 (162 h P13)

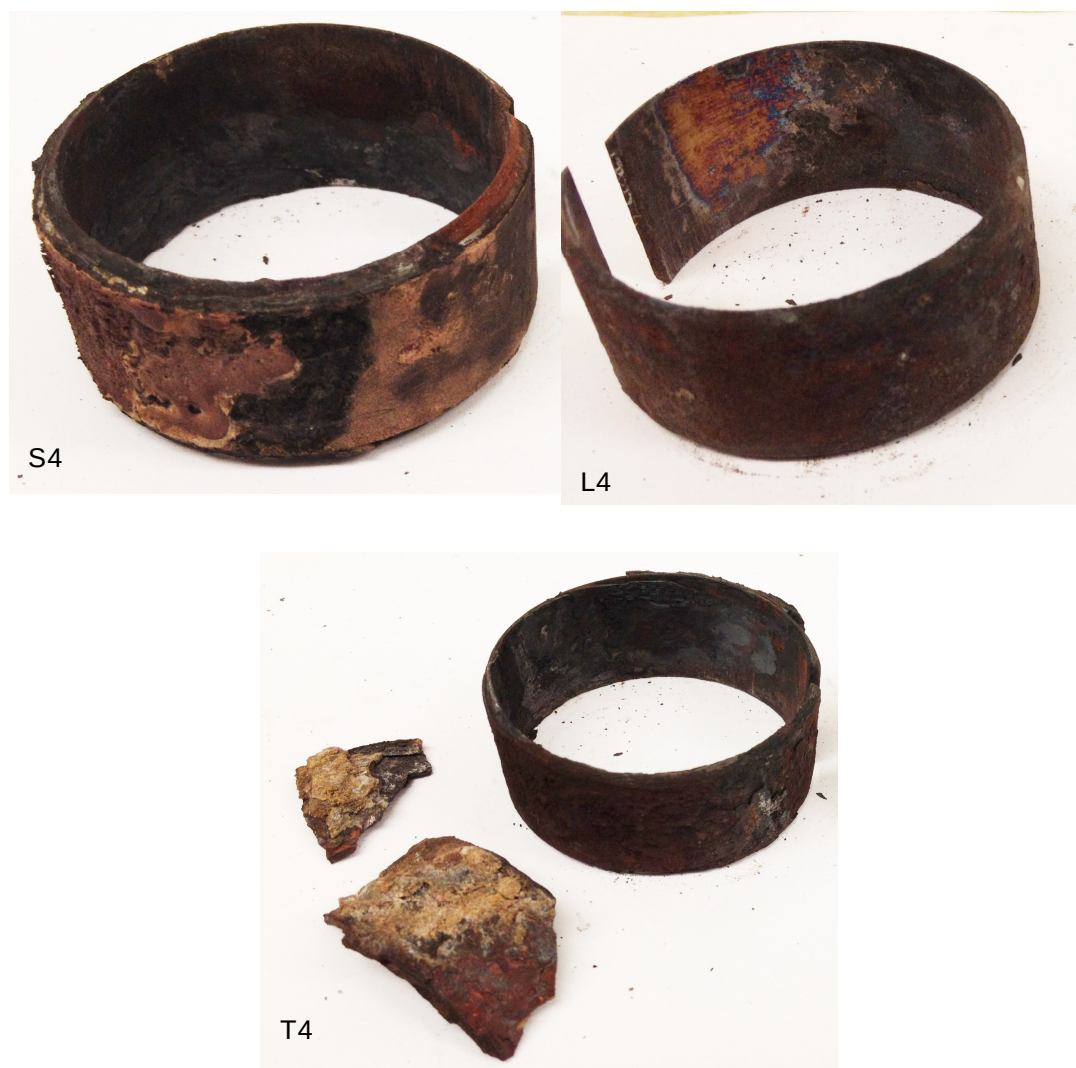
Figure 65. **Probe 2** – temperature zone 1 (450 °C) – S4, L4, T4 (313h P13 +236h P14 + 162h P13)

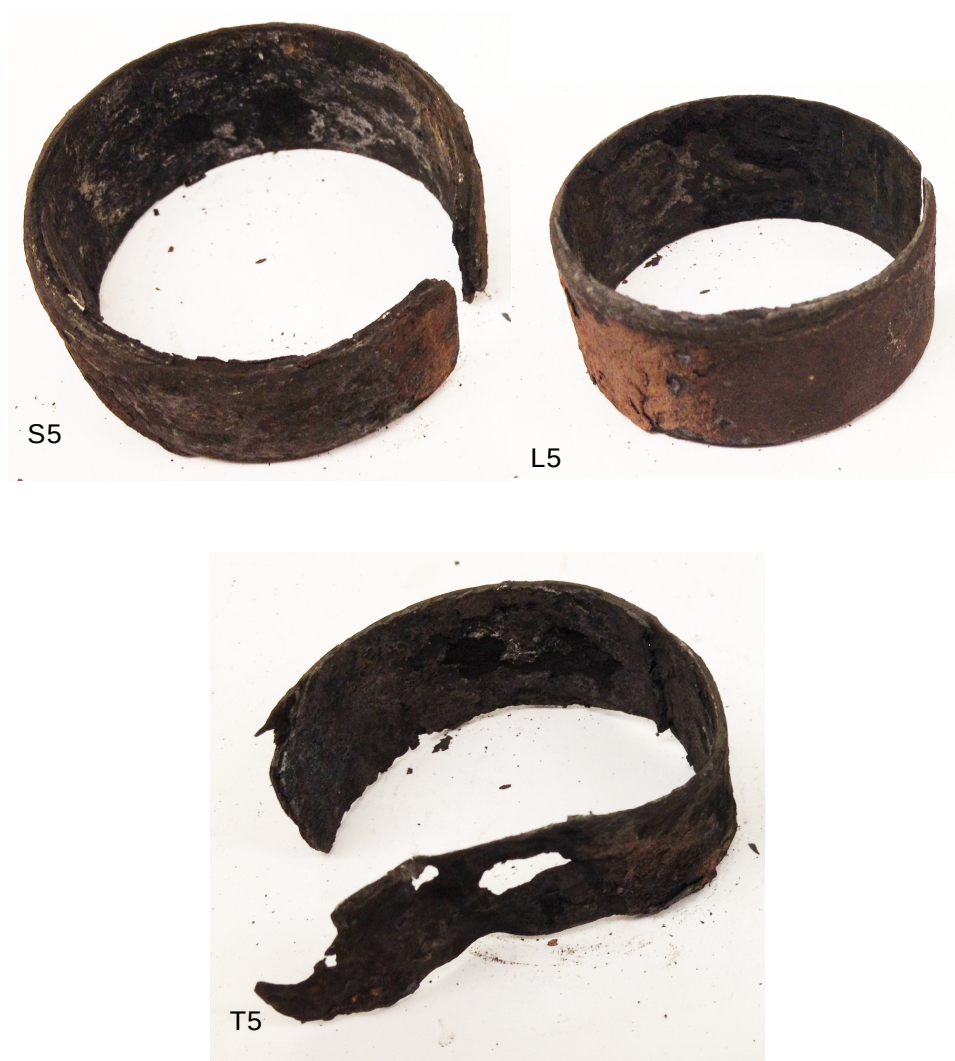
Figure 66. **Probe 2** – temperature zone 2 (600 °C) – S5, L5, T5 (313h P13 + 236h P14+ 162h P13)

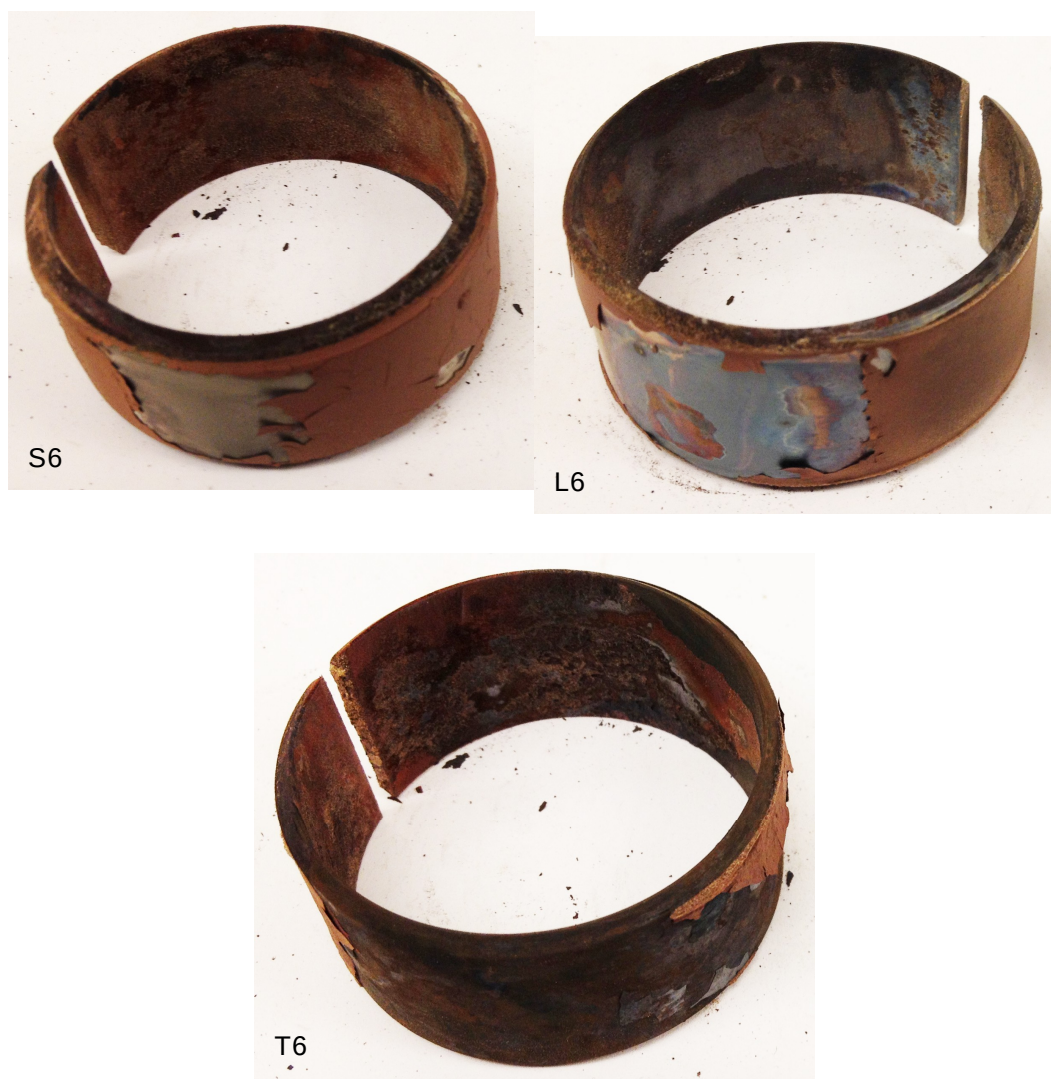
Figure 67. **Probe 2** – temperature zone 3 (600 °C) – S6, L6, T6 (313h P13)

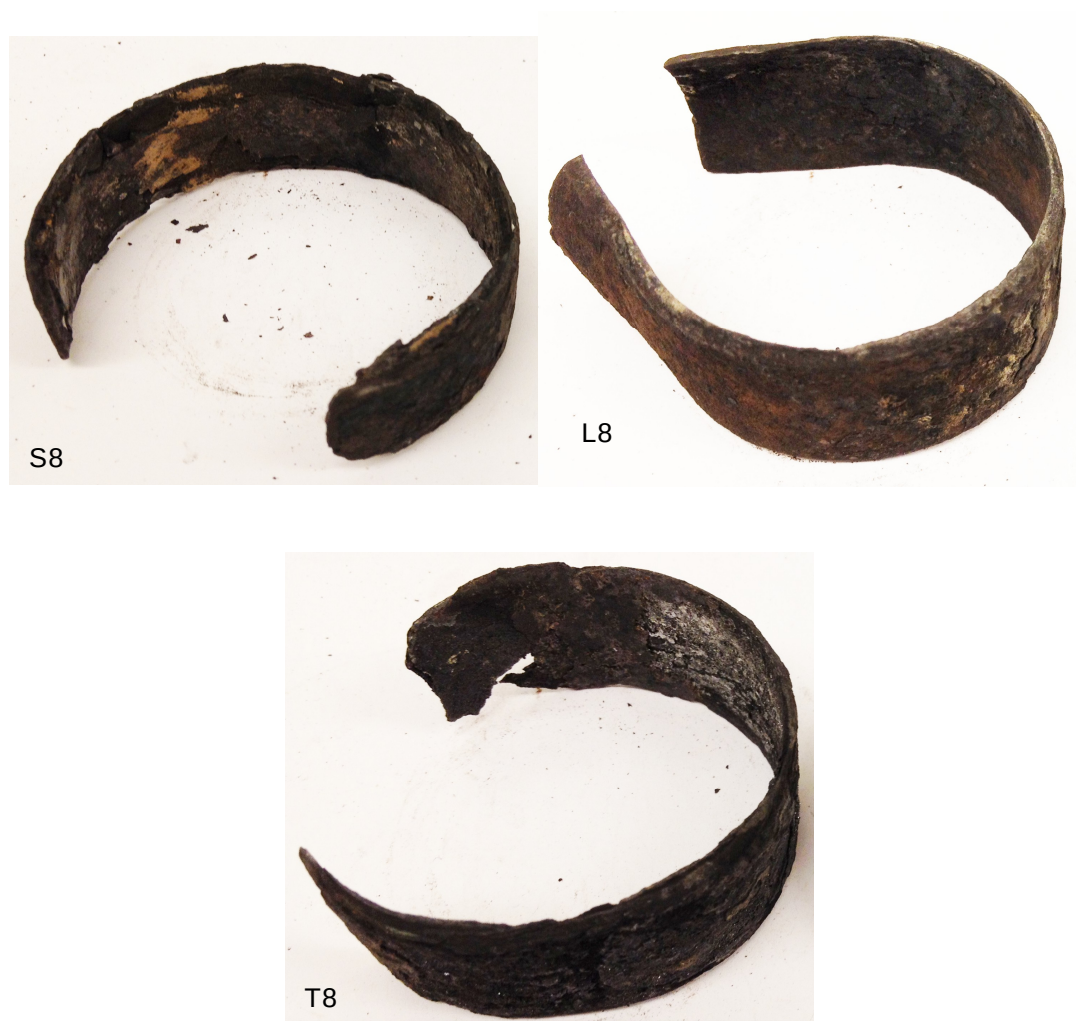
Figure 68. **Probe 2** – temperature zone 3 (600 °C) – S8, L8, T8 (236h P14)

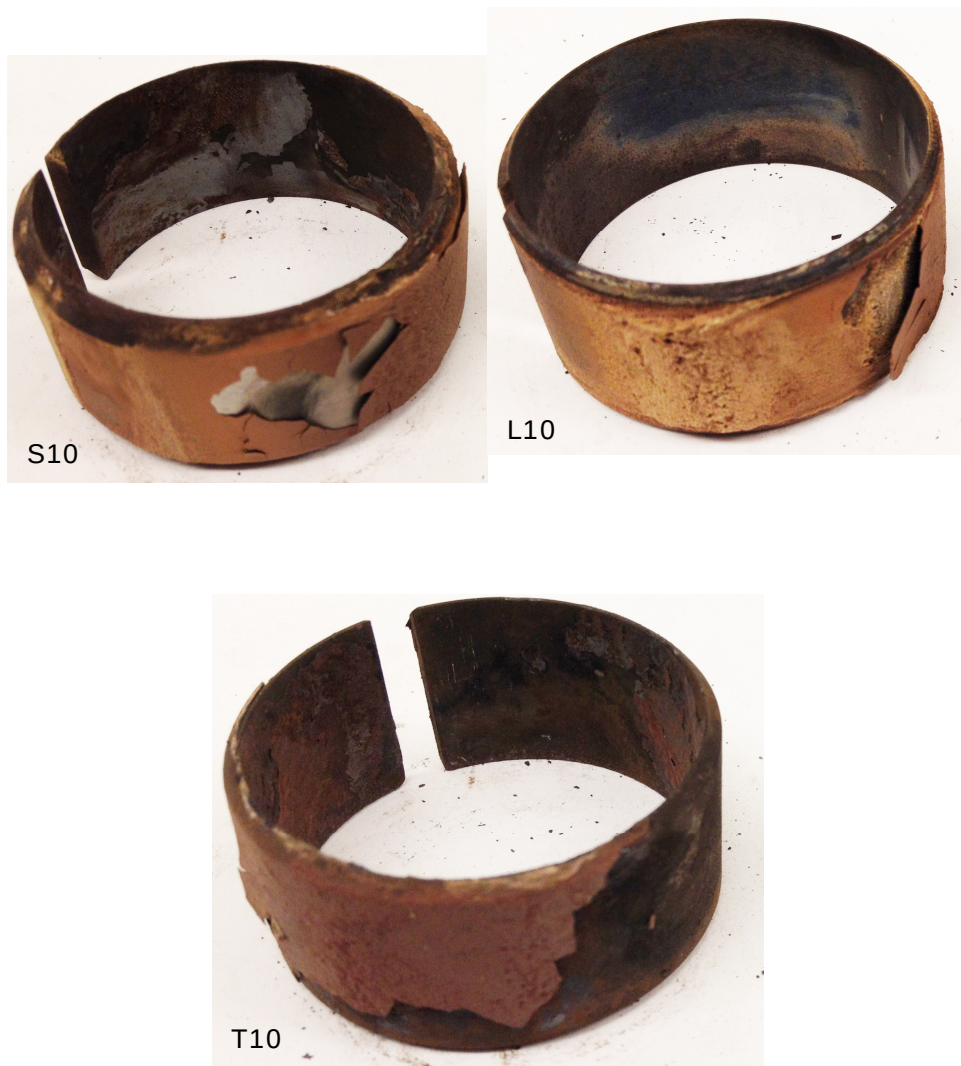
Figure 69. **Probe 2** – temperature zone 3 (600 °C) – S10, L10, T10 (162h P13)
