## **Oxidation of EPDM: oxidation depth measurements and effects on material properties**

Authors: Konsta Sipilä, Harri Joki, Anna Jansson<sup>1</sup>, Louise Wogelred<sup>1</sup>  
<sup>1</sup>SP Technical Research Institute of Sweden

<b>Report's title</b>		
Oxidation of EPDM: oxidation depth measurements and effects on material properties		
<b>Customer, contact person, address</b>		<b>Order reference</b>
SAFIR 2018 Research Programme		
<b>Project name</b>		<b>Project number/Short name</b>
Condition Monitoring, Thermal and Radiation Degradation of Polymers Inside NPP Containments		108835/COMRADE
<b>Author(s)</b>		<b>Pages</b>
Konsta Sipilä, Harri Joki, Anna Jansson, Louise Wogelred		21
<b>Keywords</b>		<b>Report identification code</b>
EPDM, oxidation, ToF-SIMS, FTIR, DSC		VTT-R-01190-17
<b>Summary</b>		
<p>Polymers are known to be susceptible to heterogeneous oxidation when they are exposed to harsh environments, e.g. relatively high dose rates of ionizing radiation in oxygen containing atmosphere. Exposure to such environments could cause a formation of oxidation profile in the vicinity of the surface, where degree of oxidation is decreased as moved towards the bulk. This kind

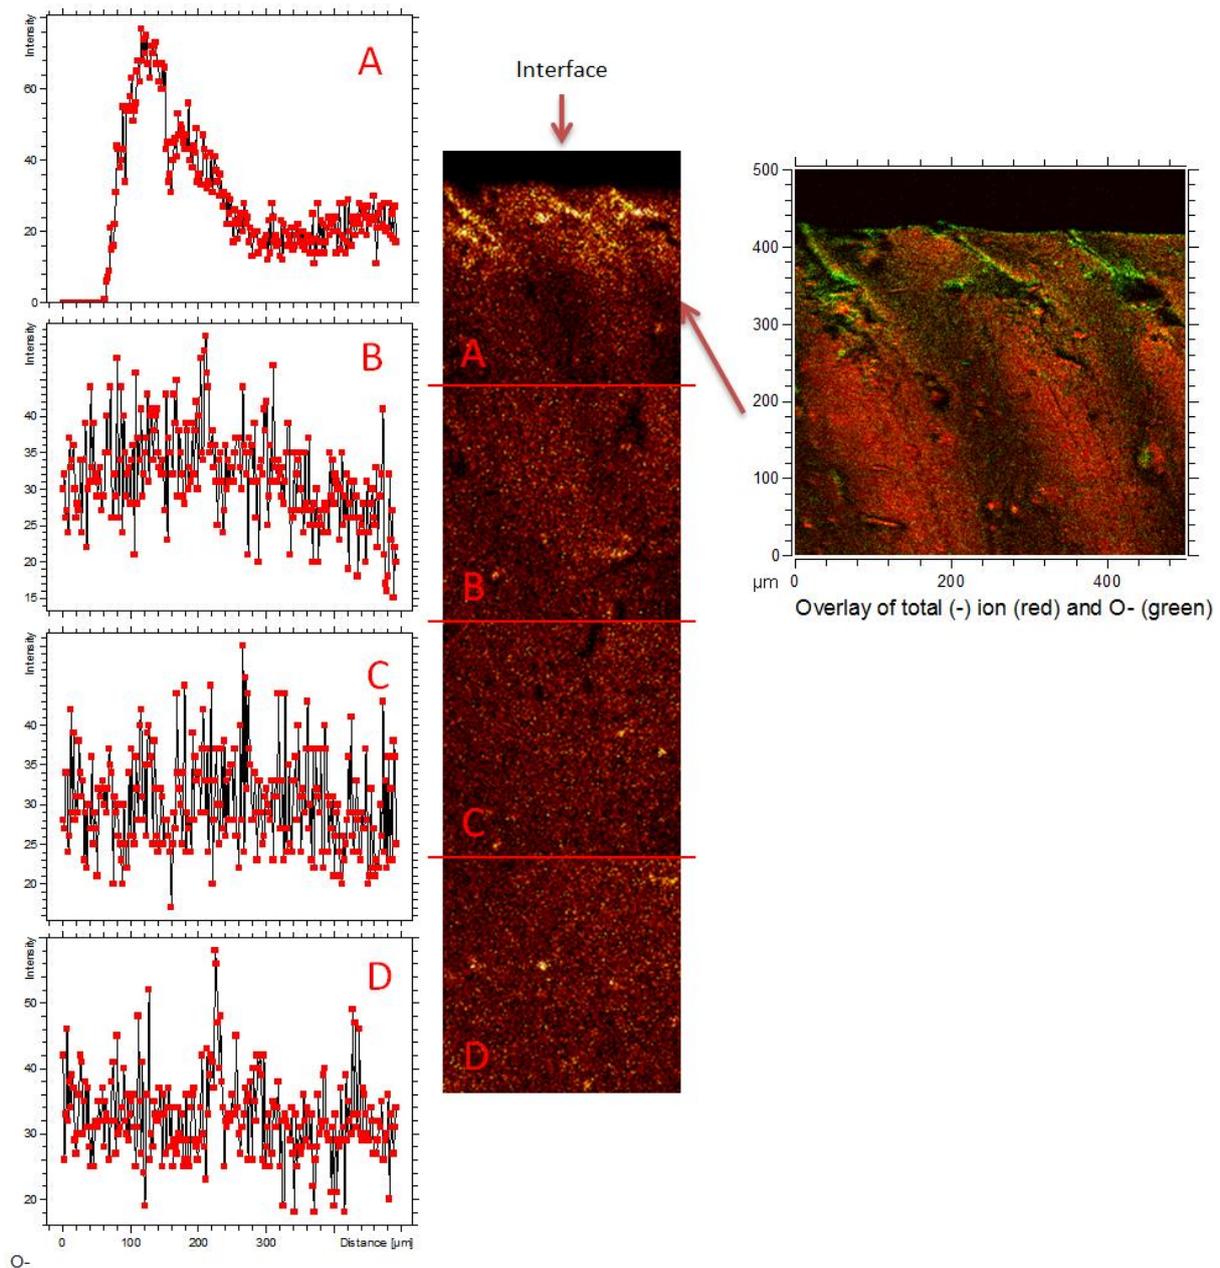
Figure 1: ToF SIMS analysis result on the EPDM reference sample. To the left oxygen intensity measurement spectra as function of distance from the surface. Corresponding images on the surface are pointed out with letters A, B, C and D. Oxygen is visualized with green colour in the overlay imaging to the right.

The principle how the ToF SIMS analyses were performed is shown in Figure 1. The pulsed ion beam is introduced first to the bulk material of the cross section surface (shown as D in the middle picture in Figure 1) from which it begins to progress towards the direction of the interface. Since two cross section surfaces were analysed at once (not seen in Figure 1), the

vicinity of the interface in the graphs may be located either at the distance 0  $\mu\text{m}$  or at ca. 400  $\mu\text{m}$  depending on the direction of the ion beam. In Figure 1 (in the middle) one of these cross section samples is seen with the interface pointed by an arrow. The  $\text{O}^-$  signal intensity (i.e. the oxygen content) is recorded as a function of distance from the interface (shown on left in Figure 1). Also a graphic two dimensional illustration on the analysed oxygen content on the cross section surface can be produced with this method (shown right in Figure 1). Even though the surface of the reference sample seems to be quite rough, oxygen (green colour in the image) can be detected in higher quantities in the vicinity of the surface than in the bulk. From the reference sample it can be analysed that the oxidation layer is approximately 220  $\mu\text{m}$  thick. The high intensity variation detected from the bulk analyses are considered to be caused by the uneven surface.

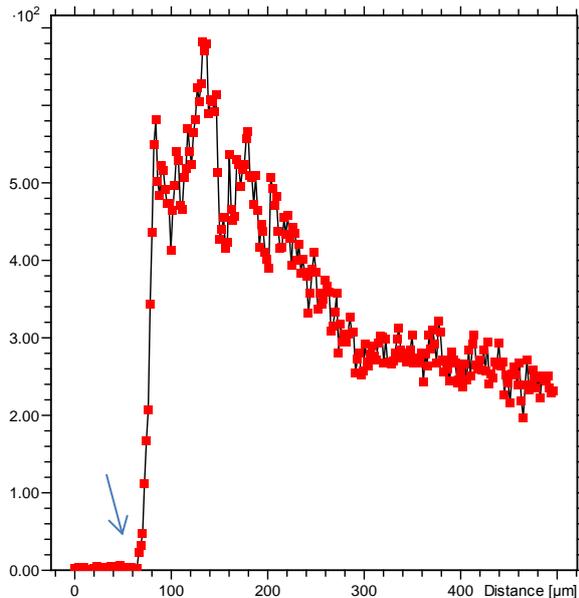
Figure 2: O<sup>-</sup> signal intensity as function of distance from the interface (shown with an arrow) for second reference measurement.

The repetitive measurement for the reference sample is shown in Figure 2. Again, the thickness of the oxidized surface layer can be evaluated to be 220  $\mu\text{m}$ . In case of the reference sample, good repeatability is achieved.

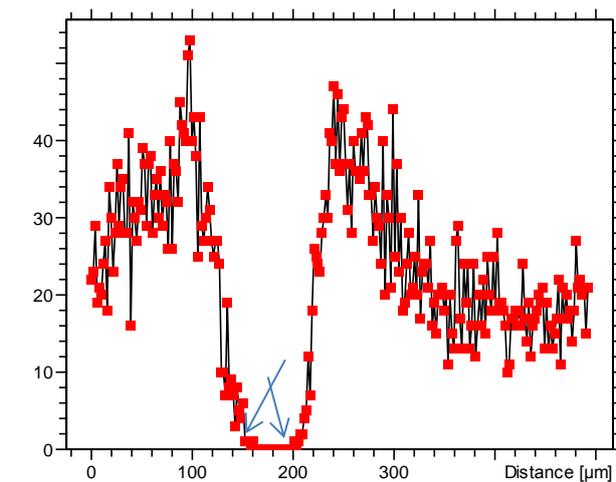
Figure 3: O<sup>-</sup> signal intensity as function of distance from the interface (shown with arrows) after exposure to 228 kGy of gamma radiation.

Figures 3 and 4 show the results obtained from samples exposed to ageing environment 1. From the first analysis round the oxidized layer thickness is calculated to be 140 and 160  $\mu\text{m}$  and from the repeated measurement 340  $\mu\text{m}$ . The repeated measurement with the second sample yielded in approximately double as high oxidized layer thickness.

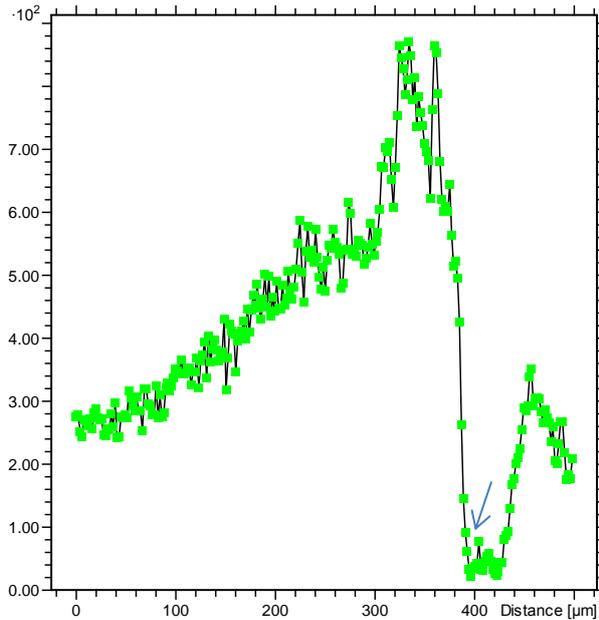
Figure 4: Repeated measurement result of  $O^-$  signal intensity as function of distance from the interface (shown with an arrow) after exposure to 228 kGy of gamma radiation.

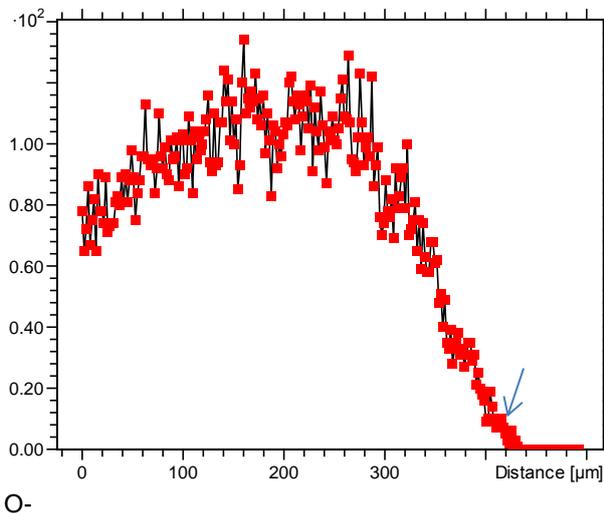
Figure 5:  $O^-$  signal intensity as function of distance from the interface (shown with an arrow) after exposure to 125°C.

The oxidation profile for the thermally only aged sample is shown in Figure 5. The bulk level intensity was achieved approximately 520  $\mu\text{m}$  from the interface. The intensity level of the bulk material can be seen in Figure 6, which is continuation from Figure 5. In Figure 6 as the distance in x-axis grows, more closer the interface is. In the case of this thermally only aged sample, the other cross section sample did not yield in clear intensity levels within the bulk material so no oxidized layer thickness could be determined.

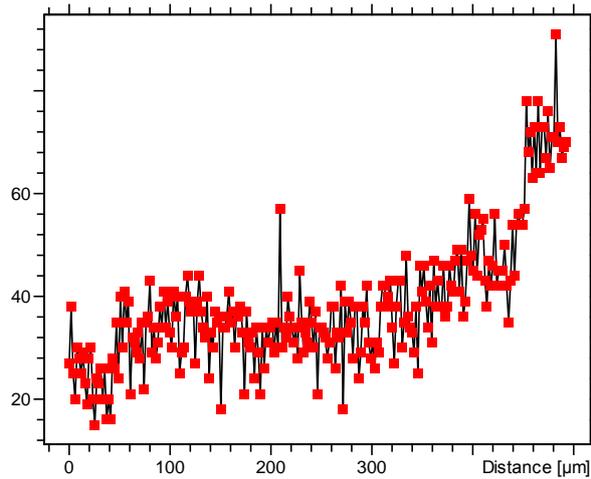
*Figure 6:  $O^-$  signal intensity in the bulk material after exposure to 125°C. Above 400  $\mu\text{m}$  the higher intensity is due to the oxidation layer (continuation from the previous figure).*

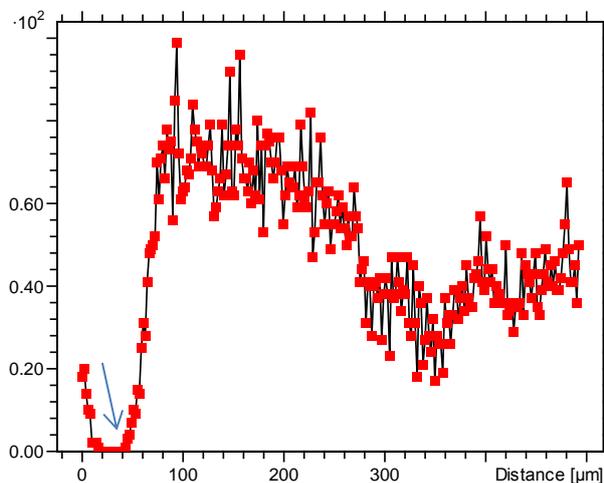
*Figure 7:  $O^-$  signal intensity as function of distance from the interface (shown with an arrow) after exposure to 228 kGy and 125°C.*

In Figure 7 the spectrum for sample that was exposed to gamma radiation and thermal ageing is displayed. The oxidation layer thickness is estimated to be ca. 240  $\mu\text{m}$ . Here again, the other cross section surface displayed uneven surface characteristics, as can be seen in Figure 8, when compared to the opposing even cross section surface shown in Figure 9. From Figure 8 it can be seen that the other cross section sample has a flaw which separates the oxidazide surface layer from the less oxidized bulk material.

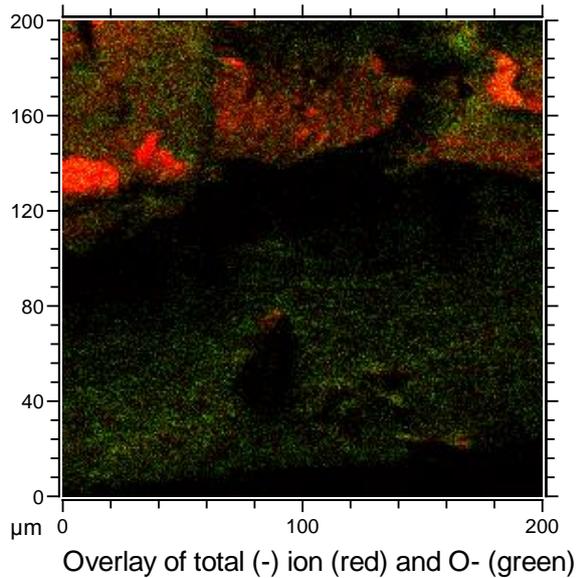
*Figure 8: Two dimension oxidation graph obtained with sample irradiated and exposed to thermal ageing with uneven cross section surface (opposite surface to the one shown in next figure). Interface is on the bottom of the figure.*

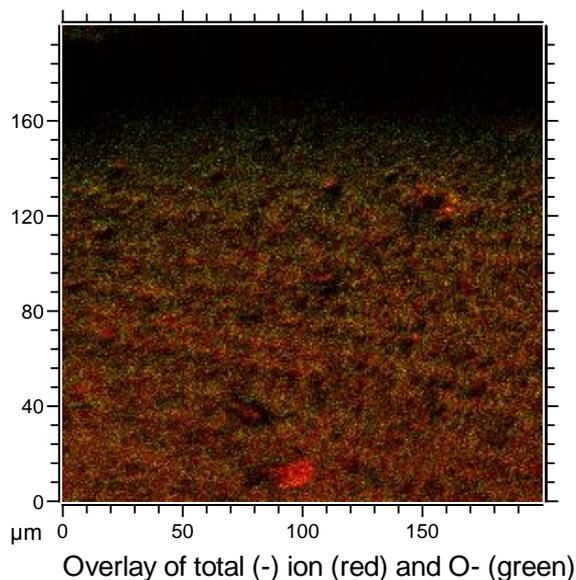
*Figure 9: Two dimension oxidation graph obtained with sample irradiated and exposed to thermal ageing with even cross section surface (opposite surface to the one in previous figure). Interface is on the top of the figure. The cross section surface is clearly less rough than the opposing surface shown in previous figure.*

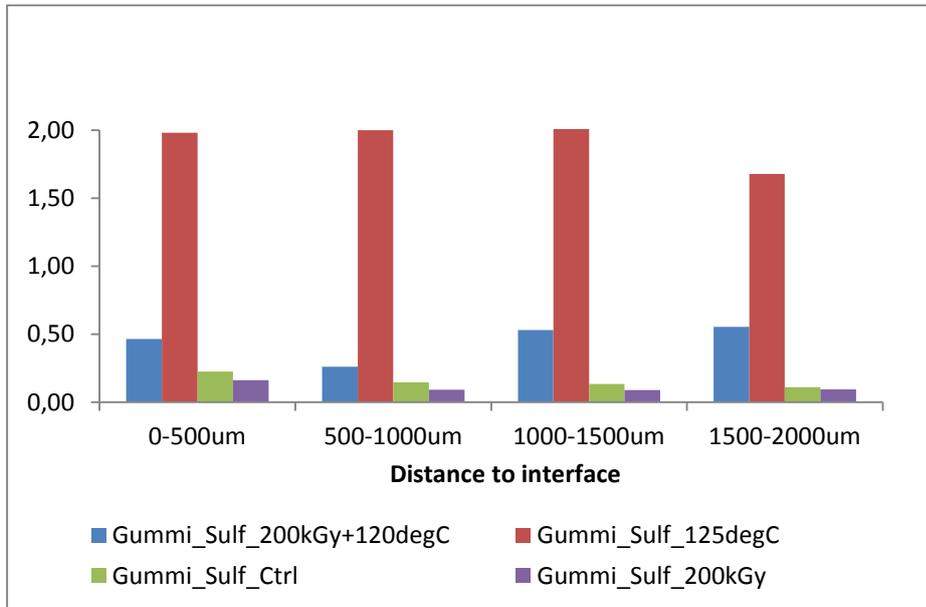
Figure 10: Ion intensity of O- normalized to CH- (y-axis) vs distance to interface (x-axis) after exposure to different ageing environments. Green bar indicates reference sample, purple ageing condition 1, red ageing condition 2 and blue ageing condition 3.

The O<sup>-</sup> - signal was normalized to the CH-signal in order to compare the amount of oxygen in different samples since the signal itself is not quantitative. The comparison between CH-intensity measurements indicate that when thermal ageing only is applied, the CH-intensity is clearly higher than in other samples, as shown in Figure 10. This would indicate that the thermo-oxidative ageing would be greater than radiation induced ageing. This observation is in aligne with the tensile test results.

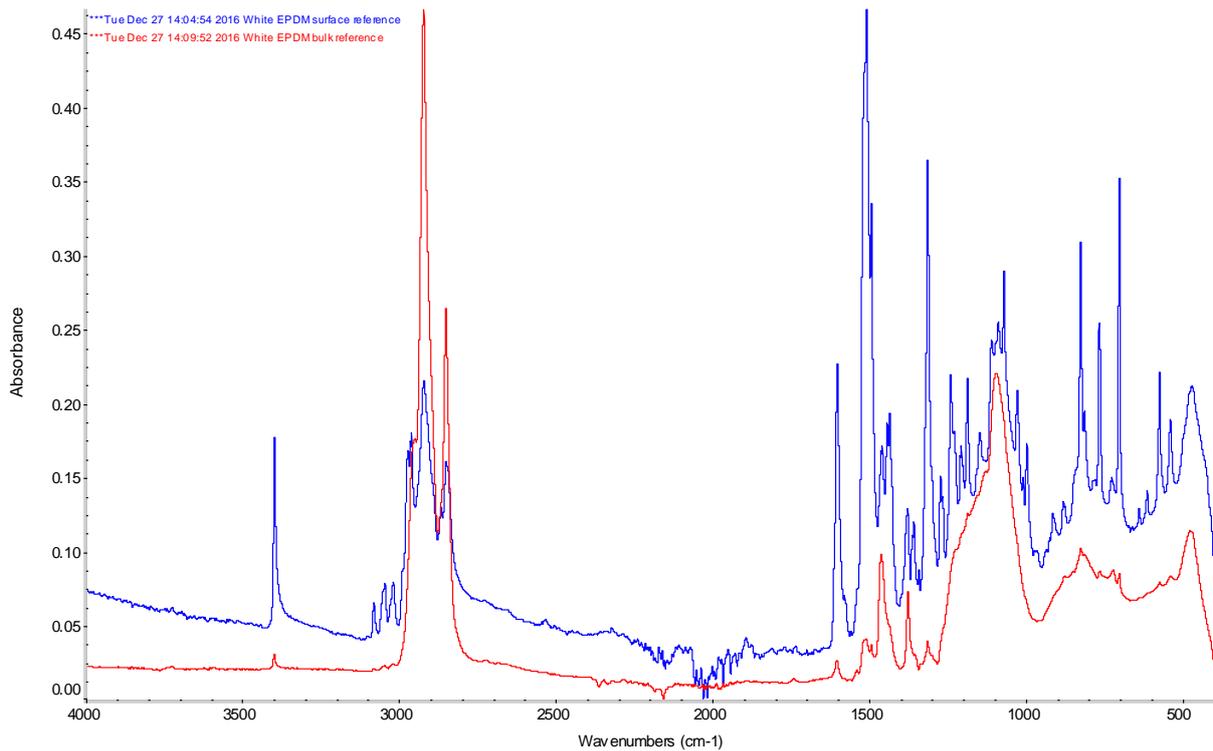
Figure 11: Comparison of the surface (blue spectrum) and the bulk (red spectrum) of the reference sample shows a difference in absorbance between the bulk and the surface.

A difference between the surface and the bulk material was observed on the reference material, as shown in Figure 11. Based on the differences in the two spectra, it was suspected that a coating or release agent may have been applied on the surface and/or an additive may have migrated to the surface. No relevant match to the spectrum achieved on the rubber material surface was found in the reference databases. Di-methylbenzyl Diphenylamine was the closest match and this chemical is used as catalyst in for example epoxy systems. More data on the ingredients of this specific EDPM blend would be required for more detailed interpretation of result.

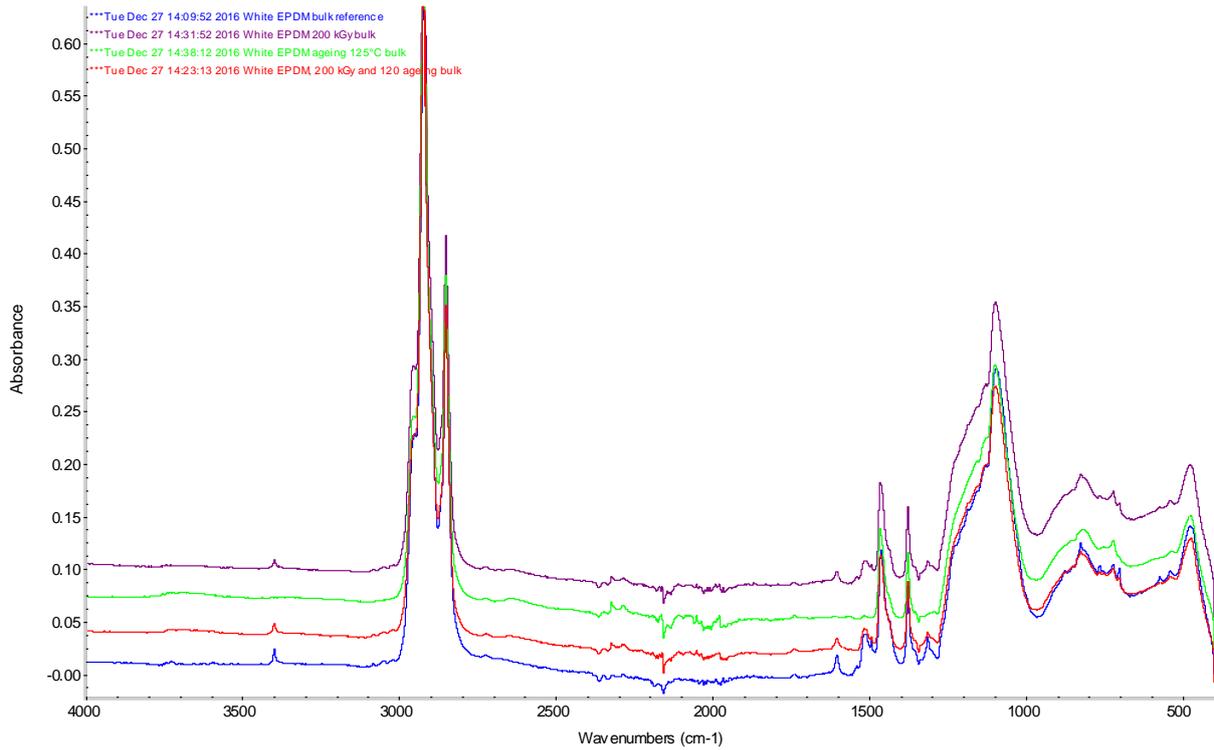
Figure 12: Spectra from the bulk material in samples before and after ageing.

In Figure 12 bulk spectra recorded from the aged and reference samples are compared. From the comparison it can be seen that the bulk material does not change significantly upon irradiation or ageing, which is along with the results obtained with ToF SIMS. All samples except for the sample which was only aged at 125°C showed a small absorption band at 1600 and 3400  $\text{cm}^{-1}$ . These absorption bands are also present on the spectra from the surface and probably origin from the sample preparation.

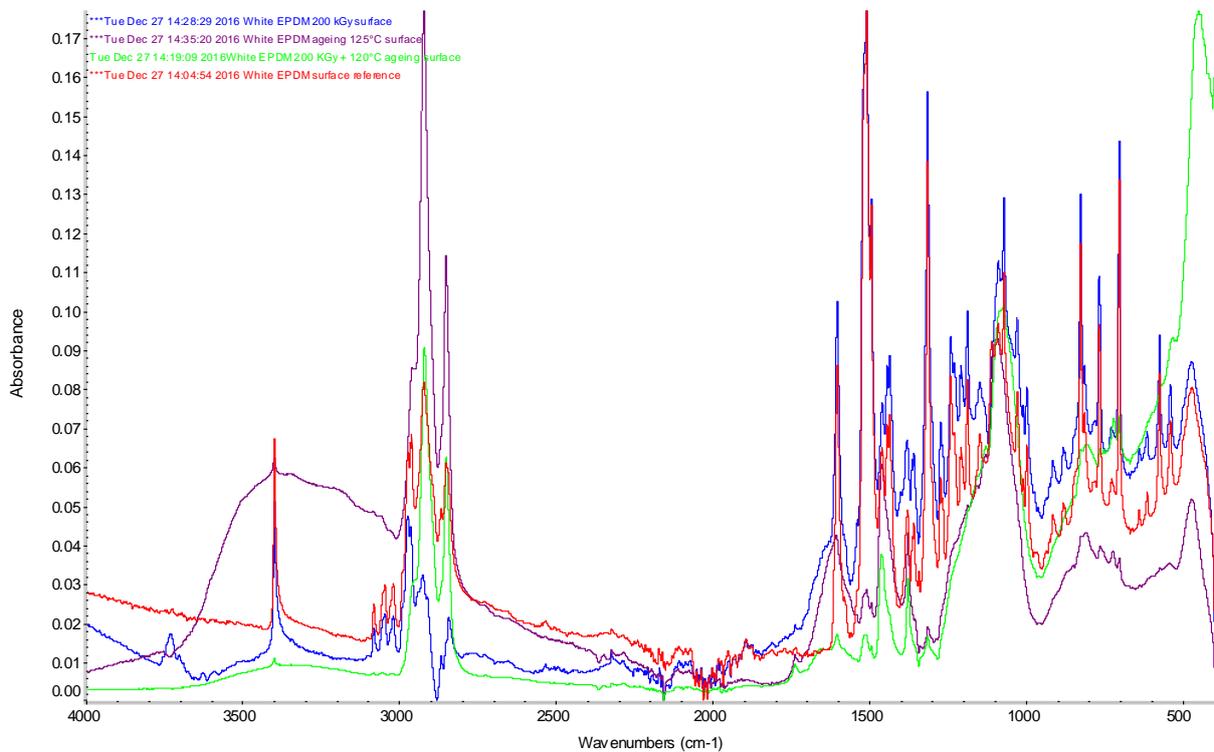
Figure 13: Spectra from the sample surfaces before and after ageing.

In Figure 13 the recorded surface spectra for reference and surface samples are shown. It seems that ageing conducted at elevated temperature has effect on the absorption bands between 500-1500  $\text{cm}^{-1}$  since they seem to disappear and the spectra becomes more similar to the bulk material. For the irradiated only sample the spectrum at these wavenumbers does not differ that much from the reference. The explanation is probably that a substance on the surface evaporates or decomposes at the elevated temperature. Another interesting observation is that only thermally aged sample shows a broad absorption band between ca. 3550-3000  $\text{cm}^{-1}$ . This is thought to be related to formation of OH-groups.

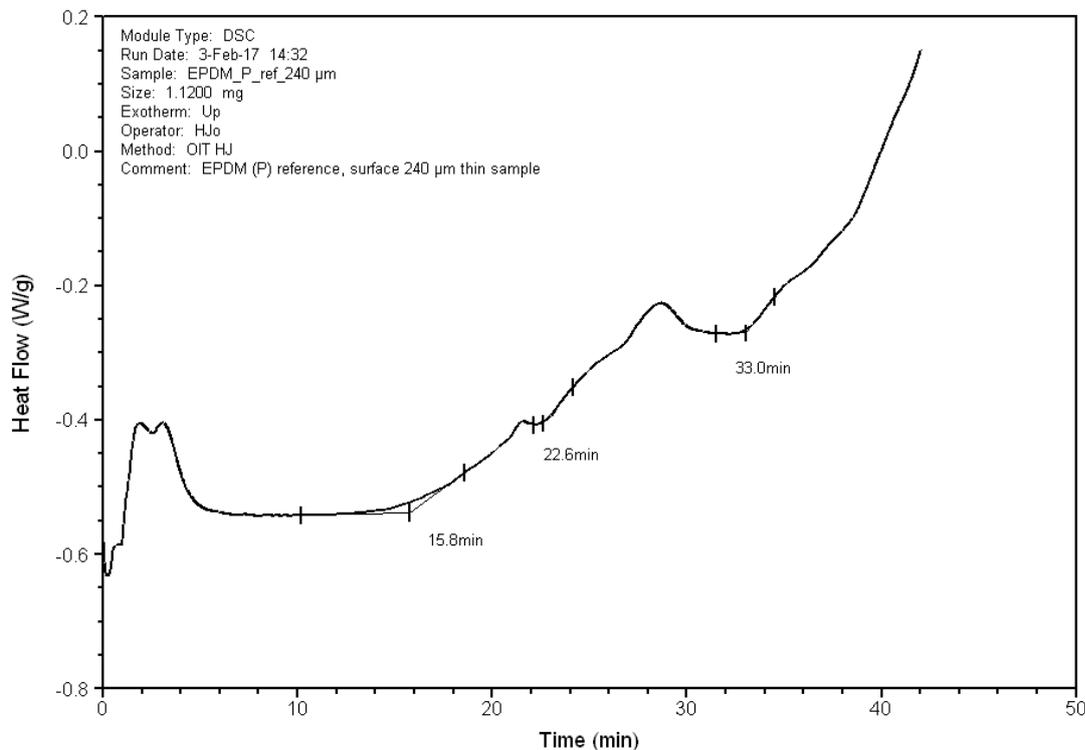
Figure 14: DSC thermogram for 240  $\mu\text{m}$  thick sample prepared from the surface of reference sample.

The results for the reference sample oxidation profile measurements are shown in Figures 14 and 15. The sample preparation became more challenging than expected. In Figure 14 the sample thickness was 240  $\mu\text{m}$  and in Figure 15, 700  $\mu\text{m}$ . The formed thermograms show exothermic peaks with different magnitudes at the corresponding induction times. Differences in the exothermic peaks hint that there are some differences in the compositions between the surface and bulk samples. In order to evaluate these difference in detail, the ingredients of the blend would be required. The OIT defined for the surface sample is about half the size than in the case of the bulk sample which indicates that more oxidation has occurred in the surface layers. During the sample preparation it was noted that repeatability in order to obtain samples of same sizes was challenging as well as preparing thin (i.e. < 200  $\mu\text{m}$ ) samples. Thus DSC analysis has a limited resolution when oxidation profile formation is considered, especially when compared to ToF SIMS analysis.

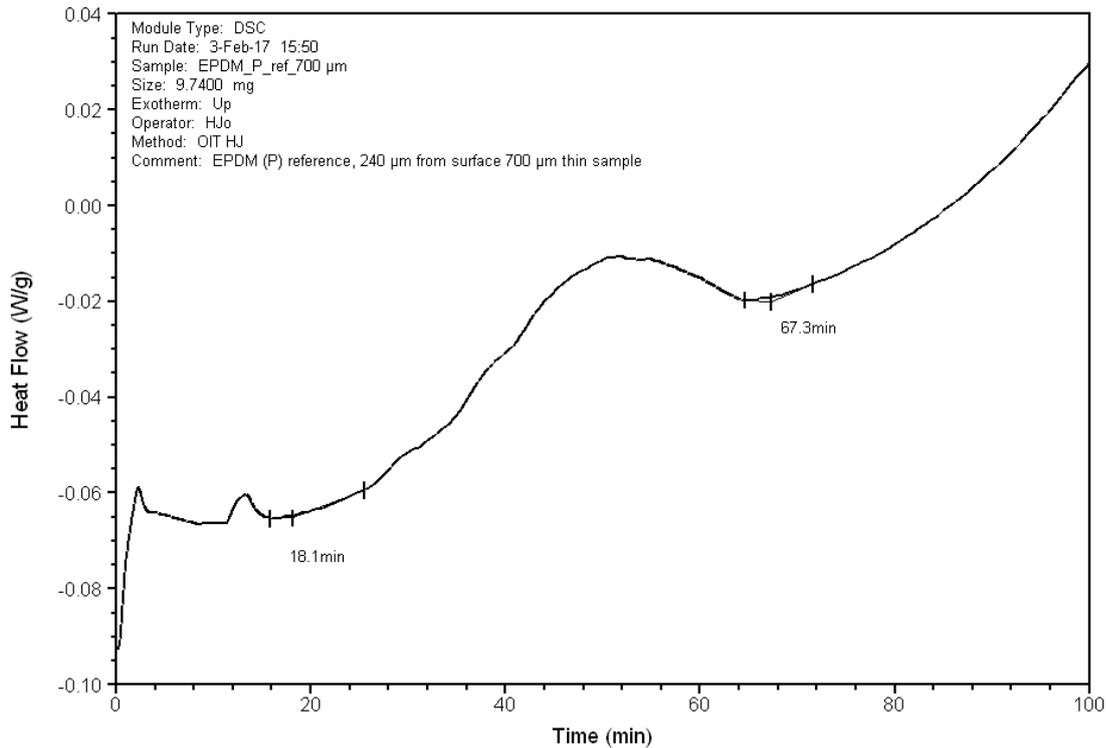
Figure 15: DSC thermogram for 700 μm thick sample prepared from 240 μm beneath the surface of reference sample.

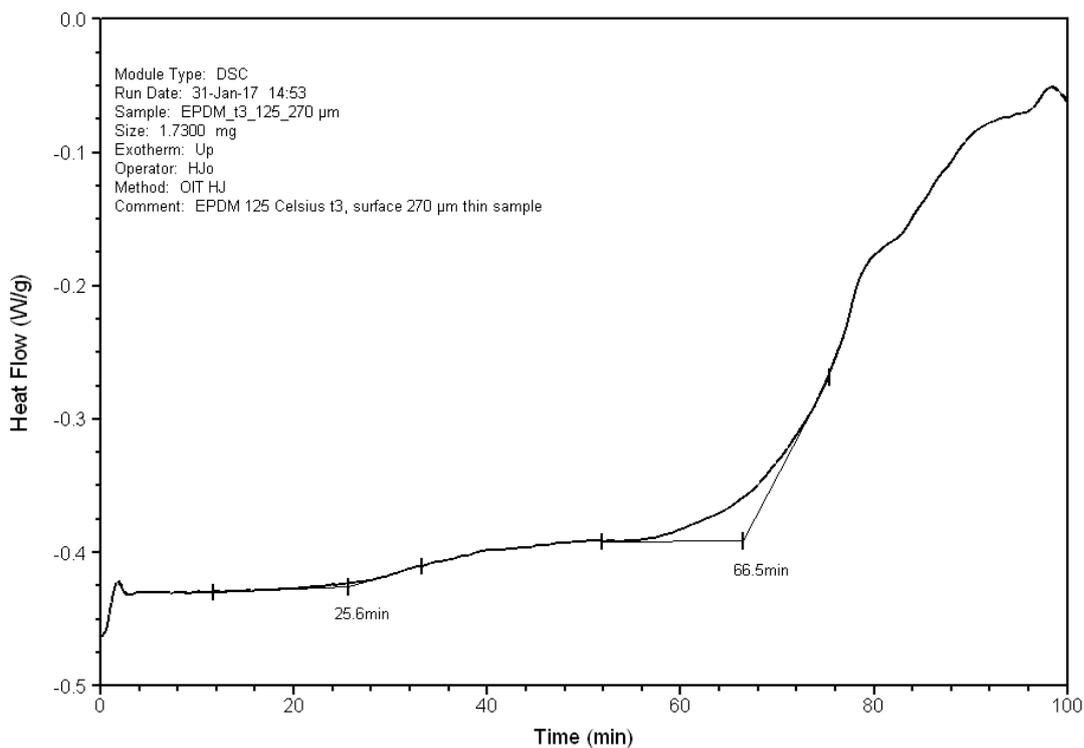
Figure 16: DSC thermogram for 270 μm thick sample prepared from the surface of sample aged at 125°C.

In Figures 16 (from surface up to 270 μm deep) and 17 (from 270 μm to 690 μm) DSC thermogram for samples that had been aged 125°C are shown. The two recorded spectra seem to be very similar to each other. Also the calculated OITs are close to each other. This would indicate that similar oxidation conditions are present up to 690 μm from surface.

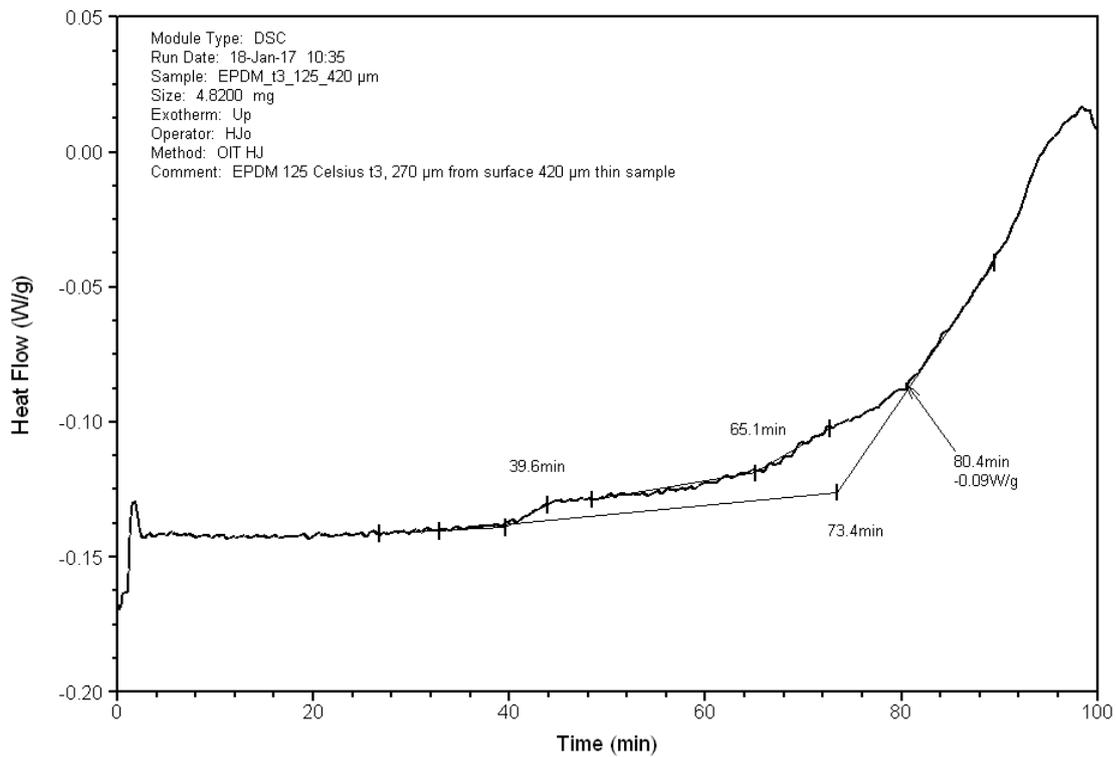
Figure 17: DSC thermograph for 420 μm thick sample prepared from 240 μm beneath the surface of the sample aged at 125°C.

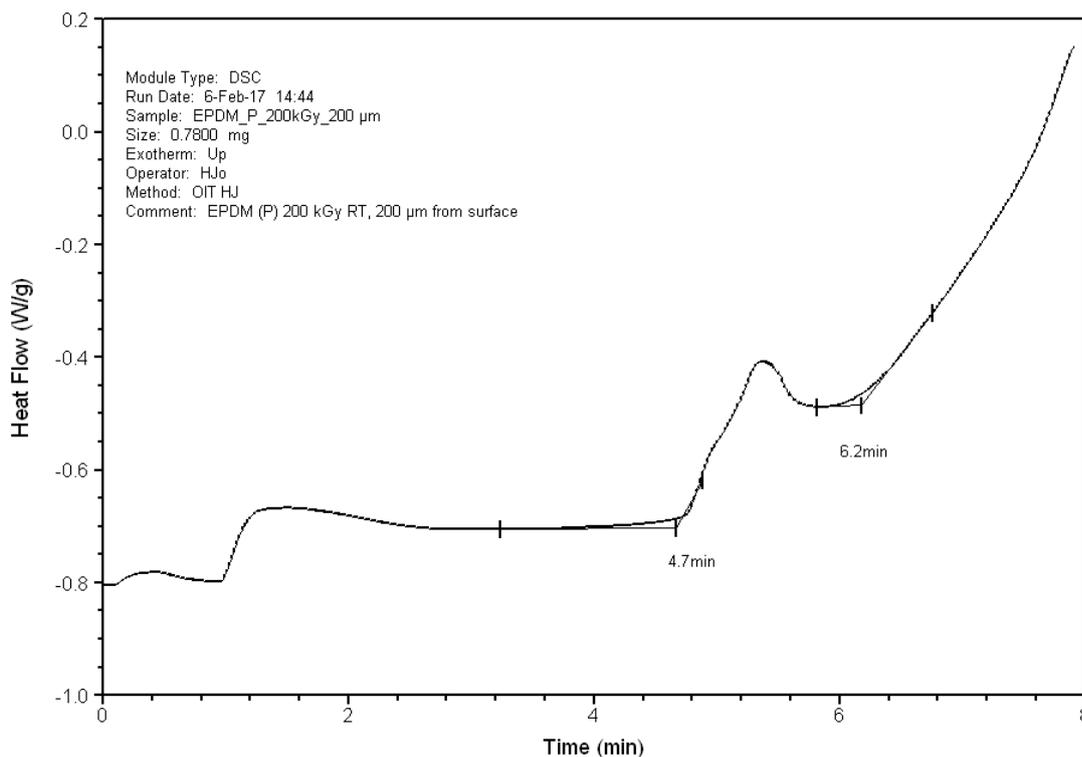
Figure 18: DSC thermograph for 200 μm thick sample prepared from the surface of sample irradiated with total dose of 228 kGy.

Figures 18 and 19 show the two thermograms measured for samples irradiated with dose of 228 kGy. The surface sample (200 μm thick) in Figure 18 has clearly different thermogram than the sample analysed beneath it (200-610 μm). OITs differ by a factor of five.

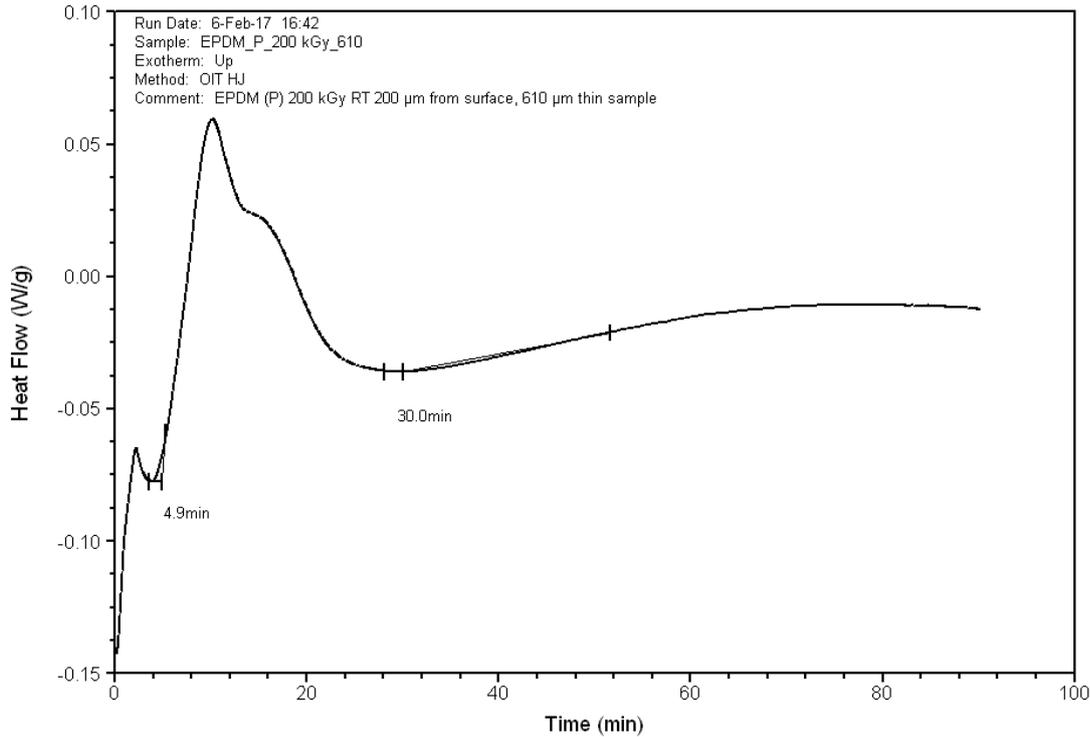
Figure 19: DSC thermograph for 410 μm thick sample prepared from 200 μm beneath the surface of the sample irradiated with total dose of 228 kGy.

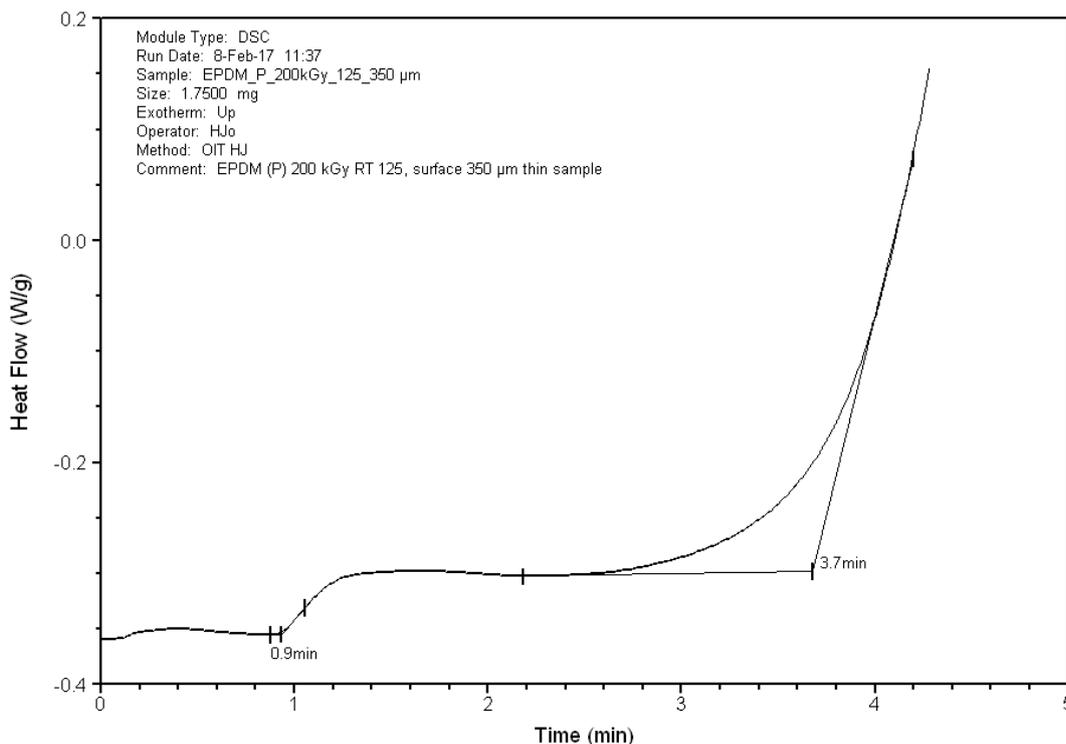
Figure 20: DSC thermograph for 350 μm thick sample prepared from the surface of sample irradiated with total dose of 228 kGy and thermally aged at 125°C.

In Figures 20-22 DSC thermograms for samples irradiated and thermally aged are shown. The measured spectra are similar in shape and the OITs are also similar independent from the sample distance from the surface. This is the reason why third sample was analysed deeper in the material. It seems that in this ageing condition samples are aged similarly up to distance of 1450 μm.

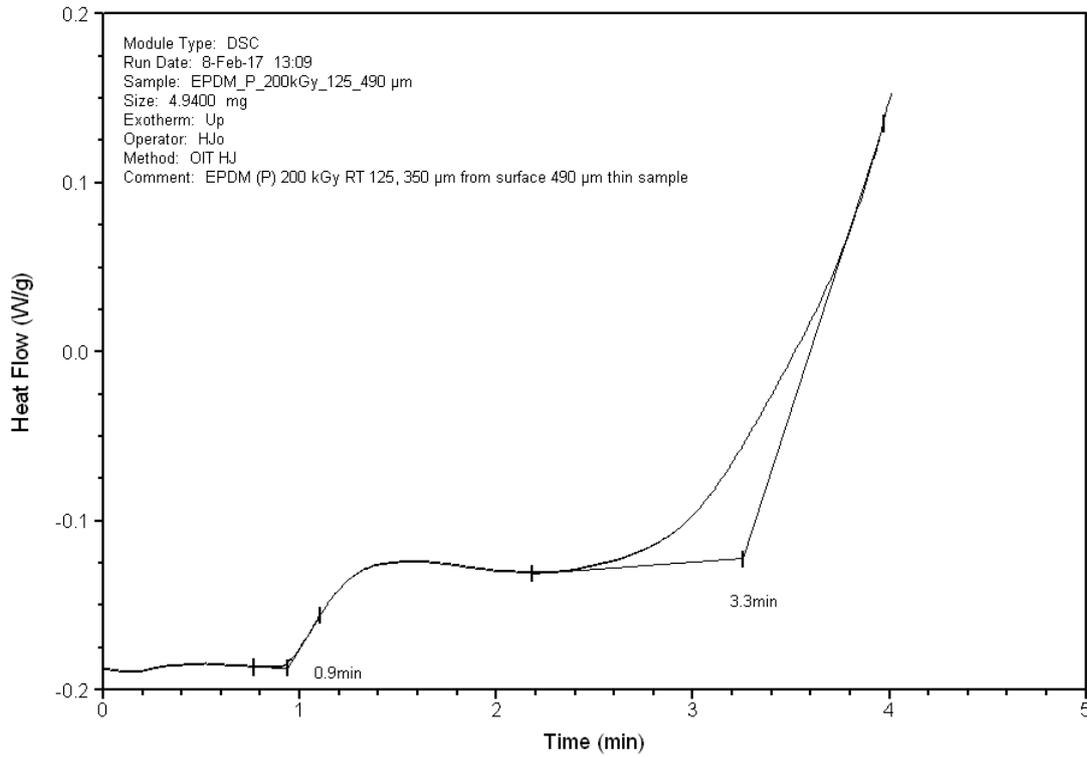
Figure 21: DSC thermograph for 490 μm thick sample prepared from 350 μm beneath the surface of the sample irradiated with total dose of 228 kGy and thermally aged at 125°C.

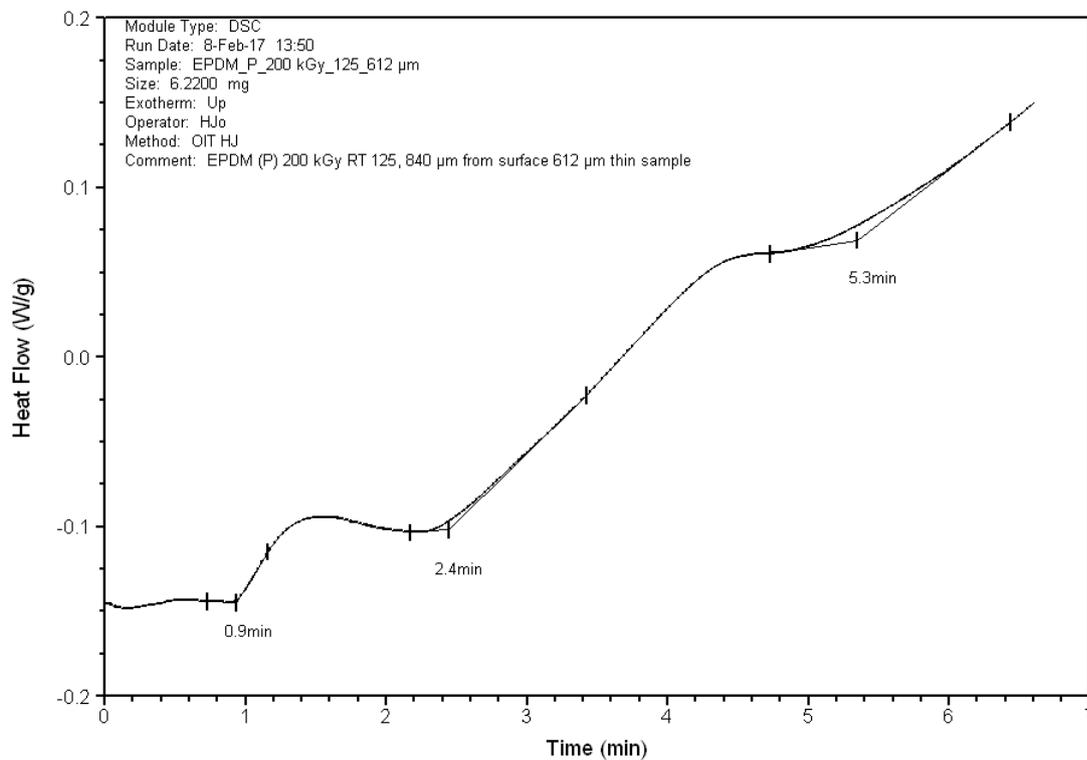
Figure 22: DSC thermograph for 612 μm thick sample prepared from 840 μm beneath the surface of the sample irradiated with total dose of 228 kGy and thermally aged at 125°C.
