KME711

Combating superheater corrosion by new materials and testing procedures - Corrosion experiments in the waste fired CFB boiler P15 at Händelö

KME720

The effect of increased fractions of waste wood on water wall- and superheater corrosion - Combating corrosion by new materials and improved material selection

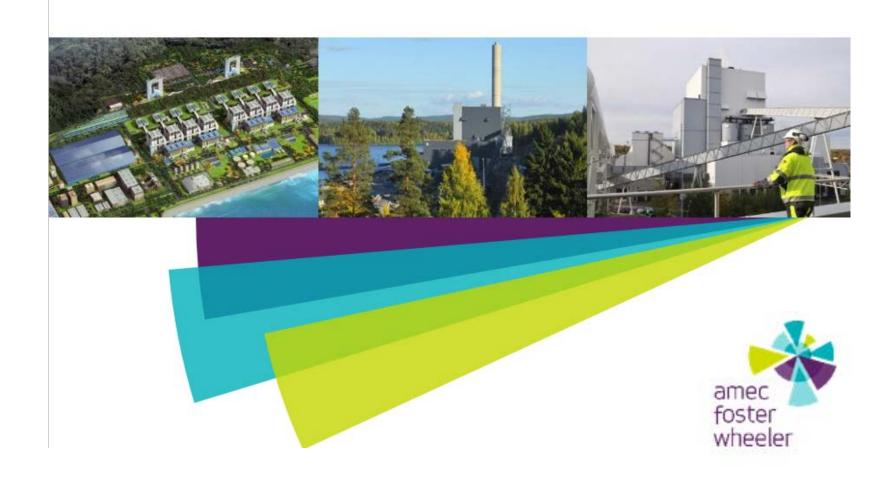
In-situ corrosion probe

Introduction in-situ corrosion probe

- Online corrosion probe (MECO[™]) system
 - Based on LPR (Linear Polarization Resistance) method
 - Three measurement electrodes, electrically connected to the measuring circuit. Ceramic insulation between the measurement electrodes.
 - W1, test material 1
 - R, reference electrode, same material as W1 or W2.
 - W2, test material 2
