KME 715 – Composite Metal Polymer (CMP) for non-stick improvements in CHP plants

Rikard Norling, Swerea KIMAB

Background – deposits on boiler components

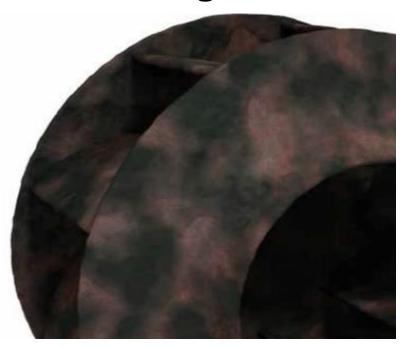
Background – use of the dual non-stick layer at low temperature – flue gas recirculating fan

Fan needed cleaning every week

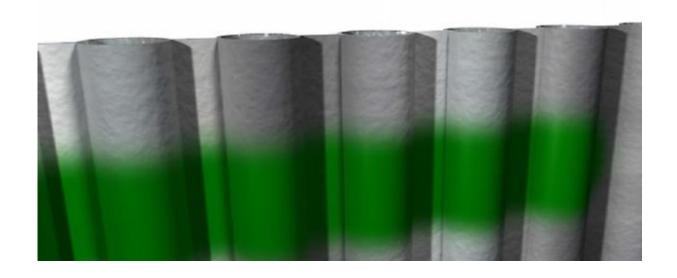
Background – Application of the layer

- A Ni-base material is applied to the C-steel (grey)
- On top of this layer, the non-stick material is deposited (green)

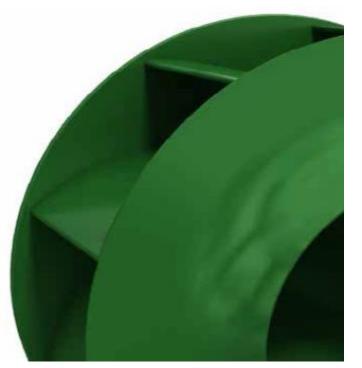
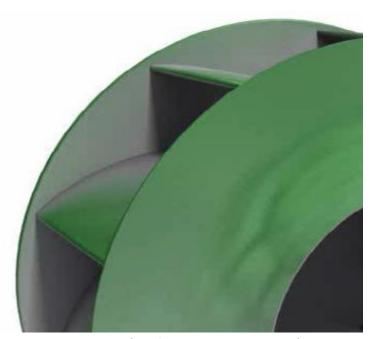
Background – use of the dual non-stick layer at low temperature – flue gas recirculating fan

- Ni-base and non-stick material were applied (left schematic)
- After one firing season, no cleaning had been needed (right schematic)
- Apparently, some non-stick material was still left

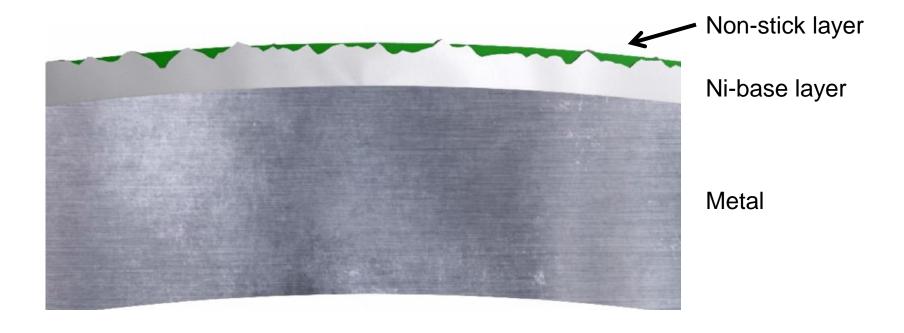
Background – schematic of non-stick layer after use

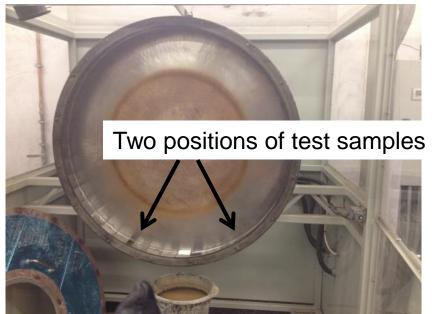
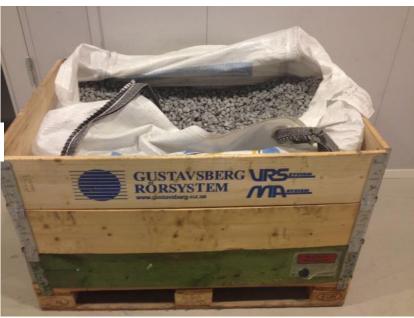
Wear tests

- Samples are attached to the inner circumference of the test apparatus
- Exposure of maximum 48 samples simultaneously

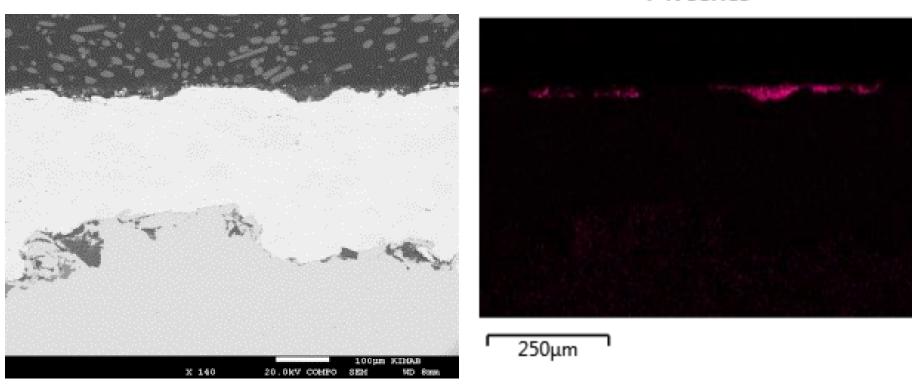
PTFE still adherent after 10 h heavy wear test

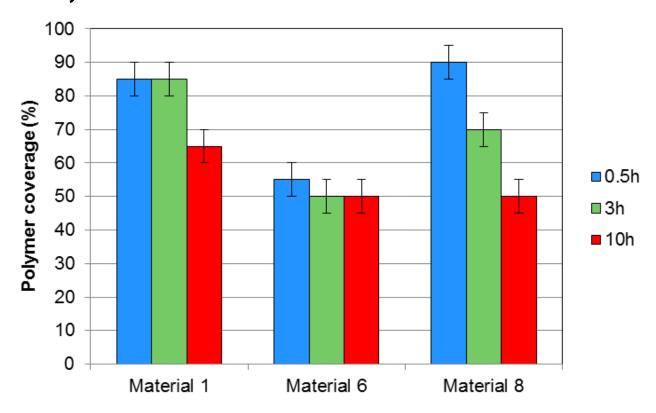
Results, Wear tests

- Material 1 PTFE
- Material 6 PTFE mix
- Material 8 Silicone

Predicted and real wear behaviour almost identical

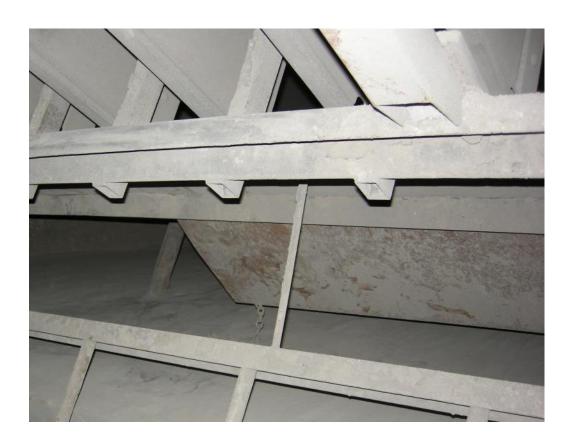
Samples mounted in ESP after exposure for 1 firing season

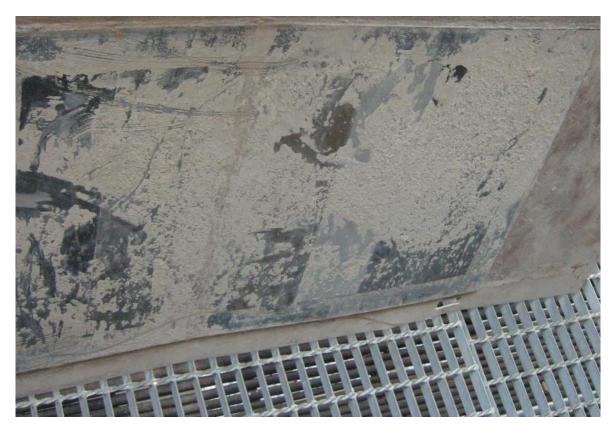
Removed ESP samples after exposure for 1 firing season

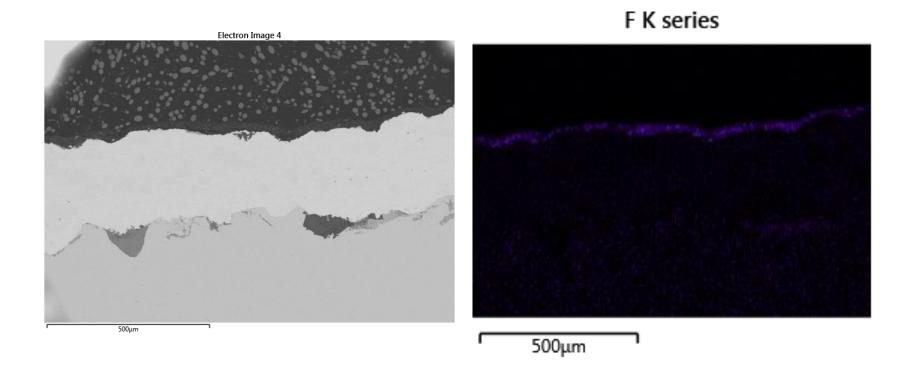
• ESP sample, Material 1 (PTFE), after exposure for 1 firing season
