# Workshop: Energiföretagens materialrelaterade problem och utmaningar i kraftvärmeanläggningar, KME

**KME 715 –  
Composite Metal Polymer (CMP) for non-stick  
improvements in CHP plants**

# **Boiler corrosion at lower temperatures – influence of lead, zinc and chlorides**

# **High temperature corrosion in used-wood fired boilers – fuel additives and coatings**

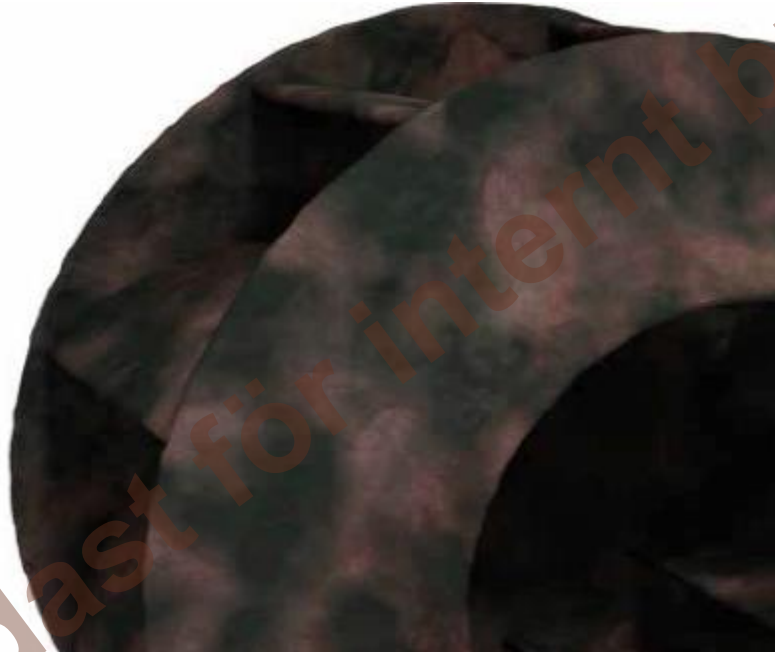
# Background – use of the dual non-stick layer at low temperature – flue gas recirculating fan

- Fan needed cleaning every week

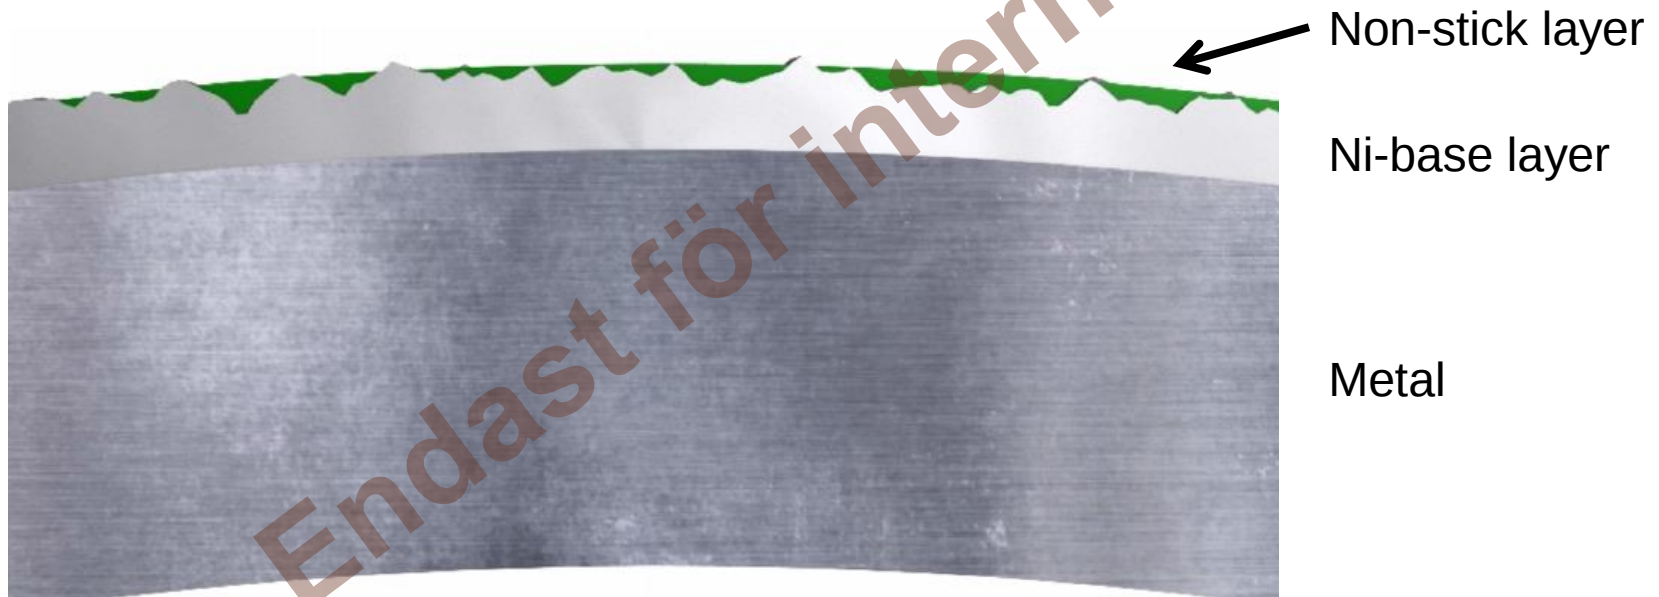
# Background – schematic of non-stick layer after use

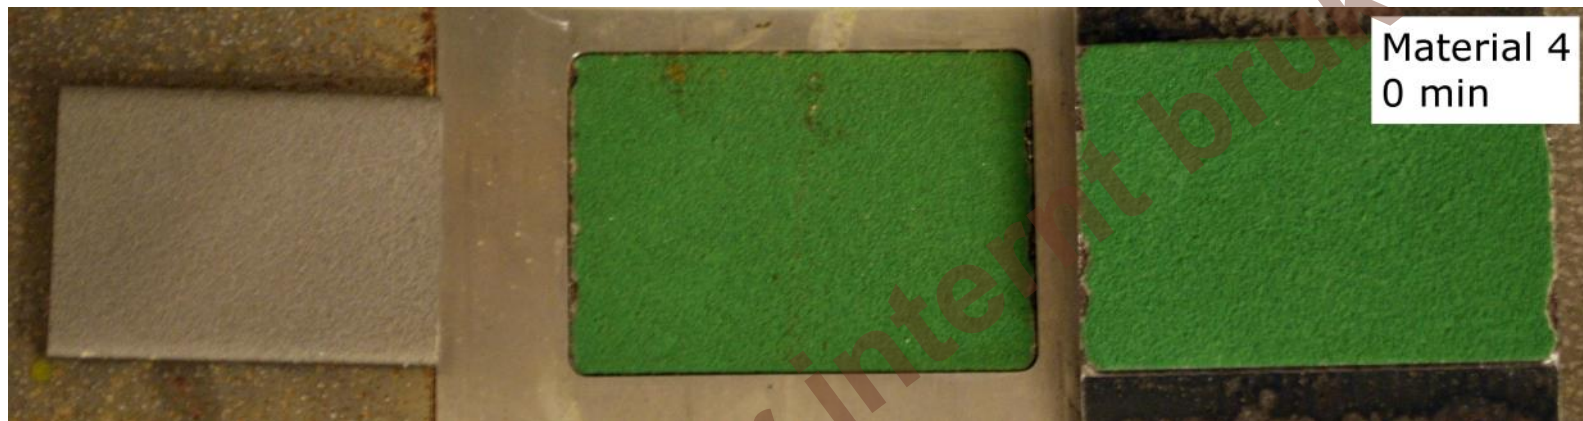
# Results, Material 4 (BN-silicate)

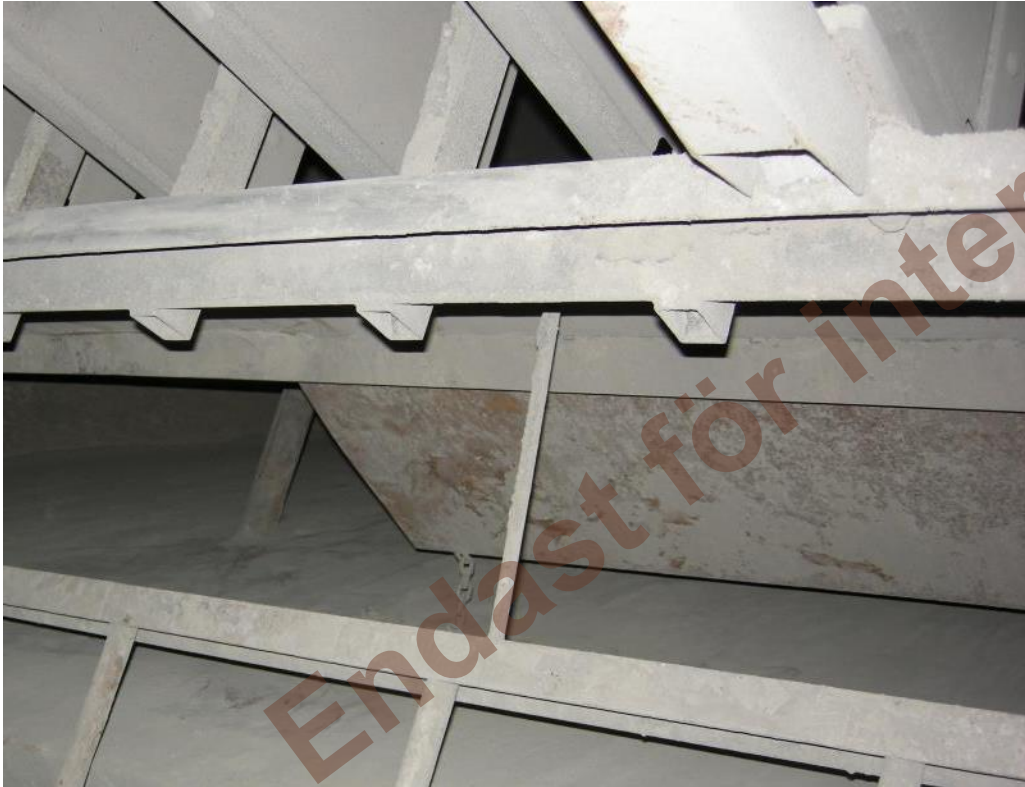
- Samples mounted in ESP after exposure for 1 firing season

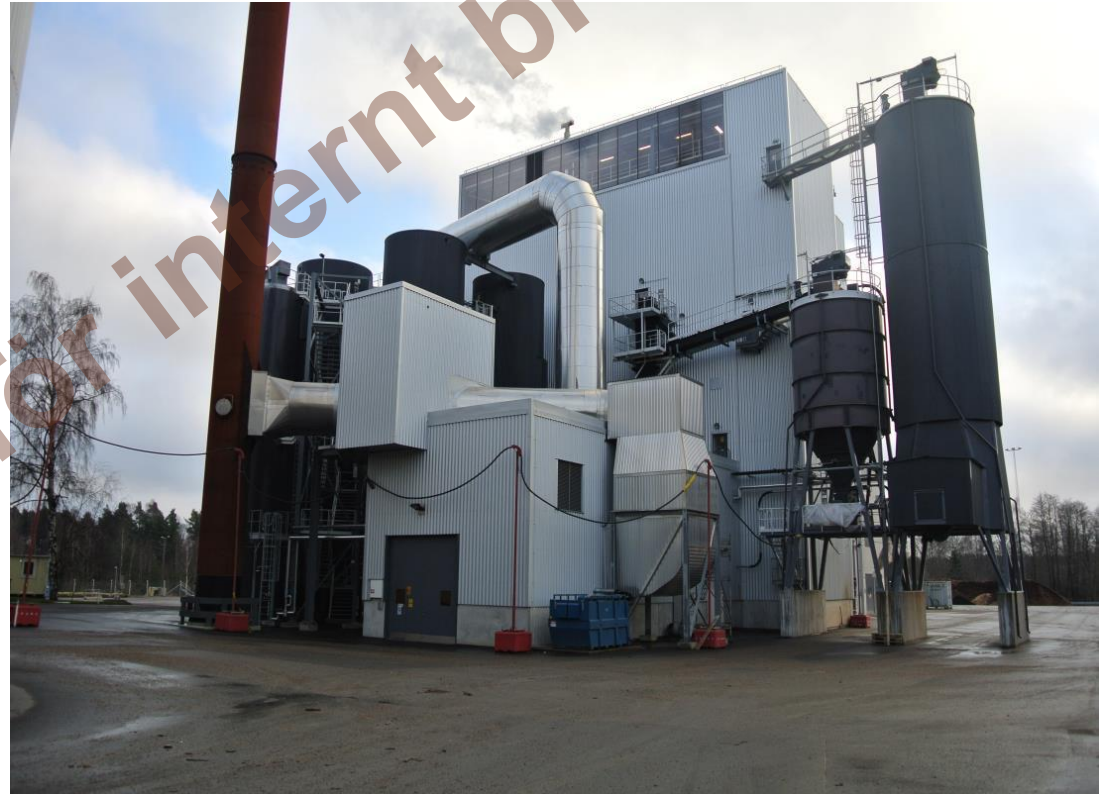
- BFB boiler
- Commissioned 2010
- 63 MW<sub>th</sub>, 20 MW<sub>el</sub>
- Steam data: 80 bar, 470°C
- Fuel 100% recycled (waste) wood
- ChlorOut (system with ammonium sulphate additive)
