**Eldstadskorrosion – Hur forskning löste problemet**

# IDBÄCKEN LINE 3 (CHP) IN NYKÖPING

# FOREST FUEL TO WASTE WOOD INCREASES THE CORROSION ON THE FURNACE WALL

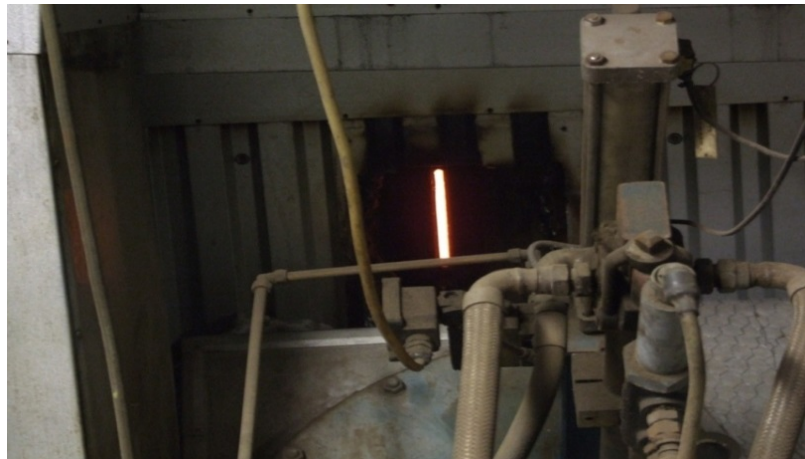
Vattenfall's in-house probe. Sits between the tubes in the furnace wall. 4 specimens on each probe. Thermocouple in each specimen for individual temperature measurement. Control temp 350 and 400°C

2-week tests

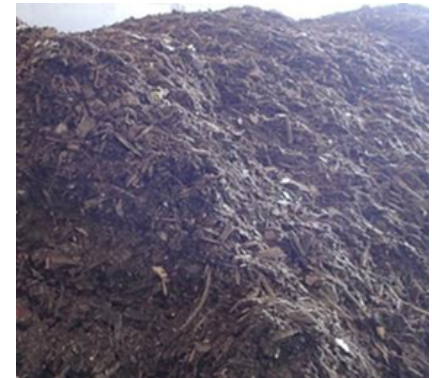
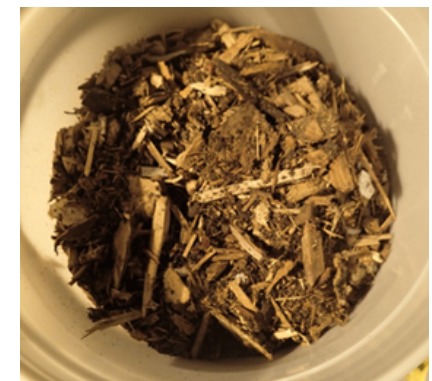
## Co-firing Used wood no.2 with sludge – furnace wall corrosion

Furnace wall corrosion can be reduced by careful control of used wood composition and mixing high Cl/Pb used wood with sludge

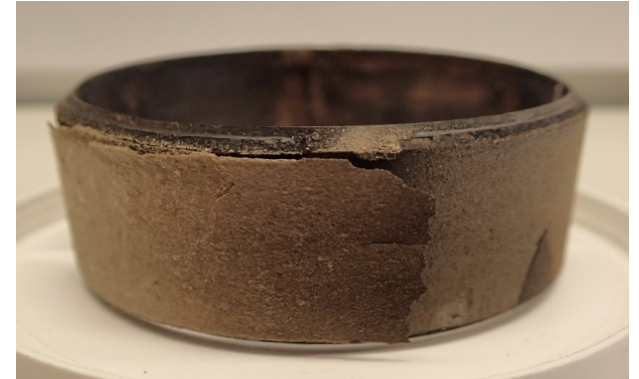
## Vattenfall's deposit probe testing in SH region. UW1 and 2

Air cooled probe – 3 hour tests. ChlorOut shut off

Three rings at temperatures 350, 450, 550°C  
(equivalent to steam temp ~520°C)

- Weigh ring before and after exposure for deposit growth rates.
- Analyse deposit with SEM for information on corrosion risk
