# Oskarshamn

## Unit 3

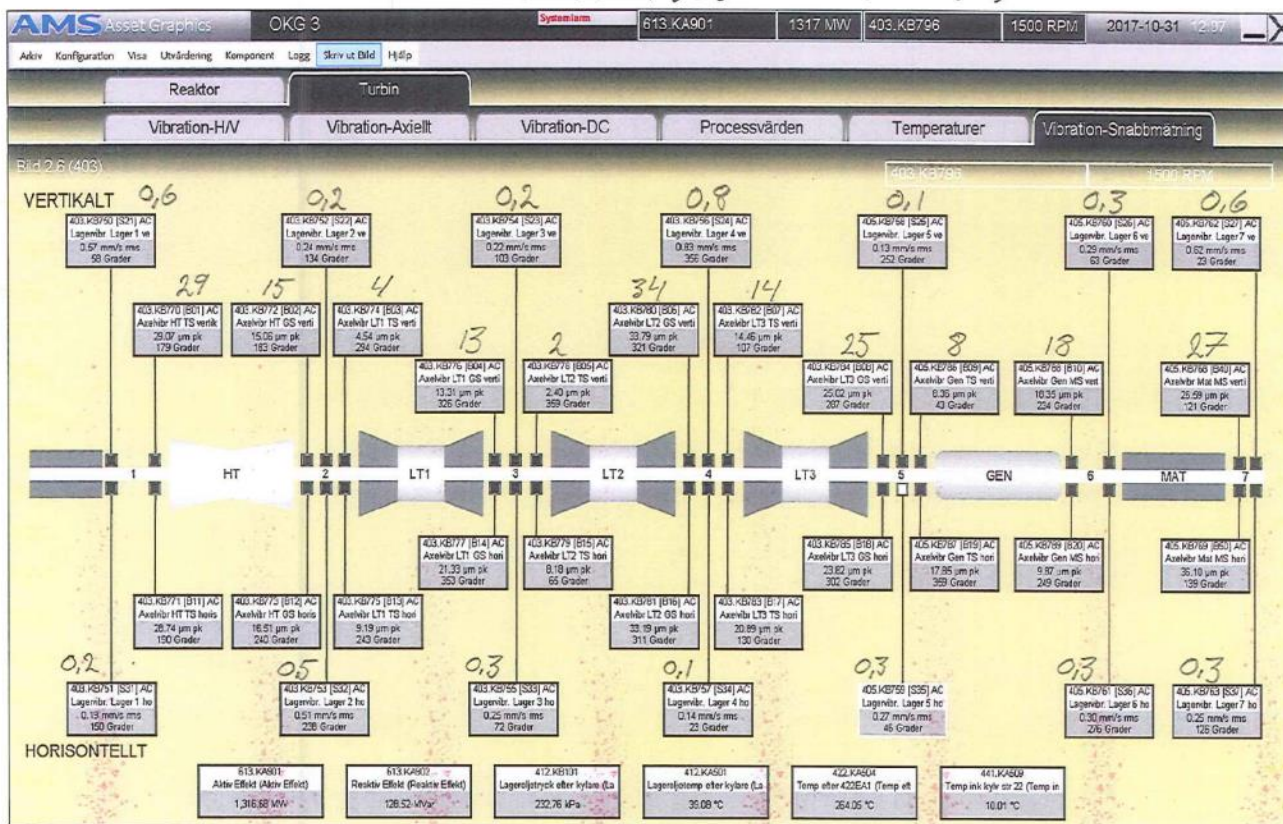
Tot. vibr. 1305 MW (120%)

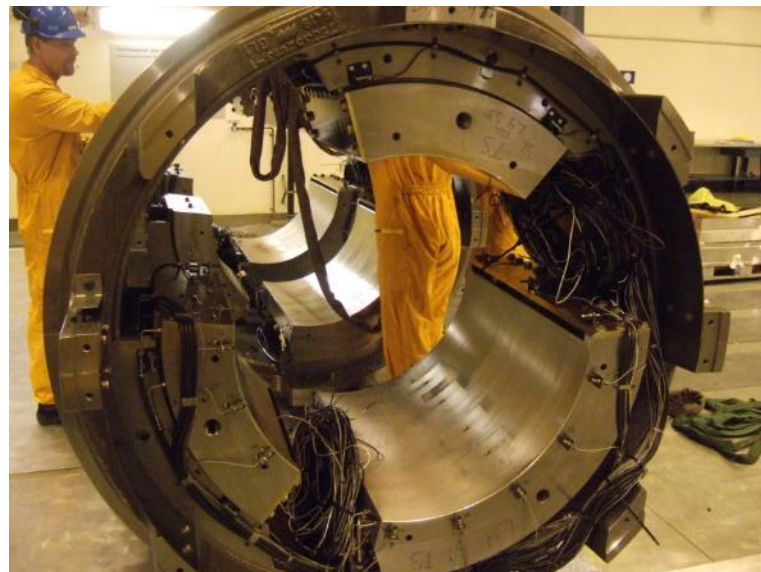
- Vibration comes exclusively from 1xn
- Over all level very low – bearing vibration in principal below 0,5 mm/s
- As usually vibration level for bearing 4 above the other one – that will most likely decrease at full power (129,1%)
- No cyclic vibration – so far

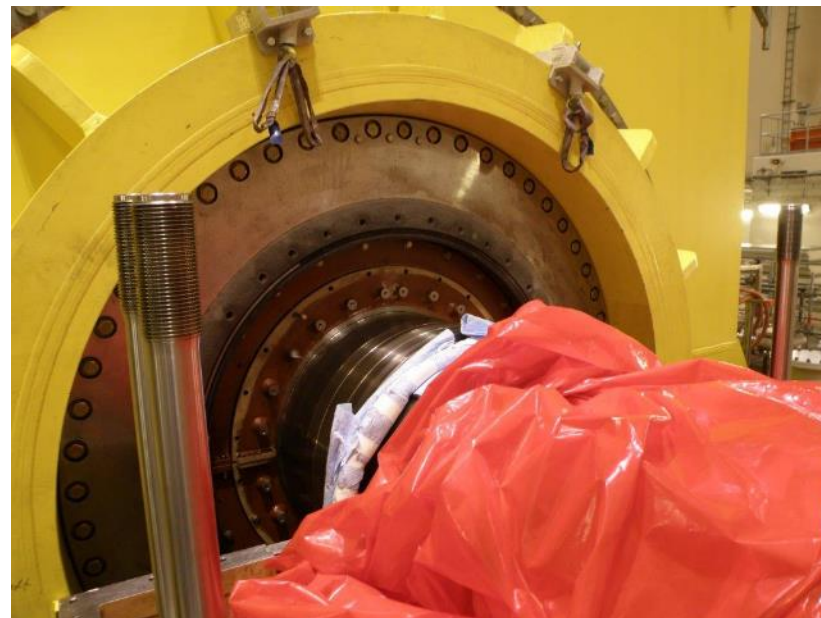
## Unit 3 - cyclic vibration

- Most likely cyclic vibration comes from H2 sealing system
- Usually appears after some process change – like pump shifts

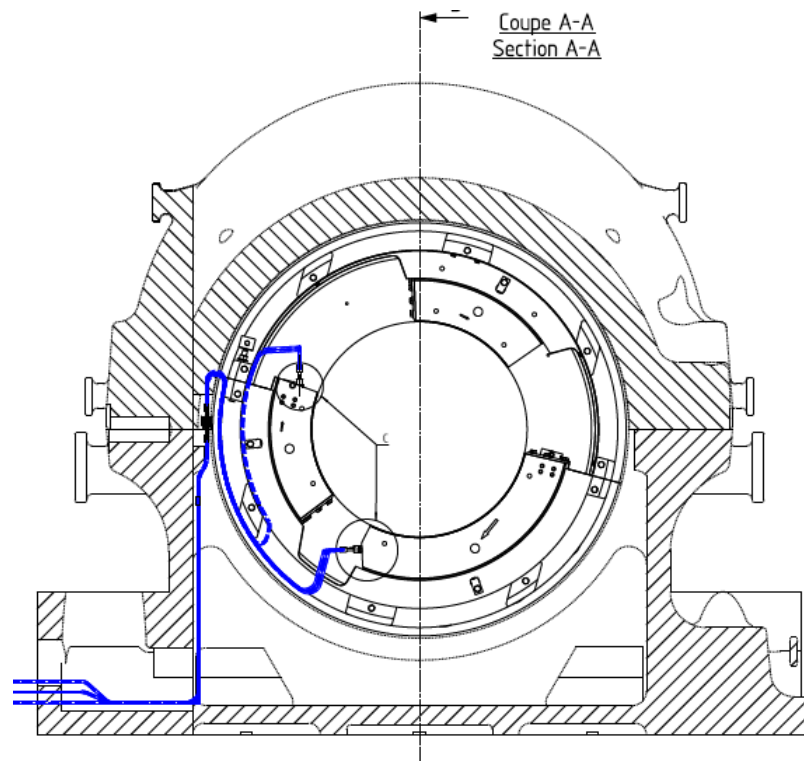
Unit 3 – 3 S(egment) Bearing  
Bearing 1 and 7 OEM – Bearing 2  
and 6 Retrofitted 2009
