KME-708/718 High temperature corrosion in used-wood fired boilers – fuel additives and coatings

Annika Talus & Rikard Norling

Background

Projects goals – KME 718

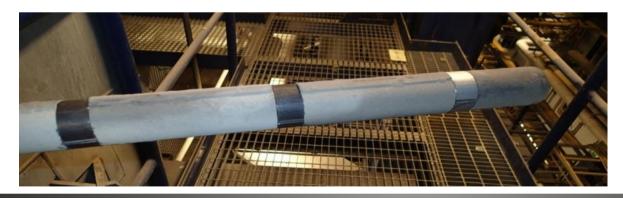
DEPOSIT PROBE TESTING IN SUPERHEATER REGION

- 3 h exposure
- Superheater deposit probe. 3 hour test, 350,450,550°C
- Material: 2216 (350 and 450 °C) and 2352 (550 °C)

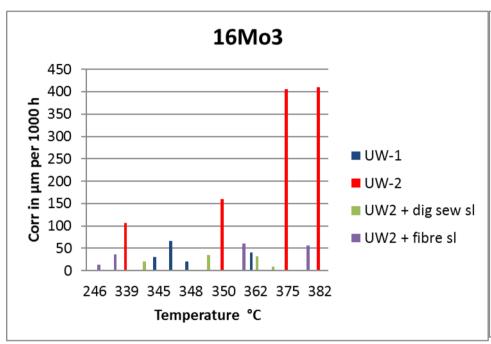
16Mo3 - uncoated tube steel

Corrosion rate and temperature. 2 week tests ~330h. Av. temp for every test piece

UW-2 is very corrosive and corrosion rate increases rapidly with temperature.
UW-1 and UW-2 plus sludge show lower corrosion rates

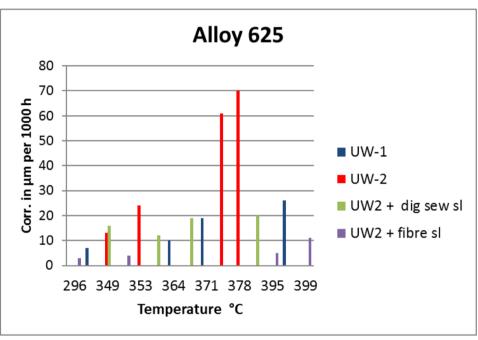
Alloy 625 - Ni-base alloy coating material – note scale 0-80µm

UW-2 is more corrosive esp. at higher temps (above 370°C) UW-1 and UW-2 plus sludge show lower corrosion rates.

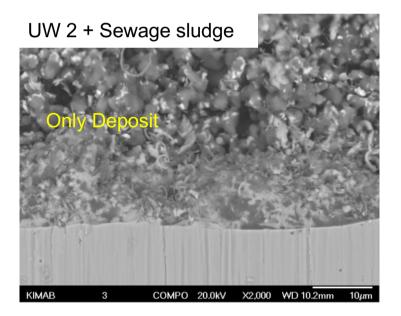
Furnace wall corrosion-probes

Alloy 625

350 °C

In general more corrosion for Alloy 625 sample with more aggresive fuel

Local corrosion with Ni, Cr- oxide as corrosion products

No/very little corrosion with sludge

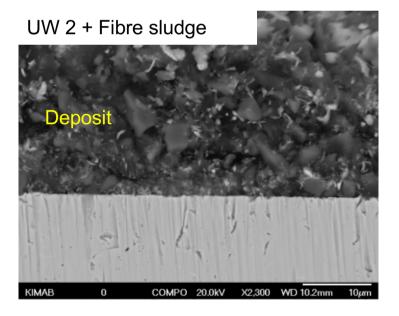
Furnace wall corrosion-probes

Alloy 625

350 °C

In general more corrosion for Alloy 625 sample with more aggresive fuel

Local corrosion with Ni, Cr- oxide as corrosion products

No/very little corrosion with sludge

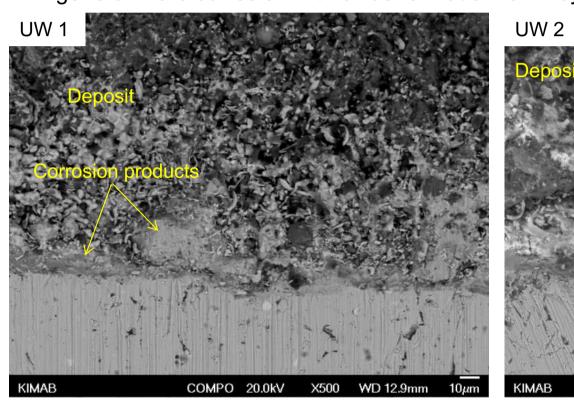
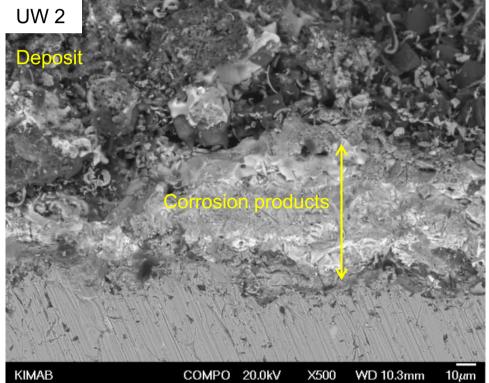
Furnace wall corrosion-probes

Alloy 625

400 °C

In general more corrosion with oxide formation for Alloy 625 sample with more aggresive fuel

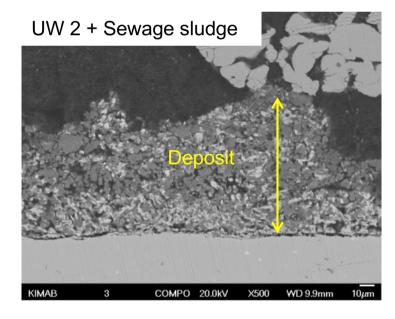
Furnace wall corrosion-probes

Alloy 625

400 °C

Local corrosion with Ni, Cr- oxide and lead molybdate

(UW2) as corrosion products

No/Very little corrosion

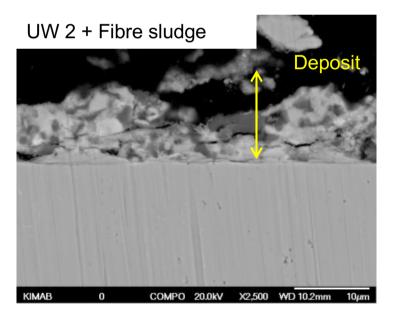
Furnace wall corrosion-probes

Alloy 625

400 °C

Local corrosion with Ni, Cr- oxide and lead molybdate (UW2) as corrosion products

No/Very little corrosion

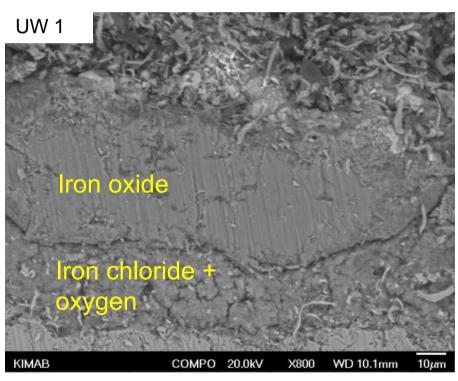
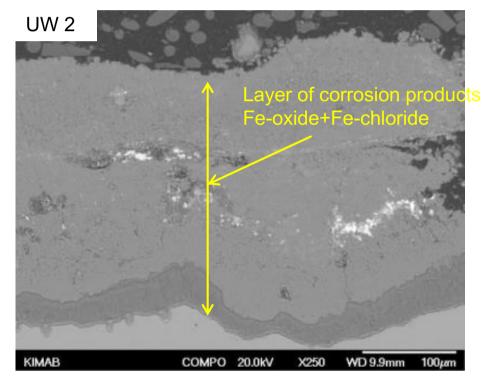
Furnace wall corrosion-probes

16Mo3 350 °C

Thicker layer of corrosion products for UW2

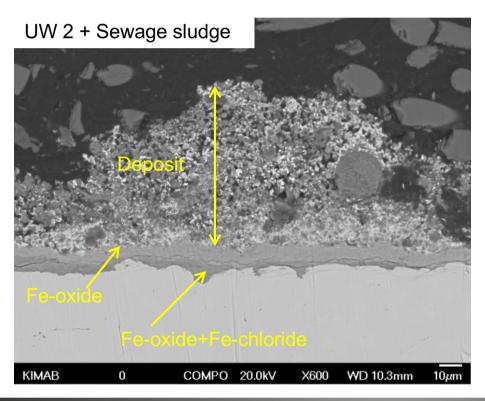
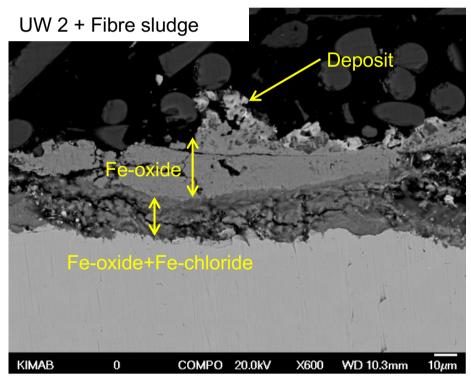
Furnace wall corrosion-probes

16Mo3 350 °C

Good results are observed when co-firing sludges

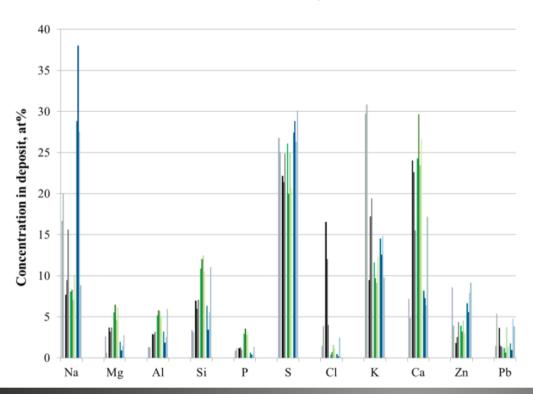
Results- deposit analyses

- Less alkali chlorides in deposits
- Instead higher amount of
 - CaSO₄, Na/KSO₄, Alkali-aluminasilicates
 - Found for both sludges but different amounts

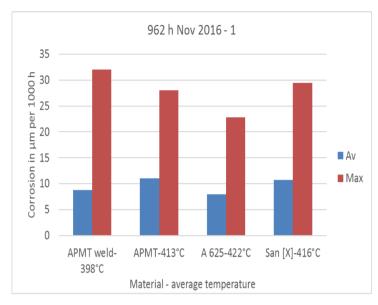
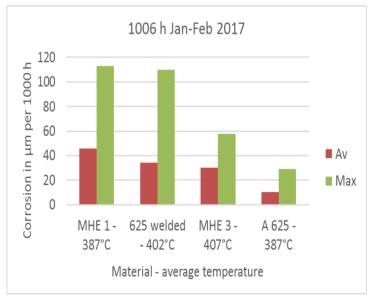
Results from Idbäcken

- Solid material (A625) performed better than welded.
- Welded A625, MHE1 and MHE3 showed similar results (20-45µm per 1000h)
- Solid San[X] similar to solid A625
- Welded FeCrAl model-alloys performed very well (less than 20µm per 1000h)

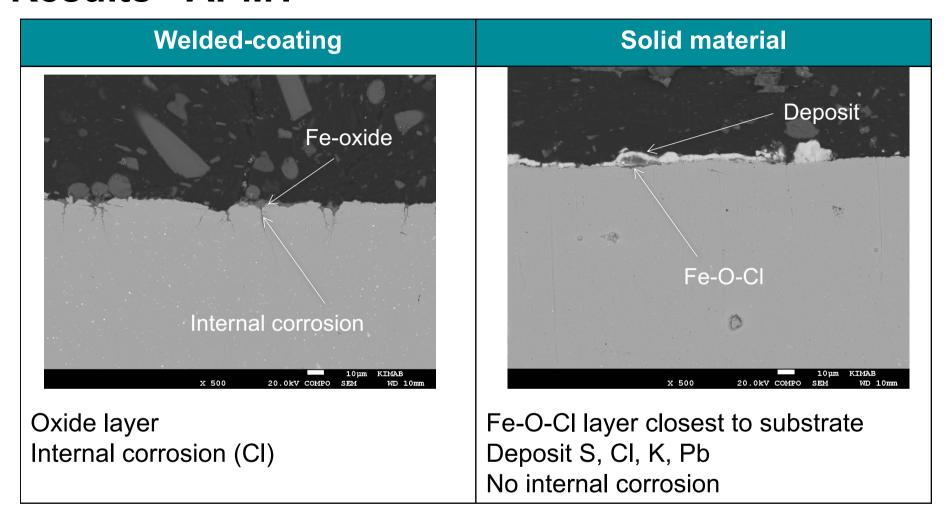
Results - APMT

Maximum propagation of internal corrosion and Cl: 40µm

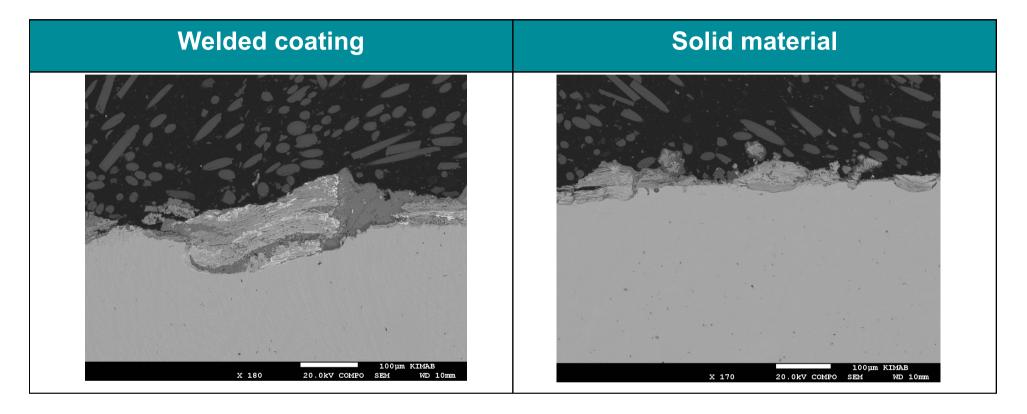
Results - Alloy 625

- Thickness uneven over sample
 - Average thickness for weld higher than solid material
- High amounts of Cl, K and Pb mixed in oxide/deposit
