# HIGH TEMPERATURE CORROSION IN USED-WOOD FIRED BOILERS – FUEL ADDITIVES AND COATINGS

# **High temperature corrosion in used-wood fired boilers**

Fuel additives and coatings

ISBN 978-91-7673- 096-6 | © 2018 ENERGIFORSK

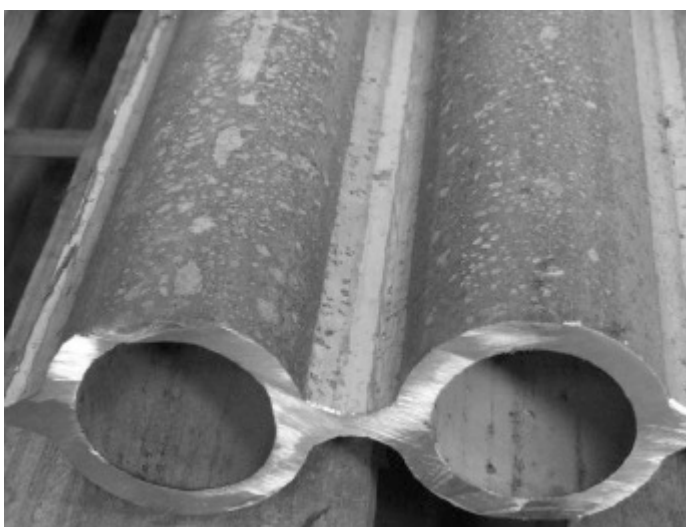
Figure 1. Photograph of part of a furnace wall before being installed in a boiler.

A part of the boiler which is subjected to a high corrosion risk is the furnace wall. The furnace wall, or so-called waterwall, is formed of tubes welded together, separated by a fin (see Fig. 1). The tubes contain pressurised water before it separates into steam and are usually made of carbon steel or low alloy steel, due to the low price, low stress corrosion cracking risk, high heat transfer properties and low thermal expansion of this steel. These materials has however been shown to be sensitive to corrosion.

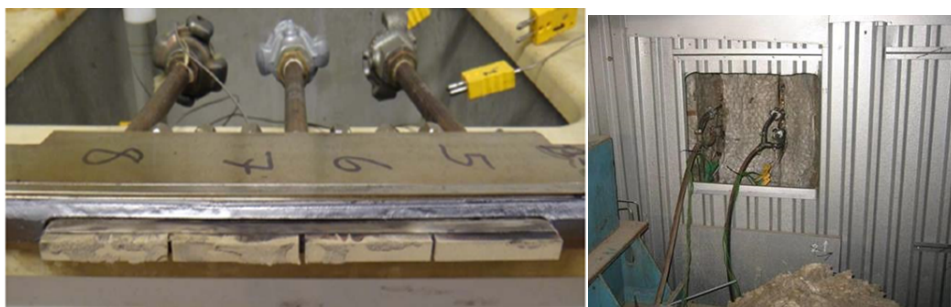
**Figure 4.** Vattenfall's wall probe after exposure (left). The probes sit vertically in a slit in the fin between two tubes, here seen from outside the furnace, (right).

Long-term material corrosion testing and fuel quality testing in the furnace region was performed with two air-cooled probes, each containing four specimens which were exposed simultaneously in the furnace region of the Idbäcken power plant. These two probes were separated by a distance of 30 cm and were positioned on the back wall at a height of 16 m. The wall probes, which were designed and built by Vattenfall Research and Development are long and thin (as can be seen in Fig. 4.) and were inserted vertically into slits made in the fins between two tubes. The probes each contained four specimens, placed vertically under each other. The specimens were of dimensions 48 mm length, 7 mm width and 6 mm thickness. The temperature was measured by a thermocouple placed centrally at the back of each specimen and normally controlled to 350 °C or 400 °C, depending on the type of test. 400 °C approximately simulates the temperature of the tube wall at 140 bar (the design pressure of the plant) and 350 °C the temperature of the tube wall at a reduced pressure of 90 bar, assuming a difference between the surface temperature and the steam of approximately 50-60 °C. For long term coating corrosion testing the total exposure time at temperature was about 1000 hours (6 weeks) and for sludge testing the exposure time was 330 h (2 weeks).

Before exposure in the boiler, the thickness of each specimen was measured with a micrometer at four equally spaced distances along the centre line. After testing, the specimens were cut at the measuring positions. (One cut, near the top, was made without water and that part of the specimen was reserved for further analysis in a scanning electron microscope). Four remaining parts of each sample were mounted in resin and used for metal thickness measurement by light optical microscope with a micrometer measuring gauge. A total of 20 points were measured after testing.
