SULFUR RECIRCULATION AND IMPROVED MATERIAL SELECTION FOR HIGH TEMPERATURE CORROSION ABATEMENT

RAPPORT 2018:531

Investigating different aspects of corrosion memory

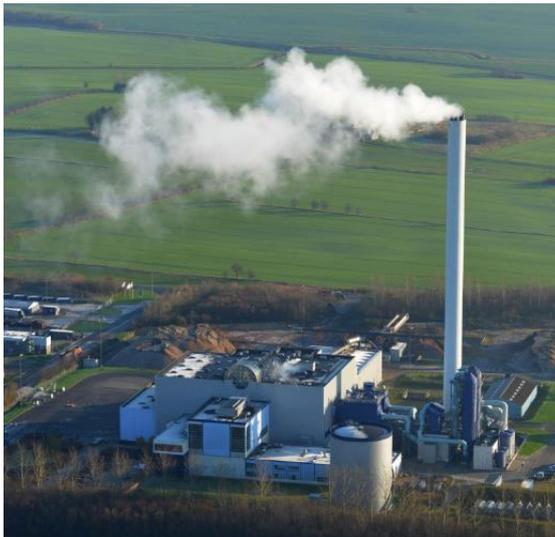
Figure 3. Maabjergværket biomass and waste fired power plant

The plant consists of two waste fired boilers with a waste capacity of 2 * 11 metric tons/h and a Straw-/woodchips boiler firing 8/7 t/h. 180.000 t/year of household and industrial waste is treated in the waste lines together with 10.000 t/year of sludge. 26.000 t/year wood chips and 34.000 t/year of straw are fired in the third line.

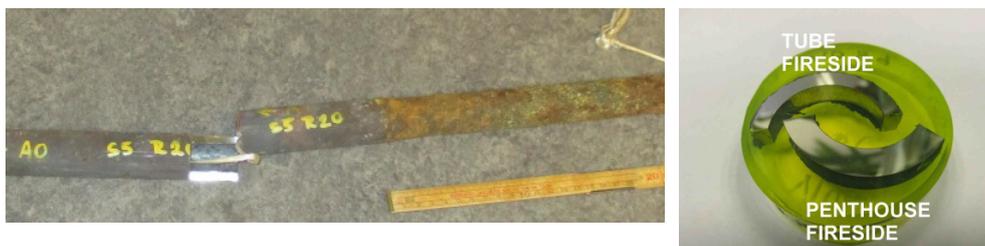
Figure 11: Tube examined for TP347H FG where section consists of both penthouse exposure and boiler exposure

A tube from boiler F (see Table 2) was investigated where tubes had been removed consisting of both the exposed tubes from the boiler and a section from the penthouse (Figure 11). In this way, a comparison can be made from ageing and fireside corrosion. To be sure that the etchant was revealing an evolution in microstructure, two specimens were mounted together and etched together to make sure that the polishing and etching process was the same when comparing one specimen to another.

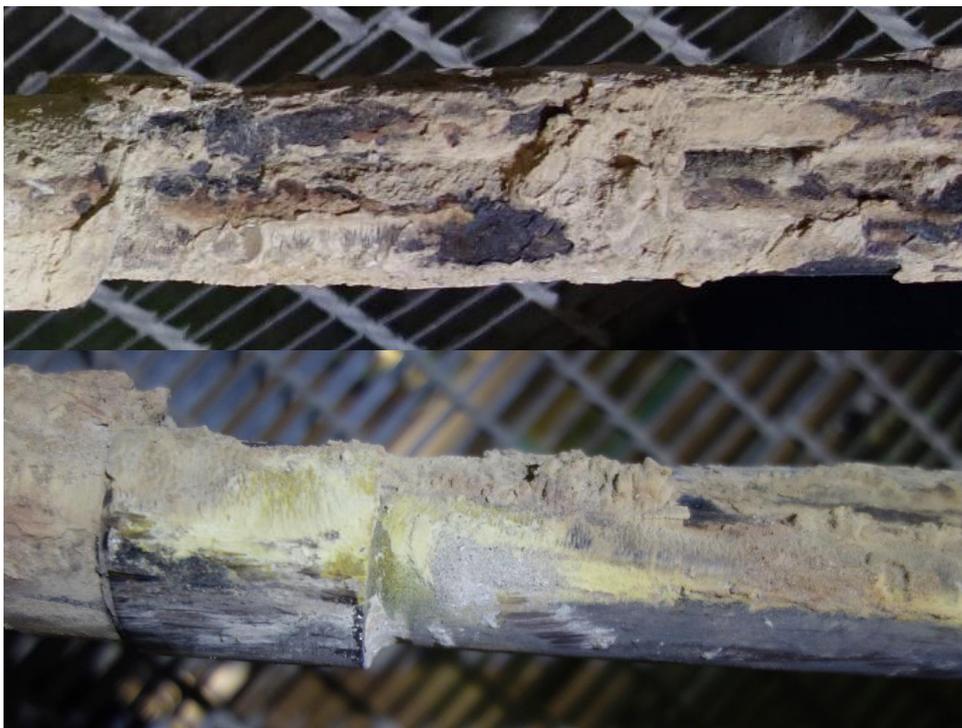
Figure 12. Photographs of the corrosion probes after 1000 + 1000 h Ref (top) and 1000 + 1000 h Rec (lower).

The deposits observed on the different air-cooled probes is shown in Figure 12. The deposits acquired on the recirculation line exhibited a slightly higher hardness than the reference line. This could be seen by the resistance of the deposits when the probes were removed/samples removed.

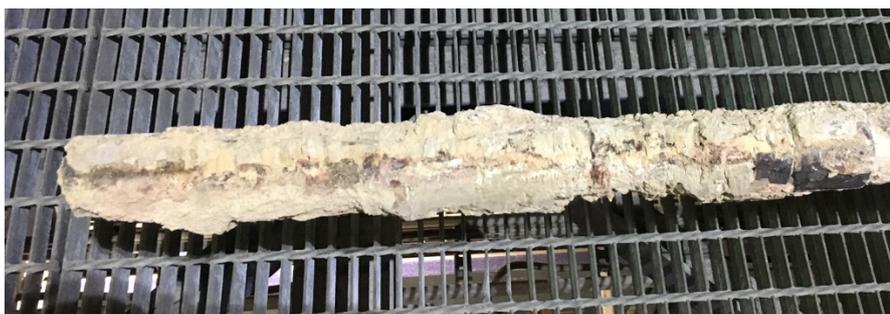
Figure 13. Probe exposed 1000h in the Sulfur Recirculation line (first) and 1000h in the reference line (after)

In order to analyse the deposit composition in the superheater region, some deposit was removed from the air-cooled probes before the removal of the samples. All the deposits were hard and difficult to remove from the probes, see example in **Figure 13**.

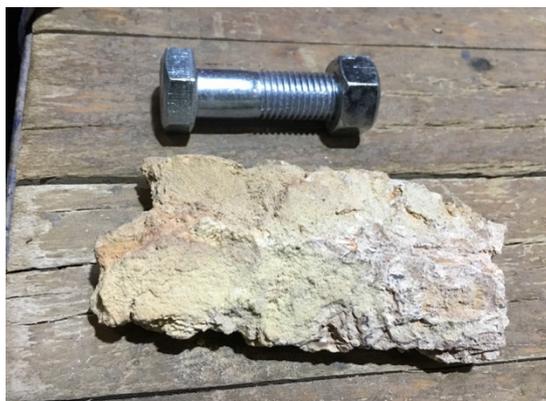
Figure 17. Piece of deposit extracted from the Sulfur Recirculation line after 2000h exposure

An example of the removed deposit is shown in **Figure 17**.

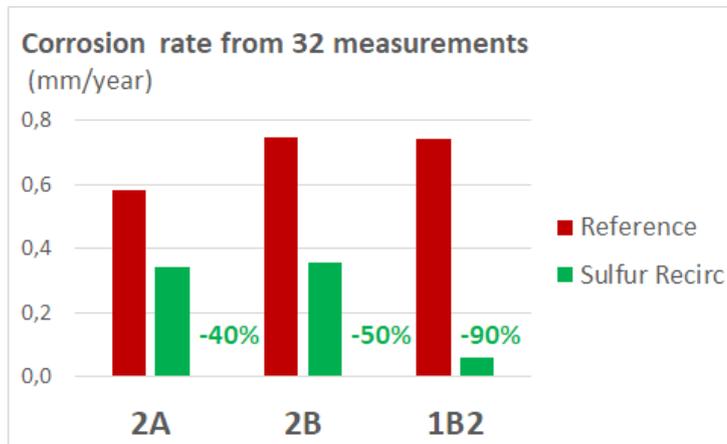
Figure 41 Mean corrosion rates in the actual superheaters for 1 year prior to Sulfur Recirculation operation (here denoted Reference) and 1 year of operation with Sulfur Recirculation in the same boiler.
