COMRADE Workshop 4- 5.12.2018

New "Linning" in Tanks on Ringhals AB

Ringhals AB – Environmental Qualification of Isolation Valves on PWR

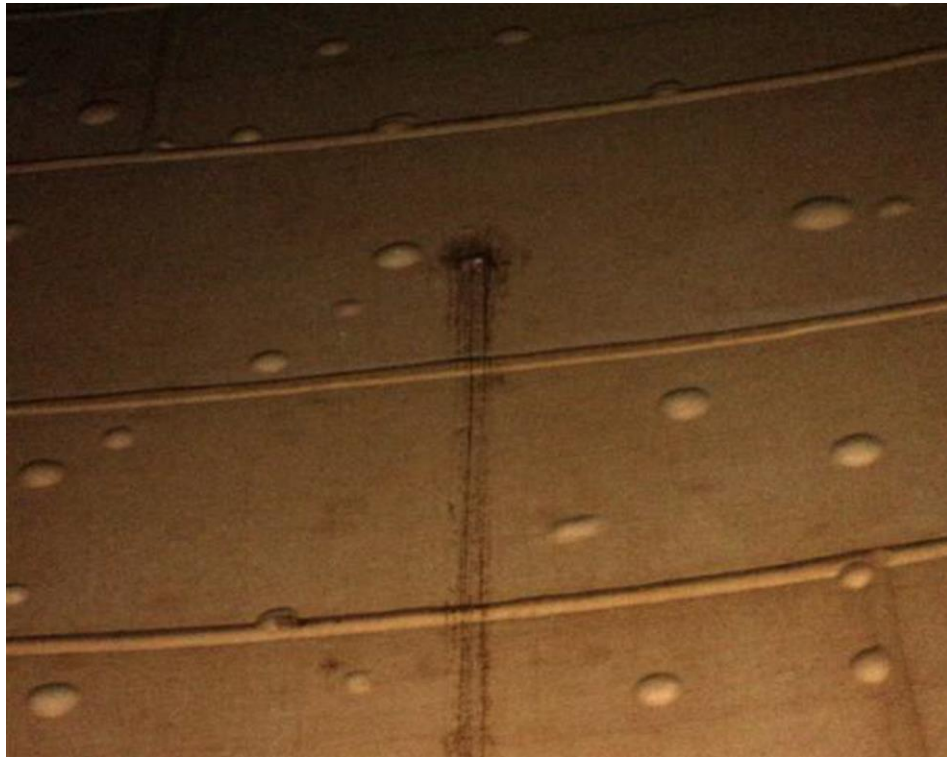
Bubbles in rubber lining

There were loose particles from the rubberized surface when the surface is sanded with grind paper

- Unfortunately, this solution has not been easy to use with replacement of rubber lining in tanks with deionized or deionized and deaerated processwater.

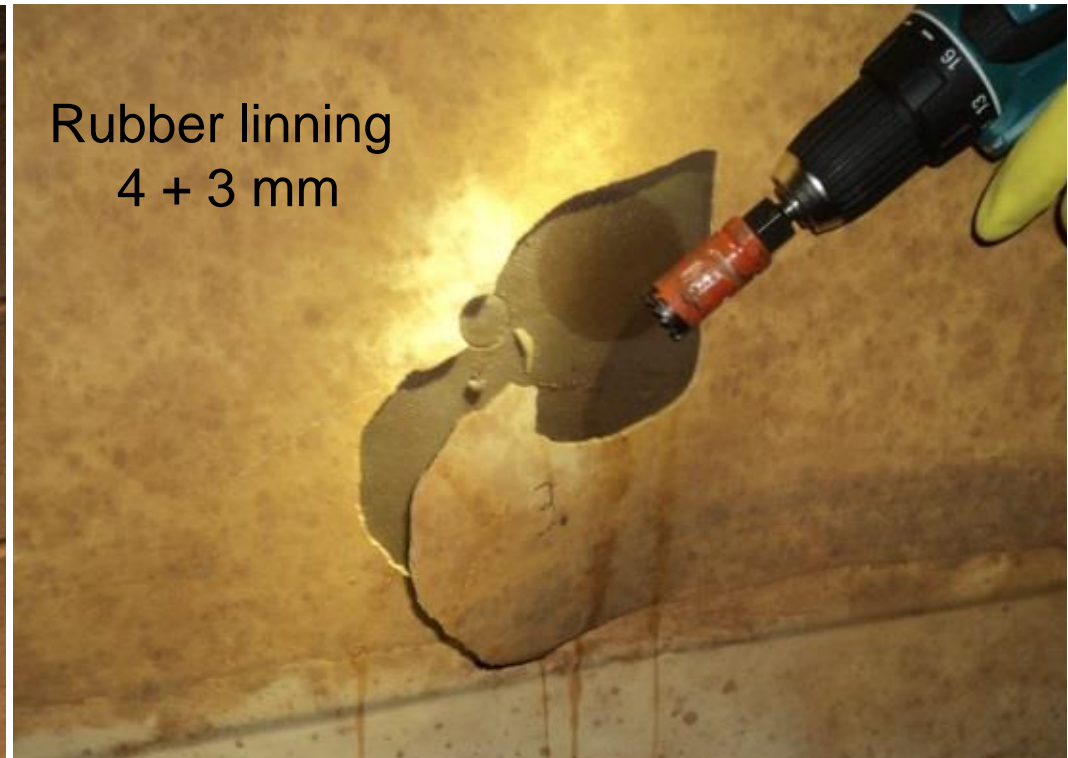
Poor adhesion

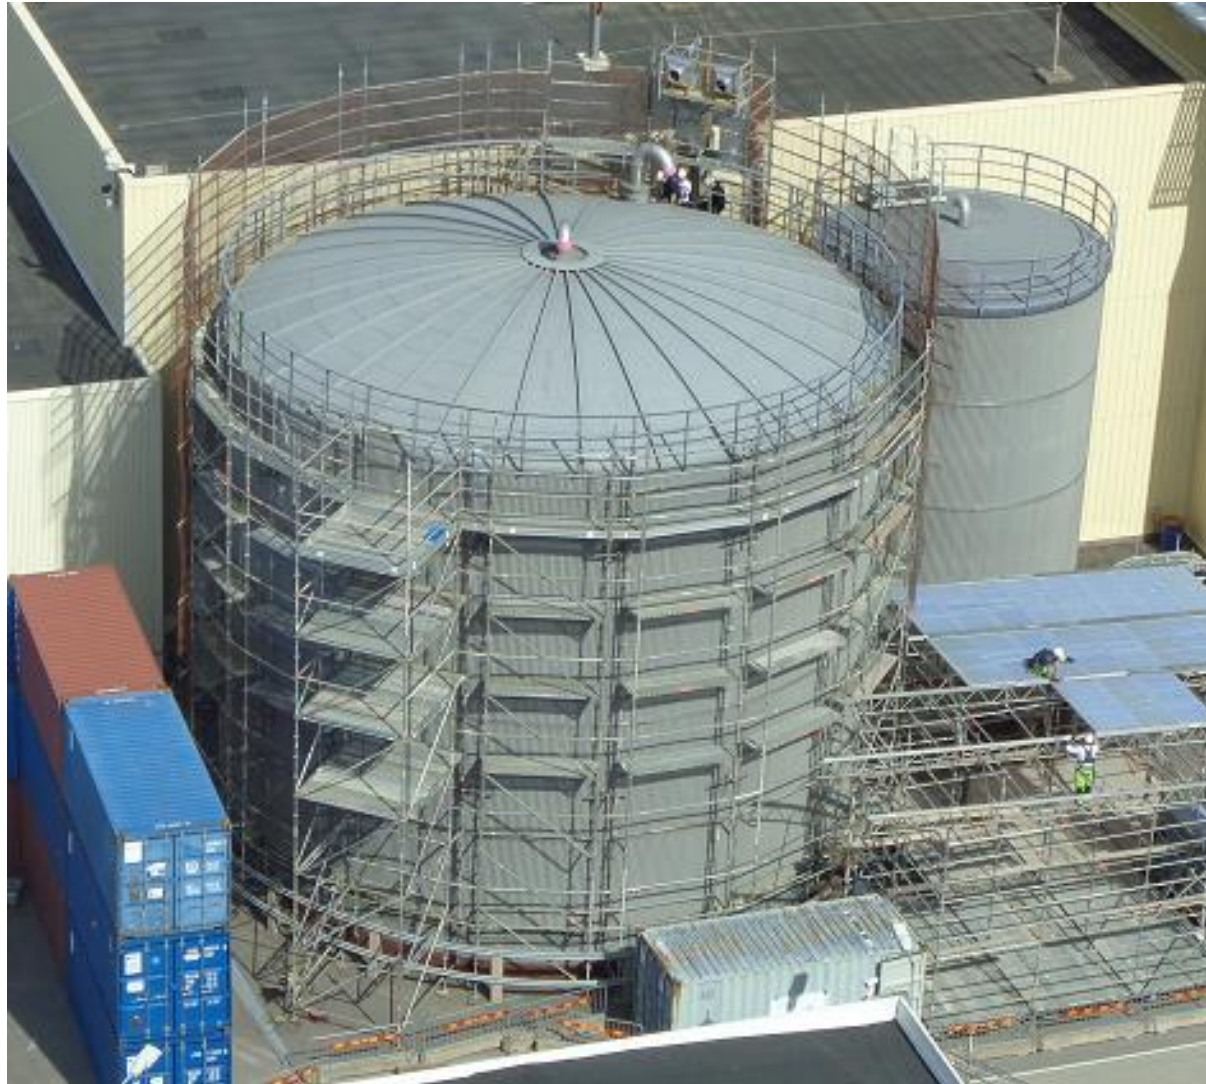
Inside area about
500 m²

- Outage 2017 painting RWST R4
- Outage 2018 painting RWST R3
- The result shows that the water quality in the tanks has improved silicon and sulphates. Chlorides and fluorides and metals are just like before painting constant low while the concentration of organic acids appears to be higher than before repair during periods without cleaning via ion exchange (perhaps depending of residues after blasting. All lackable pollutants are kept at a low level and clearly within the requirements of chemical specifications using ion exchange treatment before and after outage.

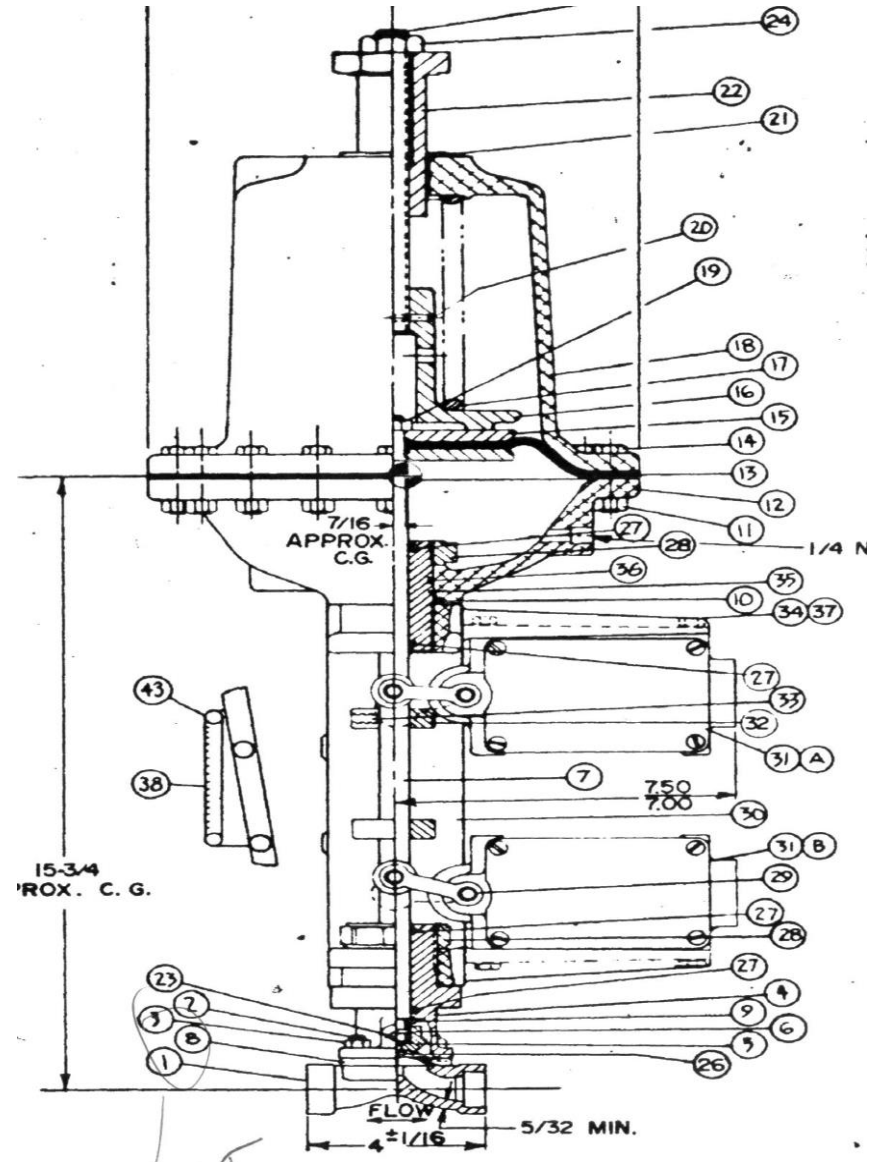
EPT

Pneumatic valve, F.C, closes with spring force when the air is released.
membrane "E.P.T" = EPDM
