# ANALYSIS OF IRRADIATED CONCRETE

REPORT 2016:239

Microscopic and mechanical tests on concrete from a  
nuclear power plant containment structure

JAN ERIK LINDQVIST, CBI, MATHIAS FLANSBJER, SP AND ERIK HANSSON, INSPECTA

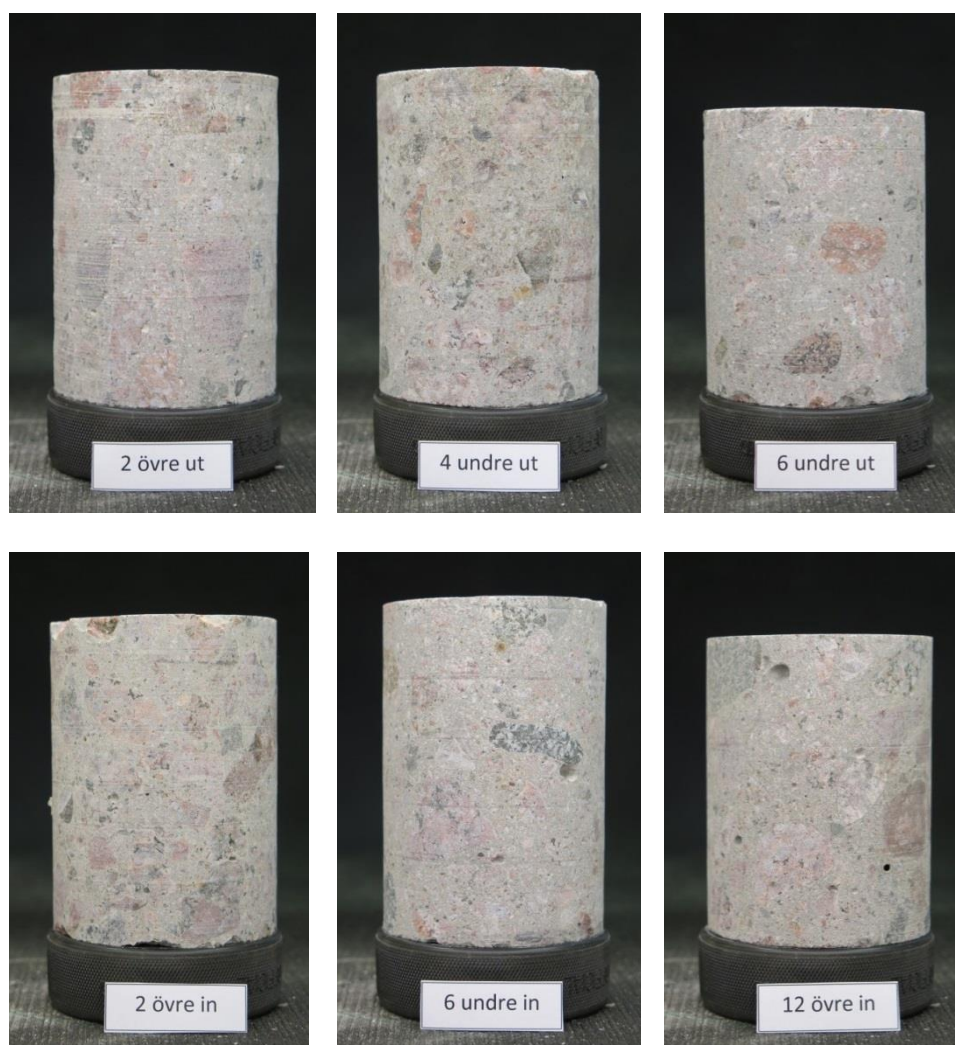
Figure T-1. Photos of the prepared test cylinders before testing. The three upper samples labelled "ut" are taken close to the outside of the structure, and the three lower samples labelled "in" are taken close to the inside of the structure.

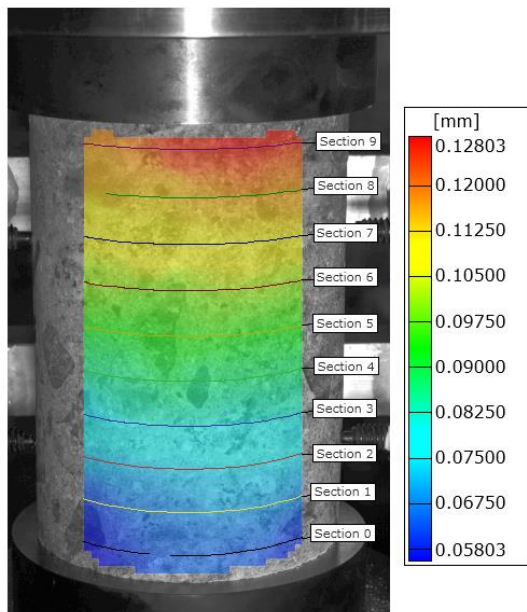
That there is some variation in strain between the various segments is natural, since the local stiffness depends on aggregate size and location. The general picture is that the strain distribution is relatively uniform along the length of the cylinder, which indicates that the tested cylinders do not exhibit any degradation of mechanical properties. There is also no significant difference between the cylinders taken towards the inside of the structure, compared with those taken towards the outside, even if the cylinders towards the inside, on average exhibit somewhat lower strains, i.e. higher stiffness, see Figure T-8.

Figure T-4. Example of deformation field for cylinder “4-undre-ut” at an axial compression stress of 23 MPa.
