Investigation of converter failure in wind turbines

A pre-study

Elforsk report 12:58

November 2012

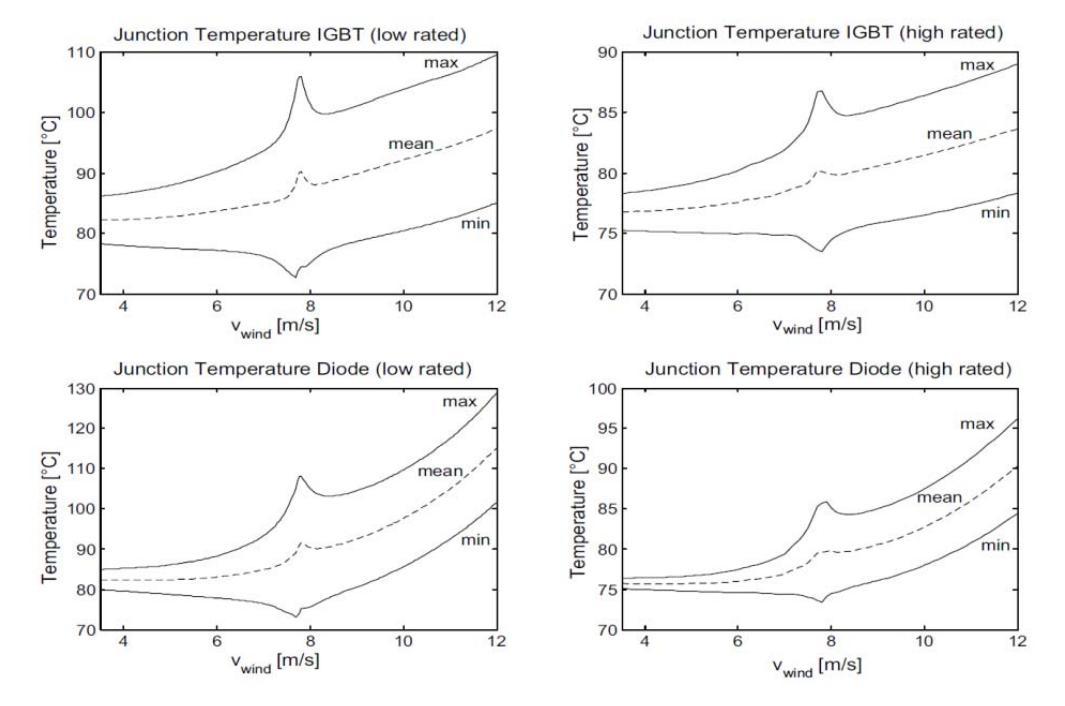
Fig. 19: Junction temperature of IGBT (top) and diode (bottom) over wind speed, for a low-rated (left) and a high-rated (right) power module [32]

- Among the power-electronic chips, the calculations suggest that the diodes are the lifetime-limiting components in the investigated system. This is due to a higher average temperature and a more severe temperature cycling in the prevailing over-synchronous operation, see also Fig. 19.

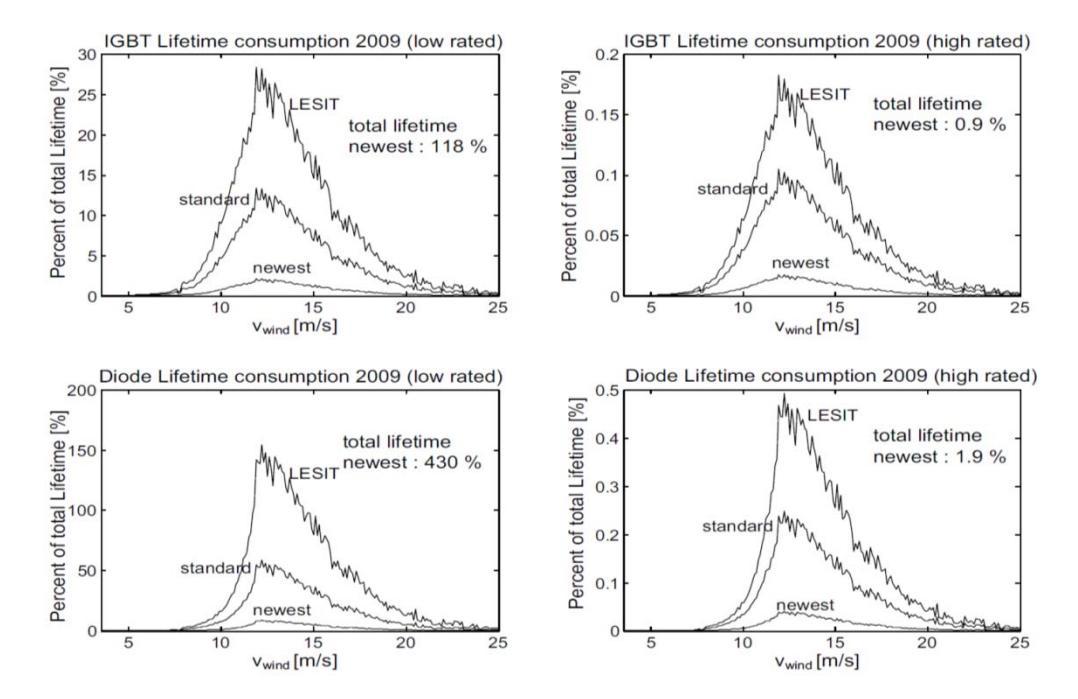
Fig. 20: Lifetime consumption of IGBT (top) and diode (bottom), for a lowrated (left) and a high-rated (right) power module, using different cycles-tofailure statistics [32]

- The lifetime consumption differs significantly with the dimensioning of the modules. As Fig. 20 reveals, the expected lifetime of the high-rated module (Fig. 20, right) of ca. 50 years is substantially higher than that of the low-rated module (Fig. 20, left). This makes clear that the lifetime of IGBT converter modules must always be seen in connection with their dimensioning.

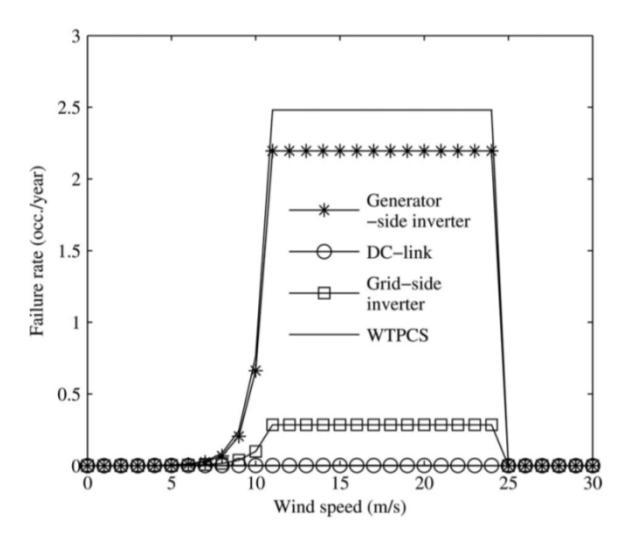
Fig. 21: Impact of wind speed on converter failure rates as proposed in [34]

The model results, shown in Fig. 21, suggest that the failure rate is highest at rated power. However, a key assumption in this work is that the heat-sink temperature and therefore the chip and driver-board temperatures are linear functions of the power losses. It means that the component temperatures are estimated highest at rated power, which is not generally the case for water-cooled modules. This limits the validity of the presented results and the relevance for this project with focus on water-cooled converter systems.

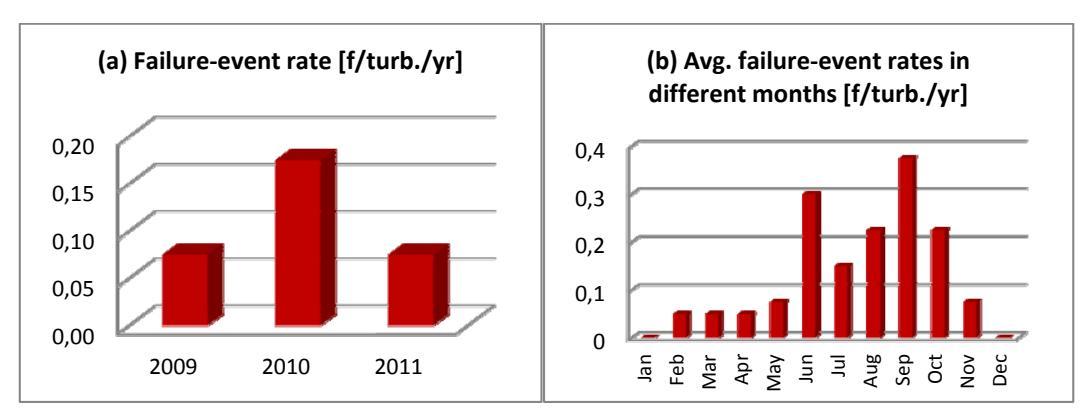
Fig. 27: Temporal distribution of converter failures at Site A during January 2009 - April 2011

While the period of observation is too short to observe possible age-related changes in the converter reliability, Fig. 27b reveals that the seasons summer and autumn are most critical with respect to converter failure at this site.

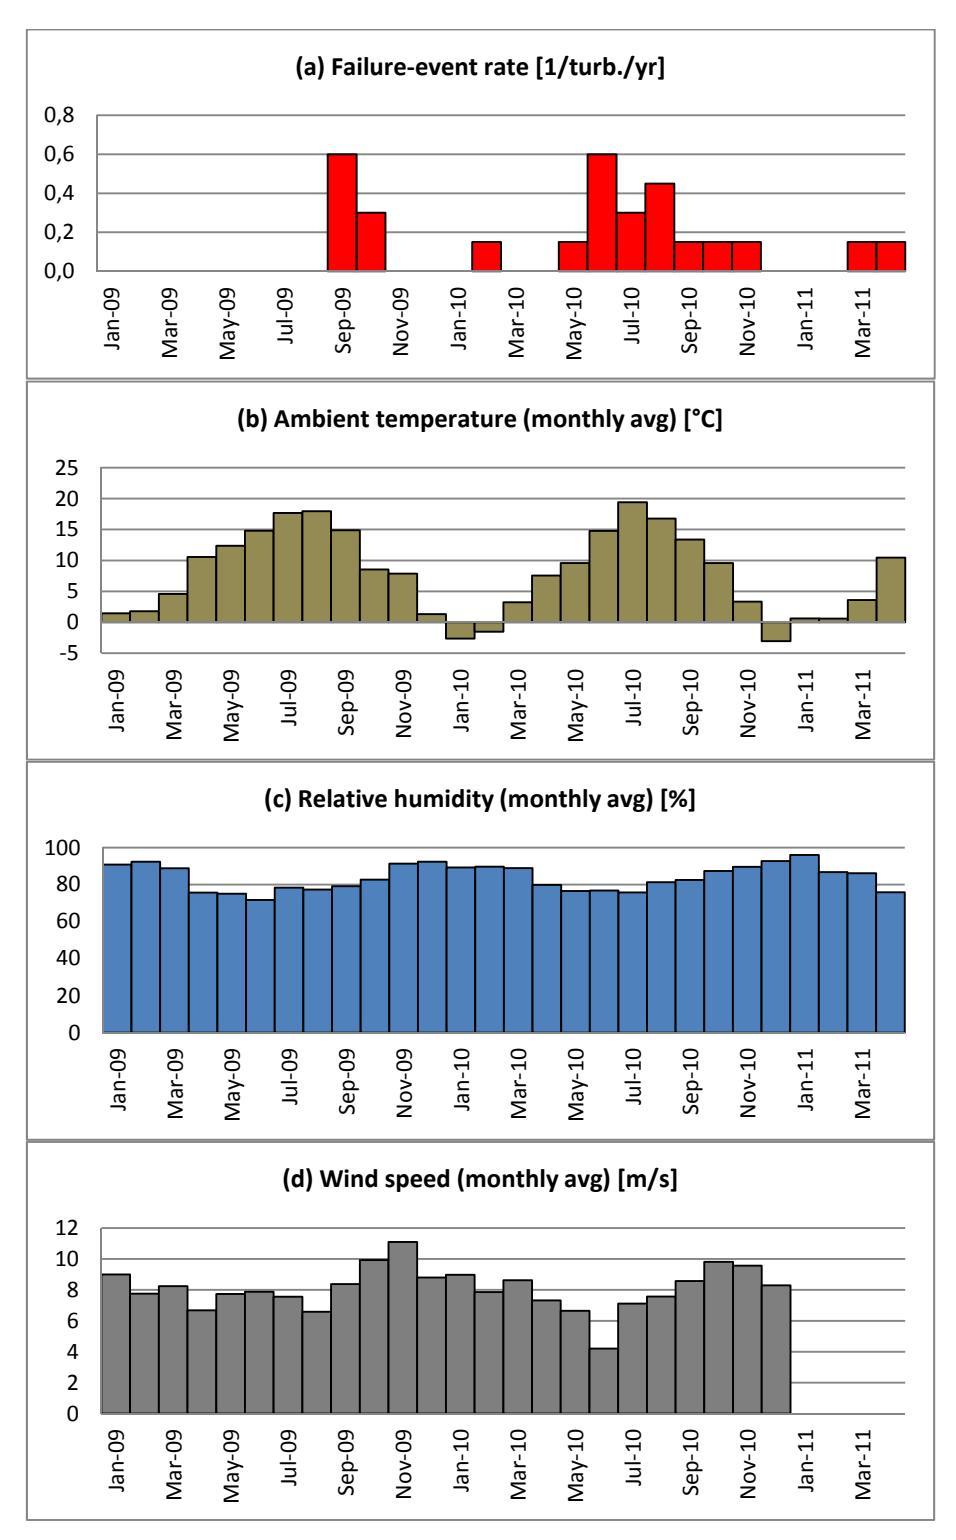
In order to identify environmental factors being correlated with failure, converter failure data from Site A has been analysed in combination with climate data from a nearby measurement station and with wind-speed data recorded by the turbine SCADA systems. Figures 28a-d show the monthly number of converter failures together with the average values of the ambient temperature, the ambient relative humidity and the wind speed in the respective month. Not surprisingly, the average temperature is highest during the summer months, while the relative humidity reaches its maxima in the winter and wind speed reaches the highest average values in autumn.

In order to quantitatively assess the correlation between converter failure and the environmental factors temperature, relative humidity and wind speed, linear correlation analysis as described in Section 4.1 has been applied to the monthly average values shown in Fig. 28. The resulting correlation coefficients and p-values are compiled in Table 5.

The only statistically significant correlation is found between converter failure and ambient temperature. Some negative correlation is observed with the relative humidity. However, as a failure rate decreasing with the relative humidity is physically not plausible, this should mainly be ascribed to the strong negative correlation of temperature and relative humidity. No statistically significant correlation is found between converter failure and the average wind speed.

Fig. 28: Converter failures and monthly average values of ambient temperature, relative humidity and wind speed at Site A

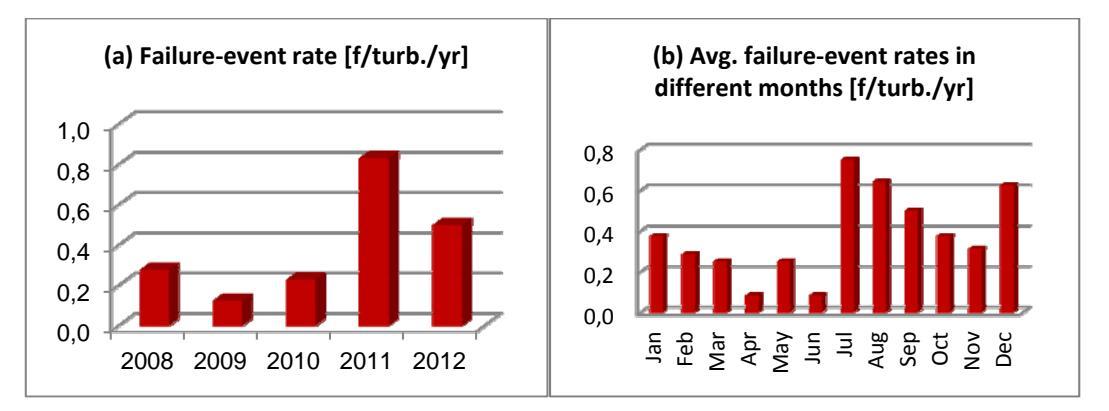
Fig. 29: Temporal distribution of converter failures at Site D during August 2008 - February 2012

As in the case of Site A, converter failure is observed most frequently during the seasons summer and autumn, see Fig. 29b. Figure 29a suggests a systematic, possibly age-related increase in the failure rate. (Note that due to the unequal distribution of failure events over the course of the year, the failure rate calculated for 2008 based on only the last five months of the year might be higher than the real average value for 2008, while the failure rate estimated for 2012 based on the two first months of the year might underestimate the real value.)

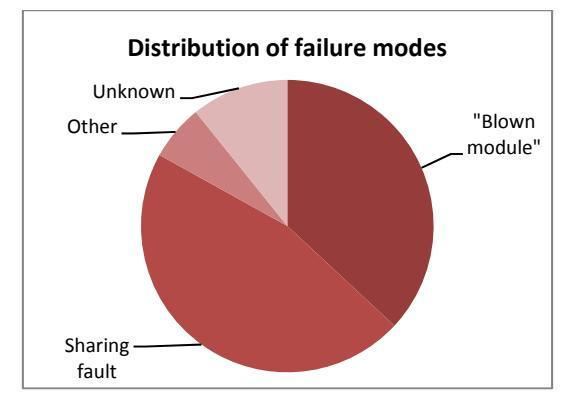
Additional information available for Site D is the mode of converter failure. As shown in Fig. 30, these are clearly dominated by explosion failure and so-called sharing faults, both having approximately equal shares. Sharing faults imply a control-system induced shutdown of the turbine when an unbalanced current-sharing between the paralleled converter units in the WT2 is detected.

This is usually the case when a converter module fails to switch. However, it can also have module-external causes like loosened cable connections.

Fig. 30: Distribution of converter failure modes at Site D

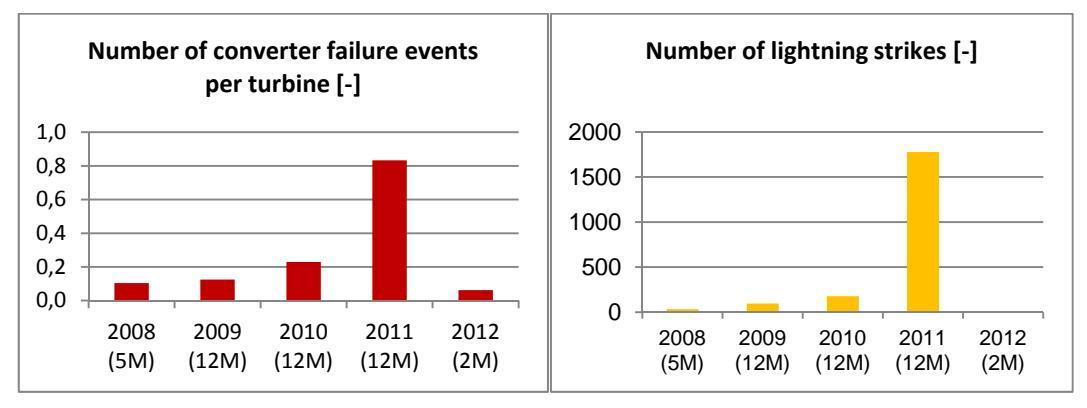
A first comparison of the annual number of converter failures per turbine and lightning strikes in Fig. 31 reveals an interesting coincidence between these on the annual timescale. In particular, an extraordinarily high number of lightning strikes in 2011 coincides with a high number of converter failures in that year.

Fig. 31: Annual numbers of converter failures and lighting strikes at Site D

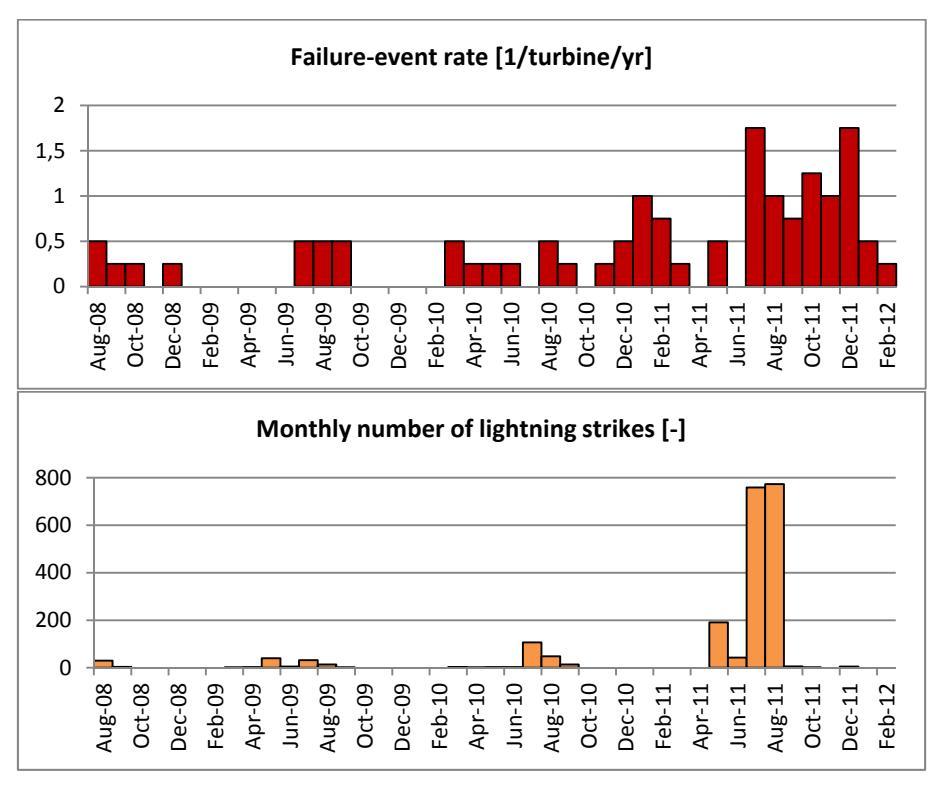
Figure 32 allows a visual comparison of the failure and lightning numbers on the monthly scale. This confirms a noticeable coincidence between the two phenomena. The apparent discrepancy observed for the period October – December 2011 can be explained by the fact that positive lightning strikes occur during the cold seasons, which are considerably stronger than negative strikes. The occurrence of a low number of strong lightning strikes during late 2011 could therefore still have contributed to the high number of converter failures during this time.

In order to quantitatively assess the correlation between converter failure and lightning strikes, linear correlation analysis has been applied to the monthly average values shown in Fig. 32. The resulting correlation coefficient of r = 0.48 with p = 0.001 confirms the visual impression of a strong correlation. In addition to the analysis on a monthly scale, for the case of Site D, it has been possible to perform a correlation analysis even on the daily scale. As described in Section 4.1, this requires exact knowledge of the date on which a failure started. In the present case, the analysis was therefore based on the failure events occurred during Jan. 2009-Dec. 2011, excluding four events reported in the failure data, for which no indication could be found in the SCADA alarm logs.

Fig. 32: Monthly converter failure and lightning strikes at Site D

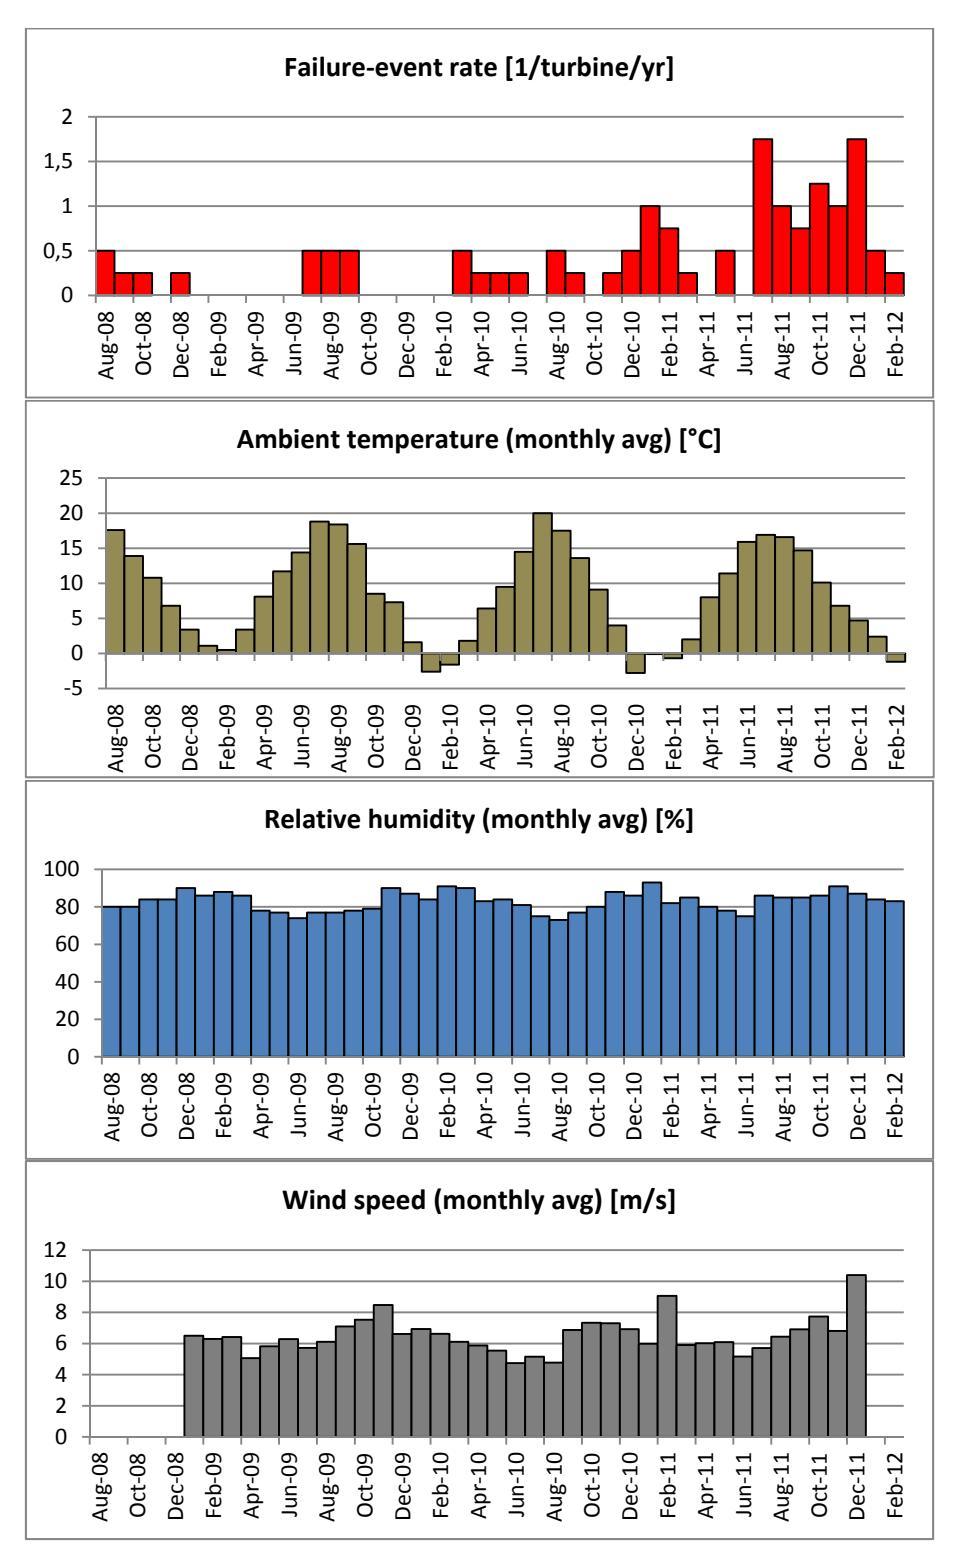
As expected, the average temperature is highest during the summer months. Both the relative humidity and the wind speed reach their highest values during autumn and winter.

Fig. 33: Converter failures and monthly average values of ambient temperature, relative humidity and wind speed at Site D

Table 6 summarises the results of the linear correlation analysis, both using monthly and daily average values. While the first is based on the data shown in Fig. 33, the latter is limited to data from the period January 2009 - December 2011.

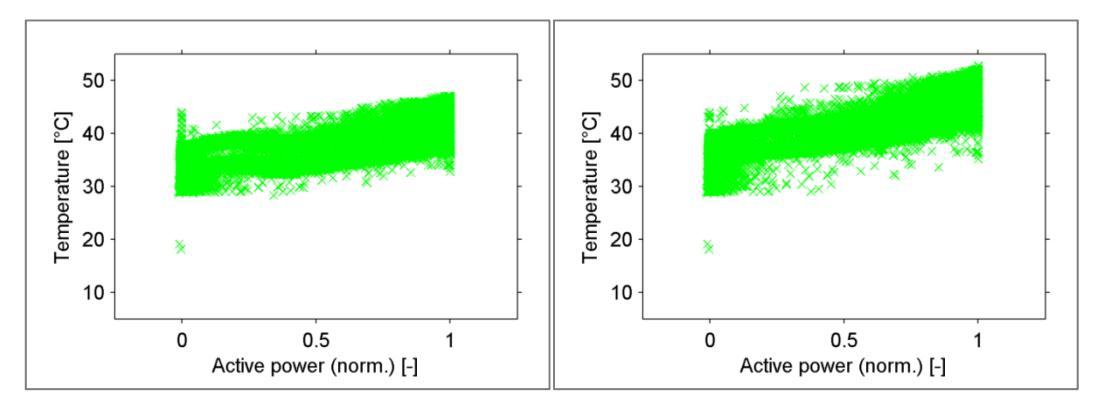
In case of the WT1 system, some information regarding the thermal conditions inside the converter modules is found in the SCADA signals: These cover the 10-min average temperature values measured by the module-internal temperature sensor which is located next to the power devices on the DCB. Figure 36 shows typical plots of the grid-side (left) and the generator-side (right) module-internal temperature over the normalised active power. The temperature varies only in a very limited range of approx. 25...55°C and increases slightly with the active power generated by the turbines.

Fig. 36: Values of the module-internal temperature over the generated active power for a grid-side module (left) and a generator-side module (right) of a WT1 system at Site A

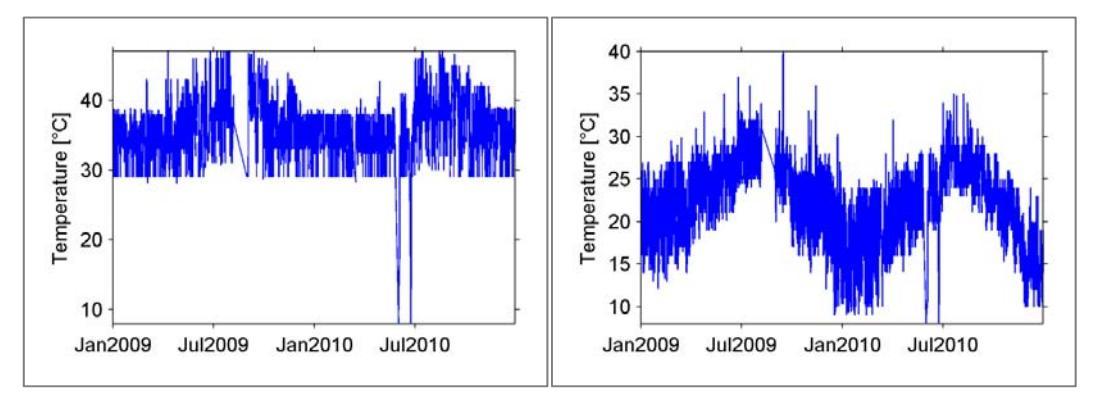
Figure 37 (left) shows the variation of the above introduced grid-side module temperature over a period of two years. As a comparison with the corresponding nacelle temperature in Fig. 37 reveals, the module temperature is maintained at temperatures between approx. 25°C and 40°C during the colder seasons and reaches slightly higher temperatures during the summer.

Fig. 37: Seasonal variation of the grid-side module temperature (left) and the nacelle temperature (right) in a WT1 turbine at Site A

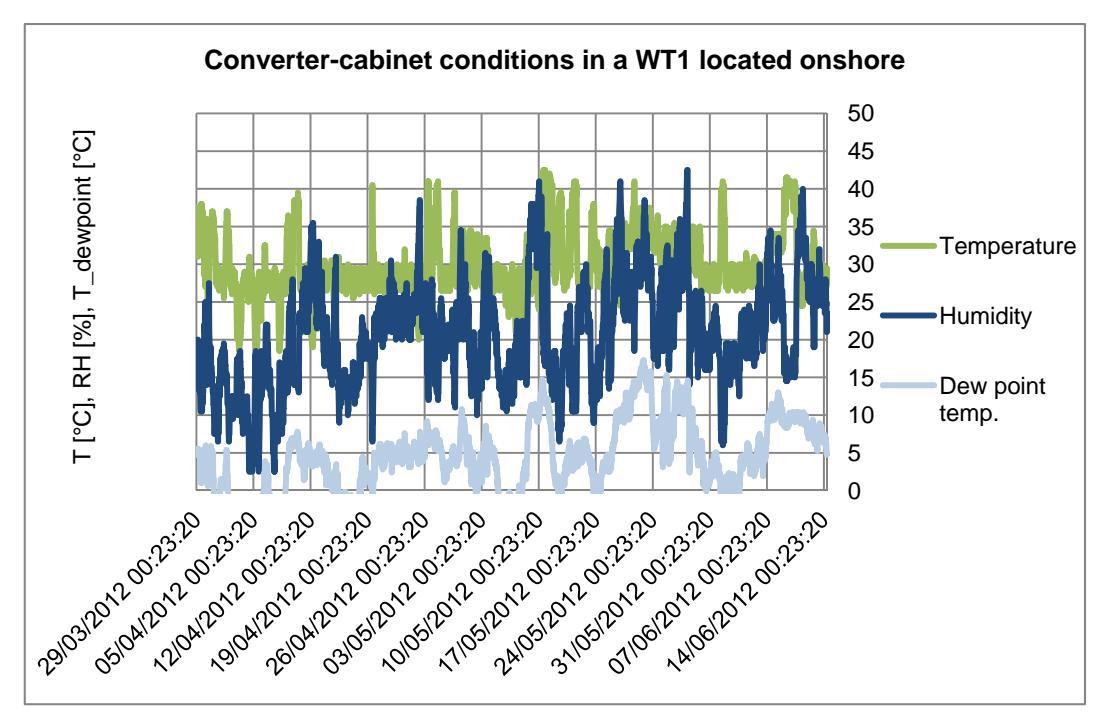
Figure 38 shows the conditions measured at a WT1 turbine at the onshore Site B. Similar results have been obtained from a second WT1 system at the same site.

Fig. 38: Temperature, relative humidity and corresponding dew-point temperature inside the converter cabinet of a turbine of type WT1

The finding that the thermal operating environment of the converter modules is not critical in the WT1 system is confirmed by the maximum-temperature data collected by means of thermo-sensitive tape: Both on the top-cover of the converter modules and at the side of the heat sink, for the grid-side and the generator-side modules, maximum temperatures in the range of 43-60°C have been found. In a single case, a maximum value of 65°C was measured on the heat sink of a generator-side module. Again, this does not provide any signs of overheating of the modules during turbine operation. Initial speculations that the cooling of the converter cabinets might be insufficient can, at least for the period April to June monitored within the present project, therefore not be confirmed.

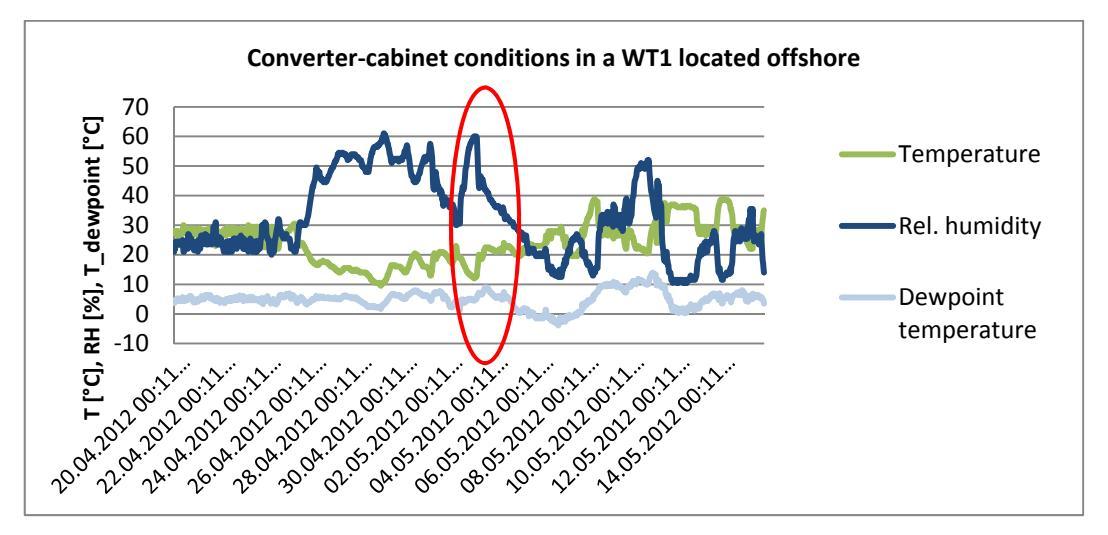
A particularly interesting case could be logged on a WT1 turbine at the offshore Site A, see Fig. 39: After a standstill period of 9 days and 2 days of major repair work with an opened nacelle (see the red-marked area in Fig. 39), a converter failure occurred during start-up of the turbine on 4 May. Similar cases were reported to have occurred before in the same offshore wind park. The logged temperature and relative-humidity data confirm that this most likely is related to condensation: Due to the standstill period, the nacelle cooled down and the relative humidity increased to values of approx. 60%. This results in a low difference between the temperature logged the top inside of the converter cabinet and the corresponding dew-point temperature, which is likely to have caused condensation on the converter modules having a high thermal inertia.

Fig. 39: Temperature, relative humidity and corresponding dew-point temperature inside the converter cabinet of a WT1 turbine with long standstill period

In summary, it can be stated that the converter operating conditions are uncritical during normal turbine operation but appear to be problematic with respect to condensation after long periods of standstill.

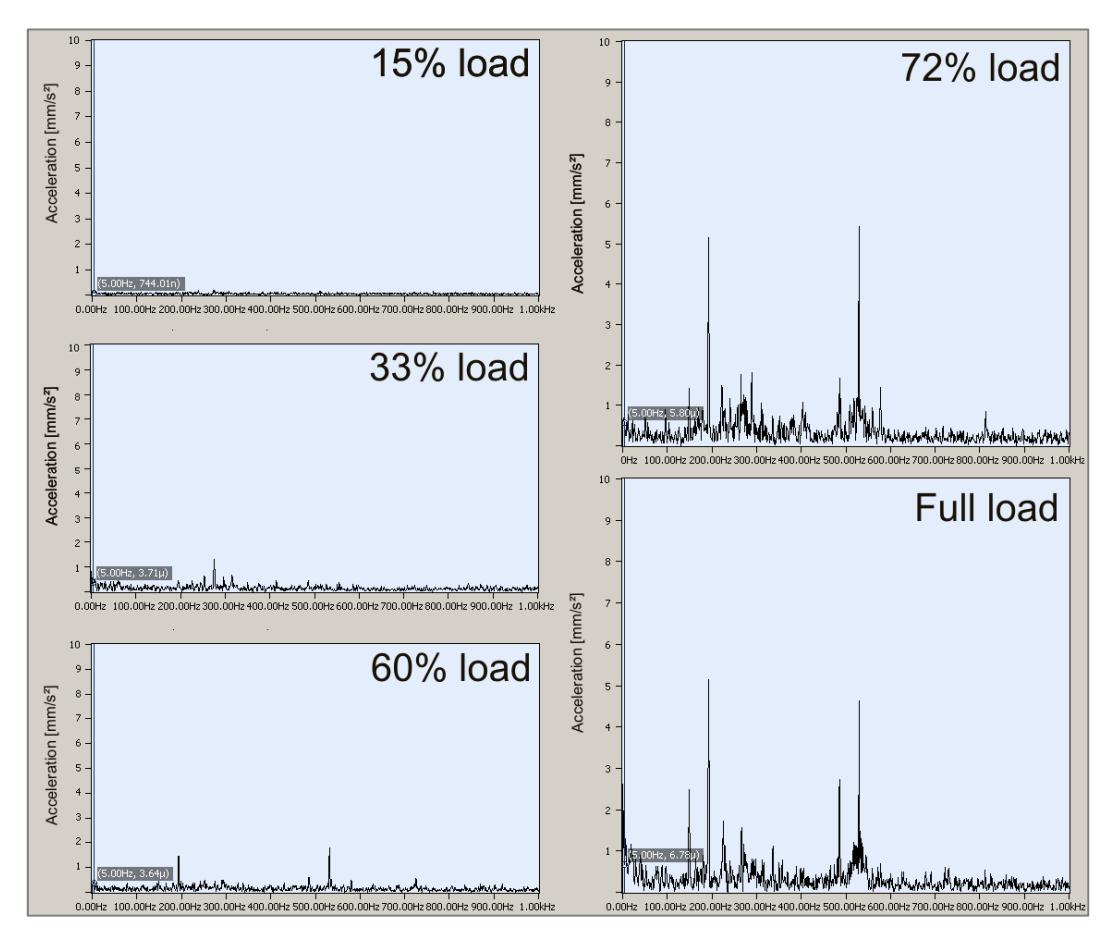
An impression of the vibration environment in which the converter modules are operating is provided in Fig. 40. This shows the acceleration spectrum measured on the heat sink of a converter module on a WT1 turbine at Site A in different operating points. The frequency range is limited to the frequencies below 1 kHz, which are considered to be the relevant frequencies with respect to mechanical impact on the converter. Note that, according to information from the manufacturer of the vibration condition-monitoring system used for the measurements, the amplitudes in this spectrum can contain an error of up to 15%.

Fig. 40: Acceleration spectrum measured on a converter module of a WT1 at Site A at different loads

Not surprising, Fig. 40 shows a strong increase in the acceleration level from low to high load, while little difference is found between the 72% and the full-load point. In the upper load range, peak acceleration values are observed at frequencies close to 200 Hz and 530 Hz. However, the observed maximum levels of acceleration remain far below the levels applied during reliability-testing at the manufacturer.

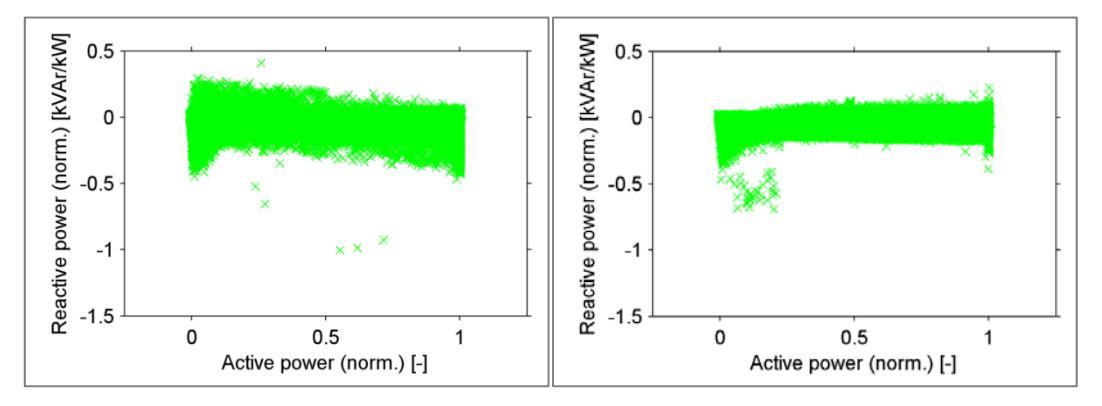
For the same turbine, Fig. 42 (left) shows a scatter plot of the produced reactive power over the active power generated by the turbine. Figure 42 (right) provides the same for an adjacent turbine in the same radial.

A comparison with the corresponding plot concerning the WT1 system in Fig. 34 makes clear that the amount of reactive power provided to or consumed from the electric power grid is considerably higher in case of WT2. However, the amount of reactive power requested from different turbines at Site D shows substantial differences, as a comparison of the plots in Fig. 42 demonstrates.

While Fig. 42 (left) represents the situation on the turbine with the highest number of converter failures in the wind park, Fig. 42 (right) is from a turbine without any converter failures in the investigated period. Based on the observed discrepancy and the fact that the loading of the converter-internal diodes increases with the reactive power, an interesting question is if there is a correlation between the number of converter failures on a turbine and the amount of reactive power requested from this turbine. To clarify this, a linear correlation analysis of the number of failures per turbine and the average amount of reactive power requested from the turbine was carried out for the whole park. However, no statistically significant correlation between these quantities was found.

Fig. 42: Scatter plots of reactive vs. active power from a WT2 system with (left) and without (right) converter failures; quantities are normalised with the rated turbine capacity

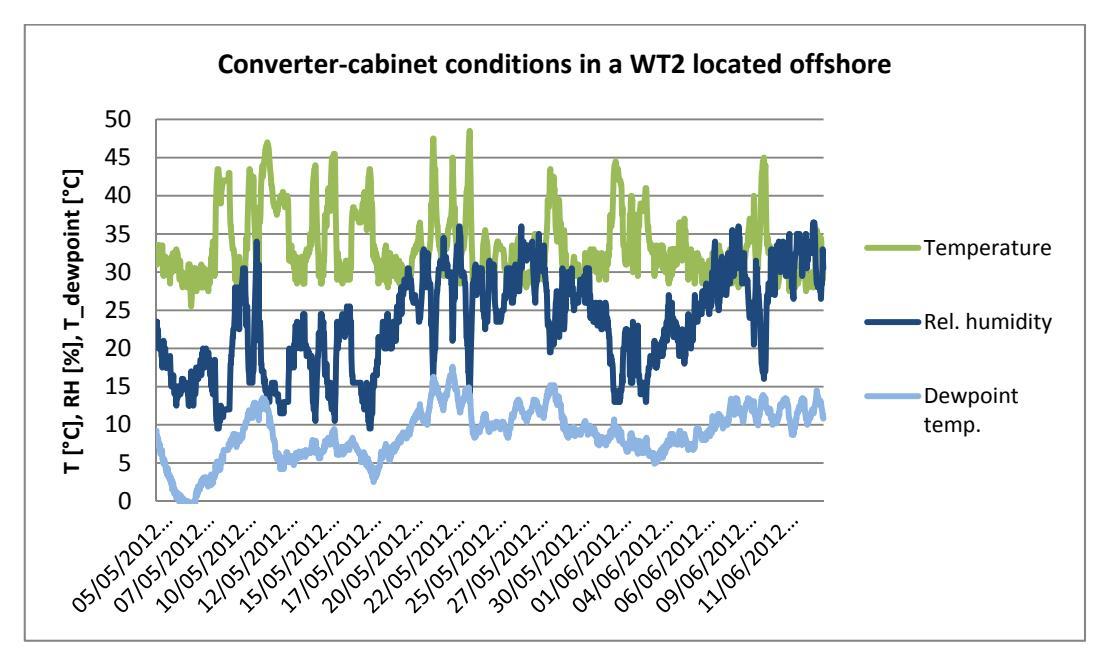
Also in case of the WT2, the operating conditions inside the converter cabinets of single onshore and offshore turbines have been explored by means of temperature and humidity loggers. Figure 43 shows the conditions measured at a turbine at Site D.

The converter-cabinet temperature is found to range between 25 and 50°C, while the relative humidity remains below 40%. The dew-point temperature lies significantly below the measured temperature at all times so that there is clearly no risk of condensation during normal operation.

Thus, also in the case of the WT2, no exceptional conditions are found inside the converter cabinet which would be likely to favour converter failure.

Fig. 43: Temperature, relative humidity and corresponding dew-point temperature inside the converter cabinet of a WT2 turbine at Site D

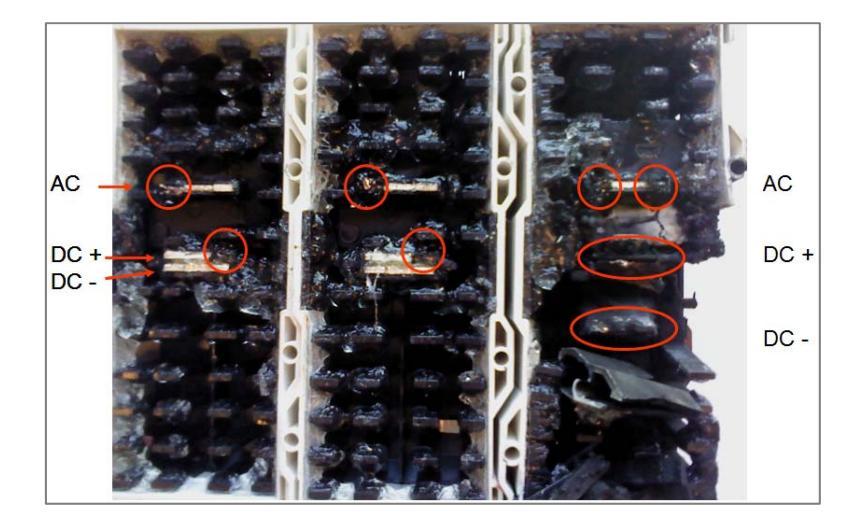
Not surprisingly, also the analysis of the second destructed module revealed signs of very high currents through the module. As visible in Fig. 47, all three paralleled half-bridges show the same damage pattern: The connections to the DC+ and the AC side show melting in the same contact points. The considerable displacement of the DC- connection from the DC+ connection observed in Fig. 47 gives evidence of a very strong energy release.

Fig. 47: Identical melting-damage pattern at the connections to AC and DC+ in all three half-bridges

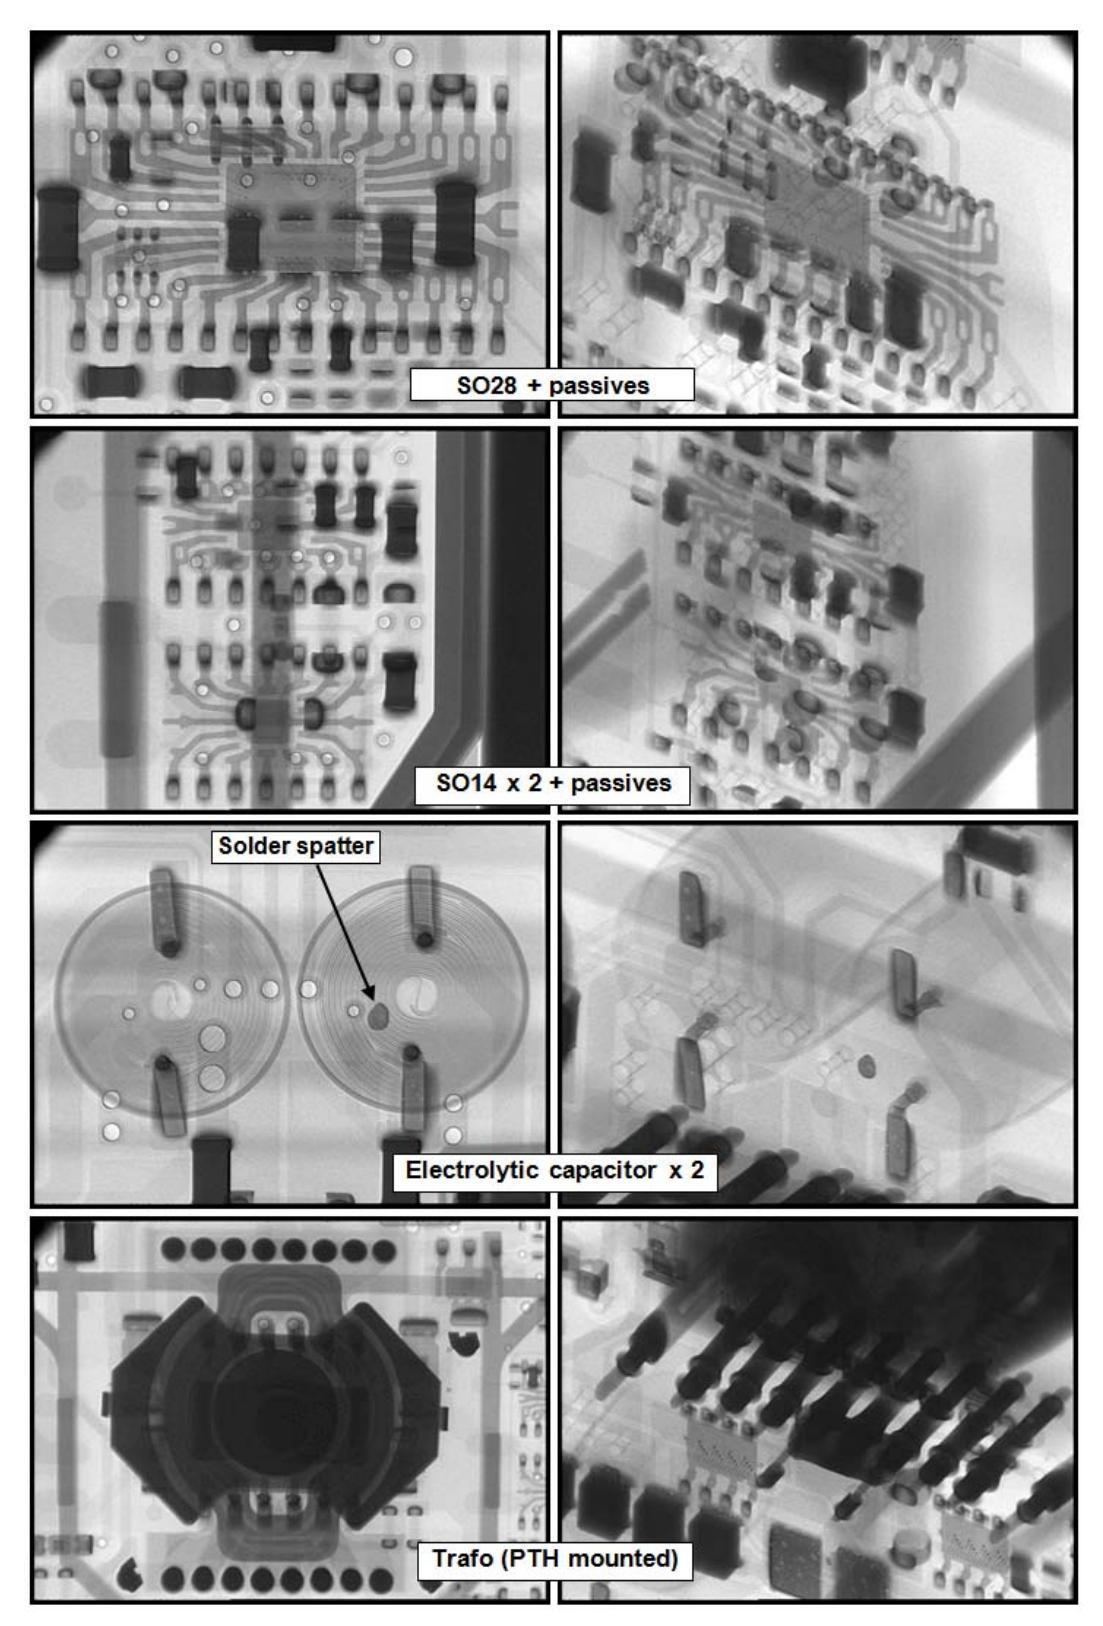
Figure 55 shows X-ray images of various driver-board solder joints in converter module #1. These indicate a generally acceptable solder-joint appearance, apart from some solder spatter and some voiding in solder joints of passive components. However, X-ray inspection of the driver board via holes (Fig. 56) showed a somewhat uneven hole plating, in addition to a quite thin plating. Possibly this could be a reliability concern during temperature cycling / power cycling in field operation.

Fig. 55: X-ray images, top and oblique views, of driver-board solder joints in converter module #1

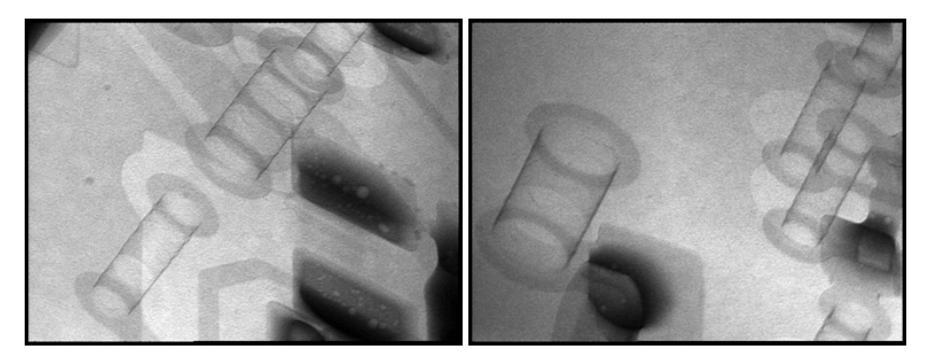
Fig. 56: X-ray images, top and oblique views, of driver-board via-holes in converter module #1

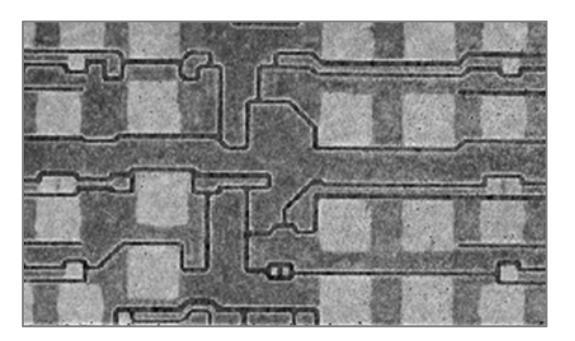
Figure 58 shows an image from SAM analysis of the die-attach solder of the IGBT and diode chips of a half-bridge in converter module #1. All three halfbridges were investigated. The SAM analysis showed similar acoustic signal response from all chips in the three half-bridges, indicating intact die attach solder in all chips. The analysis was carried out from the backside of the halfbridges, i.e. through the substrate.

Fig. 58: SAM image (excerpt) showing a graphical representation of the acoustic signal response from the die-attach solder of a half-bridge
