# **Advantages and disadvantages with different types of transducers measuring valve vibration**

*Elisabet Blom*

Tests done on big  
high pressure  
valves

The electric-  
hydraulic control  
valve has broken.

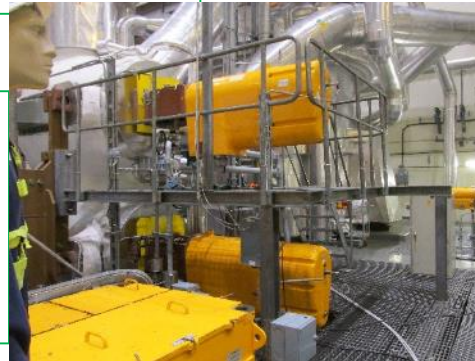
There have  
been more than  
one failure

Consequences  
for production;  
several days  
reduced effect

One of the possible  
causes was vibrations.  
Another was  
pulsations

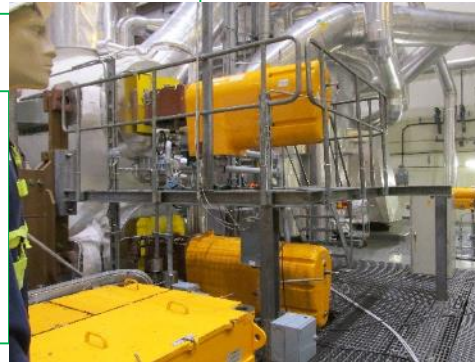
The electric-hydraulic control valve has broken.

There have been more than one failure

Consequences for production; several days reduced effect

One of the possible causes was vibrations. Another was pulsations

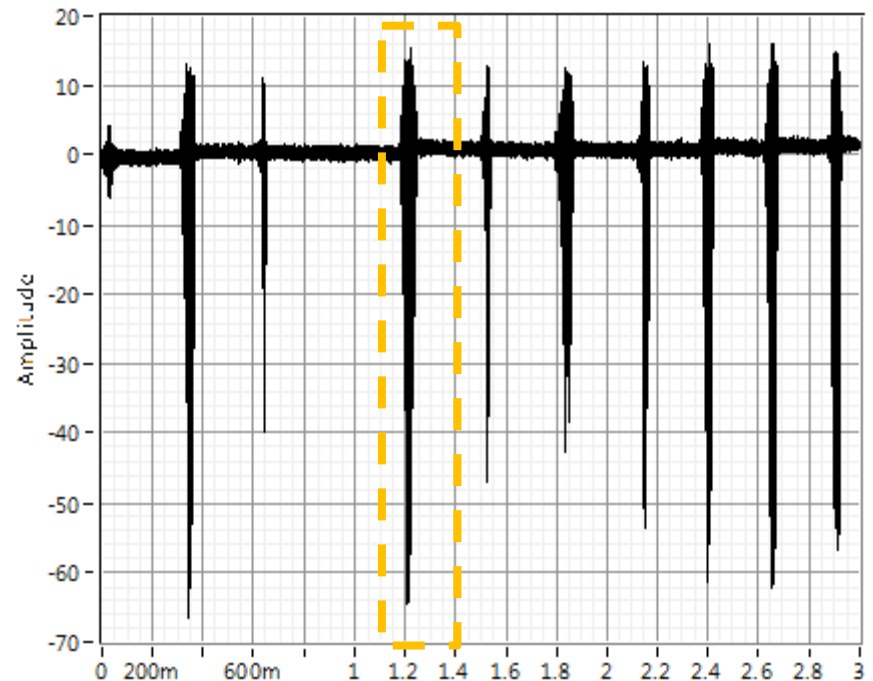
Why are spikes  
asymmetric ?

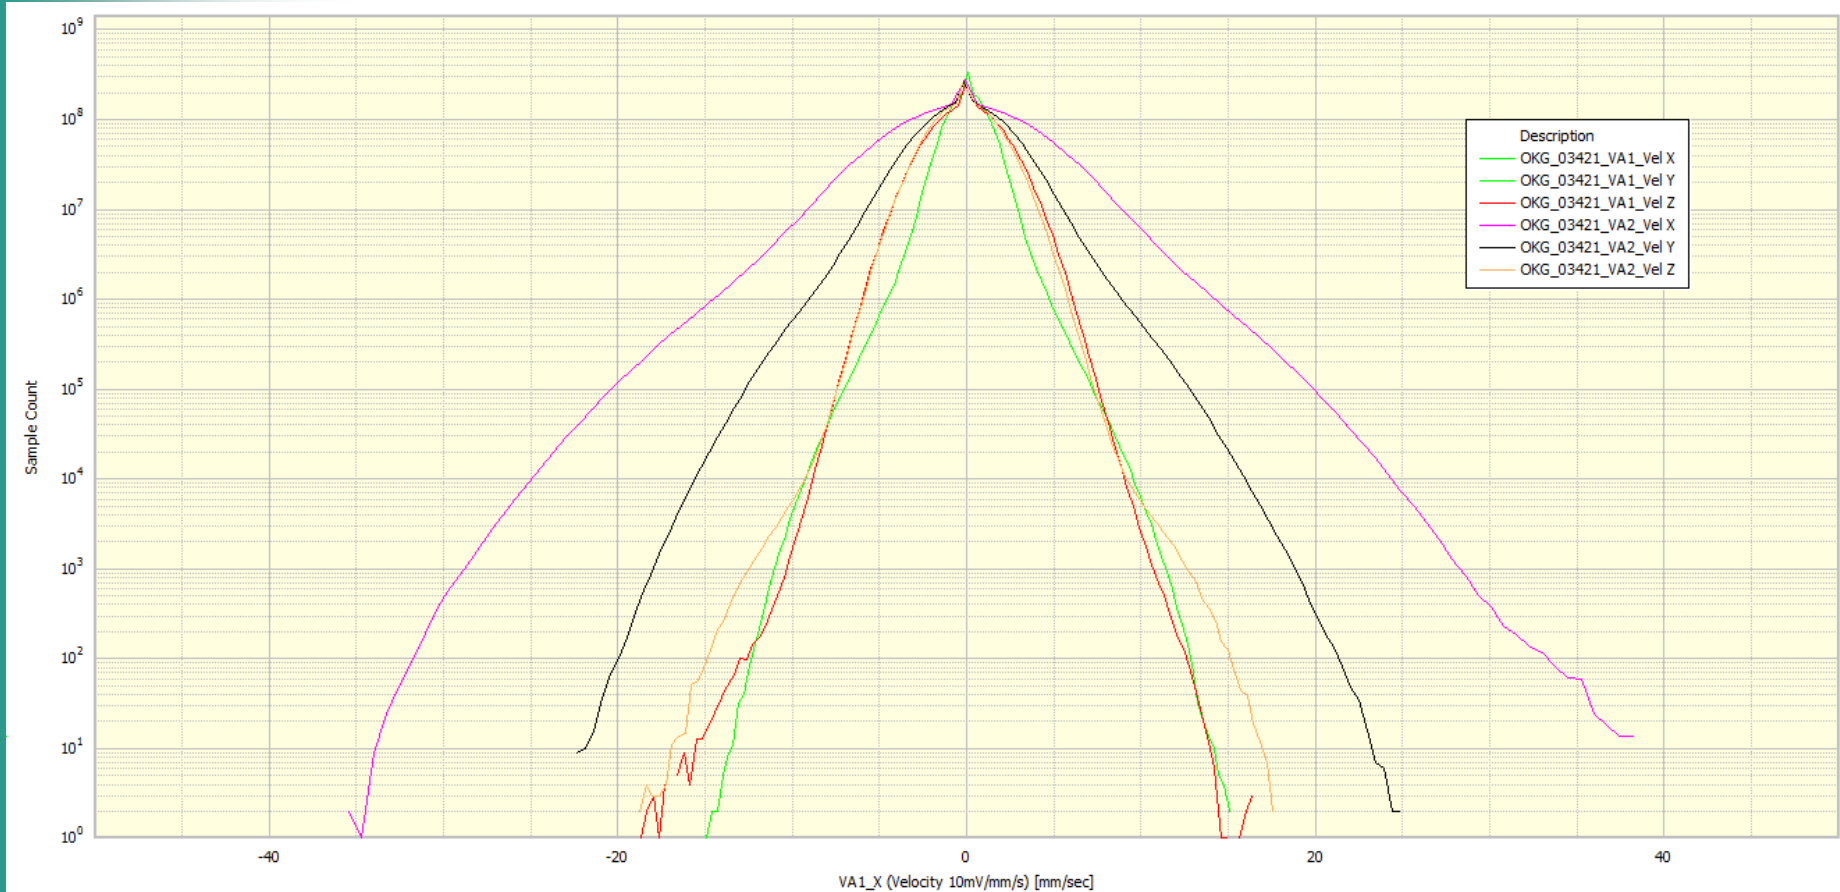
# Velocity transducer VT1613

- Dytran & Wilcoxon general purpose 100 mV/g industrial accelerometers did not provide usable signals.
- Velocity transducer VT1613 provides slightly asymmetric histogram.
- 356B21 (glued) 10 mV/g shows symmetric histogram.
- 356B21 w. mech. Filter not measured by 3rd party
- Data up to 60% load.
