KME-508/515

# **Furnace wall corrosion in biomass-fired boilers at higher steam temperatures and pressures**

## Summary

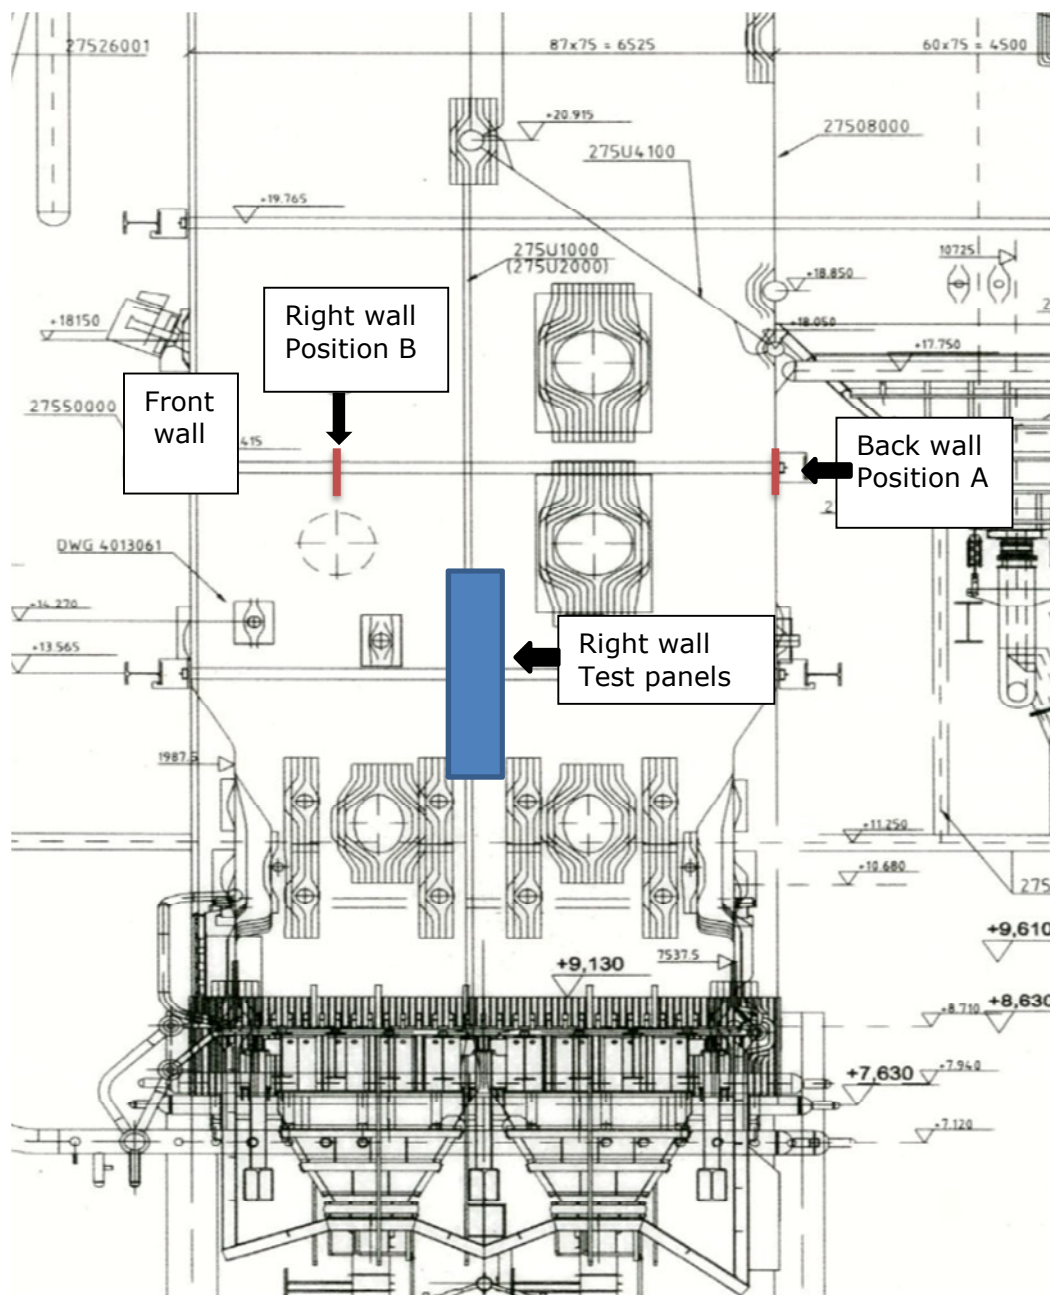
The furnace walls are made of the low alloy steel 16Mo3, which have been progressively coated with the Ni-base alloy Alloy 625. Test-tubes, coated with a number of different alloys for evaluation, were welded into the furnace wall on the right hand-side ( motorway side - seen from the front looking towards the back wall) as shown by the blue rectangle in Fig. 2.1.1. Holes for probe testing were made near the coated tubes on the right, where corrosion is considered to be moderate (known as position B) and also on the back wall in an area of high corrosion (position A).

**Fig. 2.1.1** Schematic diagram showing a section through the Idbäcken boiler, viewed from the right wall. The right wall with the position of the test panels and probe position B is shown at the front of the figure. The back wall is on the right.

The furnace walls were completely replaced in 2008 and the corrosion rate continues to be high when firing 100% waste wood at moderate to low oxygen levels. Locally, metal loss rates of 1.5 mm per year have been measured in the worst affected areas. With an operating time of 6500-7000 hours per year this amounts to a metal loss rate of 0.2 mm per 1000 h. Since 2012 all of the walls have been weld overlay coated with the nickel-based alloy, Alloy 625.

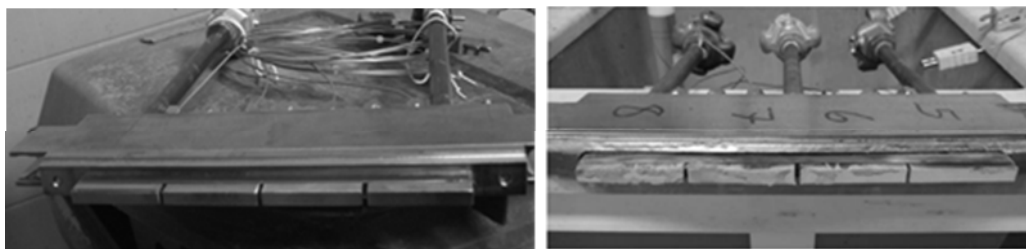
**Fig. 2.2.1 The wall probe (left) before and (right) after exposure. The probe contains four specimens.**

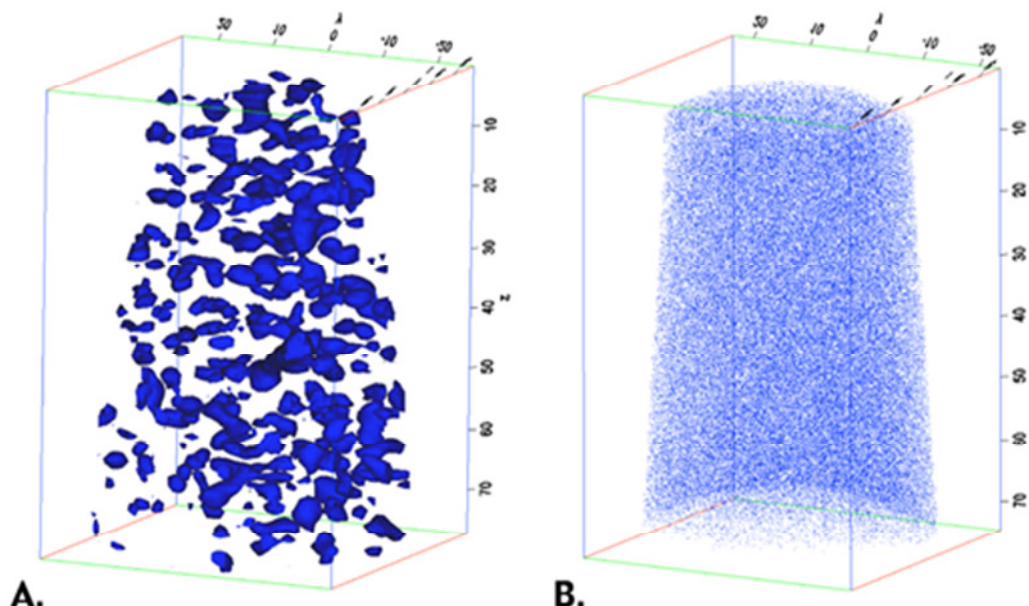
Two aged samples (10Cr-8Al & 21Cr-5Al) were analysed with atom probe tomography in order to study the homogeneity of the microstructure. The 10Cr-8Al was aged at 500 °C for 10,000 h, whereas the 21Cr-5Al-alloy sample originated from the 48 h electrical resistance measurement at the same temperature. By studying the 48 h sample, the drop in electrical resistance could be proven to originate from a phase separation. No indications of phase separation had been observed for the 10Cr-alloys in previous tests, hence the AP would provide the ultimate answer. Fig. 3.5.1 shows that the 21Cr-5Al alloy aged for 48 h in 500 °C, shows clear signs of phase separation. Chromium rich regions have been formed, and are evenly spread throughout the analyzed volume. The result clearly shows the fast phase separation at 500 °C for the 21Cr-5Al alloy. By contrast, no phase separation could be seen for the 10Cr-8Al alloy aged for 10,000 h.

**Fig. 3.5.1** Computer reconstruction of analyzed volumes (50 x 50 x 75 nm<sup>3</sup>). The reconstruction of the 21Cr-5Al alloy aged for 48 h at 500 °C (A), show isosurfaces containing at least 30 % Cr atoms. The formation of Cr-rich  $\alpha'$  clusters is typical for the phase separation. The 10Cr-8Al alloy (B), aged for 10,000 h at 500 °C shows a perfectly homogeneous structure, i.e. Cr atoms are evenly spread throughout the volume.

The study thus shows that Fe10CrAl alloys are immune to  $\alpha$ - $\alpha'$  phase separation at 450-600 °C. While the 21Cr-5Al alloy was clearly hardened at 450-500 °C, no signs of hardening or phase separation were observed for the Fe10CrAl alloys, at least up to 10,000 h.

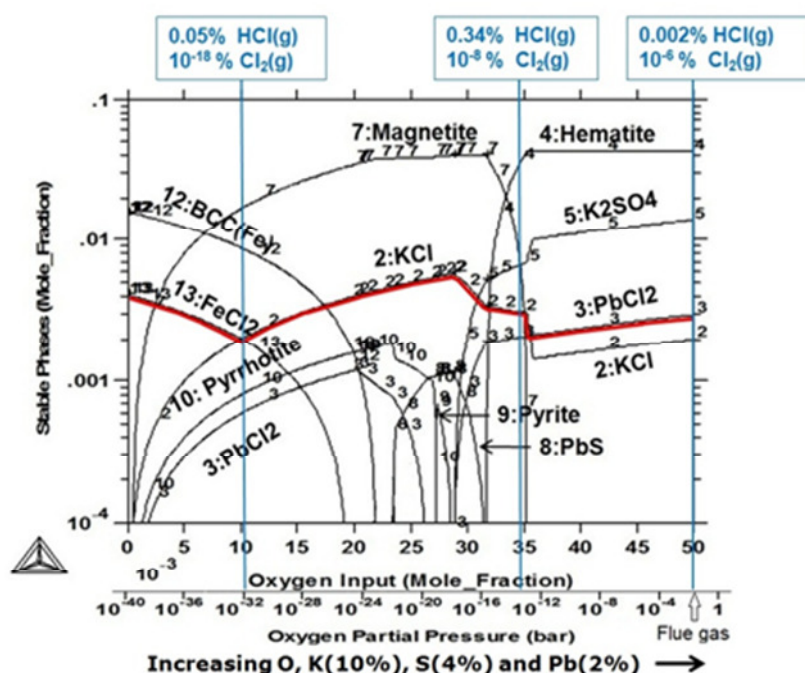
The amounts of chlorine in hydrated form (HCl) and gaseous molecule chlorine ( $\text{Cl}_2$ ) are calculated in the iron case and are shown at three different positions in boxes, Figure 3.7.1. It can be seen from the modelling that chlorine gas exists at extremely low levels (less than 0.1 ppm) at the tube surface at different oxygen partial pressures; instead the hydrated form is thermodynamically favoured, i.e. gaseous hydrogen chloride. (This is a smaller molecule than chlorine which could easily diffuse through a defect oxide of the type formed on the steel). It seems that chlorine can attack low alloy steels by gaseous hydrogen chloride rather than chlorine gas.

**Fig. 3.7.1** Modelling of iron in flue gas at 400°C (input in 1 mole: 0.017Fe, 0.003Cl, 0.01H, balance N and gradient of O, K, Pb and S). The amount of K, Pb and S are related to the oxygen amount by factors 0.1, 0.02 and 0.04, respectively. The dominant Cl phases are shown by the red line. The amounts of HCl and  $\text{Cl}_2$  at 3 different positions are shown in blue boxes.

Fig. 3.7.1 shows that the calculated amount of HCl in the flue gas is 0.002% , or 20 ppm, which is similar to the value of 15 ppm measured by FTIR in the Idbäcken boiler (see section 3.3.1).

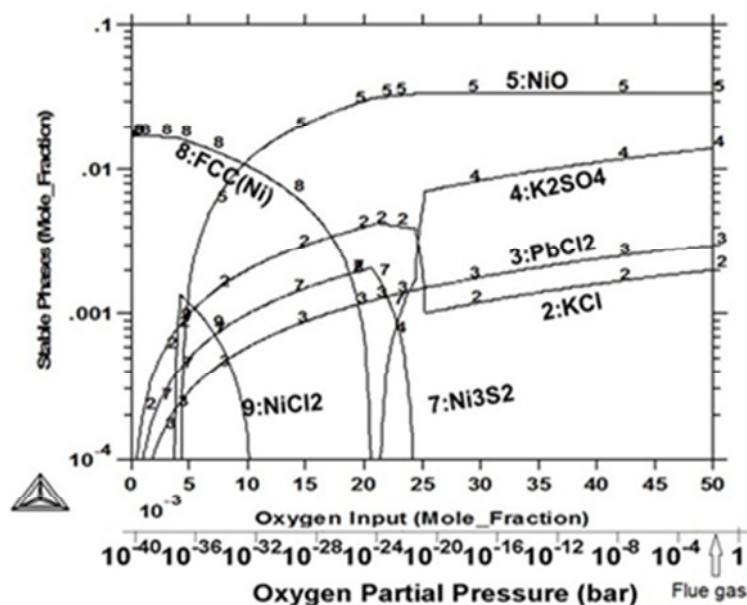
**Fig. 3.7.2 Modelling of nickel. Input in mole: 0.017Ni, (instead of Fe). Otherwise same conditions as Fig. 3.7.1**

As shown in the Thermo-Calc modelling, Figs 3.7.1 and 3.7.2, the stable phases in contact with the flue gas are metal oxides i.e. hematite and nickel oxide. (In the presence of chromium, spinel oxides containing chromium, iron and nickel are thermodynamically expected.) In the presence of heavy metals like zinc and lead, heavy metal chlorides may form as indicated in the modelling by lead chloride. However, at sufficiently high oxygen partial pressures other lead containing phases may form as shown by XRD data from the nickel coated tube, i.e. lead potassium chromate. This phase is unfortunately not included in the Thermo-Calc data bases. Alkali chlorides such as potassium chloride are also expected unless the sulphur and oxygen content is high enough to convert potassium chloride to potassium sulphate. This conversion tendency towards potassium sulphate can be observed in the modelling at higher oxygen partial pressures than  $10^{-16}$  in the case of iron and  $10^{-21}$  in the case of nickel, i.e. this process is thermodynamically more favoured in the case of nickel.
