# **Critical corrosion phenomena in power generation from biomass**

Identification of chlorine resistant high  
temperature coatings/materials

Participants

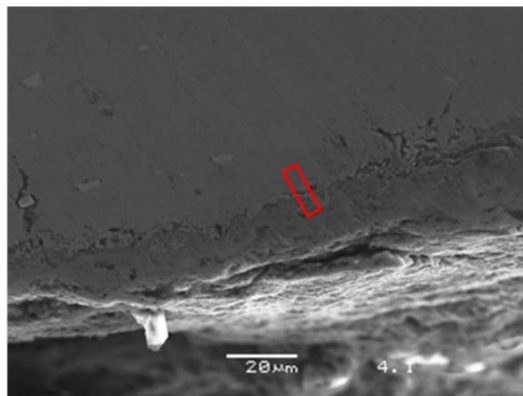
A thin foil for TEM was prepared using focussed ion beam (FIB) and subsequent lift out from the location shown in Figure 5. The thin foil spanned from the outer oxide/corrosion products across the interface to the metal and into the zone with internal grain boundary attack.

**Figure 5:** Location of TEM sample.

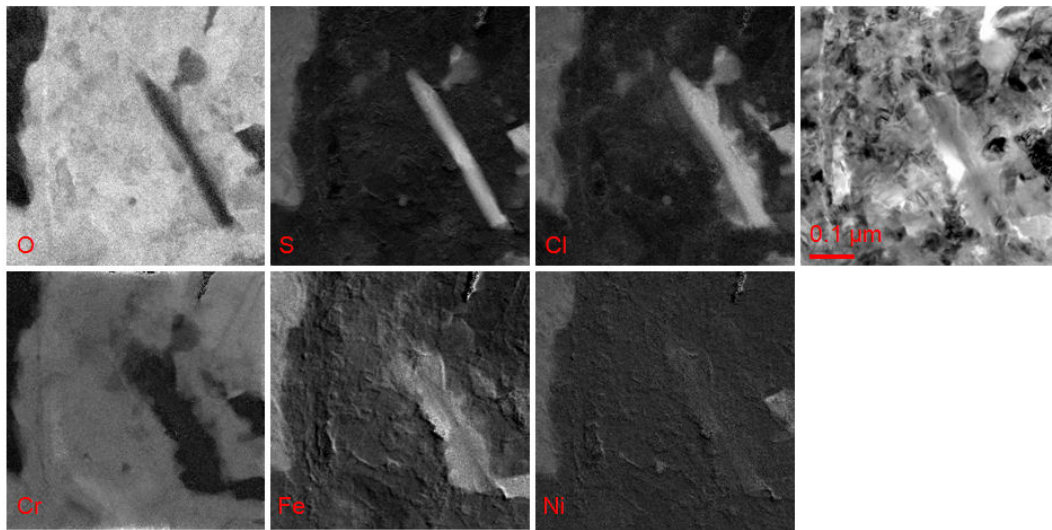
**Figure 7:** Chemical maps obtained using EFTEM and corresponding TEM bright field image. Location 6 in Figure 6.

The investigations reveal that the corrosion layer is inhomogeneous on a nano-scale and further the following observations can be made:

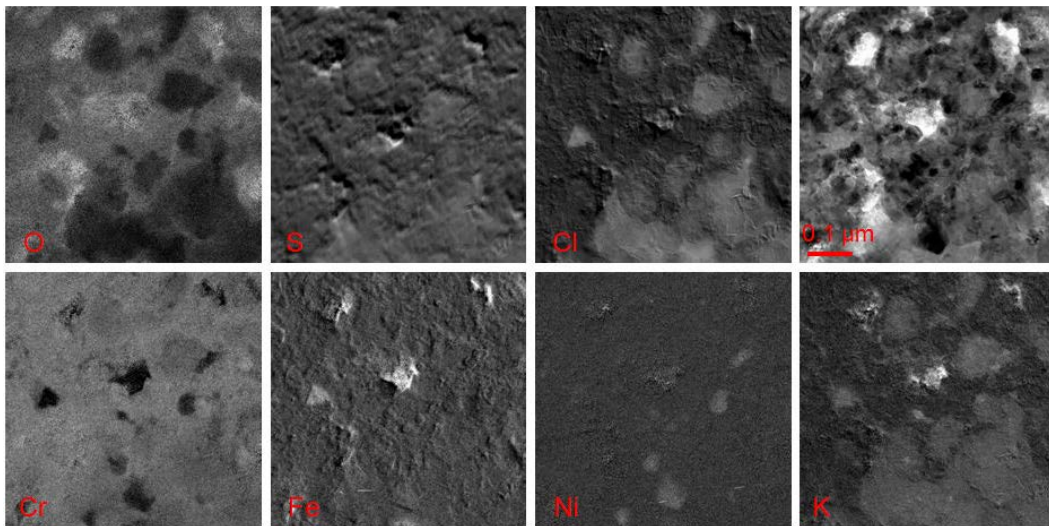
**Figure 8:** Chemical maps obtained using EFTEM and corresponding TEM bright field image. Location 4 in Figure 6.

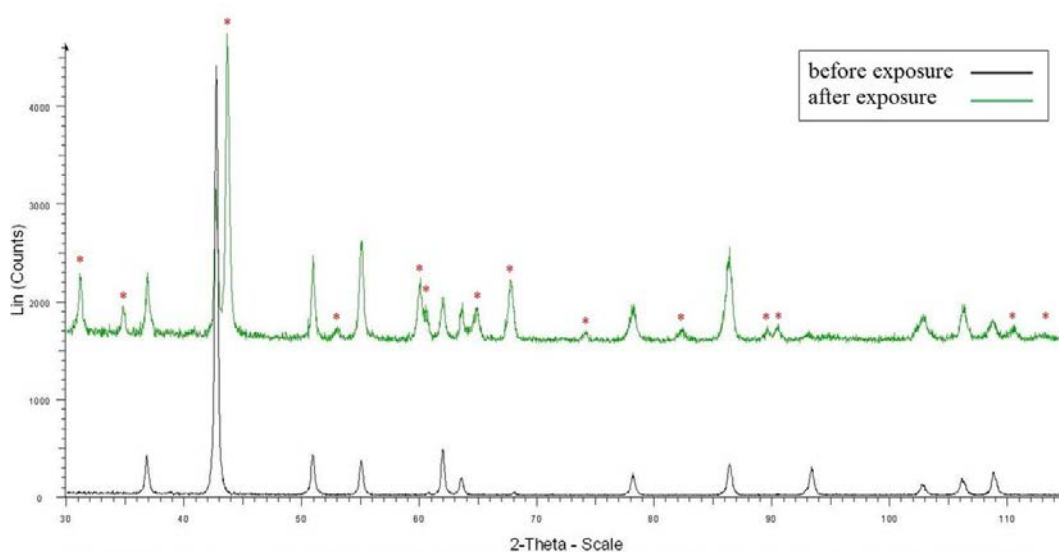
X-ray diffraction (XRD) was used before and after exposures to document the presence of reaction products. Figure 12 shows the measured spectra for  $\text{Cr}_2\text{O}_3$  and clearly shows that potassium-chromate has formed during the exposure.

**Figure 12:** XRD spectra of the pellet consisting of  $\text{Cr}_2\text{O}_3$  and KCl, before and after exposure. The new peaks (marked with stars) that appear after exposure are due to the formation of  $\text{K}_2\text{CrO}_4$ .

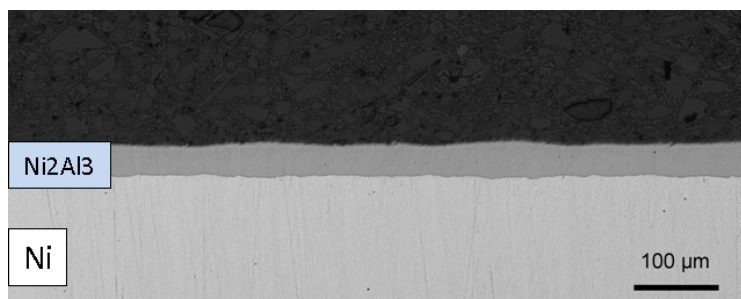
**Figure 15:** Light optical image of the layer formed after aluminising at  $650^\circ\text{C}$  for 8 hours.

The treatment led to formation of a  $\sim 30\mu\text{m}$  thick layer of  $\text{Ni}_2\text{Al}_3$  as shown in Figure 15. The presence of  $\text{Ni}_2\text{Al}_3$  was confirmed by XRD; see Figure 16. A thin

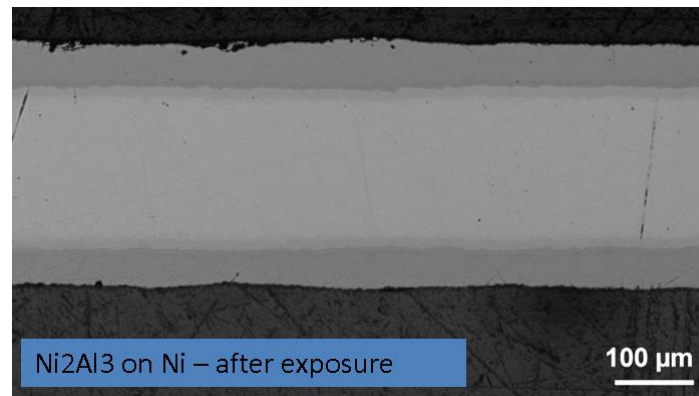
An initial screening experiment was carried out at DTU. An aluminised sample was exposed at 600 °C for one week in static laboratory air after application of approximately 1 mm of KCl powder to one surface (KCl powder particle size of 63-90  $\mu\text{m}$ ). After exposure little or no observable surface degradation was visible, see Figure 17. At the interface between bulk nickel and the coating, the  $\text{NiAl}$  zone has grown as a result of interdiffusion.

**Figure 17:** *Light optical image of an aluminised sample after KCl exposure at 600°C for one week.*

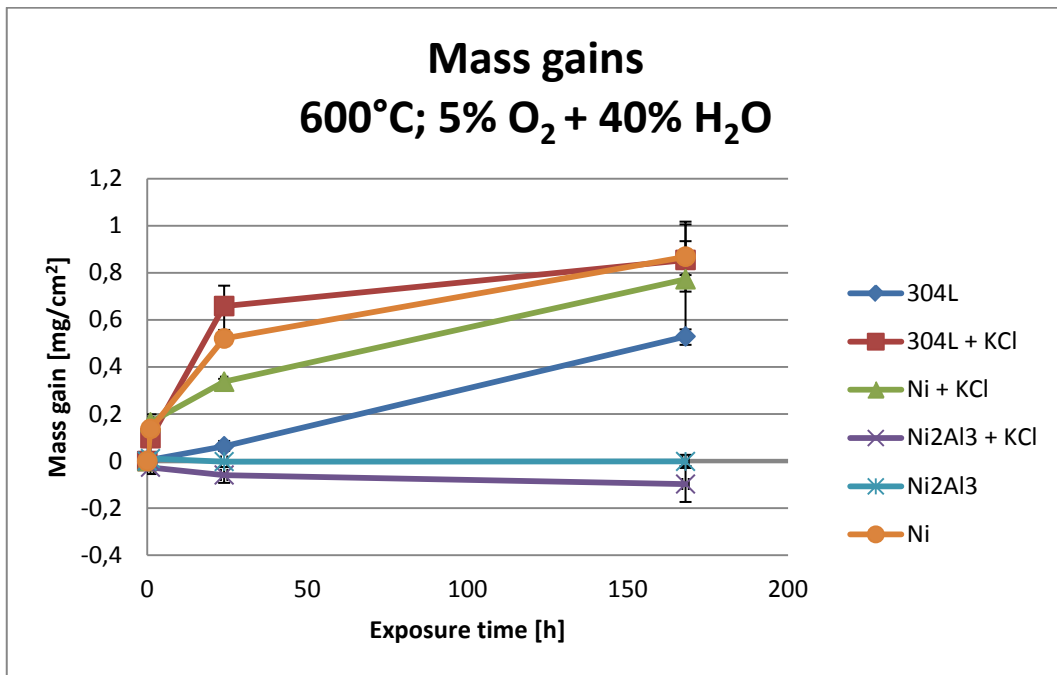
The corrosiveness of small amounts of KCl towards 304L, Ni and  $\text{Ni}_2\text{Al}_3$  is illustrated in Figure 18 showing the mass gain in 5%  $\text{O}_2$  with 40%  $\text{H}_2\text{O}$  with and without KCl(s) at 600 °C. In the presence of KCl the initial corrosion rate is strongly accelerated for the stainless steel. In the absence of KCl the stainless steel shows a non-protective behaviour after longer exposure times

due to evaporation of  $\text{CrO}_2(\text{OH})_2$  in the presence of water vapour [33]. Both Ni without KCl and with KCl show a similar behaviour as the stainless steel in the presence of KCl, i.e. after breakaway corrosion. However the presence of small amounts of KCl does not result in a faster corrosion rate of Ni. Instead both the Ni without and Ni exposed in the presence of KCl follow a similar growth rate. KCl is known to evaporate under these conditions [21], which could explain the smaller mass gain of Ni exposed with KCl. The mass gain of the Ni sample exposed for 168 hours corresponds to a calculated oxide thickness of about 2  $\mu\text{m}$  using NiO. Exposure of the  $\text{Ni}_2\text{Al}_3$  coated sample indicates the formation of a protective oxide scale with small mass gains. The mass gain of the sample exposed for 168 hours without KCl corresponds to a calculated average oxide thickness of 190 nm, using  $\text{Al}_2\text{O}_3$ . The scatter in mass gain is in addition very small. Exposures of the  $\text{Ni}_2\text{Al}_3$  coated samples in the presence of KCl gives a mass loss approximately corresponding to the amount of deposited salt. This indicates that very little of the salt reacts with the  $\text{Ni}_2\text{Al}_3$  phase and that a protective oxide forms also in the presence of KCl similar to the exposure without KCl.

**Figure 18:** Mass gain of 304L, Ni and  $\text{Ni}_2\text{Al}_3$  samples exposed with and without small amounts of KCl(s) in 5%  $\text{O}_2$  with 40%  $\text{H}_2\text{O}$  at 600 °C.

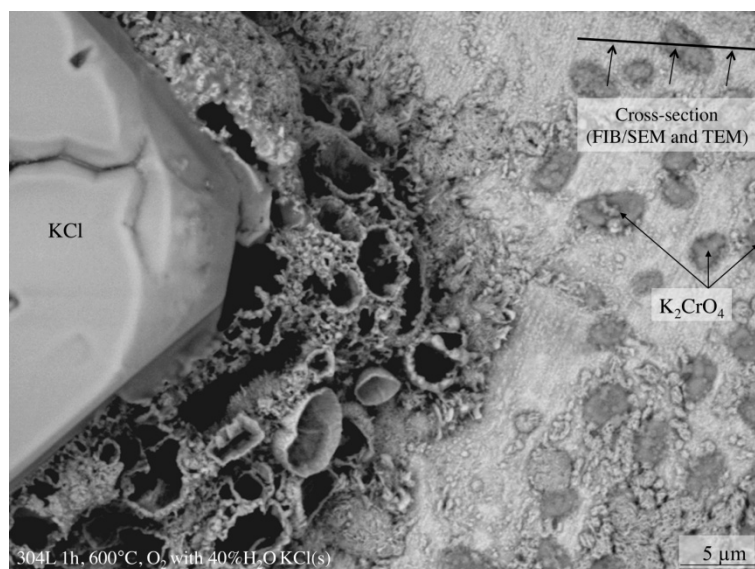
The breakdown mechanism of the protective oxide was investigated. This was done through a detailed microstructure characterization of the oxide scales formed after 1, 24 and 168 h. The presence of KCl(s) causes a breakdown of most of the protective scale, even though it is not in direct contact with KCl(s) particles, starting after only 1 h exposure. A fast growing porous oxide formed in direct contact with (former) KCl(s) particles and an about  $2 \mu\text{m}$  thick scale covered most of the surface. A thin scale covered just some regions after one hour.  $\text{K}_2\text{CrO}_4$  particles were in addition randomly distributed all over the scale after 1 h exposure, see SEM image in Figure 20.

**Figure 20:** SEM BSE image of 304L samples exposed with KCl(s) at 600 °C for 1h.

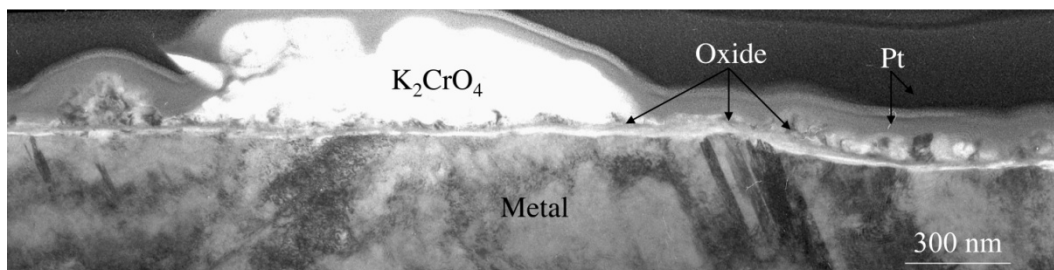
The  $K_2CrO_4$  particles are situated above the oxide scale and are not in direct contact with the subjacent metal, see TEM image of FIB cross-section in Figure 21. The thin scale contains lower Cr levels than has been observed in corresponding scales formed in the absence of KCl. The breakdown of the protective scale is suggested to be caused primarily by the formation of  $K_2CrO_4$ , depleting the protective oxide in chromium [21].

**Figure 21:** TEM image of samples exposed with KCl(s) at 600 °C for 1h (see position of cross-section in Figure 20).

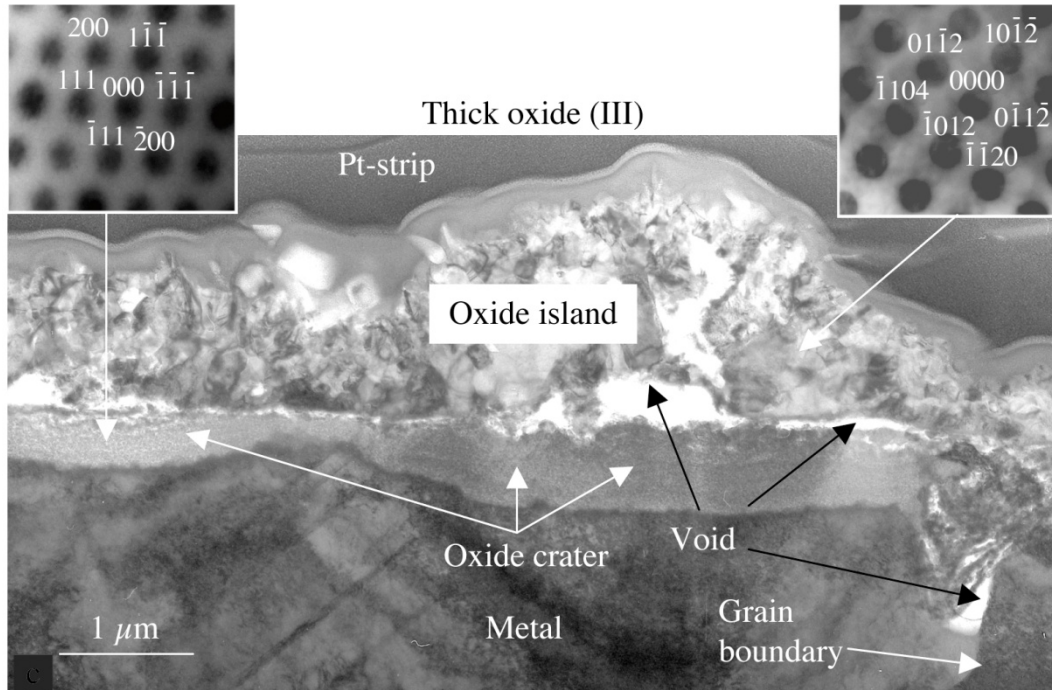
After one hour of exposure large parts of the sample surface was covered with a thicker scale, see Figure 20. The thicker oxide scale is shown in cross-section in Figure 22. The oxide thickness is generally around 1-2  $\mu\text{m}$  but somewhat thinner just above the steel grain boundary. It is built up by a two-layered structure, *i.e.* an outward growing oxide island and an inward growing oxide crater separated by the original metal surface. Convergent beam electron diffraction (CBED) was employed in the TEM to determine the structure of the oxide scale. It showed that the outer layer has a corundum structure while the inward growing layer has a spinel structure, see CBED patterns in Figure 22. At the interface between the oxide island and the oxide crater several micrometer long horizontal voids can be observed. Another type of pores can also be found, with a diameter typically below 200 nm. A void has formed in the vicinity of the steel grain boundary together with some inward growing oxide.

STEM/EDX analysis showed that the outer layer is Fe rich while the inner layer contains a typical composition of 40 wt.% Fe, 40 wt.% Cr and 20 wt.% Ni. Combining the diffraction analysis with quantitative STEM/EDX analysis shows that the oxide island contains almost pure hematite ( $\text{Fe}_2\text{O}_3$ ), while the oxide crater contains  $(\text{Fe,Cr,Ni})_3\text{O}_4$ . No or very little ( $< 0.5$  wt.%) K or Cl could be found in the thick oxide scale.

**Figure 22:** TEM image of the thicker oxide scale formed on samples exposed with KCl(s) at 600 °C for 1h. The thick oxide scale can be divided into an oxide island and an oxide crater. A CBED pattern from the oxide island, indexed a corundum structure ( $\text{M}_2\text{O}_3$ ) with the zone axis  $[2 \ -2 \ 0 \ 1]$  and a CBED pattern from the oxide crater indexed as a spinel structure ( $\text{M}_3\text{O}_4$ ) with the zone axis  $[0 \ -1 \ 1]$  are inserted.

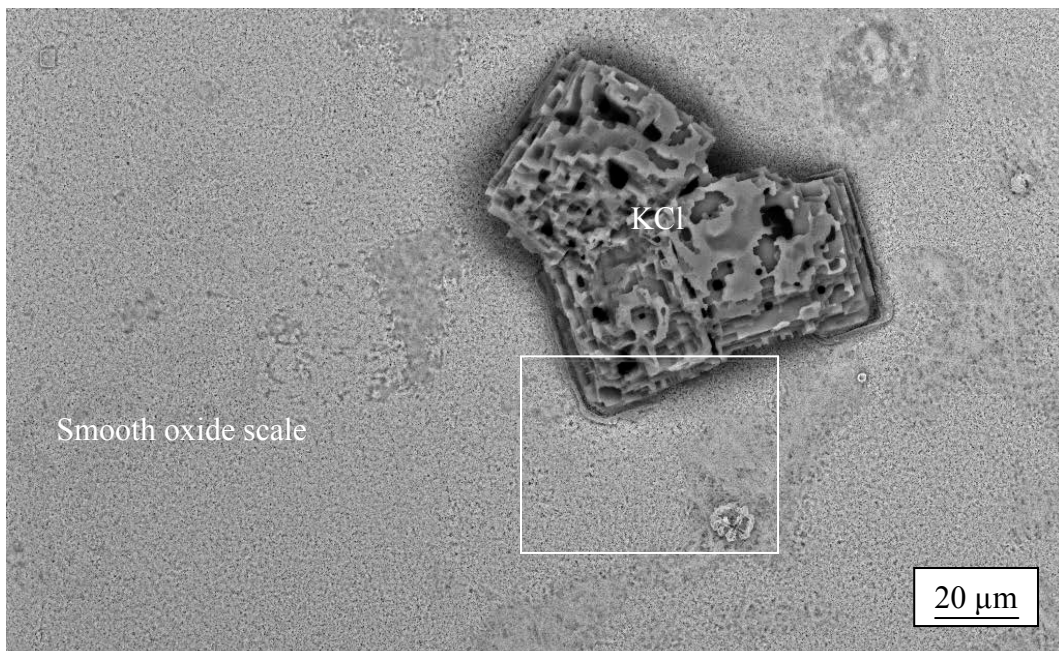
In the presence of KCl the Nickel samples show a smaller mass gain, see Figure 18. This indicates that the growth rate in presence of small amounts of KCl is similar as the reference exposure. The smaller mass gain could be explained by the evaporation of KCl. XRD shows the presence of Ni and NiO on all samples while KCl is detected only after 1 hour of exposure. However, in contrast to the exposures in the absence of KCl, oxidation with KCl(s) gives rise to two different types of morphologies already after 1h exposure, see Figure 24. Thus, the low magnification image in Figure 24 shows a smooth oxide on large parts of the surface while an oxide rim starts to form around KCl particles where KCl particles were deposited prior to the exposure.

**Figure 24:** SEM BSE image of the oxide scale and a KCl particle on pure Nickel after one hour of exposure. The main part of the sample is covered with a smooth oxide scale. The marked area corresponds to Figure 25.

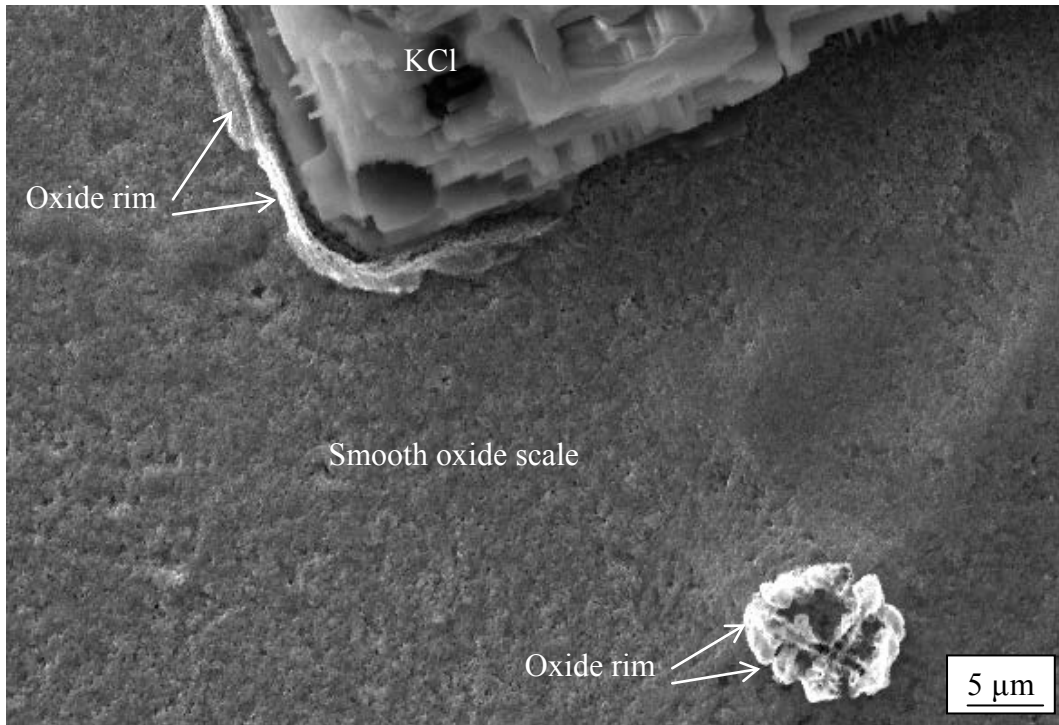
The high magnification SEM SE image in Figure 25 shows that an oxide rim has started to grow in the vicinity of the KCl particle. This phenomenon was observed around all KCl particles while the smooth oxide scale in between particles has the same type of morphology as the samples exposed without KCl.

**Figure 25:** SEM SE image of the oxide scale and a KCl particle on pure Nickel after one hour of exposure, an oxide rim can be seen next to the KCl particle. The main part of the sample is covered with a smooth oxide scale.

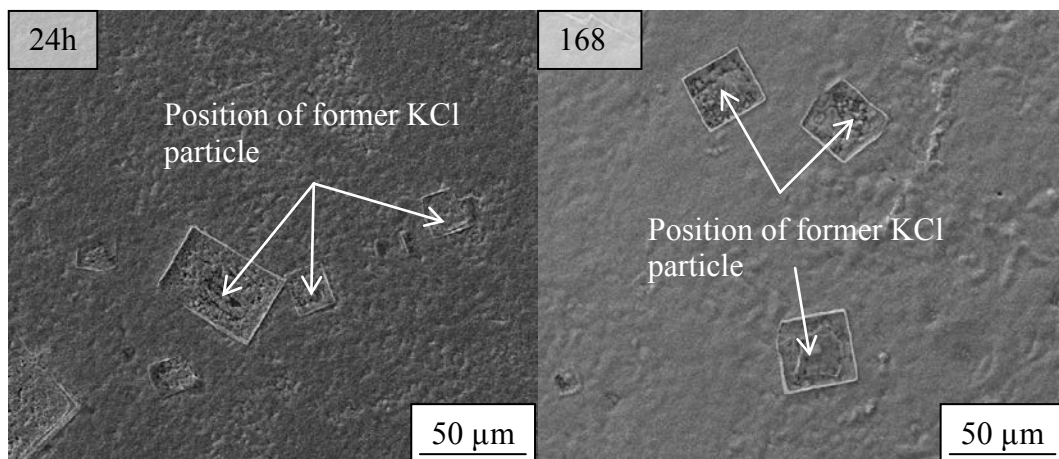
**Figure 26:** SEM SE images of the oxide scale formed after 24 and 168 hours exposure on Nickel in the presence of KCl. The main part of the sample is covered with at smooth oxide scale while oxide rims have formed around former KCl particles.

After longer exposure times (24 and 168h) most of the KCl has vanished probably due to evaporation leaving only the oxide rims indicating former KCl particles position, see Figure 26. No indication of spallation was observed.
