# **FeCrAl alloys as components in biomass– and waste– fired boilers**

Kristina Hellström, Niklas Israelsson, Jan–  
Erik Svensson, Bo Jönsson, Dilip  
Chandrasekaran, Johanna Nockert–Olovsjö,  
Anna Jonasson, Bengt–Åke Andersson, Paul  
Cho, Per Kallner, Pamela Henderson

The corrosion resistance of certain components in a waste-fired boiler can be improved significantly if the existing material is replaced with FeCrAl material, such as thermo shield tubes and shielding of superheaters. The results also surprisingly show that the pre-oxidation is not favorable when the material is used at lower temperatures, below 700 °C. This means that production of major boiler components in FeCrAl material would be greatly facilitated.

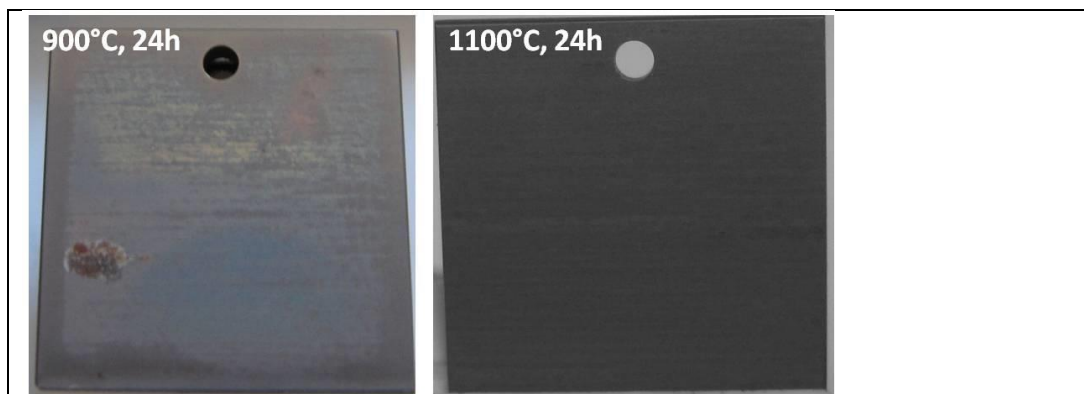
After a second exposure with KCl, a few percent of the surface was corroded on the material pre-oxidized for 24 hours at 900 °C (*Figure 6-21*). The corrosion started on the surface far from an edge. The material pre-oxidized for 24 hours at 1100 °C showed the same appearance as after the first cycle. However, after a third exposure with KCl also this surface showed signs of corrosion, but only on a minor part of the surface. The corrosion had started at the edges of a drilled hole and at a small area on the polished surface.

Figure 6-21. SEM images of the surface of APMT pre-oxidized at different times and temperatures and thereafter oxidized two times in the presence of  $H_2O$  and KCl for 24 hours at 600 °C.

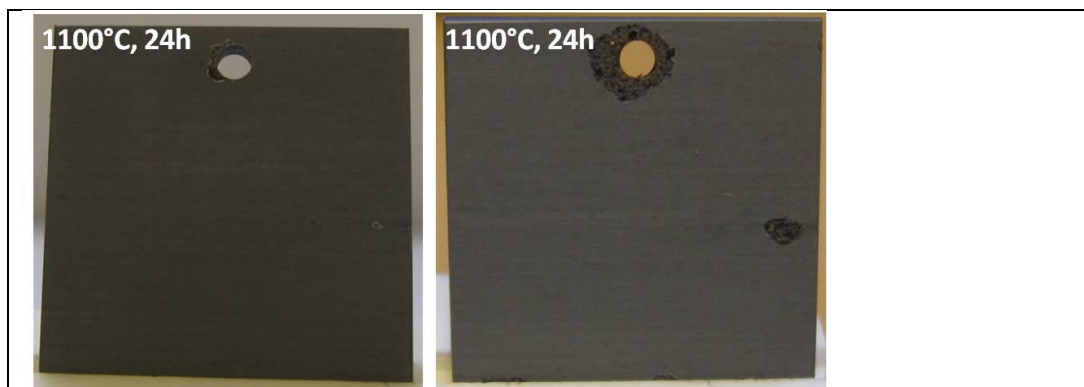
After an additional exposure with KCl the already corroded areas had become larger, now covering about 5% of the surface (Figure 6-22). However, there were no new spots where the corrosion had started, indicating that the corrosion starts at defects in the protective scale.

Figure 6-22. SEM images of the surface of APMT pre-oxidized at different times and temperatures and thereafter oxidized 3 (to the left) and 4 (to the right) times in the presence of  $H_2O$  and KCl for 24 hours at 600 °C.

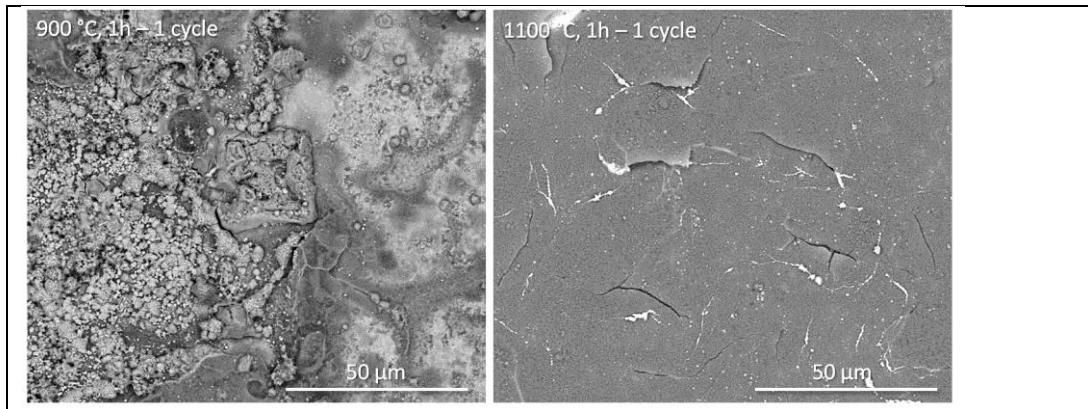
SEM investigation of the surface of the material pre-oxidized for 1 hour at 900 °C and thereafter cycled once in the presence of  $O_2$ ,  $H_2O$  and KCl reveals an uneven surface with iron-rich oxide protrusions (Figure 6-23). The same kind of areas can be seen on the material pre-oxidized for 1 hour at 1100 °C and

cycled 1 time. In addition the  $\text{Al}_2\text{O}_3$  scale from the pre-oxidation is cracked, with iron-rich oxide growing in the cracks as can be seen (Figure 6-23).

Figure 6-23. SEM image of the surface of APMT pre-oxidized at 900 or 1100 °C for 1 hour and thereafter oxidized in the presence of  $\text{H}_2\text{O}$  and  $\text{KCl}$  for 24 hours at 600°C.

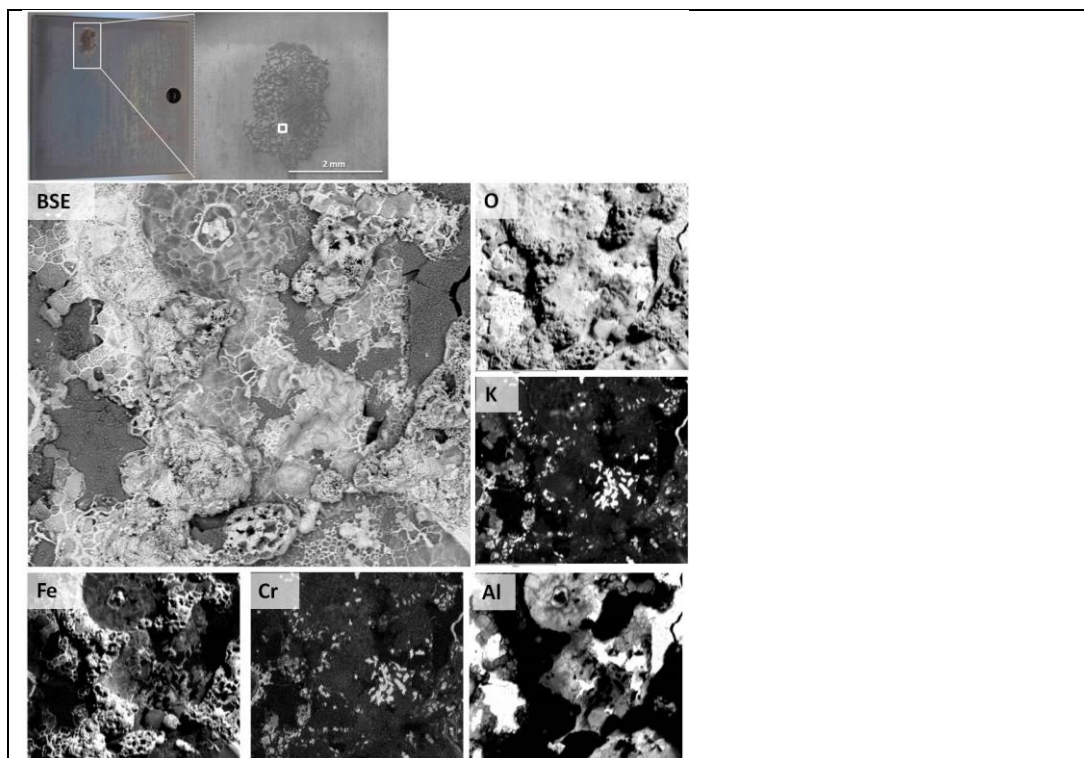
Analyses of the surface corrosion product show the formation of  $\text{K}_2\text{CrO}_4$  and Fe-rich oxide (Figure 6-24) comparable with the exposures of non-pre-oxidised FeCrAl samples.

Figure 6-24. SEM image of the surface of APMT pre-oxidized at 900 °C for 24 hour and thereafter oxidized for 2 cycles in the presence of O<sub>2</sub>, H<sub>2</sub>O and KCl for 24 hours at 600 °C.

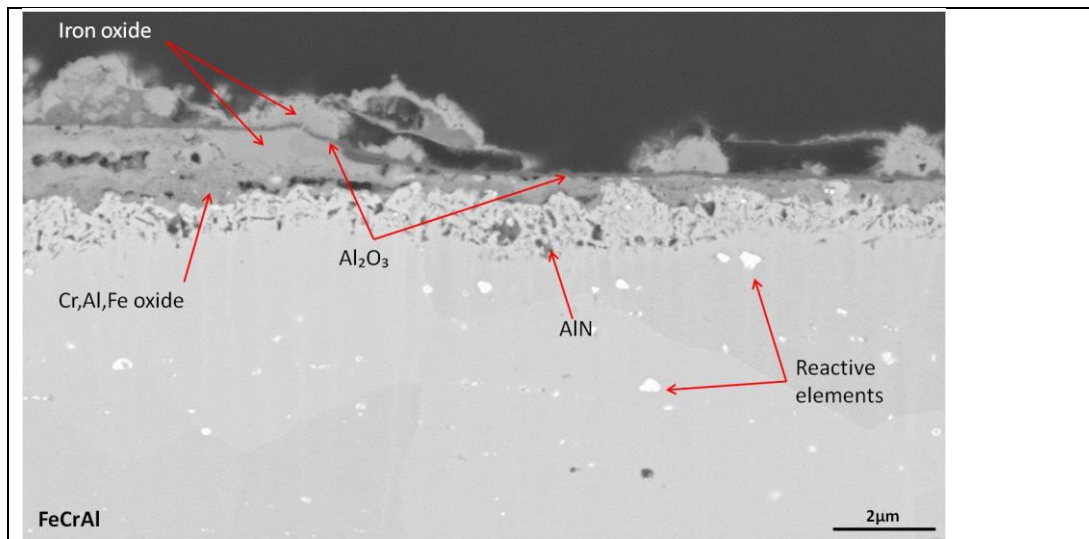
Cross sections of these oxides are shown in figure *Figure 6-25* and *Figure 6-26*. The cross section of the material pre-oxidized for 1 hour at 900 °C (*Figure 6-25*) reveals different stages of the oxidation. Iron-rich oxide forms inward and outward to the alumina scale. The oxide formation mainly seems to start inward and with time also starts to form at the gas/scale interface. A Cr-rich oxide that also contains substantial amounts of iron and aluminum is present closest to the alloy surface. It seems likely that the oxidation starts at defects and spreads below the alumina scale. The volume increase during oxidation then causes tensions in the Al<sub>2</sub>O<sub>3</sub> scale that eventually cracks resulting in the formation of oxide protrusions above the scale. Needle-like AlN particles forms in the alloy substrate just beneath the oxide scale. The formation of AlN likely inhibits the healing process of the formed cracks in the alumina scale due to the decreased Al activity in the substrate.

Figure 6-25. SEM image of the cross section of APMT pre-oxidized at 900°C for 1 hour and thereafter oxidized in the presence of  $O_2$ ,  $H_2O$  and KCl for 24 hours at 600°C.

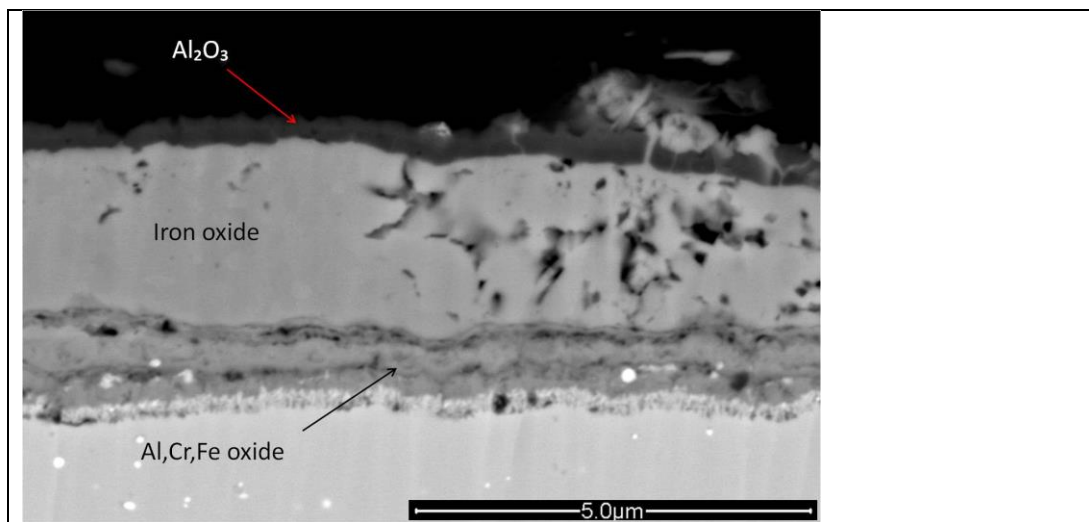
The cross section of the sample pre-oxidized for 1 hour at 1100 °C and cycled 1 time shows a similar oxide structure as the cross section in Figure 6-25. One difference is that the oxide formed in Figure 6-26 grows mainly inward compared to the alumina scale. An iron-rich oxide protrusion can be seen above the present cracks in the  $Al_2O_3$  scale.

Figure 6-26. SEM image of the cross section of APMT pre-oxidized at 1100 °C for 1 hour and thereafter oxidized in the presence of  $O_2$ ,  $H_2O$  and KCl for 24 hours at 600 °C.

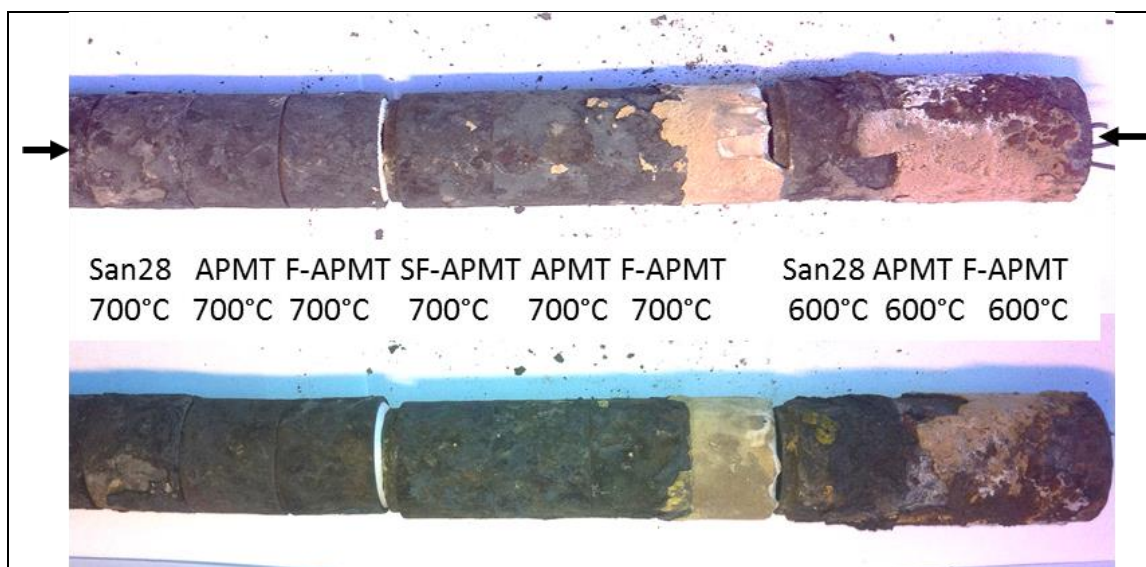
Figure 6-30 shows two optical images of the samples exposed for 1000 hours. The upper image is facing the camera with the windward side and the lower one is turned 180°. Between the sample F-APMT 700°C and San28 600°C there is a ceramic bright colored piece separating the samples. No deposit remained on the samples exposed at 700 °C after demounting. However, again there was a substantial amount of beige-gray, yellow and white colored deposit attached to the samples exposed at 600 °C. The surfaces which had lost their deposits ranged from gray to black. The rough morphology and the colors observed indicate that the rings were severely corroded. With respect to corrosion resistance no major distinction between the alloys could be made by visual inspection. During separation of the samples from each other all the deposit fell off.

Figure 6-30. Photo showing the samples after probe exposure for 1000 h. Sanicro 28 to the left followed by Kanthal® APMT, pre-oxidised Kanthal® APMT, standard pre-oxidized Kanthal® APMT, Kanthal® APMT, pre-oxidised Kanthal® APMT, Sanicro 28, Kanthal® APMT and pre-oxidised Kanthal® APMT to the right. The arrows on the topmost image mark the position of the thermal element (facing the winward side). The samples on the image below have been turned 180°.

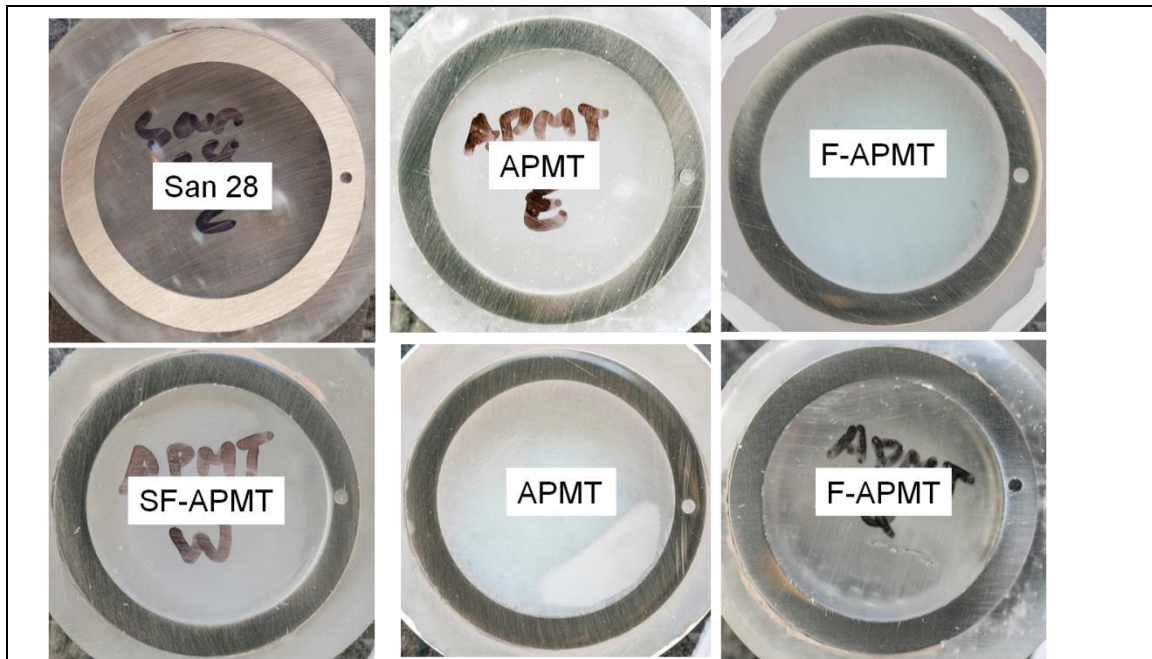
Figure 6-32 show camera images of polished cross-sections of the samples exposed for 24 h at 700 °C. The surface of the samples exposed appears smooth, without any visible material loss. After 400 h, the surface of Sanicro 28 is very rugged all around the circumference, indicating substantial material loss. The surfaces of the APMT and pre-oxidized APMT samples also have some rugged areas but to a much lesser extent than Sanicro 28. The uneven surface of pre-oxidized APMT and APMT appears mostly on the half

circumference towards the wind side and are also pronounced on top of the as was the case after exposure at 600 °C for 24 h.

Figure 6-32. Photos showing the cross-sections of the samples after probe exposure at 700°C for 24 h. The pre-oxidized APMT is marked "F-APMT" and Sanicro 28 "San 28".

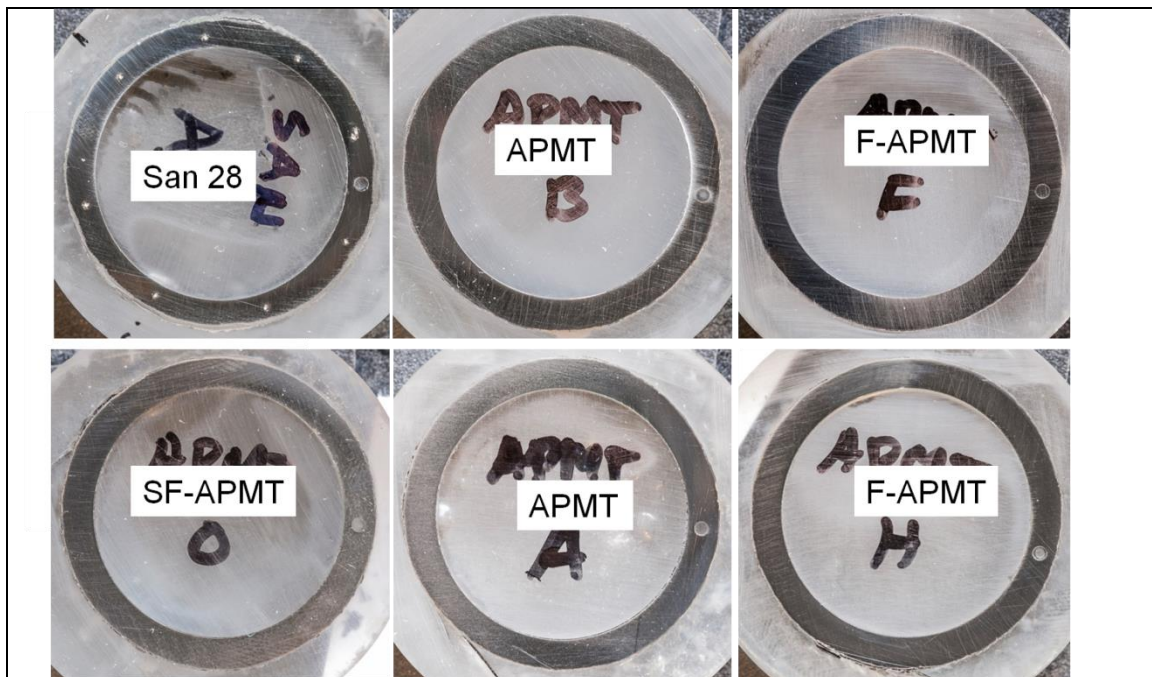
Figure 6-33 show camera images of polished cross-sections of the samples exposed for 400 h at 700°C. The surface of Sanicro 28 appears very rugged all around the circumference. The APMT samples with and without pre-oxidation appears rather similar. They are a little bit rugged on the surface but much less than Sanicro 28.

Figure 6-33. Photos showing the cross-sections of the samples after probe exposure at 700°C for 400 h. The pre-oxidized APMT is marked "F-APMT" and Sanicro 28 "San 28".

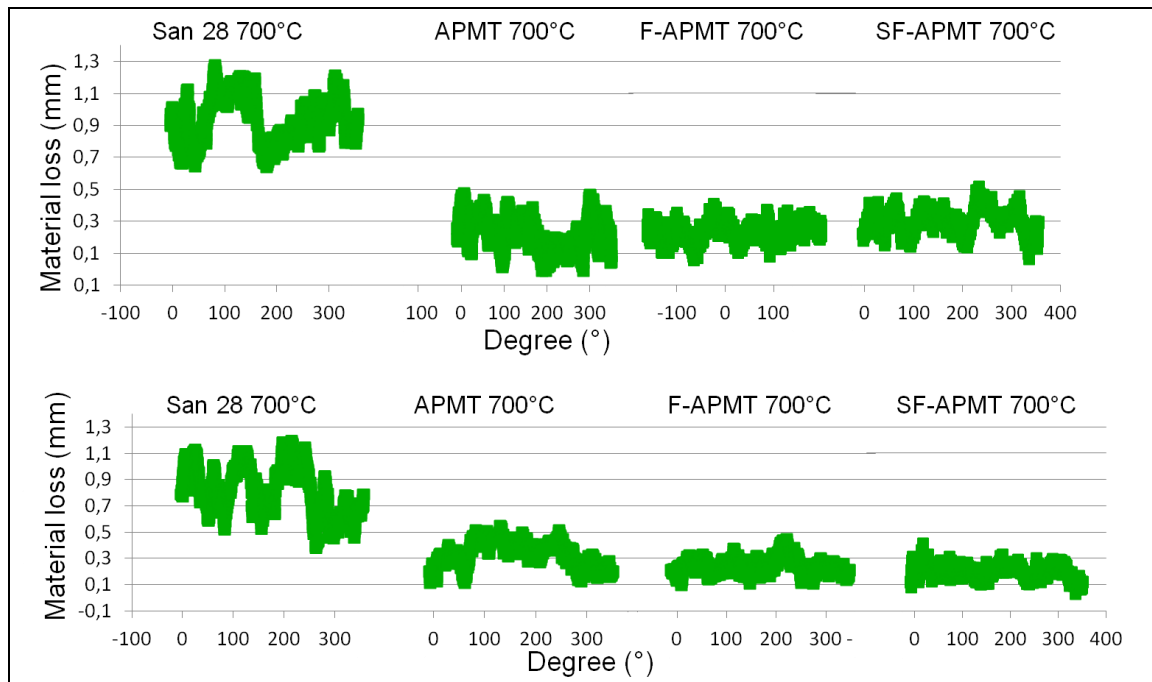
*Figure 6-36* show the material loss around the circumference of Sanicro 28, APMT and pre-oxidized APMT (SF-APMT and F-APMT) after probe exposure at 700°C for 400 h and 1000 h. The material marked SF-APMT was pre-oxidized at 1050°C for 8 h and F-APMT at 1100°C for 24 h. 0° at the x-axes is the position of the thermo couple. The mean, max and min values obtained for the material loss of these materials is shown in *Table 6-3*. The obtained material loss values are in accordance with the cross-sectioned images, the most rugged surface shows the highest material loss values. Similar to the values obtained after exposures at 600°C, Sanicro28 had lost substantially more material than the APMT materials with and without pre-oxidation after exposure at 700°C for 400 h and 1000 h, the average value for Sanicro28 being around 0.9 mm as compared to around 0.3 for the APMT materials. Here the similarities with the 600°C exposure stop. After exposure at 700°C and 400 h the APMT materials with and without pre-oxidation show similar material loss values, and after 1000 h the pre-oxidized APMT showed somewhat lower values than APMT without pre-oxidation, the average values being similar (0.3 mm) but the max value being ~0.4 and 0.5 mm

respectively. Comparing the material loss of all the samples exposed at 700°C, the material loss appears to be random around the circumference, there is no preferred orientation with higher material loss.

Figure 6-36. Curves showing the material loss around the circumference of Sanicro 28, APMT and pre-oxidized APMT after probe exposure at 700°C for 400 h and 1000 h. 0° at the x-axes is the position of the thermo couple. The material marked SF-APMT was pre-oxidized at 1050°C for 8 h and F-APMT at 1100°C for 24 h.

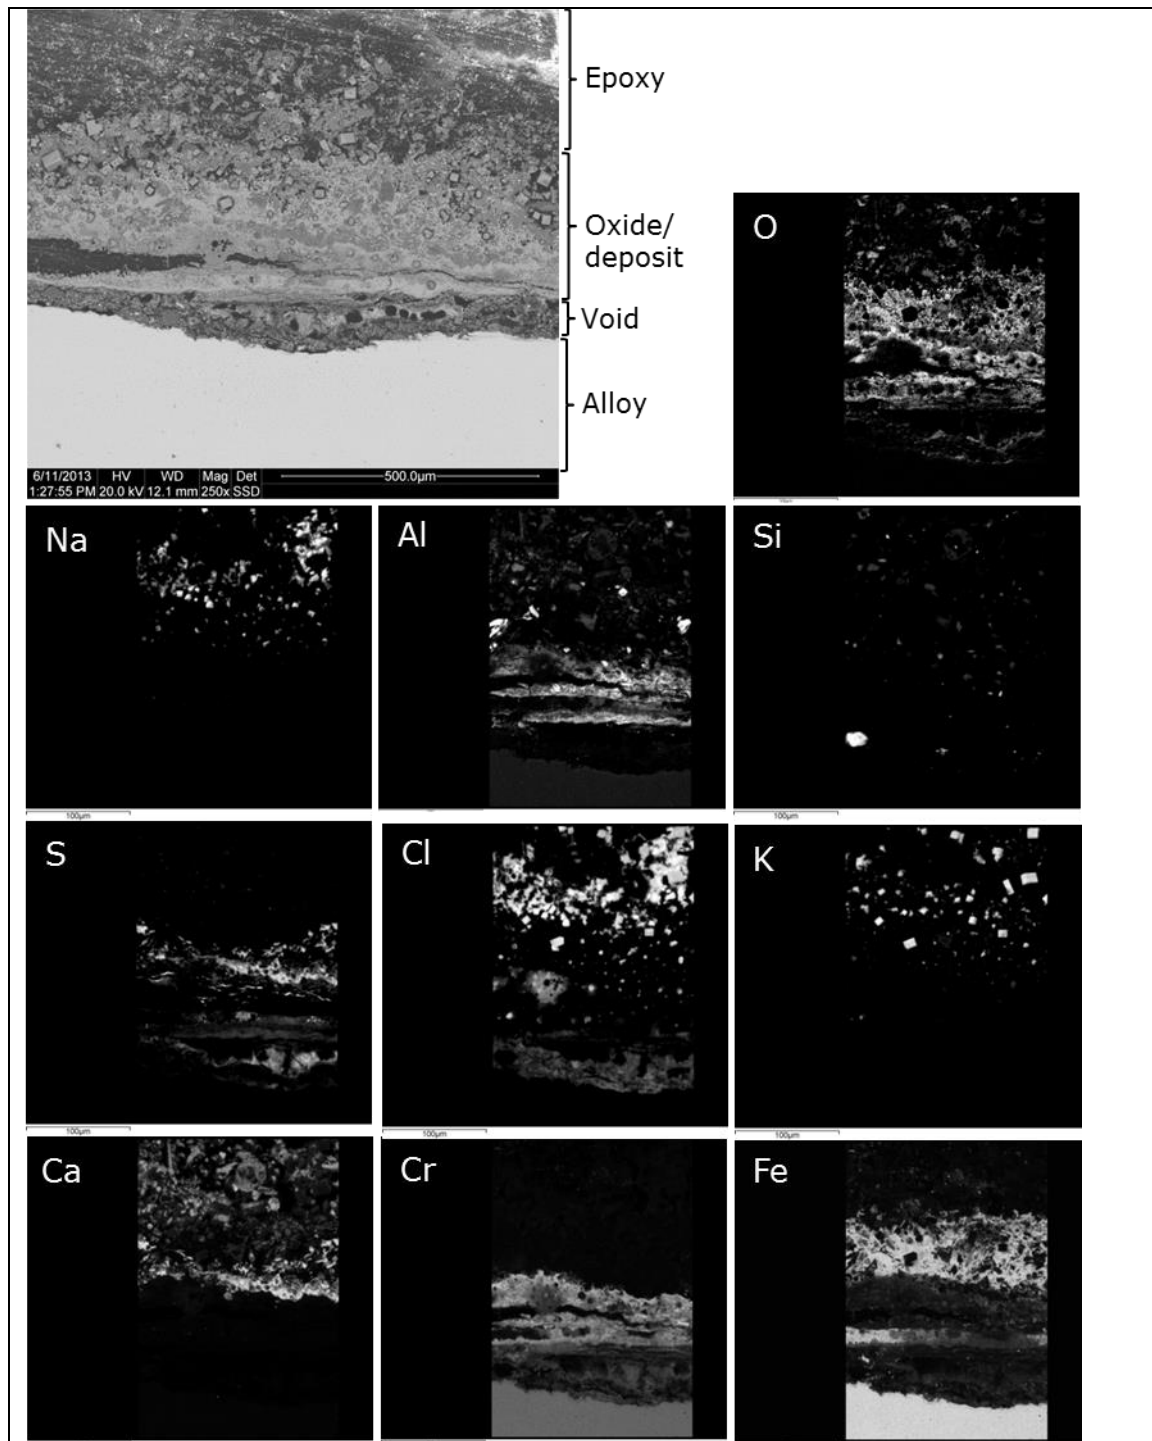
Both the non-treated APMT and the pre-oxidized (1100 °C, 24h) have a thick deposit layer on top of the oxide scale (*Figure 6-37* and *Figure 6-38*). The elemental maps in *Figure 6-37* and *Figure 6-38* shows that the deposit mainly

consists of K, Na, Cl, Ca, S. These elements correspond well to NaCl, KCl and CaSO<sub>4</sub> which were detected using XRD (see *Table 6-4* and *Table 6-5*). The APMT sample without pre-oxidation forms a mixed oxide of Fe, Cr and Al (*Figure 6-37*). The alloy does not form a continuous pure Al<sub>2</sub>O<sub>3</sub> at the present environment. The continuous Al<sub>2</sub>O<sub>3</sub> layer from the pre-oxidation of APMT (1100 °C, 24 h) does not show protective behavior and has failed already after 24 hours of exposure at 600 °C in the boiler (See *Figure 6-39*). A iron, chromium-rich oxide has formed over and under the former protective alumina layer. Chlorides and sulfur were detected in the oxide/alloy interface on both samples and is believed to be metal chlorides (e.g CrCl<sub>2</sub>, FeCl<sub>2</sub>) and sulfides of the alloying elements (See *Figure 6-37* and *Figure 6-39*). No depletion of the alloying elements was detected in the alloy beneath the scale on both samples.

Figure 6-37. SEM-BSE image and elemental maps of the cross-section of APMT exposed for 24 hours at 600 °C.

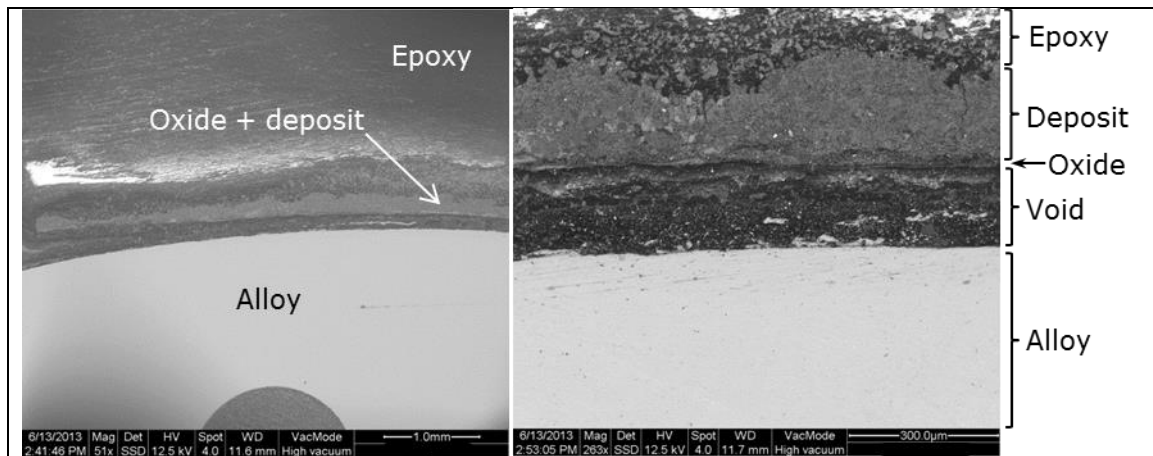
Figure 6-38. SEM-BSE images of the cross-section of pre-oxidized APMT (1100 °C for 24 h) APMT exposed for 24 hours at 600 °C.

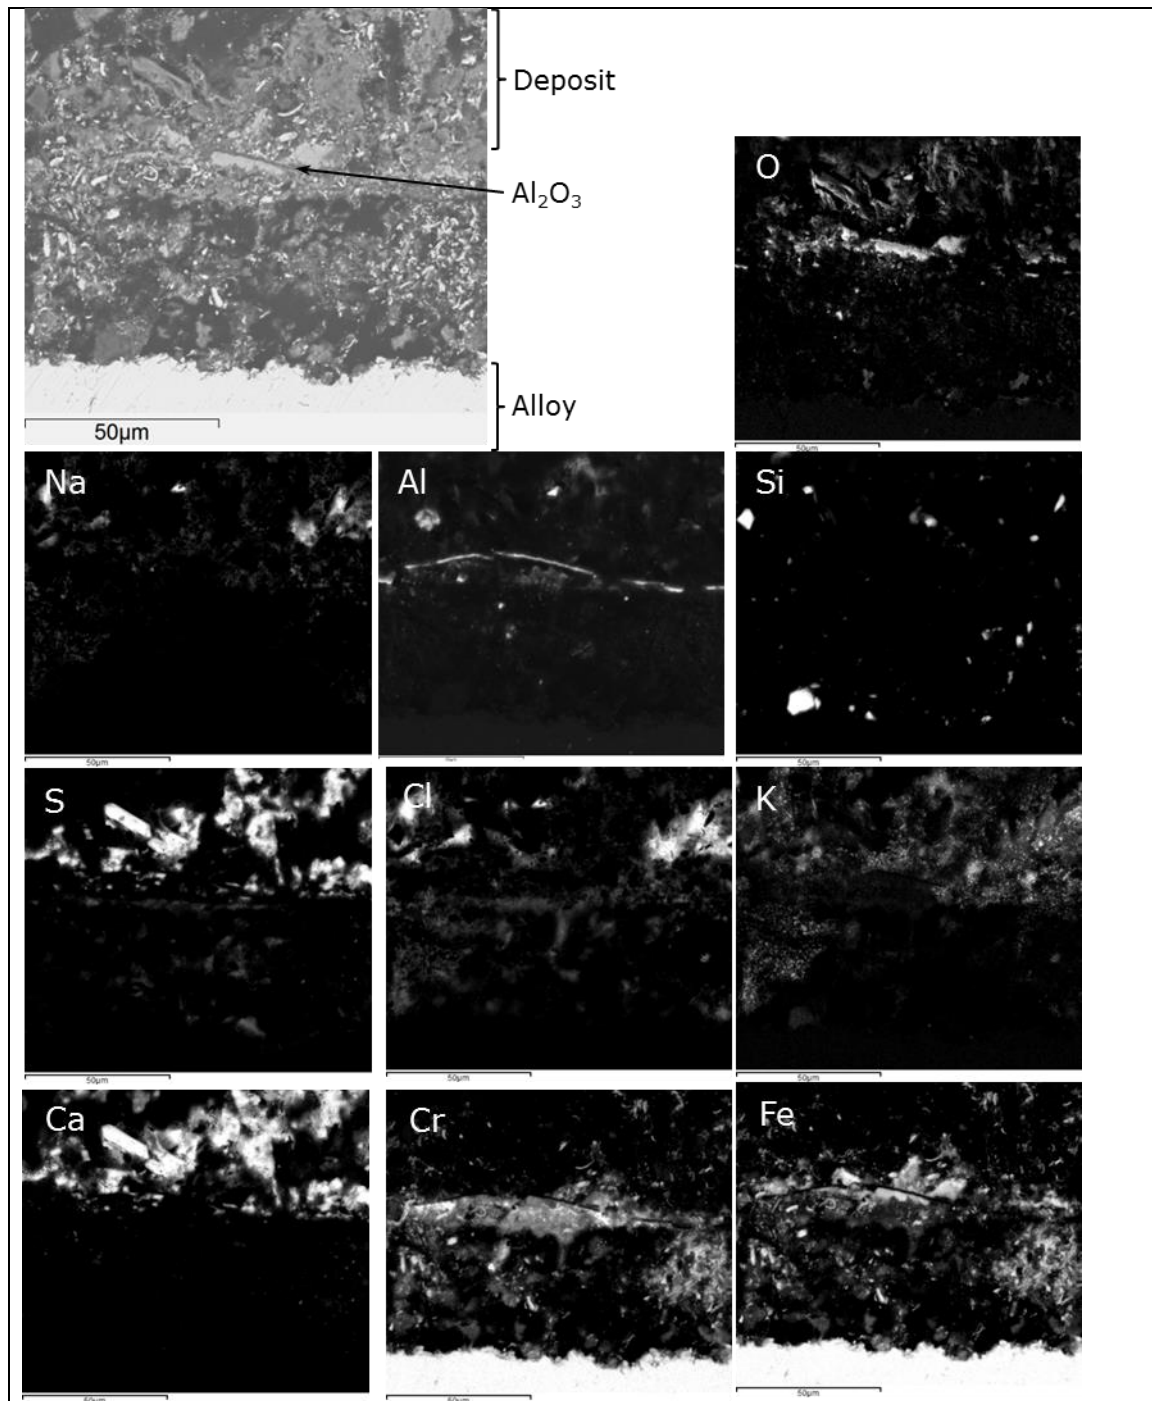
Figure 6-39. SEM-BSE image and elemental maps of the cross-section of pre-oxidized APMT (1100 °C for 24 h) exposed for 24 hours at 600 °C.

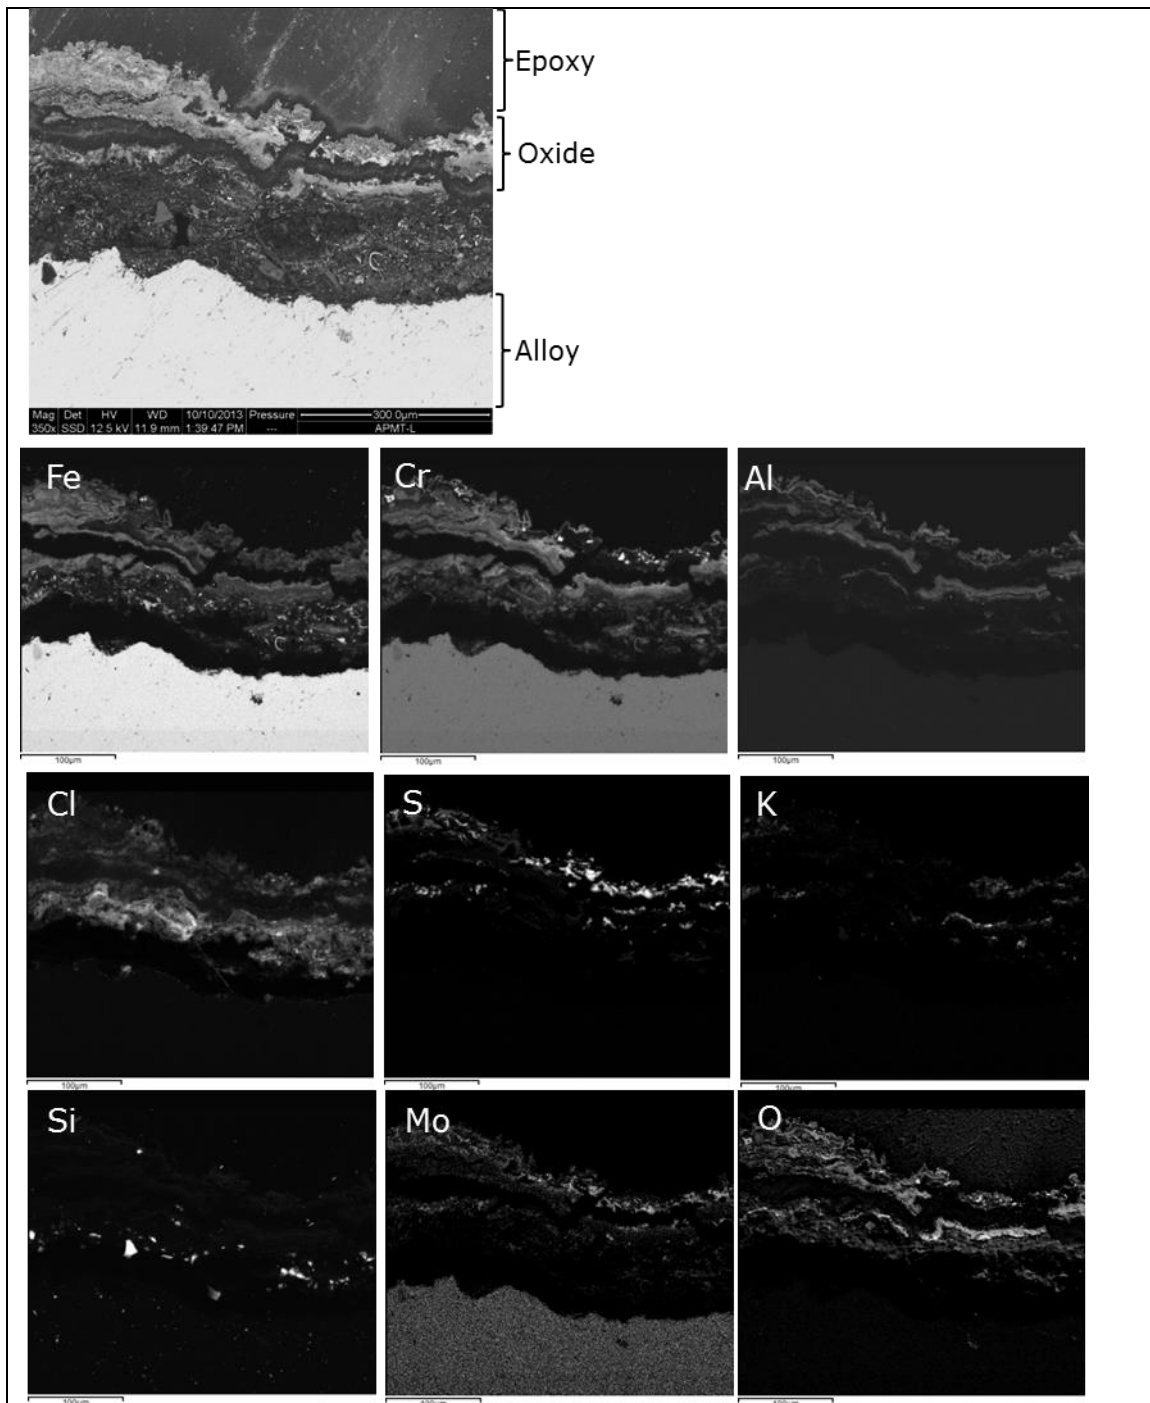
The majority of the deposit layer is not present after 1000 hours of exposure at 600 °C, however some of the deposit was detected on the pre-oxidized sample and consisted of NaCl and KCl (*Figure 6-41*). No protective alumina layer was detected on the non-treated APMT or the pre-oxidized APMT (1100 °C, 24h). The present oxide scale is similar on both samples and consists of a mixture of Fe, Cr, Al oxides (*Figure 6-40* and *Figure 6-41*). Sulfur is found in the oxide while a ~60-100 µm thick metal chloride layer is present between the oxide and alloy on both samples (*Figure 6-40* and *Figure 6-41*). No depletion of the alloying elements was detected in the alloy beneath the scale on both samples after 1000 hours exposure at 600 °C.

Figure 6-40. SEM-BSE image and elemental maps of the cross-section of APMT exposed for 1000 hours at 600 °C.

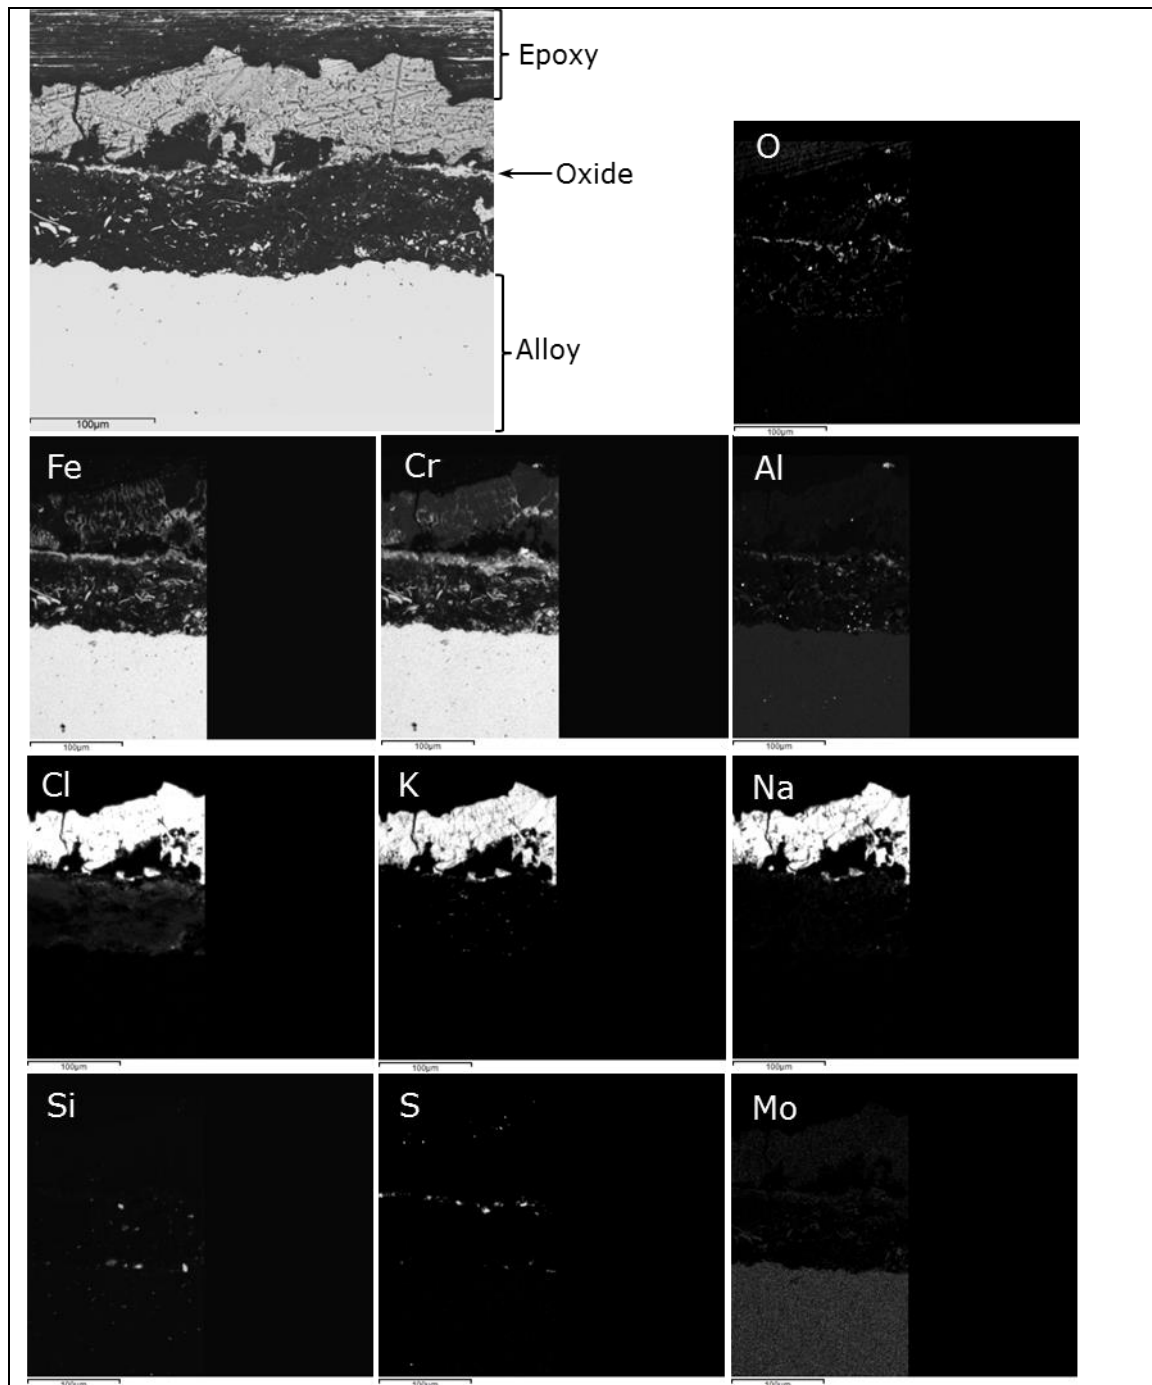
Figure 6-41. SEM-BSE image and elemental maps of the cross-section of pre-oxidized APMT (1100 °C for 24h) exposed for 1000 hours at 600 °C.

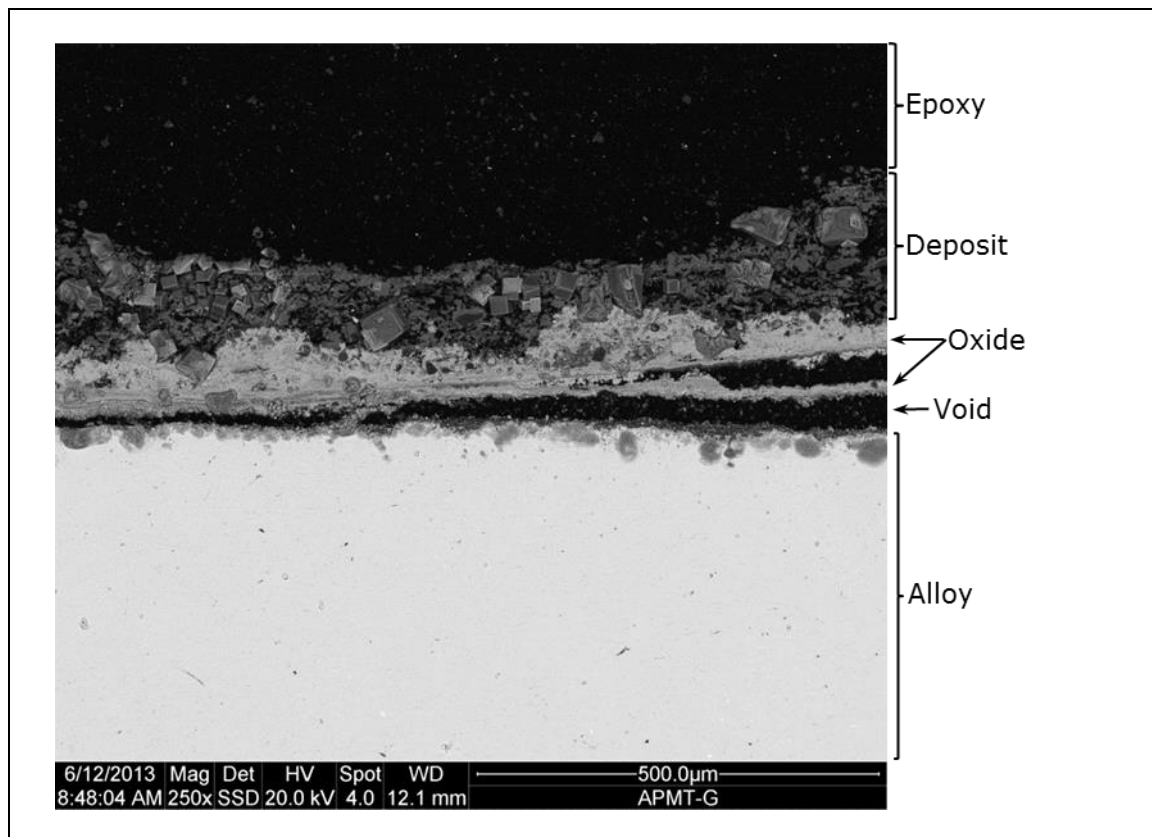
The non-treated APMT coped better at 700 °C compared to 600 °C. The formed oxide at 700 °C seems denser and no iron-rich oxide is detected in the deposit layer as after 600 °C (compare *Figure 6-37*, *Figure 6-42* and *Figure 6-43*). The alloy tries to form a continuous alumina layer at least two times during the first 24 hours as can be seen in *Figure 6-43*. Instead of the desired alumina layer a mixed oxide of Fe, Al and Cr is formed similar as at 600 °C. Not as much metal chlorides were detected compared to 600 °C after 24 hours. Sulfur was detected at the oxide/alloy interface. Chromium rich metallic precipitates are detected in the alloy (*Figure 6-43*). Roughly 30 µm of the alloy beneath the oxide scale is depleted in aluminium and chromium and is believed to be connected to the chromium-rich metallic precipitates.

*Figure 6-42. SEM-BSE image of the cross-section of APMT exposed for 24 hours at 700 °C.*

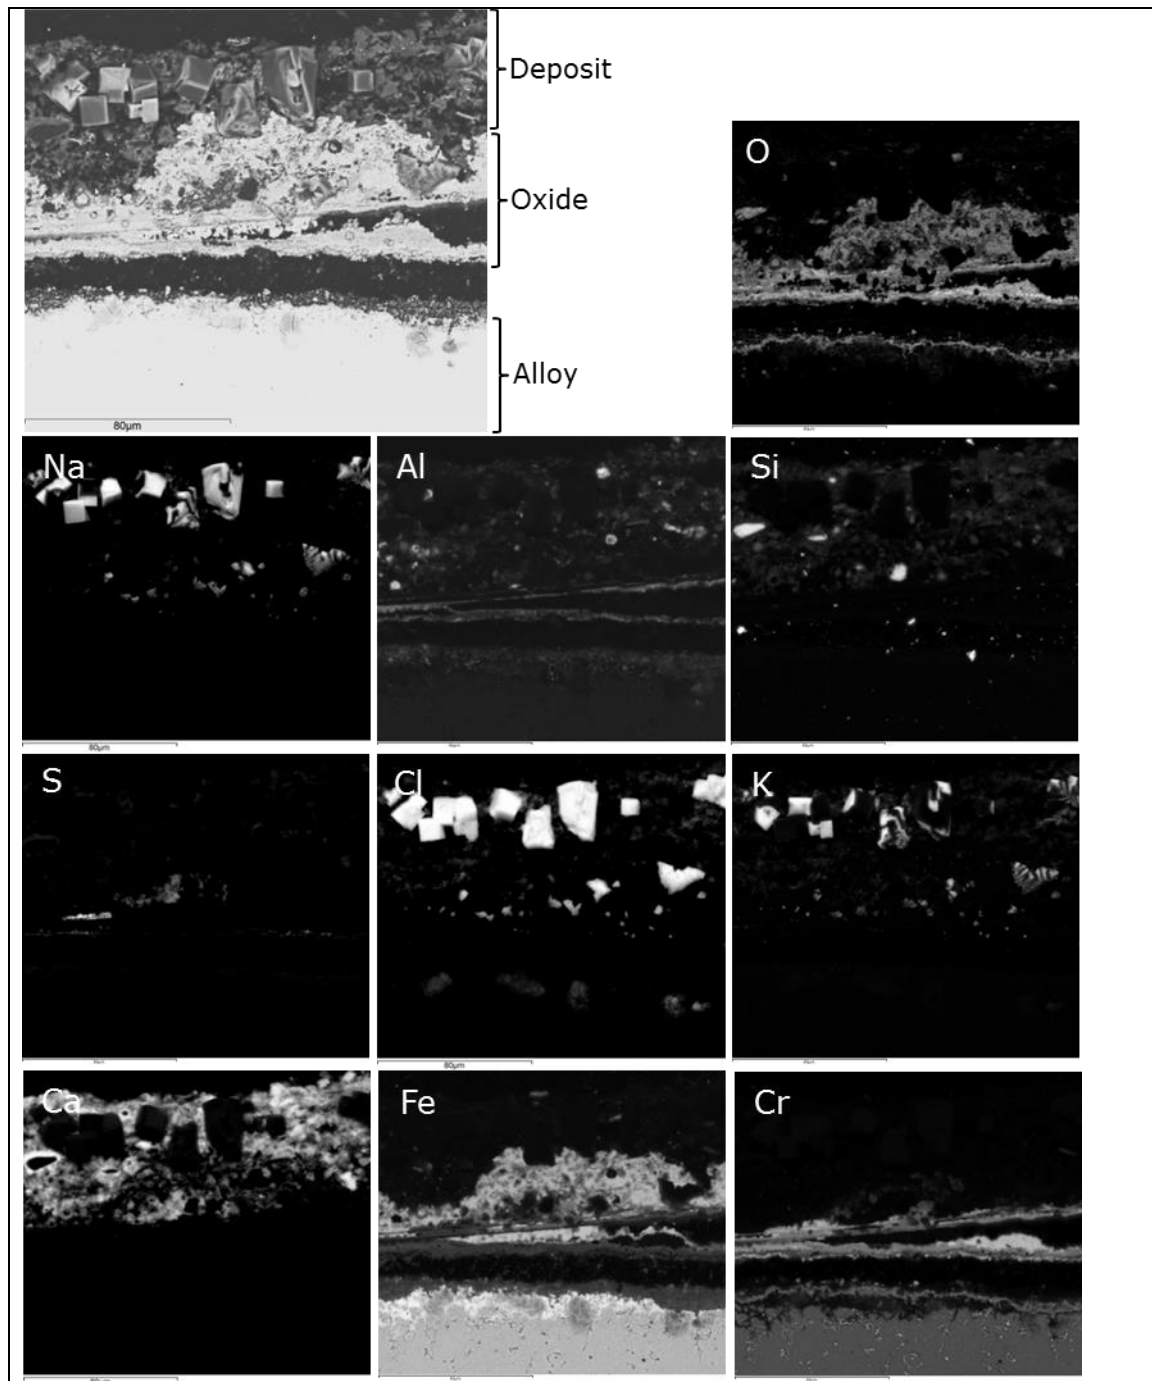
Figure 6-43. SEM-BSE image and elemental maps of the cross-section of APMT exposed for 24 hours at 700 °C.

No deposit was detected on the non-treated APMT after the boiler exposure at 700 °C for 1000 hours. A well adherent oxide scale is present on the alloy surface as can be seen in *Figure 6-50*. *Figure 6-51* reveals that the oxide scale is layered with an iron-rich oxide closest to the exposure environment and an aluminum/chromium-rich oxide closest to the alloy. Minor amounts of metal chlorides might be present and the chromium rich metallic particles are even more prominent after 1000 hours compared to 24 hours (compare *Figure 6-43* and *Figure 6-51*).

However, raising the exposure temperature to 700°C is enough for the material to form an aluminium-rich layer, evident by the two alumina layers formed on the APMT exposed for 24 and 1000 h at 700°C in the boiler (*Figure 6-43* and *Figure 6-51*). It has also been shown in the laboratory that an α-Al<sub>2</sub>O<sub>3</sub> scale can form on the FeCrAl material Kanthal® AF at 700°C<sup>22</sup>. However, the protectiveness of the alumina scale appears to be lost in a similar manner as described above, but a new scale can repeatedly be formed. The presence of this protective scale may be a reason for the lesser amount of chlorides found at the scale/alloy interface, compared to 600°C. Another is the higher volatility of Cl-containing species at the higher temperature, which have two implications. The formed Cl-containing species will evaporate more easily and the condensation of Cl-containing species in the flue gas will be decreased.

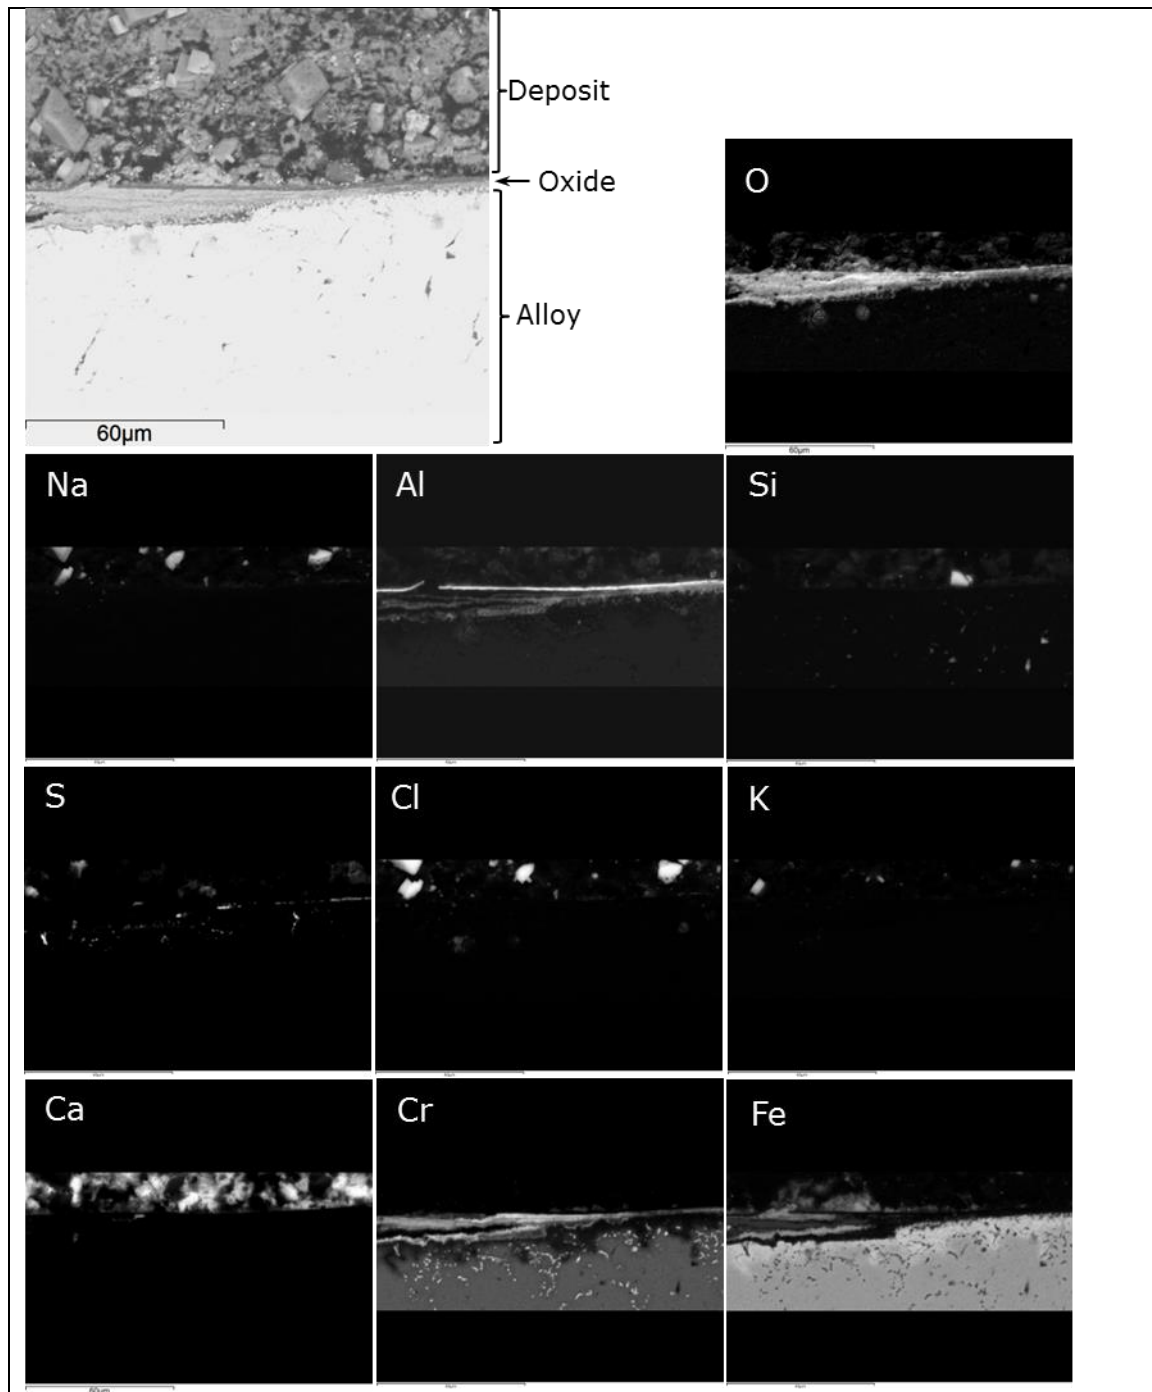
Figure 6-45. SEM-BSE image and elemental maps of the cross-section of pre-oxidized APMT (1100 °C for 24h) exposed for 24 hours at 700 °C.

Sandvik Heating Technologys standard pre-oxidation conditions (1050, 8h) was also tested throughout the exposures and was decided to be investigated further. The standard pre-oxidation (1050 °C, 8h) showed similar results as the sample pre-oxidized for 1100 °C for 24 hours (compare *Figure 6-44*, *Figure 6-45*, *Figure 6-46* and *Figure 6-47*).

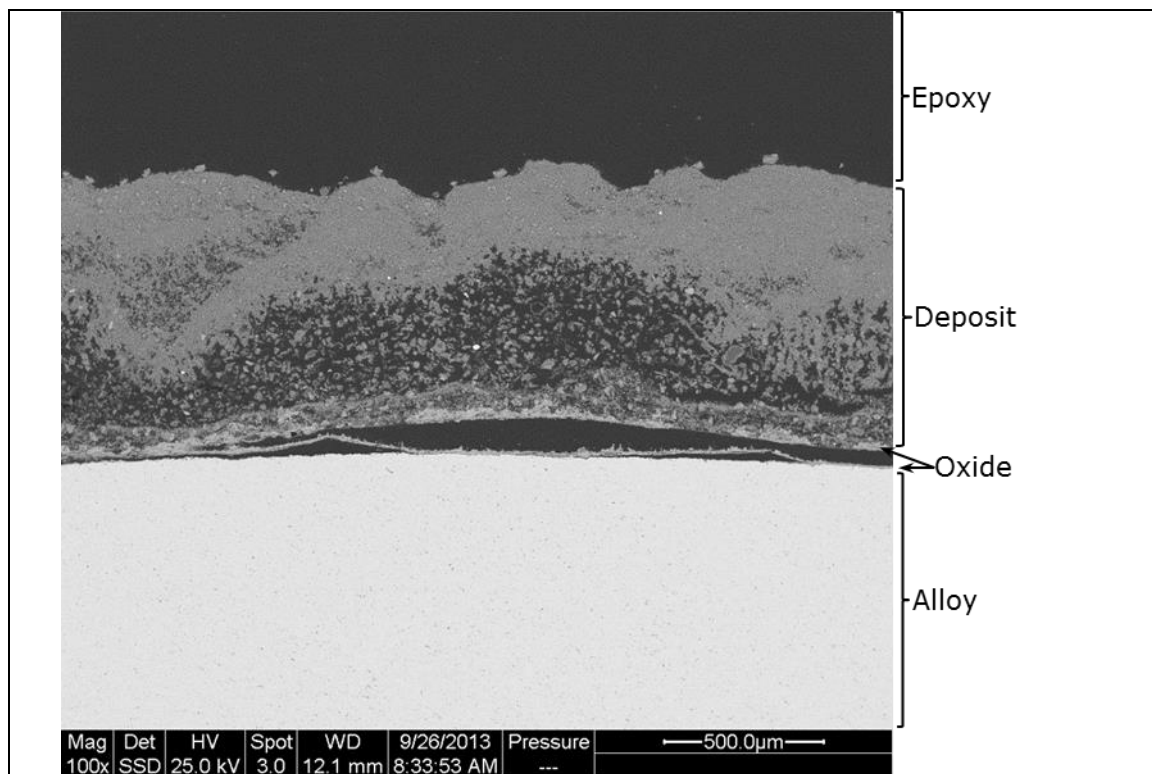
*Figure 6-46. SEM-BSE image of the cross-section of pre-oxidized APMT (1050 °C for 8 h) APMT exposed for 24 hours at 700 °C.*
