# **FeCrAl alloys as components in biomass– and waste– fired boilers**

Kristina Hellström, Niklas Israelsson, Jan–  
Erik Svensson, Bo Jönsson, Dilip  
Chandrasekaran, Johanna Nockert–Olovsjö,  
Anna Jonasson, Bengt–Åke Andersson, Paul  
Cho, Per Kallner, Pamela Henderson

The corrosion resistance of certain components in a waste-fired boiler can be improved significantly if the existing material is replaced with FeCrAl material, such as thermo shield tubes and shielding of superheaters. The results also surprisingly show that the pre-oxidation is not favorable when the material is used at lower temperatures, below 700 °C. This means that production of major boiler components in FeCrAl material would be greatly facilitated.

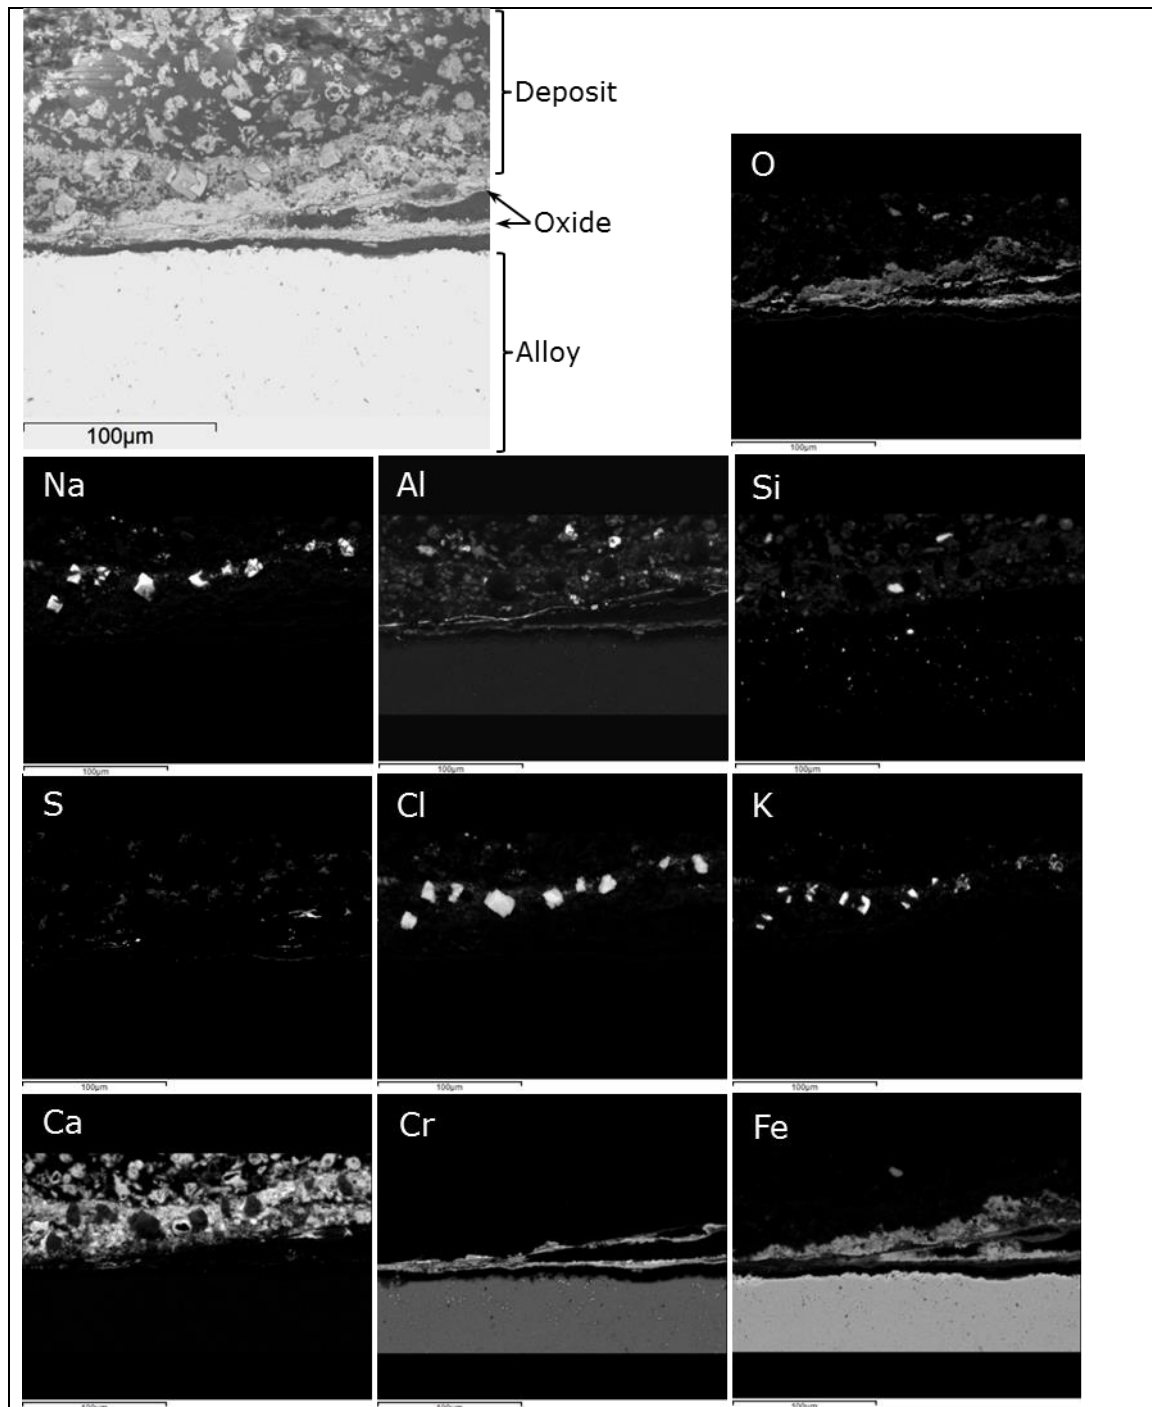
Sandvik Heating Technologys standard pre-oxidation conditions (1050, 8h) was also tested throughout the exposures and was decided to be investigated further. The standard pre-oxidation (1050 °C, 8h) showed similar results as the sample pre-oxidized for 1100 °C for 24 hours (compare *Figure 6-44*, *Figure 6-45*, *Figure 6-46* and *Figure 6-47*).

Figure 6-47. SEM-BSE image and elemental maps of the cross-section of pre-oxidized APMT (1050 °C for 8h) exposed for 24 hours at 700 °C.

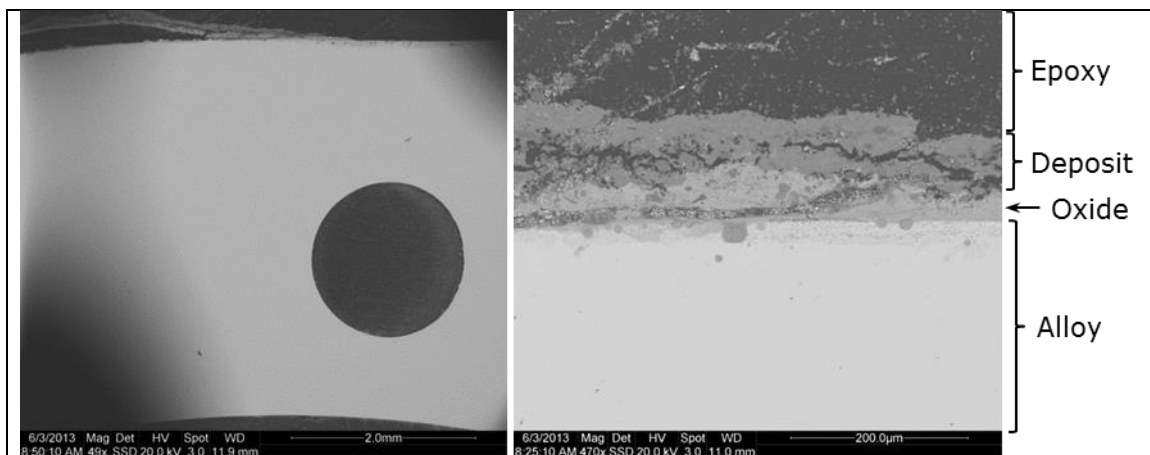
San28 was chosen to add as a reference at 24 hours at 700 °C. Even on this material the oxide/deposit layer detaches from the surface on substantial amounts of the sample ring (*Figure 6-48*). An iron-rich oxide is present directly underneath the deposit layer which includes Na, K, Ca, Si and Cl. The deposit is most probably consisting mainly of NaCl, KCl, CaSO<sub>4</sub> which were detected by XRD (*Table 6-4* and *Table 6-5*). Underneath the iron-rich oxide an almost pure chromia layer is present. There is an oxidation affected zone in the alloy containing sulfur and oxygen with the alloying elements. Metal chlorides are also detected in the cross section (*Figure 6-49*).

*Figure 6-48. SEM-BSE images of the cross-section of San28 exposed for 24 hours at 700 °C.*

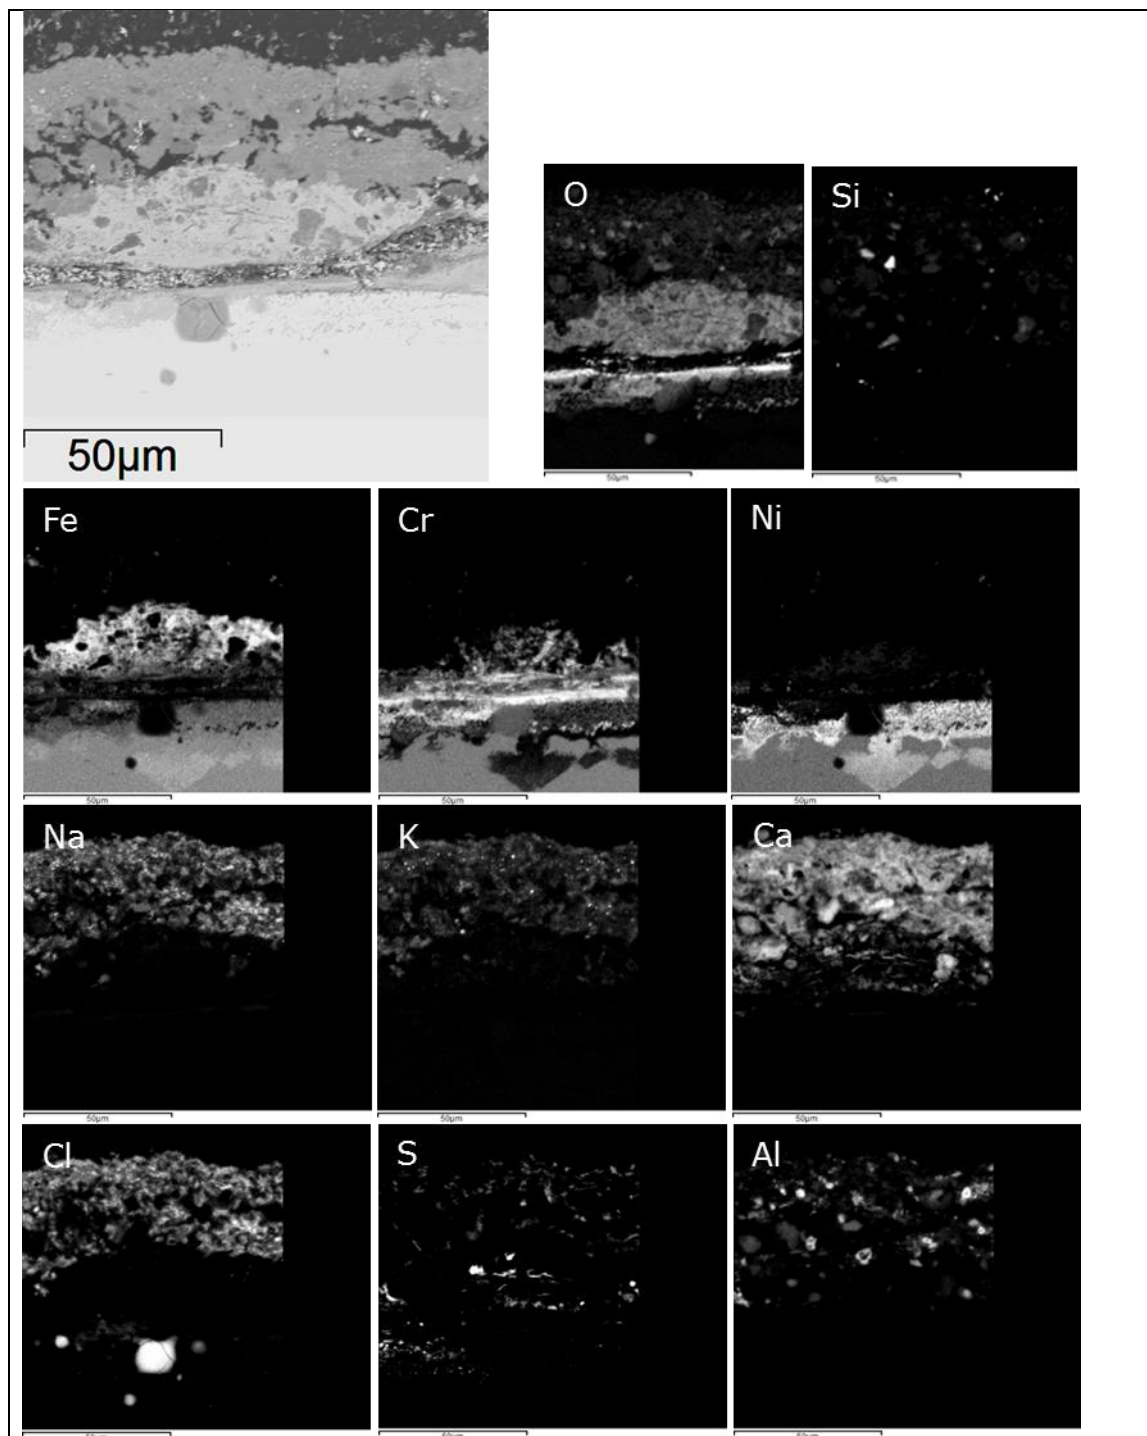
Figure 6-49. SEM-BSE image and elemental maps of the cross-section of San28 exposed for 24 hours at 700 °C.

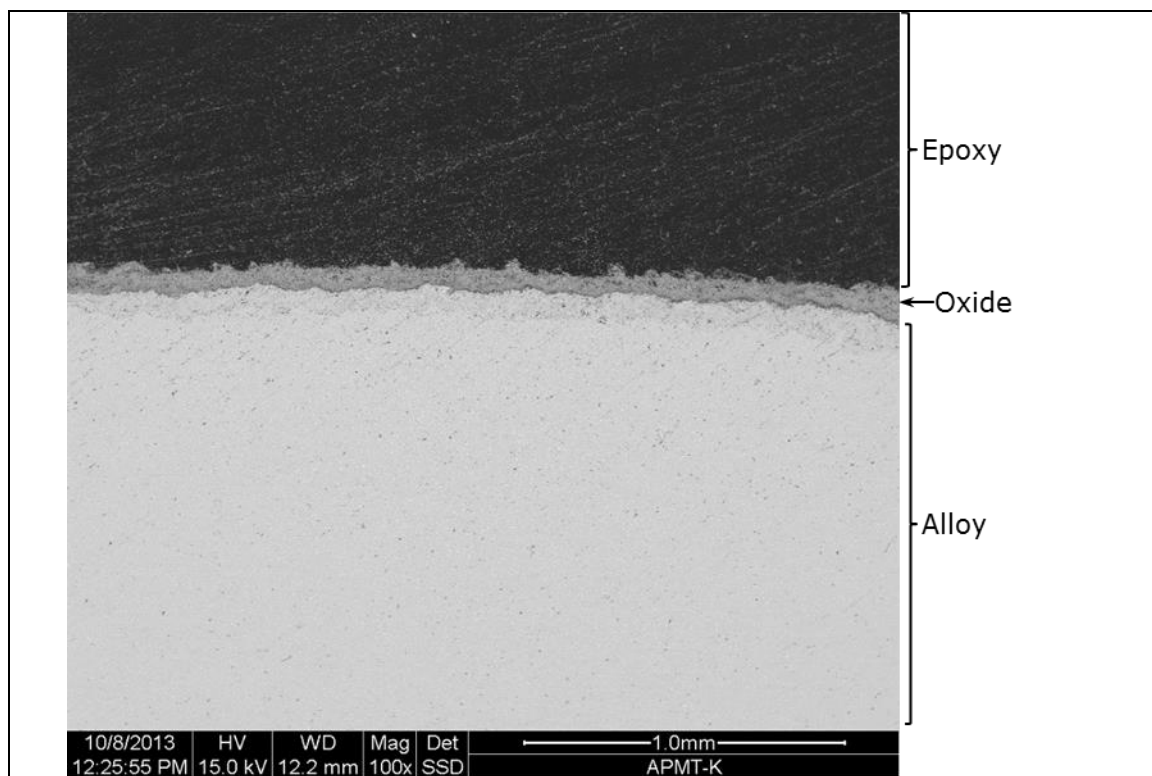
No deposit was detected on the non-treated APMT after the boiler exposure at 700 °C for 1000 hours. A well adherent oxide scale is present on the alloy surface as can be seen in *Figure 6-50*. *Figure 6-51* reveals that the oxide scale is layered with an iron-rich oxide closest to the exposure environment and an aluminum/chromium-rich oxide closest to the alloy. Minor amounts of metal chlorides might be present and the chromium rich metallic particles are even more prominent after 1000 hours compared to 24 hours (compare *Figure 6-43* and *Figure 6-51*).

*Figure 6-50. SEM-BSE image of the cross-section of APMT exposed for 1000 hours at 700 °C.*

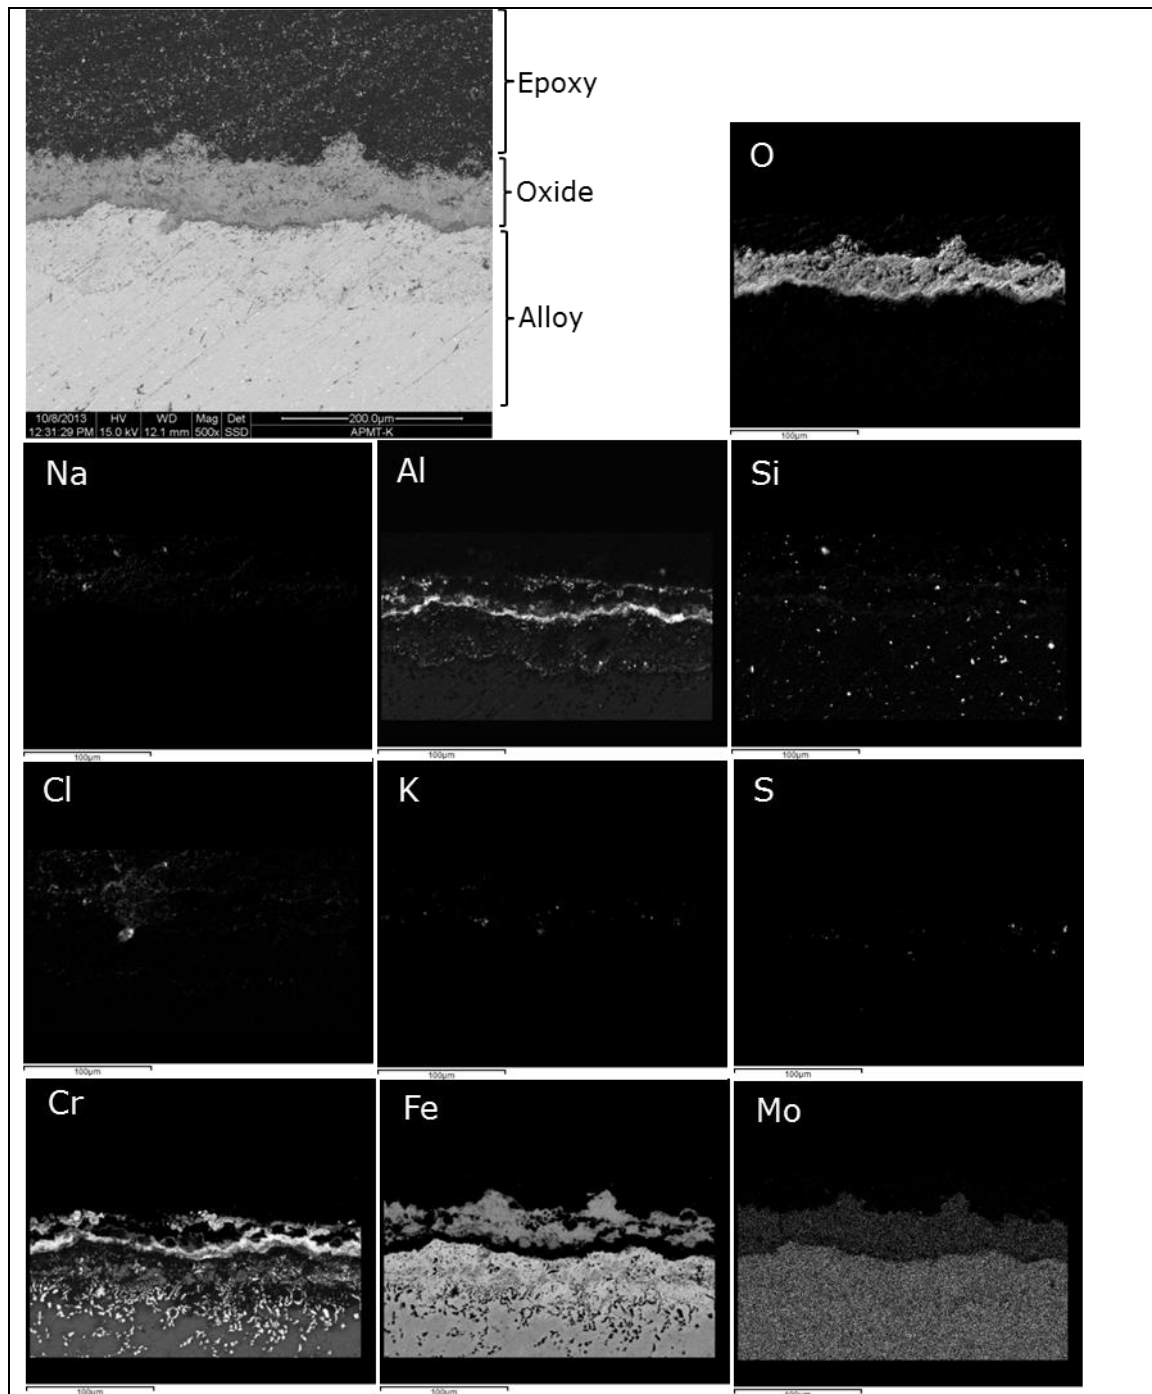
Figure 6-51. SEM-BSE image and elemental maps of the cross-section of APMT exposed for 1000 hours at 700 °C.

However, raising the exposure temperature to 700°C is enough for the material to form an aluminium-rich layer, evident by the two alumina layers formed on the APMT exposed for 24 and 1000 h at 700°C in the boiler (*Figure 6-43* and *Figure 6-51*). It has also been shown in the laboratory that an α-Al<sub>2</sub>O<sub>3</sub> scale can form on the FeCrAl material Kanthal® AF at 700°C<sup>22</sup>. However, the protectiveness of the alumina scale appears to be lost in a similar manner as described above, but a new scale can repeatedly be formed. The presence of this protective scale may be a reason for the lesser amount of chlorides found at the scale/alloy interface, compared to 600°C. Another is the higher volatility of Cl-containing species at the higher temperature, which have two implications. The formed Cl-containing species will evaporate more easily and the condensation of Cl-containing species in the flue gas will be decreased.

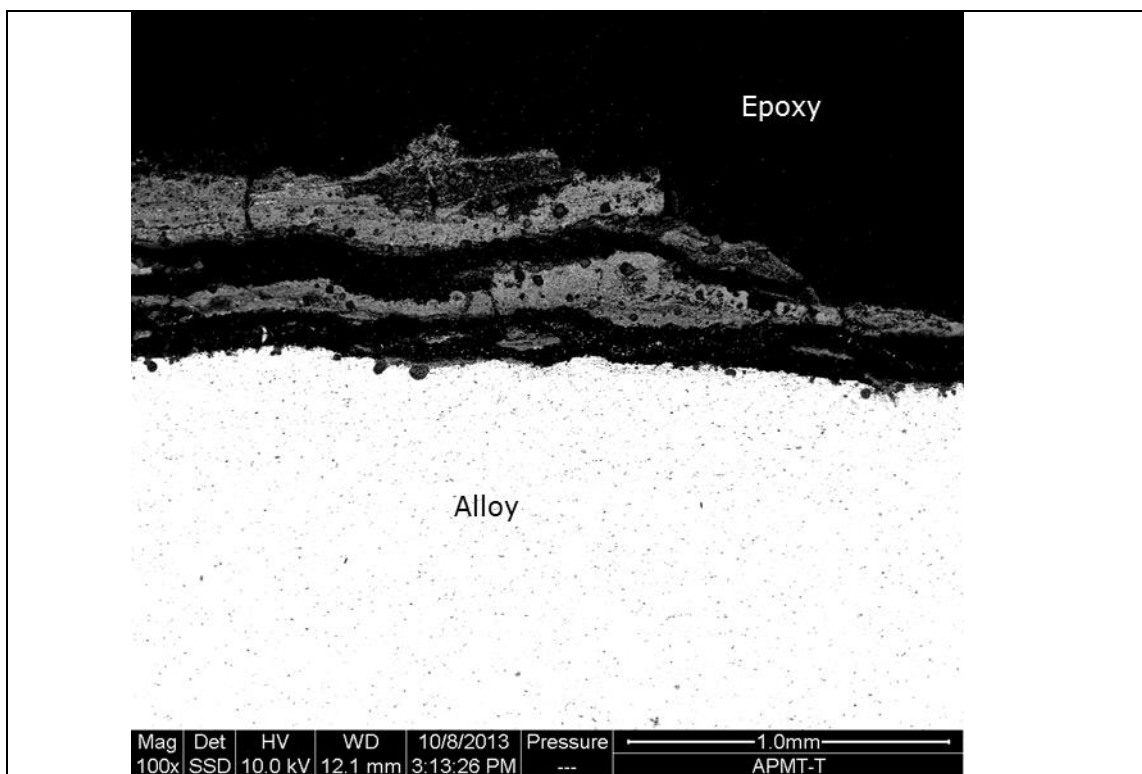
A roughly 600  $\mu\text{m}$  thick and porous oxide/deposit layer which has detached from the alloy is present on the pre-oxidized (1100  $^{\circ}\text{C}$ , 24h) sample after 1000 hours of exposure at 700  $^{\circ}\text{C}$  (Figure 6-52). The alumina scale from the pre-treatment was nowhere to be found. Instead a thick iron-chromium-rich oxide is present with an alumina enrichment at the oxide/alloy interface (Figure 6-53). Minor amounts of metal chlorides are present in the scale and sulfur is detected in the oxide/alloy interface. Sulfur signal also originates from the alloy bulk but is from the overlap between S and Mo, e.g. no sulfur is in the alloy matrix.

A roughly 50  $\mu\text{m}$  thick oxidation affected zone is present in the alloy substrate which contains aluminum nitride particles according to SEM/EDX point analyses (not shown). It is believed that the AlN formation depletes the surrounding alloy in aluminum and the chromium rich metallic phase forms which also contain iron and molybdenum according to SEM/EDX point analyses.

Figure 6-52. SEM-BSE image of the cross-section of pre-oxidized APMT (1100  $^{\circ}\text{C}$  for 24 h) APMT exposed for 1000 hours at 700  $^{\circ}\text{C}$ .

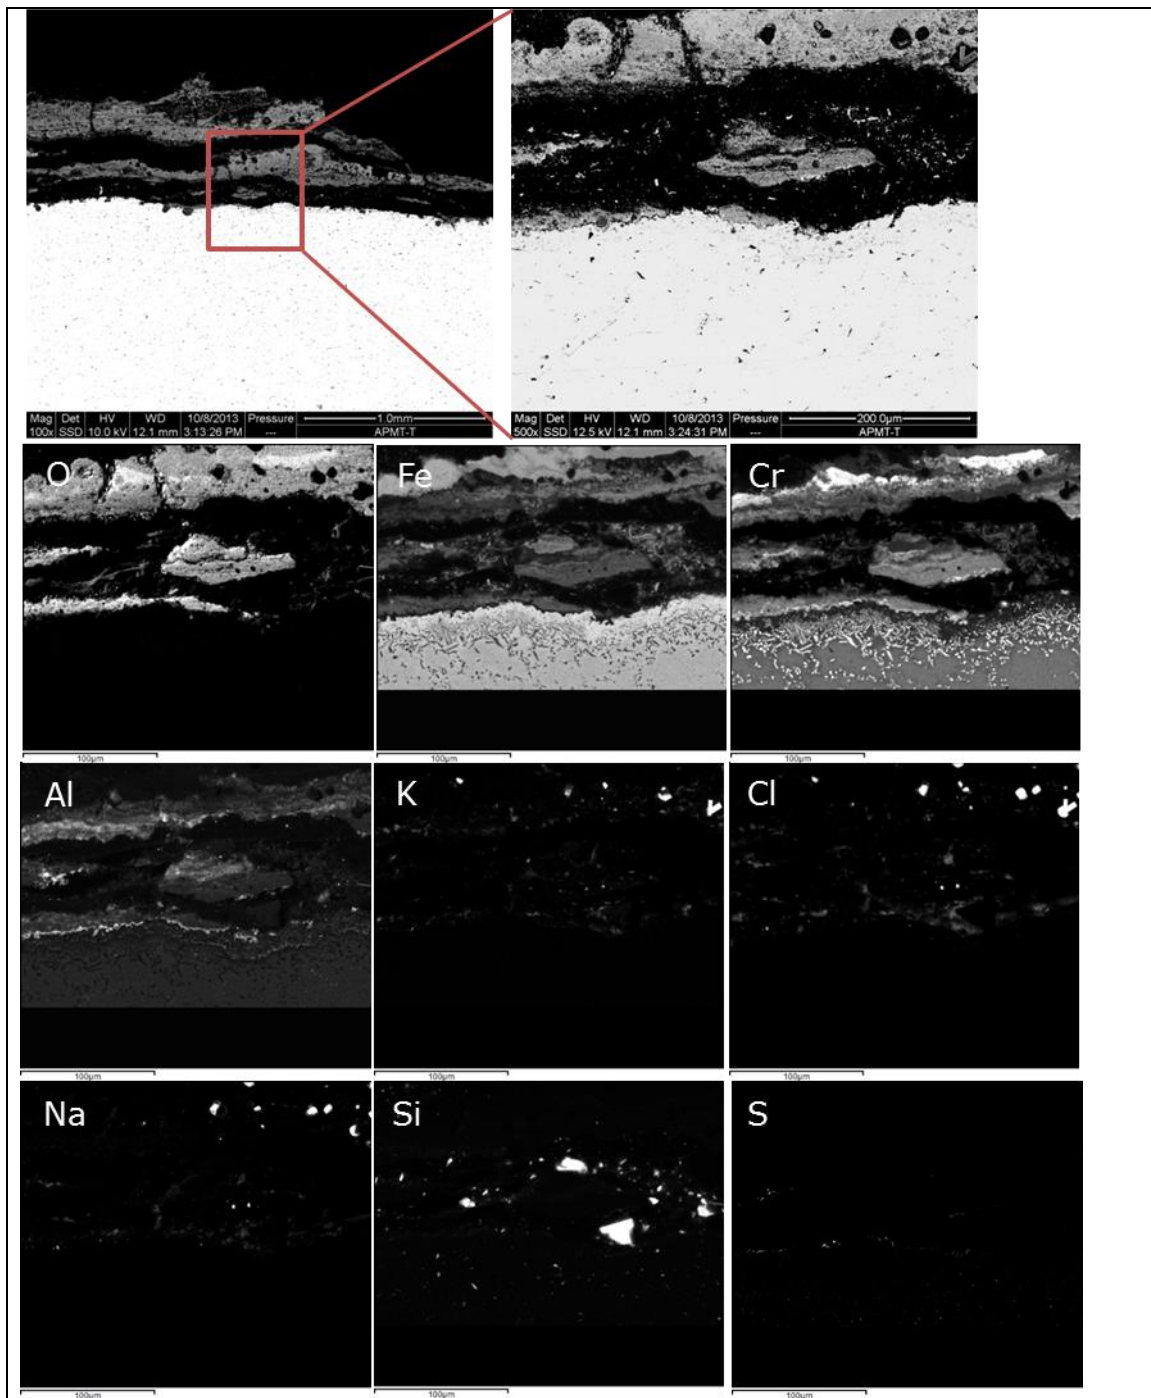
Figure 6-53. SEM-BSE image and elemental maps of the cross-section of pre-oxidized APMT (1100 °C for 24h) exposed for 1000 hours at 700 °C.

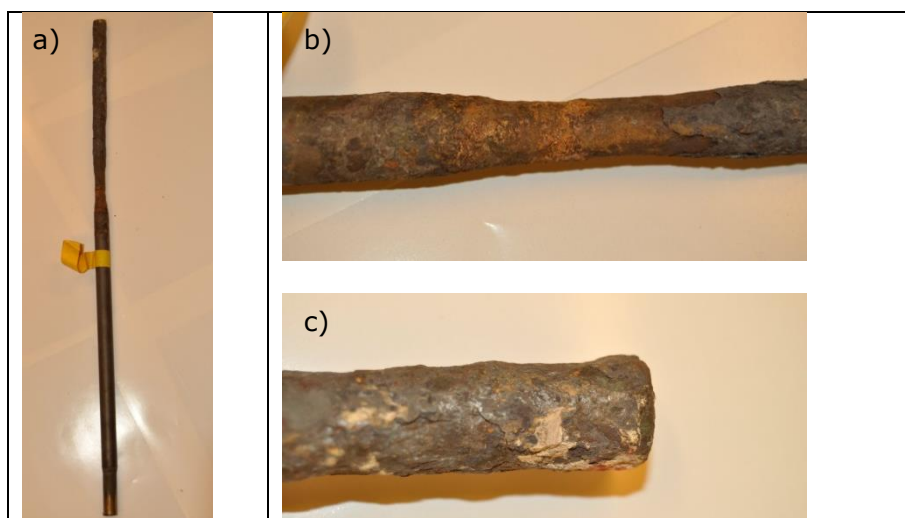
Results for the thermal shield tubes exposed at the position KT024 and KT020 in the Händelö boiler P14, are shown in *Figure 6-54*. These thermal shield tubes are compared to each other because they are of different materials (IN 625 and pre-oxidized APMT) and are exposed at similar temperature ( $\sim 810^{\circ}\text{C}$  and  $\sim 840^{\circ}\text{C}$ , respectively) at similar position in the boiler (see, *Figure 5-12*, *Figure 5-13* and *Figure 6-54*). The images acquired 2011-12-05 shows that a thin yellowish deposit covered large parts of the surface of the material of both thermal shield tubes. The images acquired 2012-04-15 (*Figure 6-55*, *Figure 6-56*, and *Figure 6-54*) and the measurements of the diameter show that the material loss was larger on the pre-oxidized APMT material than on the IN 625, with a diminishment of the diameter of 5.1 and 1.6 mm, respectively. The most of the material of the thermal shield tubes were lost close to the wall of the boiler, as evident by the images acquired after the exposure. After exposure, the IN 625 material was more or less covered by a greenish oxide, and a thin layer of deposit covered some parts of the surface. The greenish oxide indicates the formation of NiO, which was confirmed by XRD, see *Table 6-6*. The thermal shield tube at the positions KT020 (APMT) was rust colored close to the boiler wall, the rest of the tube was covered with a thin yellowish deposit and rust-colored flaked areas. The XRD indicates the presence of iron-containing oxide ( $(\text{Fe,Al,Cr})_2\text{O}_3$ ), but also a weak peak corresponding to  $\alpha\text{-Al}_2\text{O}_3$  (*Table 6-6*). This aluminum oxide is probably not protective anymore judging from the rust-colored surface. Both IN 625 and APMT show medium strong peaks corresponding to the base material, indicating a similar scale thickness on both materials.

Figure 6-55. Images of the thermal shield tube exposed at position KT020.

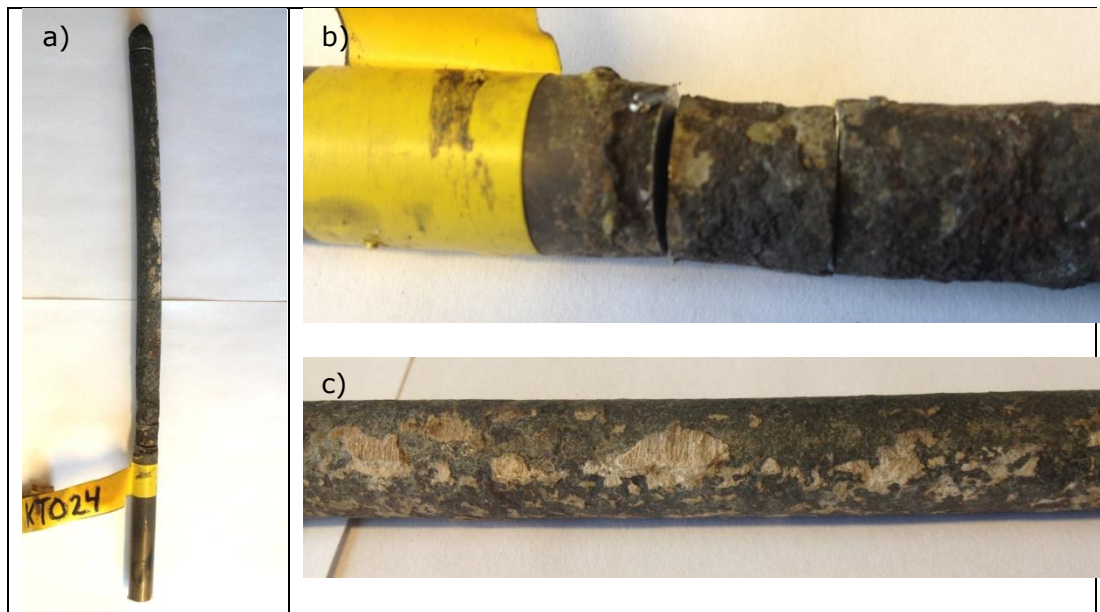
Figure 6-56. Images of the thermal shield tube exposed at position KT024.

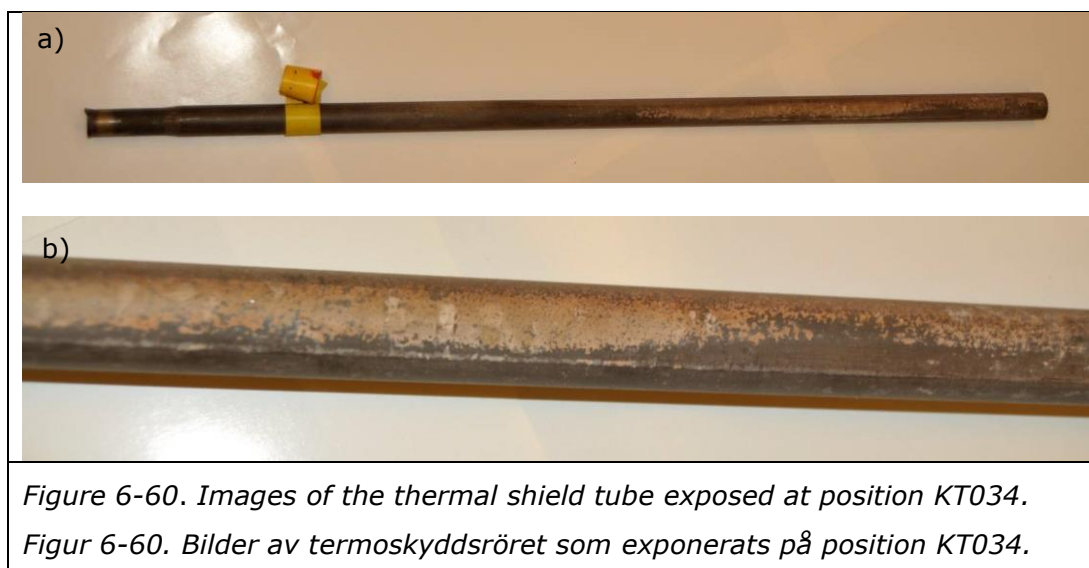
Figure 6-59 shows the results for the thermal shield tubes at the positions KT034 and KT037. These thermal shield tubes were made of pre-oxidized APMT and the exposure temperature were approximately 410°C and 450°C, respectively. On the images acquired 2011-12-05, both thermal shield tubes appear intact. KT034 was covered by a thin layer of deposit, whereas KT037 had a thick layer of deposit built up on the side facing the wind. After the whole exposure time the thermal shield tubes still appeared intact and yellowish deposit covered parts of the surfaces (*Figure 6-59, Figure 6-60, and Figure 6-61*). The maximum material loss was measured to be 0.34 mm and 0.42 mm, respectively. These values are significantly lower than for the thermal shield tube at the position KT043 where the temperature is about 150°C higher. The XRD analyses showed similar results for both tubes (*Table 6-6*). The substrate peak was strong, indicating a thin oxide on the material. Peaks corresponding to the oxides  $(\text{Fe,Al,Cr})_2\text{O}_3$  and  $\alpha\text{-Al}_2\text{O}_3$  were found, indicating the presence of a protective oxide on the material surfaces.

Figure 6-60. Images of the thermal shield tube exposed at position KT034.

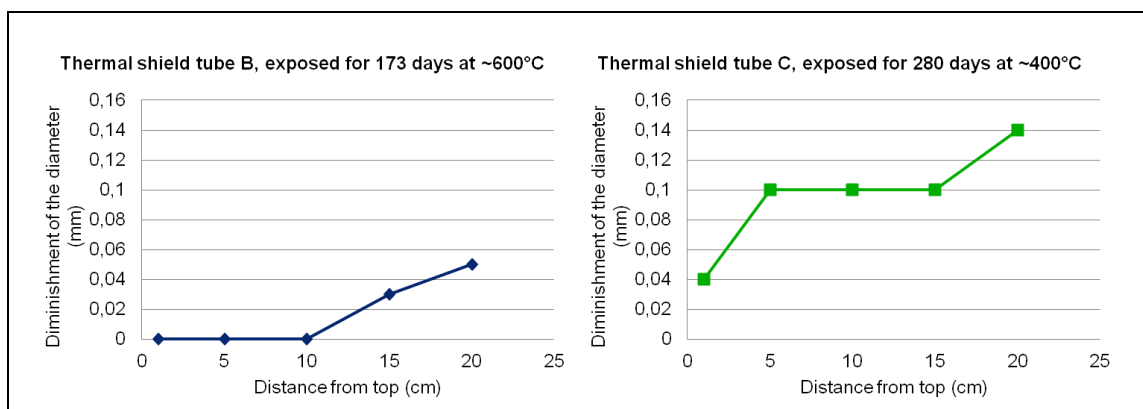
of the rod that had been situated close to the boiler wall had some rust colored regions on the surface. The material loss measurements show only a small diminishment of the diameter (less than 50  $\mu\text{m}$ ) of the second half of the tube length, which was situated closest to the wall of the boiler during exposure. The top of the tube were analyzed by XRD and showed peaks corresponding to the protective oxide  $\alpha\text{-Al}_2\text{O}_3$  (not shown).

The surface of Tube C is more affected of the exposure than tube B. The material appears to spall at some locations and form thick oxide products (Figure 6-68). A rust-colored deposit covers a large proportion of the surface of the tube. The material loss was higher than for tube C, with a diminishment of the diameter of up to 140  $\mu\text{m}$ . In accordance with the material loss on tube B, tube C also showed largest material loss on the part of the tube that had been situated close to the boiler wall during the exposure. The top of the tube were analyzed by XRD and showed peaks corresponding to the protective oxide  $\alpha\text{-Al}_2\text{O}_3$  (not shown). In addition peaks corresponding to iron oxides were present.

Figure 6-69. Diagrams showing the diminishment of the diameter of the thermal shield tubes after exposure at Idbäcken.

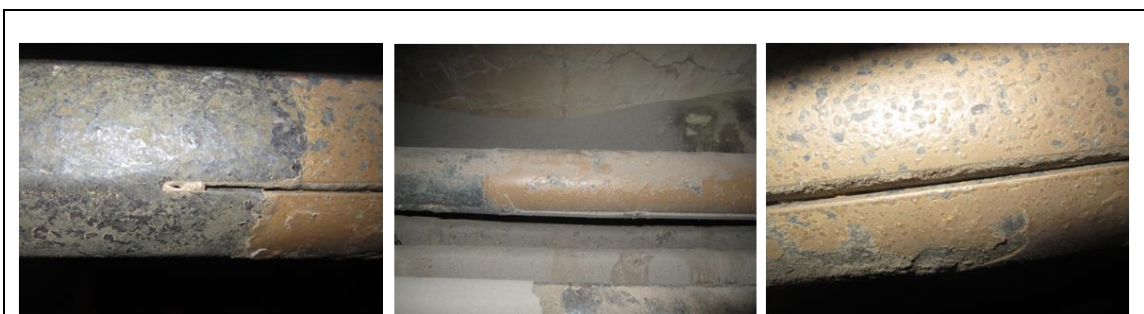
Shield sheets for the tertiary superheaters were inserted in the Händelö boiler P14 and exposed from 2011-07-25 to 2012-04-15. The shield sheets were manufactured of 253Ma and pre-oxidized APMT. *Figure 6-70* shows images of the shield sheets acquired 2011-12-05. The 253Ma material has a black-green surface. The green color indicates the presence of NiO. The APMT material is covered with a brownish product, probably deposit from the flue gas. The appearance of the material is similar after the total exposure time.

*Figure 6-70. Images showing the shield sheet at the tertiary superheaters exposed from 2011-07-25 to 2012-04-15 at the Händelö plant. The part of the shield sheet with a green-black surface is 253Ma and the part with a brownish color is pre-oxidized APMT.*

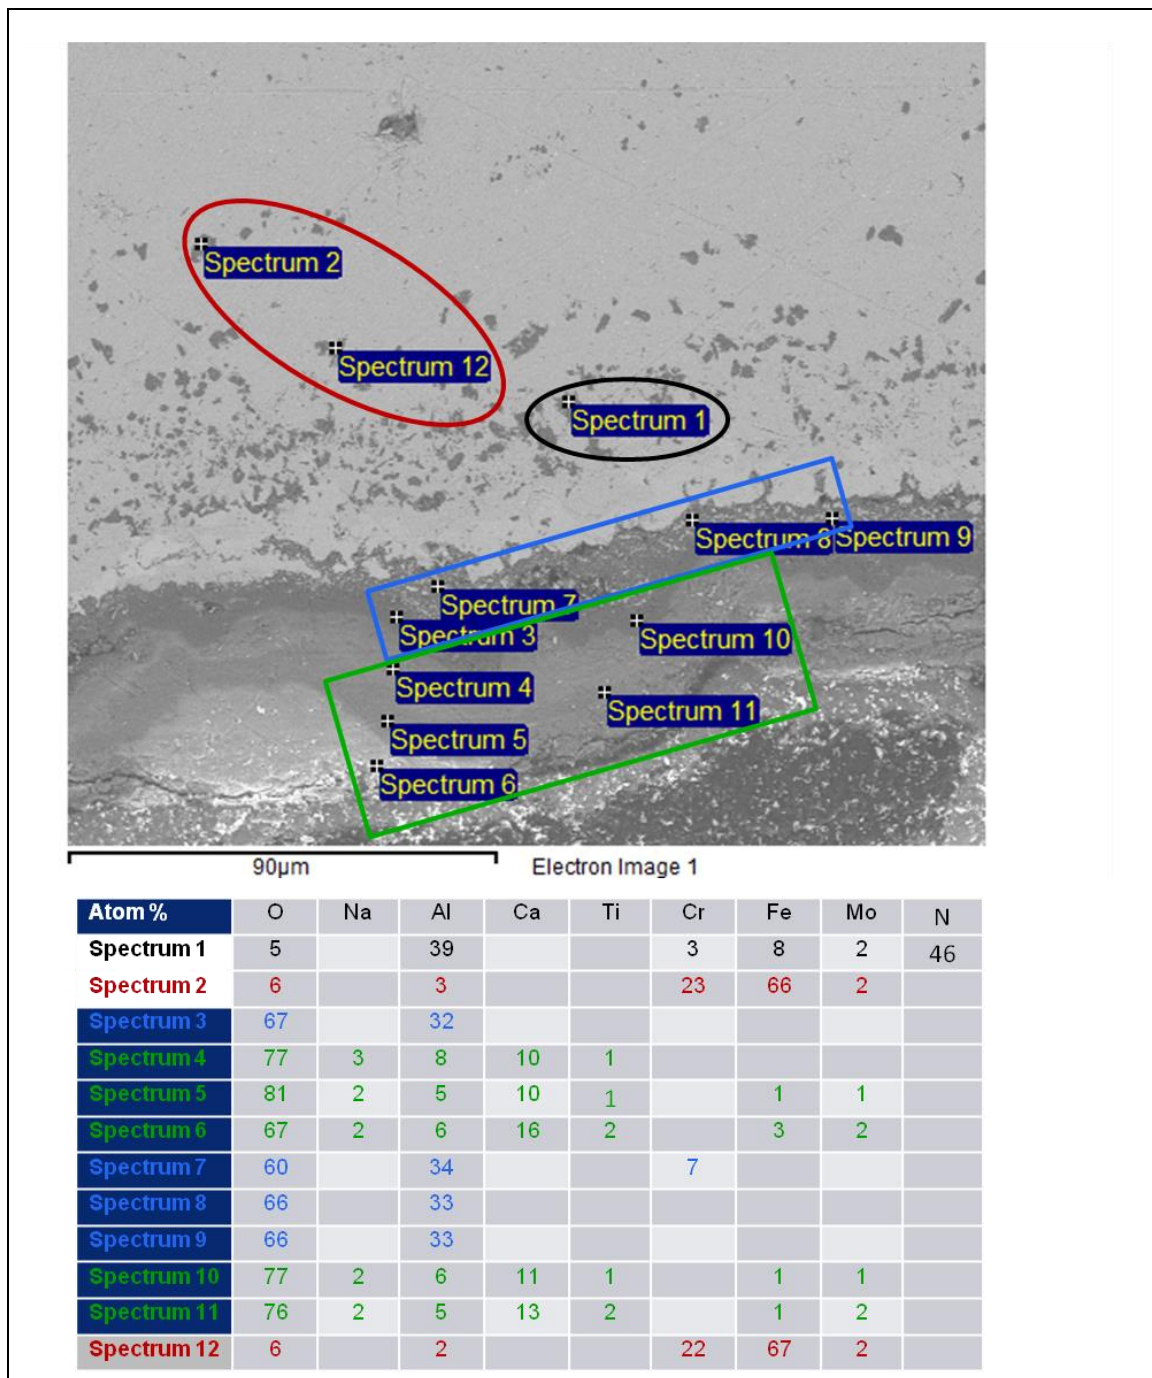
Examination of the pre-oxidized APMT and 253Ma materials was done through SEM/EDX and XRD analyses. A cross-section SEM image of the pre-oxidized APMT material is shown in *Figure 6-71*, together with EDX point analyses. The cross-section image reveals an alumina scale closest to the material surface as evident by the EDX points 7, 8, 9, and 3 with a composition of about 66at.% O and 33at.% Al. There appears to be internal oxidation close to the

alumina scale and an oxidation affected zone where nitridation of the aluminum has occurred. On top of the alumina scale there appears to be a Ca-rich oxide deposited, also containing some Na and Ti. Point analysis 2 and 12 is indicated on dark spots in the substrate. However, the results show heavy elements, which give a bright contrast in BSE SEM images. This indicates that the beam has drifted during the measurement. Therefore, it is assumed that analyses are generated from the substrate (large bright region).

Figure 6-71. Backscattered SEM image and EDX point analyses of the cross-section of the pre-oxidized APMT sheet exposed at the tertiary superheaters at the Händelö plant, boiler P14.

- An alumina oxide was found closest to the metal, indicating the presence of a protective oxide.
- Aluminum nitrides appeared to have formed in the bulk close to the external alumina scale, depleting the bulk of Al likely resulting in difficulty to re-heal a damaged alumina scale
- Ca-rich deposit

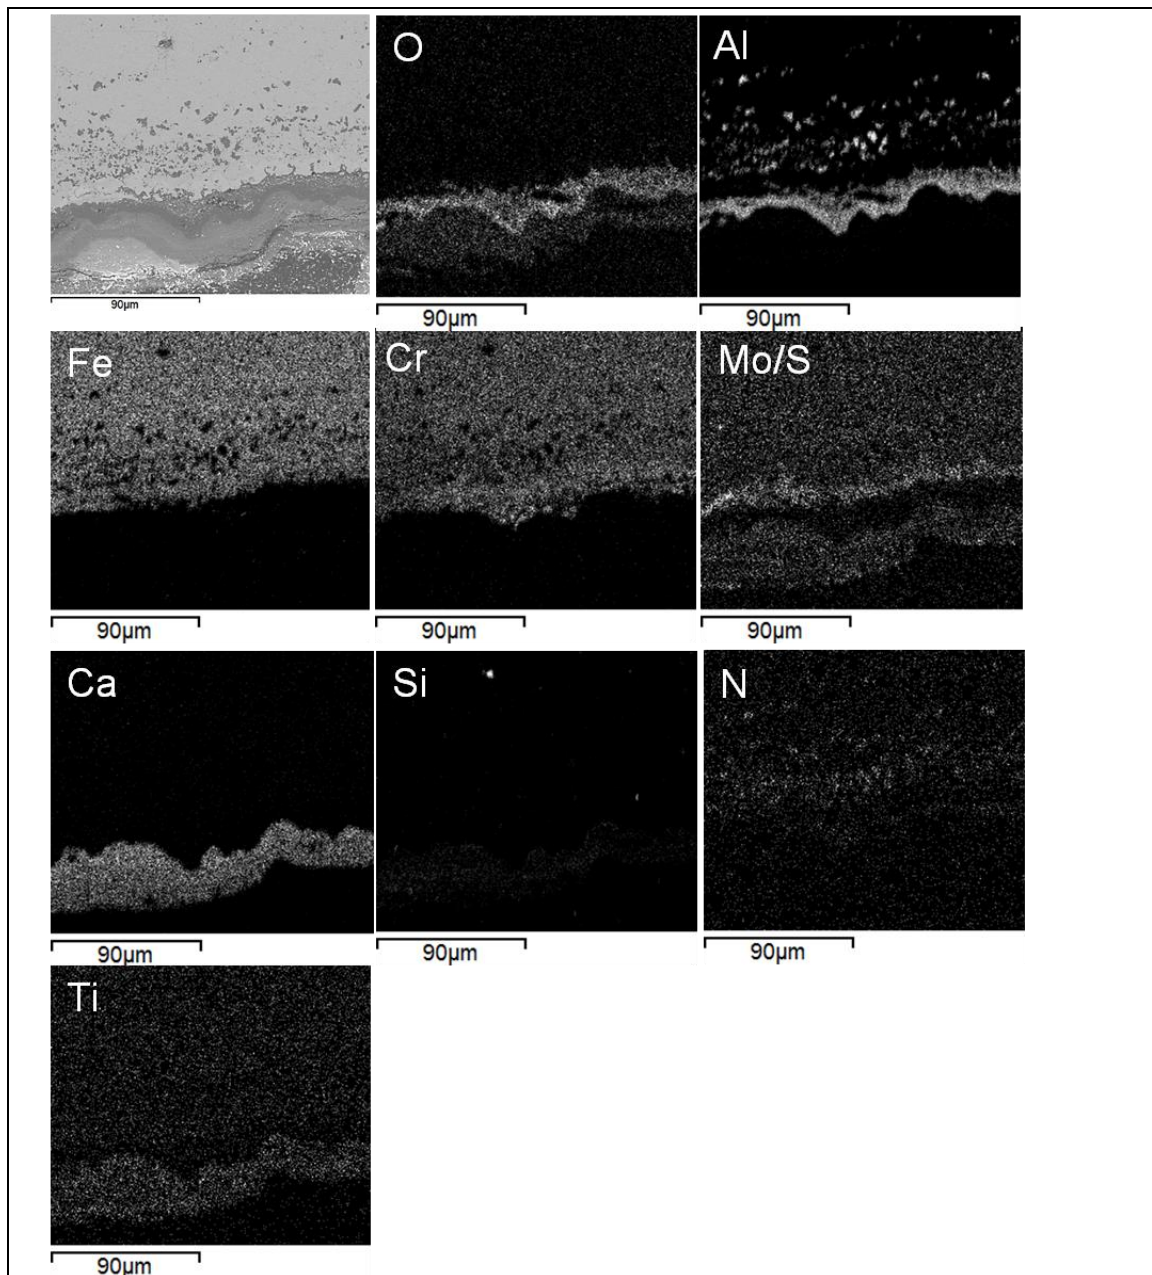
The SEM/EDX maps in *Figure 6-72* confirm the findings of the EDX point analysis. A continuous alumina scale is present on the material. Underneath the scale, there appears to be a zone with Cr enrichment. This is probably a result of Al depletion owing to the alumina scale growth and the oxidation affected zone reaching about 100  $\mu\text{m}$  into the substrate. In this zone aluminum and nitride overlaps, indicating the presence of AlN. On top of the alumina there is a Ca-rich deposit, also containing some Na, Ti and Si.

Figure 6-72. Backscattered SEM image of the cross-section of the pre-oxidized APMT sheet exposed at the tertiary superheaters at Händelö together with EDX maps for the elements O, Cr, Al, Fe, Si, Ca, N, Ti and Mo/S.

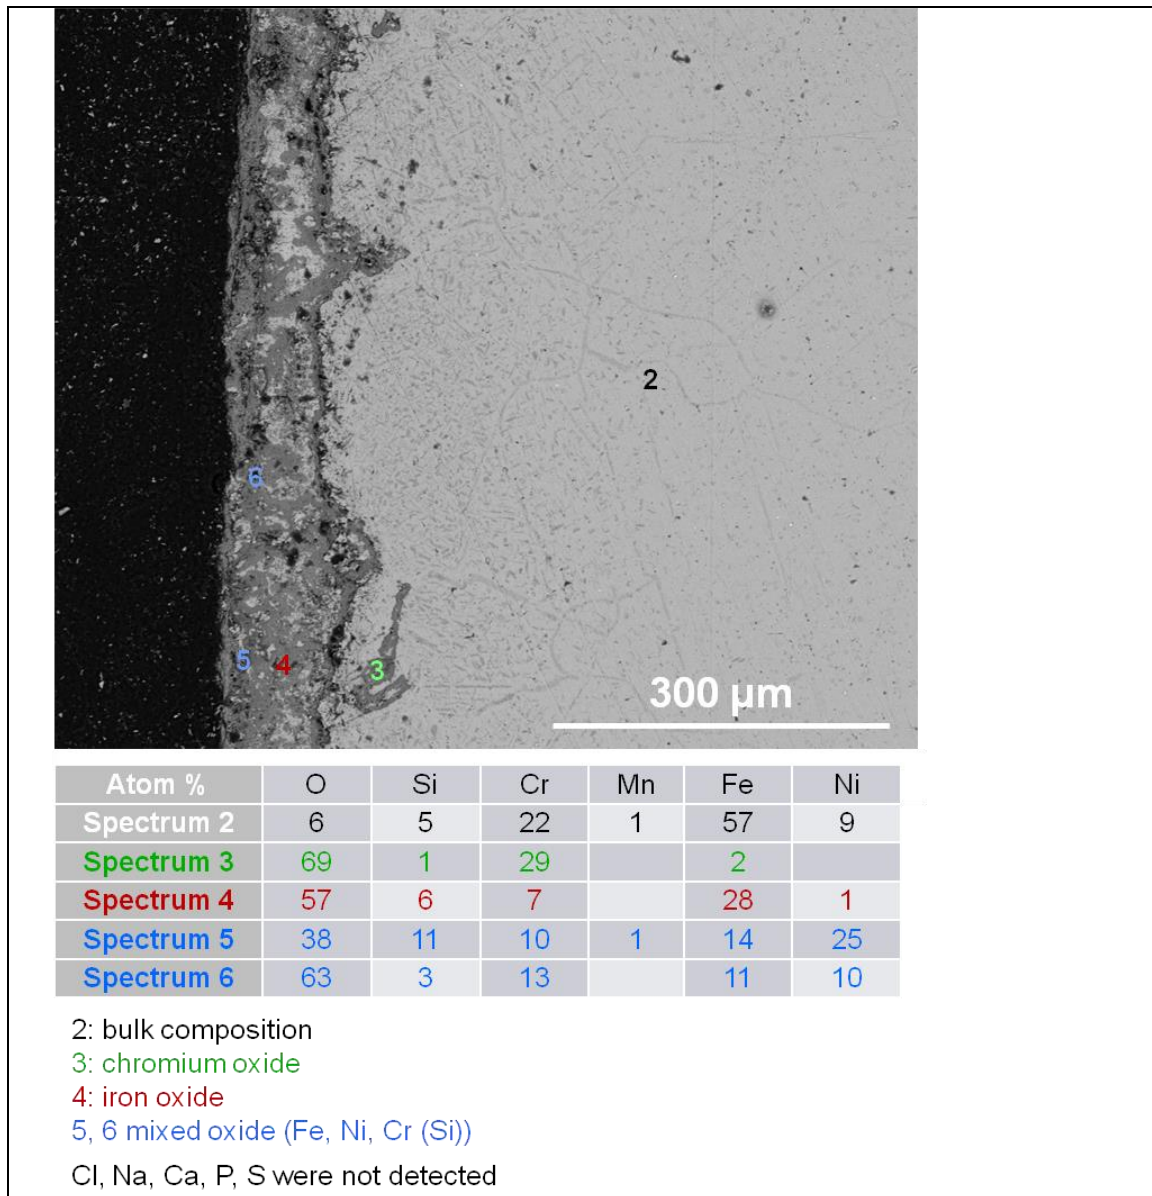
A cross-section SEM image of the 253Ma material is shown in Figure 6-73, together with EDX point analyses. The cross-section image reveals a mixed oxide consisting of Ni, Fe, Cr and Si on the surface of the material, as evident

by the EDX points 4, 5 and 6. The oxide is not continuous, it appears mixed with the substrate. Cr-oxide has formed as pegs into the substrate, see EDX point 3 consisting of 29 at.% Cr, 2 at.% Fe, 1 at.% Si and 69 at.% O. Point two shows the composition of the substrate.

Figure 6-73. Backscattered SEM image and EDX point analyses of the cross-section of the 253Ma material exposed at the tertiary superheaters at the Händelö plant, boiler P14.

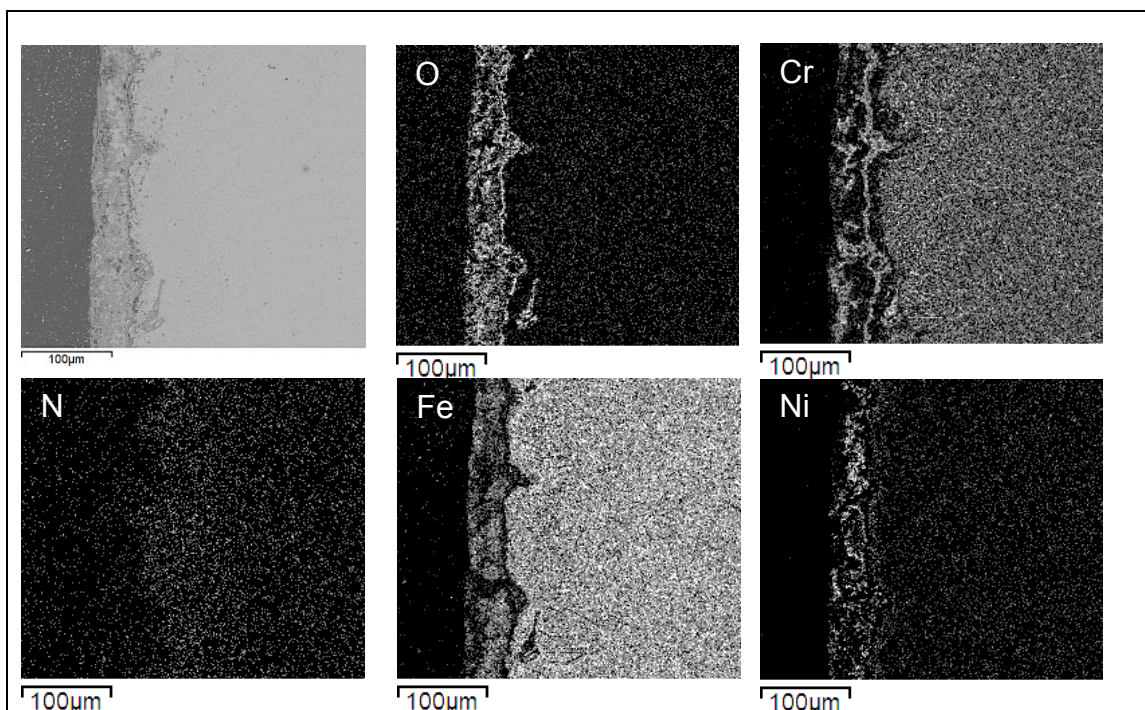
The SEM/EDX maps in *Figure 6-74* confirm the findings of the EDX point analysis. A discontinuous Fe-, Cr-, Ni- oxide can be seen on top of the surface. However there appears to be a continuous Cr-rich oxide scale closest to the substrate. Underneath this scale, there appear to be a zone with Ni enrichment/Cr depletion. This is probably a result of Cr depletion, owing to the Cr-scale growth and low diffusion rates of Cr.

*Figure 6-74. Backscattered SEM image of the cross-section of the 253Ma material exposed at the tertiary superheaters at Händelö together with EDX maps for the elements O, Cr, N, Fe, and Ni.*

- A continuous Cr-rich oxide is present on the substrate, indicating the presence of a protective scale
- Cr appears depleted in the bulk close to the Cr-rich oxide likely resulting in difficulty to re-heal a damaged chromia scale

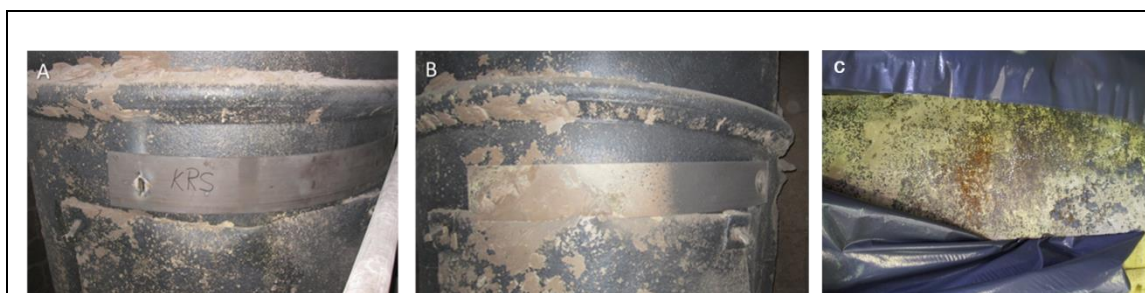
The shield sheet for the vortex finder at Händelö facility was manufactured of Kanthal APMT™. *Figure 6-76* shows images of the shield sheet before exposure (a), after exposure for 133 days (b) and after demounting after the total exposure time (265 days). From the images it can be seen that a yellowish deposit get caught on the shield sheet during exposure. The deposit appears to be rich in Ca and Na, see *Figure 6-77* and *Figure 6-78*. The oxide scale appears layered and consists of an aluminium rich layer closest to the metal, an Cr-rich layer on top and an Fe-rich outer layer, see *Figure 6-77* and *Figure 6-78*.

*Figure 6-76. Images showing the shield sheet made of pre-oxidized Kanthal APMT material A) before exposure, B) after exposure from 2011-07-25 to 2011-12-05, and C) after exposure from 2011-07-25 to 2012-04-15 at Händelö plant.*

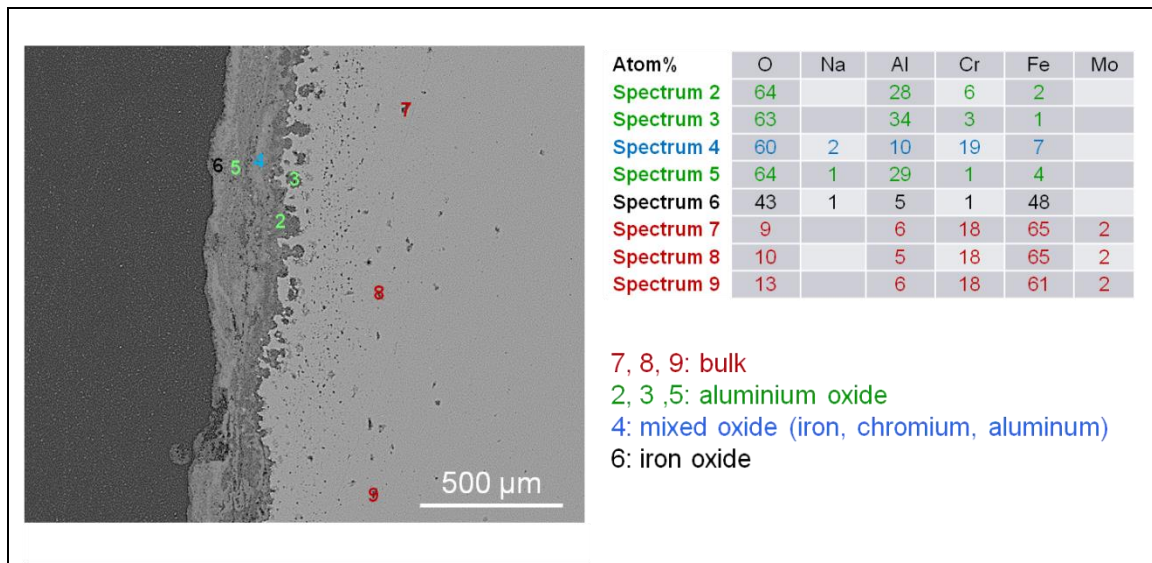
Figure 6-77. Backscattered SEM image and EDX point analyses of the cross-section of the pre-oxidized APMT sheet exposed at the vortex finder at the Händelö plant, boiler P14.
