# **FeCrAl alloys as components in biomass– and waste– fired boilers**

Kristina Hellström, Niklas Israelsson, Jan–  
Erik Svensson, Bo Jönsson, Dilip  
Chandrasekaran, Johanna Nockert–Olovsjö,  
Anna Jonasson, Bengt–Åke Andersson, Paul  
Cho, Per Kallner, Pamela Henderson

The corrosion resistance of certain components in a waste-fired boiler can be improved significantly if the existing material is replaced with FeCrAl material, such as thermo shield tubes and shielding of superheaters. The results also surprisingly show that the pre-oxidation is not favorable when the material is used at lower temperatures, below 700 °C. This means that production of major boiler components in FeCrAl material would be greatly facilitated.

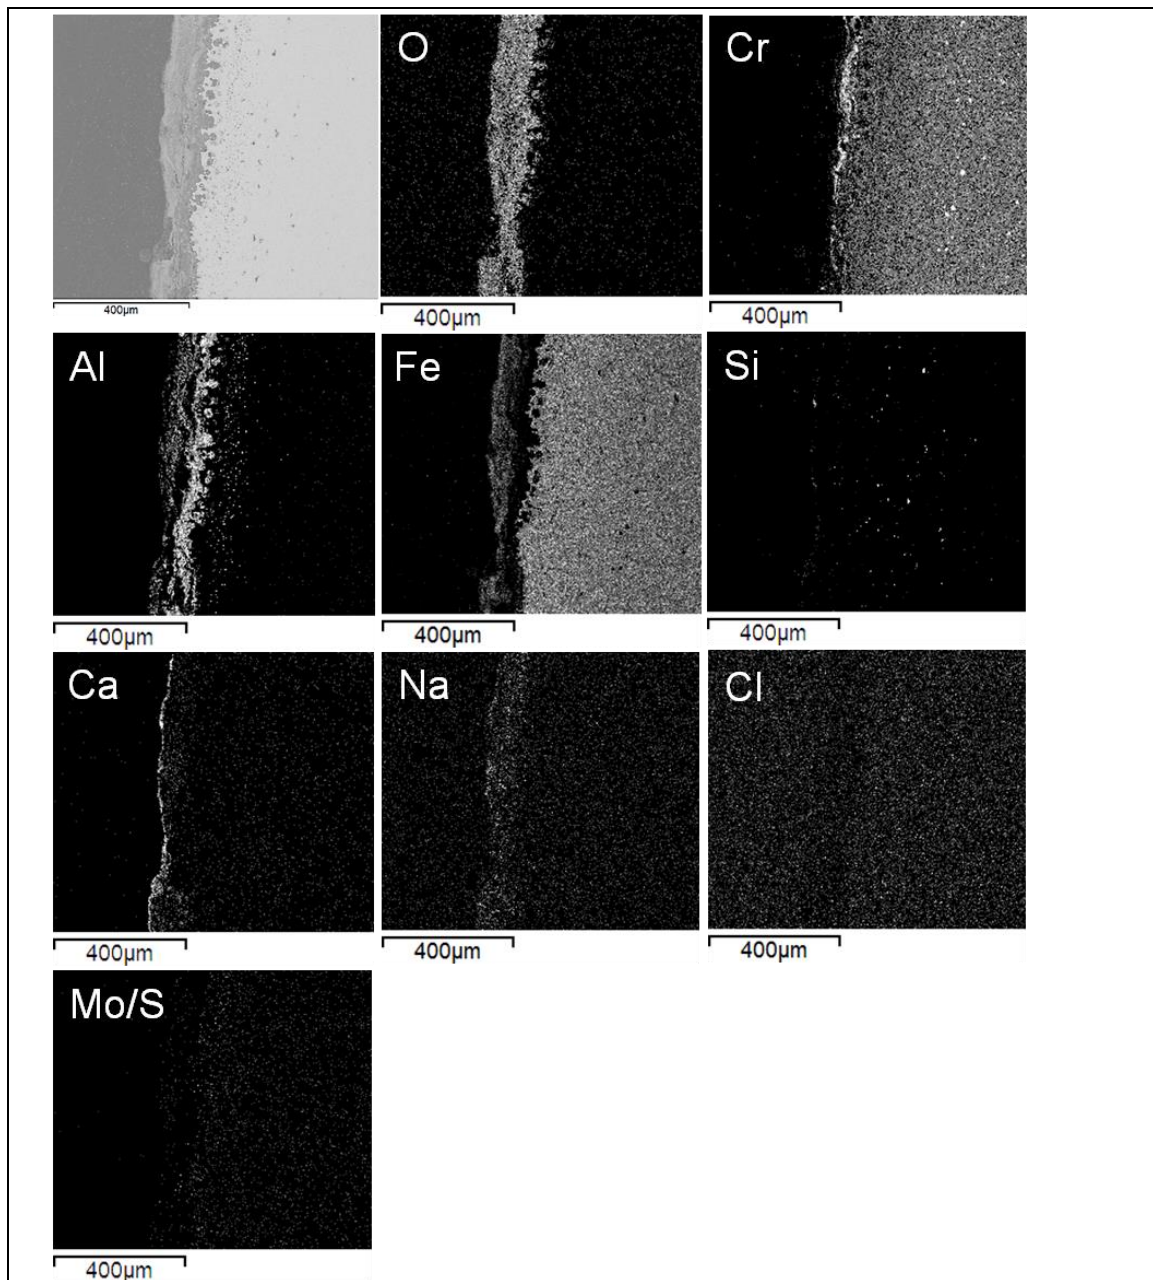
The shield sheet for the vortex finder at Händelö facility was manufactured of Kanthal APMT™. *Figure 6-76* shows images of the shield sheet before exposure (a), after exposure for 133 days (b) and after demounting after the total exposure time (265 days). From the images it can be seen that a yellowish deposit get caught on the shield sheet during exposure. The deposit appears to be rich in Ca and Na, see *Figure 6-77* and *Figure 6-78*. The oxide scale appears layered and consists of an aluminium rich layer closest to the metal, an Cr-rich layer on top and an Fe-rich outer layer, see *Figure 6-77* and *Figure 6-78*.

Figure 6-78. Backscattered SEM image of the cross-section of the pre-oxidized APMT sheet exposed at the vortex finder at Händelö together with EDX maps for the elements O, Cr, Al, Fe, Si, Ca, Na, Cl and Mo/S.
