# KME 708

## High temperature corrosion in used wood fired boilers 2014-2016

17-03-21 Pamela Henderson, Annika Talus, Mattias Mattsson, Fredrik Niklasson

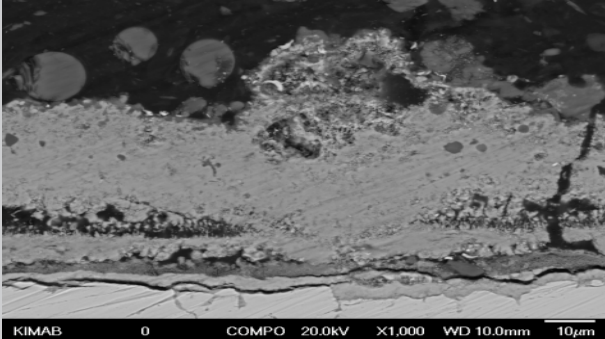
| | Low Cl/Pb | High Cl/Pb |
|---|---|---|
| 2.25Cr | <p>KIMAB 0 COMPO 20.0kV X1,000 WD 10.0mm 10µm</p> | <p>KIMAB 0 COMPO 20.0kV X850 WD 9.9mm 10µm</p> <p>More internal oxidation with Cl in grainboundaries. Spalled samples, according to SP in oxide/metal interface.</p> |

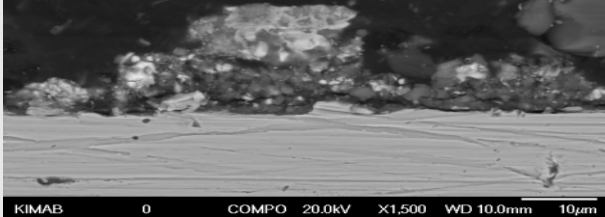
| | Low Cl/Pb | High Cl/Pb |
|---|---|---|
| 304L | <p>KIMAB 0 COMPO 20.0kV X1,500 WD 10.0mm 10µm</p> | <p>KIMAB 0 COMPO 20.0kV X2,000 WD 10.0mm 10µm</p> <p>Cl and internal oxidation</p> |
