# HIGH TEMPERATURE CORROSION IN USED-WOOD FIRED BOILERS

# **High temperature corrosion in used-wood fired boilers**

## **Part 1. KME-708**

ISBN 978-91-7673-089-8 | © 2017 ENERGIFORSK

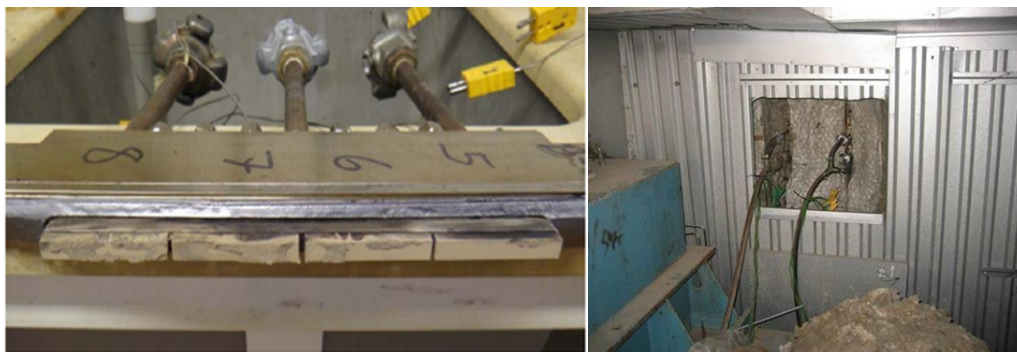
**Fig. 2.2. 1. Vattenfall's wall probe after exposure (left). The probes sit vertically in a slit in the fin between two tubes, here seen from outside the furnace, (right)**

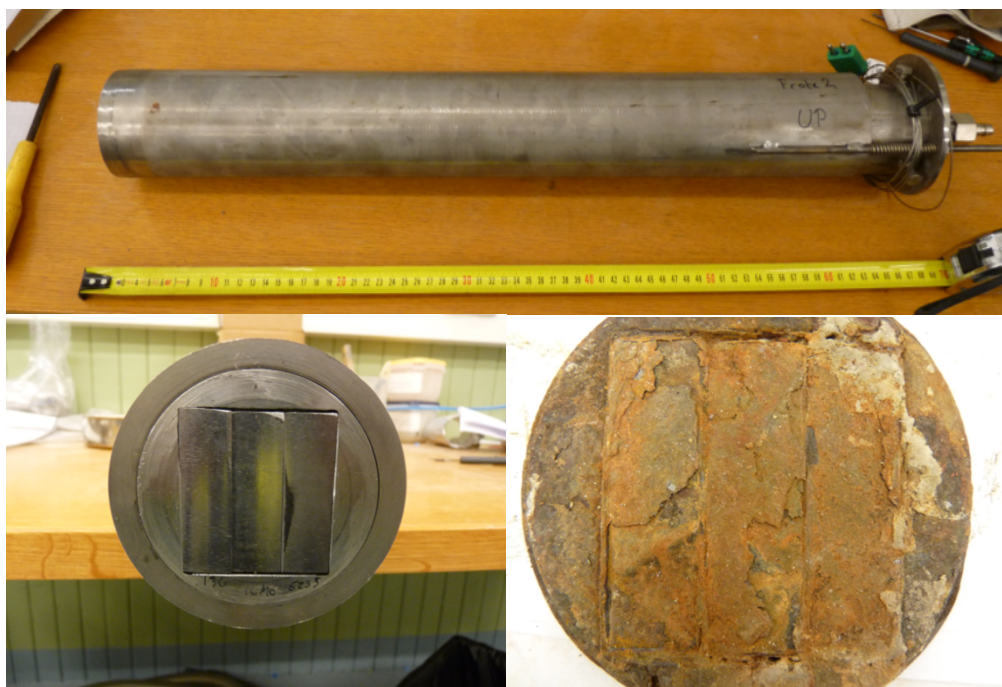
**Fig. 2.2.6.** AFW's furnace probe. Longitudinal view (upper).  
Probe tip with three specimens before exposure (lower left).  
Probe tip with three specimens after exposure at 330°C (lower right).

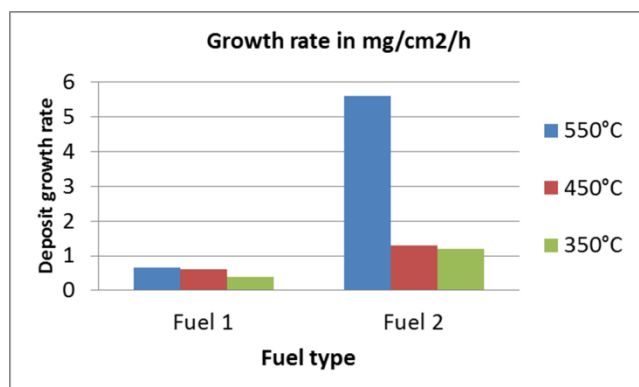
The growth rates of the deposits near the superheaters obtained from Fuel 2 were higher than those from Fuel 1, especially at the highest temperature, as can be seen from Fig. 3.1.1. Fig. 3.1.2 shows that more Cl was present in the deposits from Fuel 2 and more S was present in the deposits from Fuel 1. No Pb was detected in the deposits from Fuel 1 at the two highest temperatures of 450°C and 550°C. Sections through the rings to examine the initial corrosion showed that more corrosion was caused by Fuel 2, (see Figs. 3.1.3 and 3.1.4) on 13CrMo44 (SS2216) at 350°C and 450°C after 3 hours.

**Fig. 3.1.1** Deposit growth rates at three different ring temperatures obtained from probe testing near the superheaters. Exposure time 3 hours.

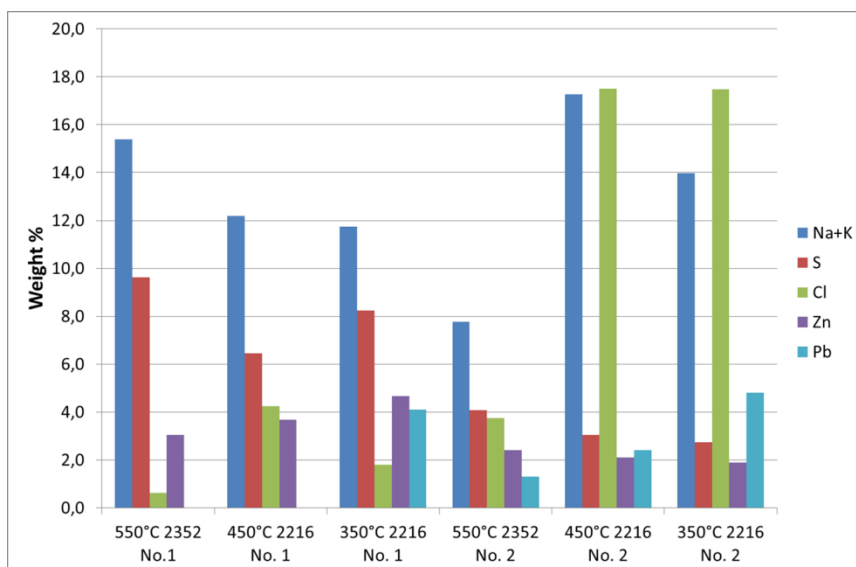
**Fig. 3.1.2** Amounts of key elements in the probe deposits at three different temperatures. Exposure for 3 hours near the superheaters. The rings used at 550°C were made of stainless steel (SS 2352) and the rings used at 350°C and 450°C were made of a low alloy ferritic steel (SS 2216).

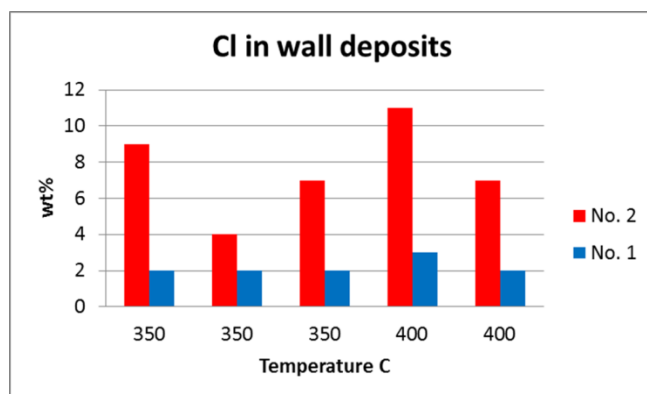
The deposits on the wall probes were of course much thicker (after 2 weeks testing) although uneven because of spalling. Some deposits from the wall corrosion probes were analysed and the results for chlorine given in Fig. 3.1.5. More Cl was found in the wall deposits from Fuel 2 which agrees with the 350°C results from the superheater probe deposits in Fig. 3.1.2. The lead concentration was found to increase in the deposit closer to the metal substrate for all samples, which meant that a thinner (spalled) deposit showed higher lead levels.

Fig. 3.1.5 Amount of Cl in the deposits on the wall probes after 333 h exposure.

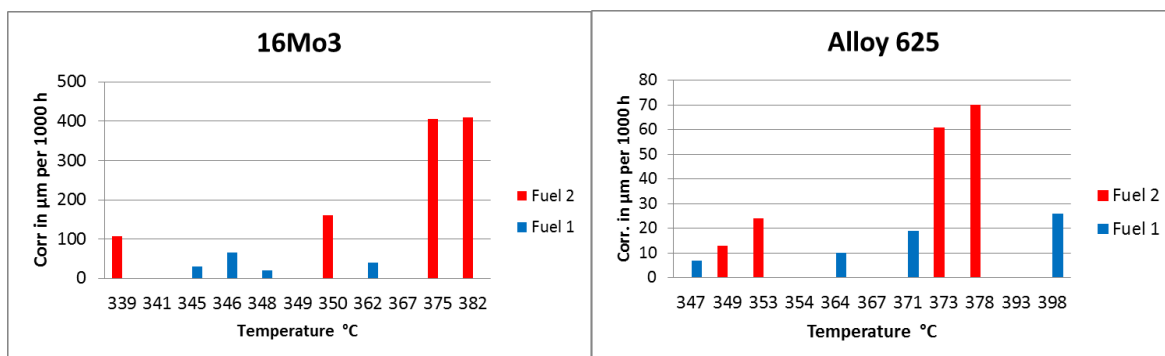
Two probes were used in parallel for each fuel case, one with a control temperature of 350°C and one at 400°C. There were two specimens of the low alloyed steel 16 Mo3 (tube steel) and two of the nickel-based alloy Alloy 625 (coating material) on each probe. (Alloy 625 is used to coat the boiler tubes in the furnace wall, but for this corrosion test specimens of solid Alloy 625 – i.e. not coated, were used.) There was some spread in temperatures along the probes, but the temperature of each specimen was measured individually. The corrosion caused by Fuel 2 was greater than that caused by Fuel 1 and also more temperature dependent, see Fig. 3.1.6.

Fig. 3.1.6. Corrosion rate in µm per 1000 h for 16Mo3 (left) and alloy 625 (right). Testing time 333 h in both cases. Note the difference in scales. Fuel 2 caused more corrosion than Fuel 1.

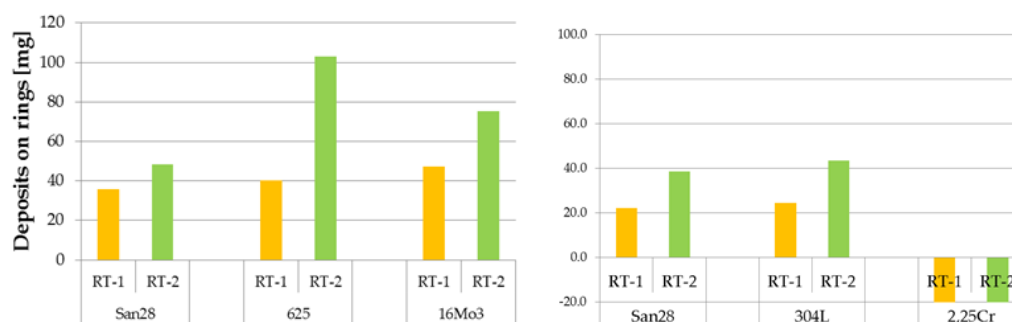
Fig. 3.2.3. Weight gain for each ring after the loose ash has been removed. Furnace wall probe at 380°C (left). Superheater probe at 550°C (right). In each case the weight gain is greater for the Fuel 2 case. The weight loss seen for 2.25Cr at 550°C (far right) indicates spalling of the oxide scale and that the temperature is too high for this steel.

In general more deposits were present on the samples exposed when firing Fuel 2 both at the furnace wall position and at the superheater position, see Figure 3.2.3. For 2.25Cr-material spallation occurred in the oxide layer when removing the loosely sitting ash/deposit and these samples thus showed a weight loss after exposure.

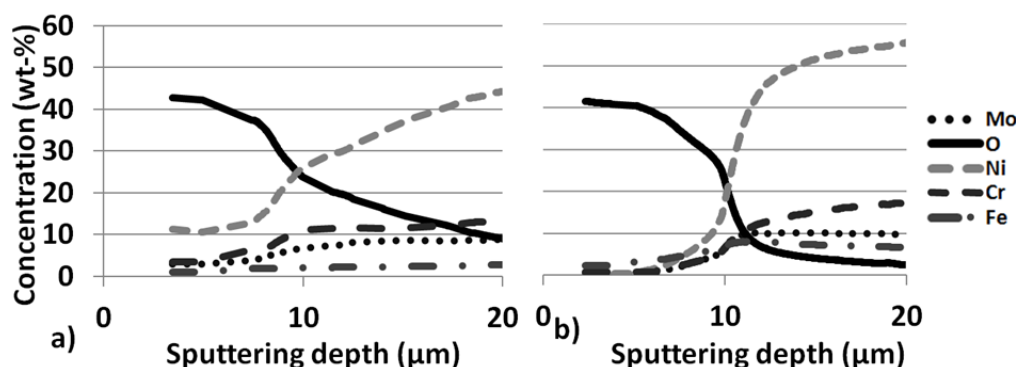
Fig. 3.3.1 GD-OES data for Alloy 625 samples a) when burning used wood b) when burning used wood+sludge

GD-OES revealed that higher amounts of Ni, Cr and Mo from Alloy 625 were found in the corrosion product of the used wood sample, compared to the mixture of used wood and sludge, indicating that the sludge had reduced the corrosion.

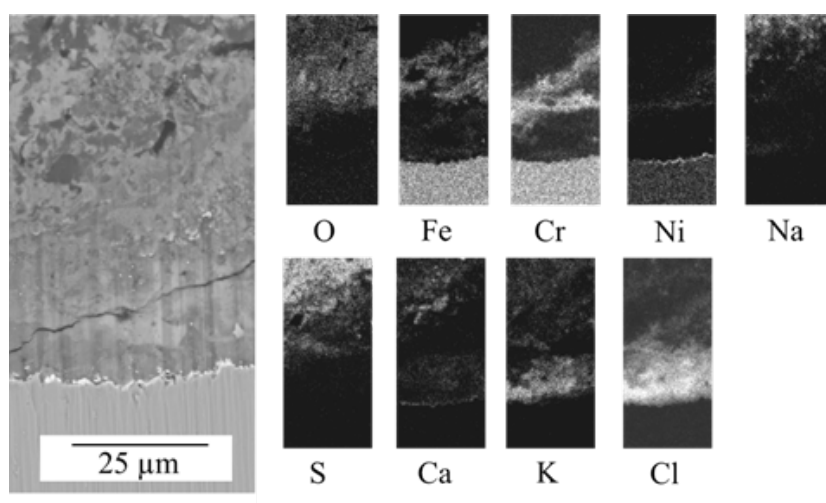
Figure 3.3.2. Element distribution by EDS mapping of 310S exposed to 100% used wood.

Typical micrographs of the initial corrosion with and without sludge or shown in Figures 3.3.2 and 3.3.3. In the mapped area of the used wood sample, chlorine is shown close to the interface, Fig. 3.3.2. The chlorine is in combination with potassium at several places. In the deposit, sulphur, oxygen, calcium and potassium are dominant but a high iron content is also observed. Closest to the alkali chloride, chromium enrichment is seen in combination with a chlorine signal indicating chromium chloride. No continuous iron oxide layer is observed; instead the iron is located in the deposit. Close to the metal surface nickel enrichment is seen. For the sludge sample a similar behaviour is seen regarding the chemical analysis, Fig. 3.3.3. However, in general, the potassium chloride area is thinner for the sludge sample. Also for this sample a chromium layer together with chlorine is observed. In the deposit, sulphur, oxygen, calcium and potassium are dominant but compared to the 100% used wood sample, very little iron is seen in the deposit. Instead, the iron is located as an oxide on top of the chromium and chloride. Another difference is also that no nickel enrichment is seen in this sample.

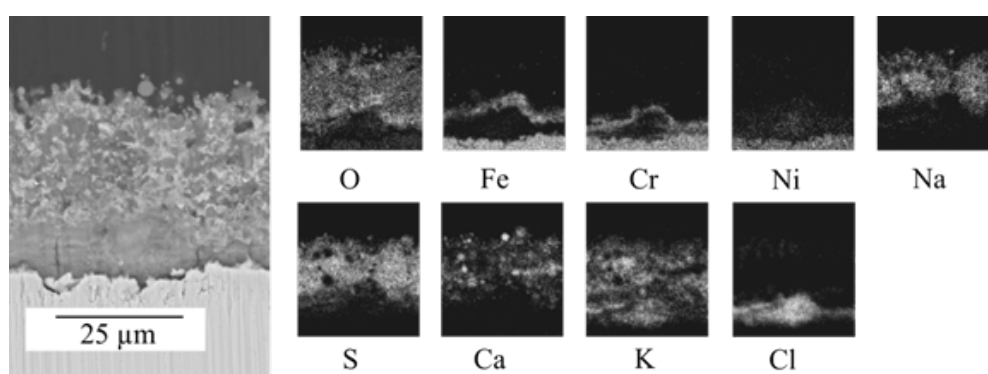
Figure 3.3.3. Element distribution by EDS mapping of 310S exposed to used wood + sludge.

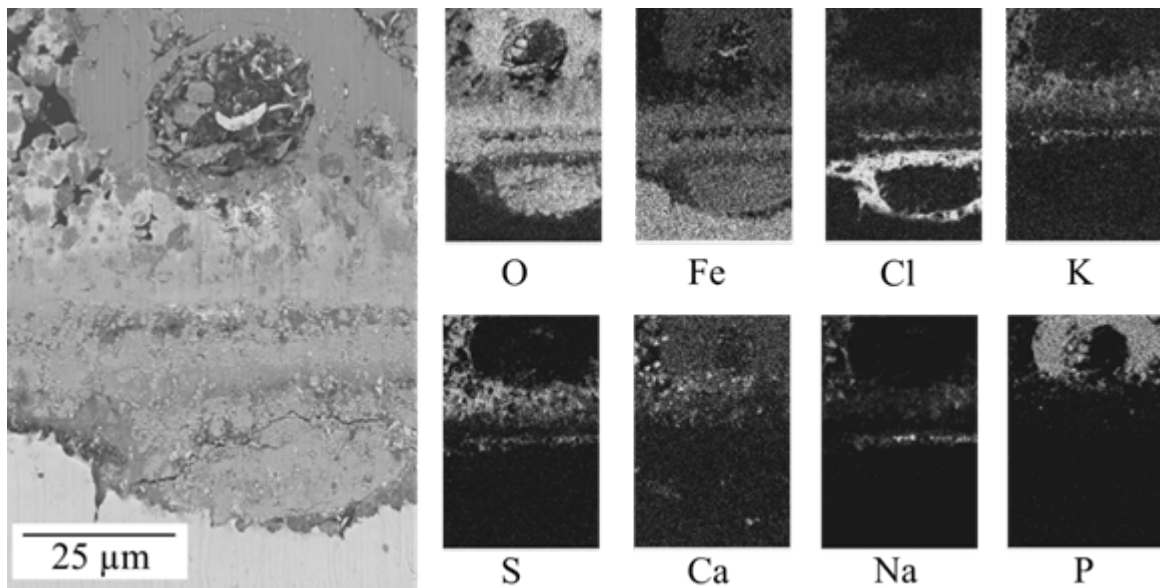
For 16Mo3 samples, tested with or without sludge additions, it was found that the chlorine close to the metal surface was mainly correlated to iron and oxygen indicating that the corrosion product was an iron chloride which had been oxidised or hydrated (Fig. 3.3.4). Due to the hygroscopic nature of iron chloride this compound has most probably absorbed moisture during sample handling after grinding when exposed to air. In order to confirm the presence of iron chloride a

Figure 3.3.4 Element distribution by EDS mapping in cross section of 16Mo3 exposed to used wood + sludge.

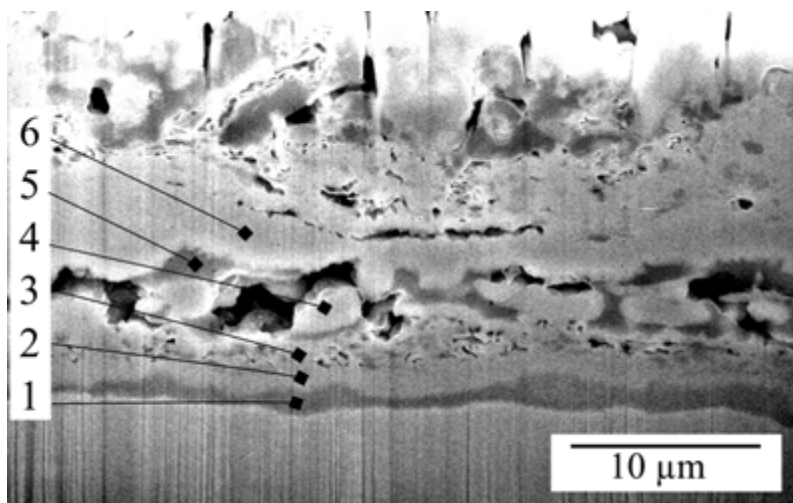
cross-sectional cut was performed in FIB on 16Mo3 where an elemental analysis was performed without exposing the cut to air. In the cross section of the sample exposed to 100% used wood, Fig. 3.3.5 and Table 3.3.4, it can be seen that there is no oxygen at the interface indicating that mainly iron chloride is present at the interface (point 1). The image also shows that the iron chloride is present as a continuous layer along the metal surface. Above this layer, iron oxides are present and further up some deposit has become mixed in with the oxide layer, (point 5). The main difference for 16Mo3 when sludge is added to the fuel is that less corrosion is observed. However, both with and without sludge addition the material showed severe corrosion considering the short exposure time of about 15 h.

Fig. 3.3.5 FIB cross section of 16Mo3 exposed to 100% used wood.

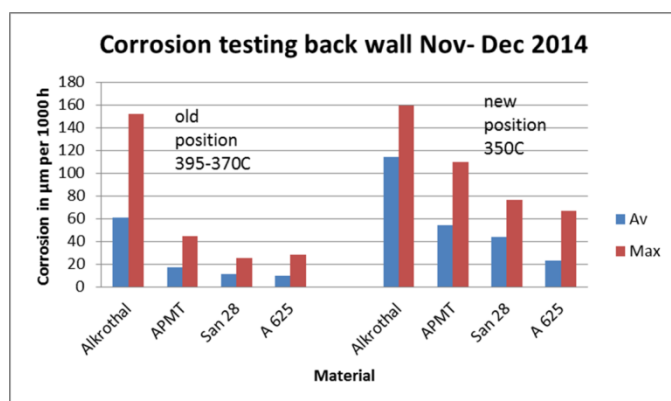
**Fig. 3.4.1** Average and maximum corrosion rates for alloys tested on the furnace back wall of Idbäcken. Nominal temperature was 400°C. Testing time was 986 h.

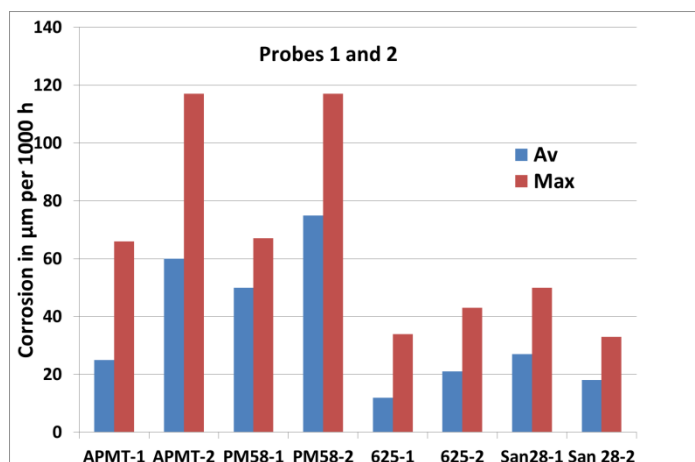
The second long-term corrosion test was performed in December 2015. Both probes contained the same materials: APMT, Nikrothal PM58, Sanicro 28 and Alloy 625. The average temperatures of all specimens were in the range 380-400°C and the control temperature was 400°C. Exposure time at temperature was 1129 h. The results are displayed in Fig. 3.4.2. Sanicro 28 and Alloy 625 showed the lowest corrosion rates.

Fig. 3.4.2 Average and maximum corrosion rates for alloys tested on the furnace back wall of Idbäcken. Two probes (no. 1 and 2) were used which were exposed at the same time during December 2015 and January 2016. Nominal temperature was 400°C. Testing time was 1129 h. APMT-1 denotes APMT on probe 1 and APMT-2 denotes APMT on probe 2, etc.

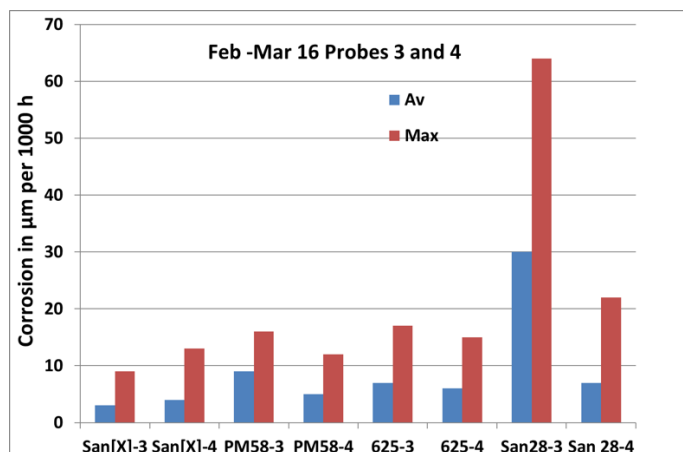
The third (and last) long-term corrosion test in Idbäcken was performed in February and March 2016. Two probes (3 and 4) were used in parallel, both in the new testing position. The probes contained the same materials: Sanicro [X], Nicrothal PM58, Sanicro 28 and Alloy 625. The average temperatures of specimens on probe 3 were in the range 395-410°C and on probe 4 360-415°C. The control temperature was 400°C and exposure time at temperature was 817 h. The results are displayed in Fig. 3.4.3. Sanicro [X] and Alloy 625 showed the lowest corrosion rates. One specimen of Sanicro 28 (San28-3) exhibited very high corrosion rates. However both Sanicro 28 specimens, San28-3 and San28-4 had similar temperatures, 398°C and 394°C respectively.

Fig. 3.4.3 Average and maximum corrosion rates for alloys tested on the furnace back wall of Idbäcken. Two probes (no. 3 and 4) were used which were exposed at the same time during February and March 2016. Nominal temperature was 400°C. Testing time was 817 h. San[X]-3 denotes Sanicro [X] tested on probe 3 and San[X]-4 denotes Sanicro [X] tested on probe 4, etc.

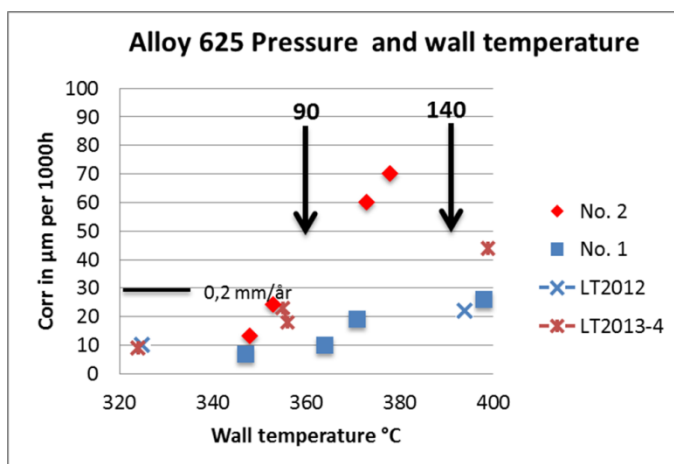
It has been shown previously that a possible way of reducing the corrosion is to reduce the boiler pressure, [33]. Reducing the boiler pressure from 140 bar to 90 bar is equivalent to reducing the metal temperature from 390°C to 360°C, (the water temperature is reduced from 340 to 310°C) giving a reduction in the corrosion rate. This method is more effective for Fuel 2 than Fuel 1 because of the greater temperature dependence of the corrosion rate, but this would still result in a corrosion rate of 1mm per year for 16Mo3. However the corrosion is reduced to 0.2 mm per year for Alloy 625, (see Fig. 4.1.1)

Fig. 4.2.1 Variation of corrosion rate for Alloy 625 with Fuels 1 and 2 (2 week tests) and comparison with long-term (6 week) testing performed during 2012 and 2013-4. Reducing final pressure from 140 to 90 bar reduces the wall temperature from 390 to 360°C.

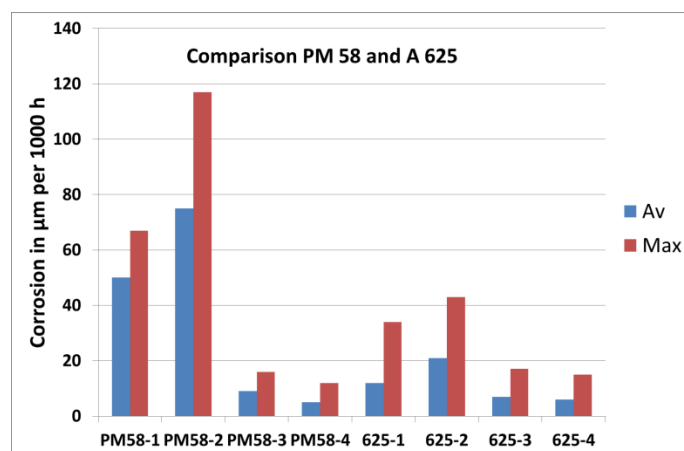
Long-term testing at the furnace wall in Idbäcken during the firing season 2015-16 showed some differences in the corrosion rates measured during December 2015- January 2016 and February – March 2016. The corrosion rates measured were higher for the Dec-Jan exposures and this was most marked for the nickel-based alloys, see Figures 4.4.1 and 4.4.2.

Fig. 4.4.1 Comparison of Nikrothal PM 58 and Alloy 625 for Dec-Jan (samples 1 and 2) and Feb –March (samples 3 and 4). Corrosion was greater during Dec-Jan.

A number of factors can affect corrosion rates, for example fuel composition, boiler load, flue gas temperature. A comparison of key boiler and fuel parameters is given in Table 4.2.1. It can be seen that the boiler load and flue gas temperatures were similar, but the Cl and Pb levels in the fuel and also the moisture content were slightly higher during testing in December and January. This probably explains the higher corrosion rates.

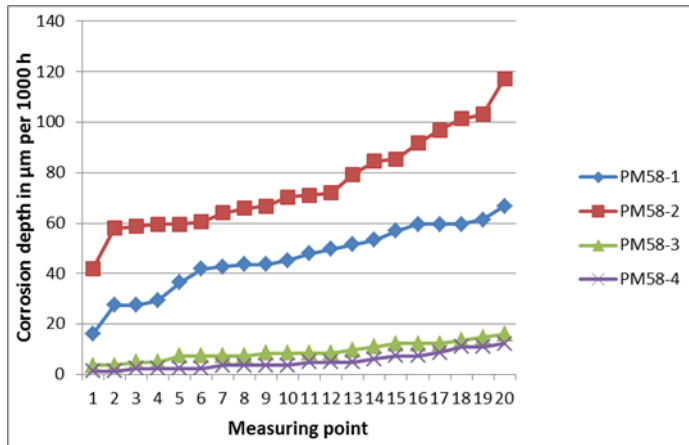
Fig. 4.4.2 Corrosion depth for each of the 20 measuring points on specimens Nikrothal PM58 1-4. The results show that corrosion in all points measured was higher for tests 1 and 2 than for 3 and 4.
