FUSE PLUG BREACH TESTS

REPORT 2018:465

Can a laboratory scale test replace a field test?

JOHAN LAGERLUND

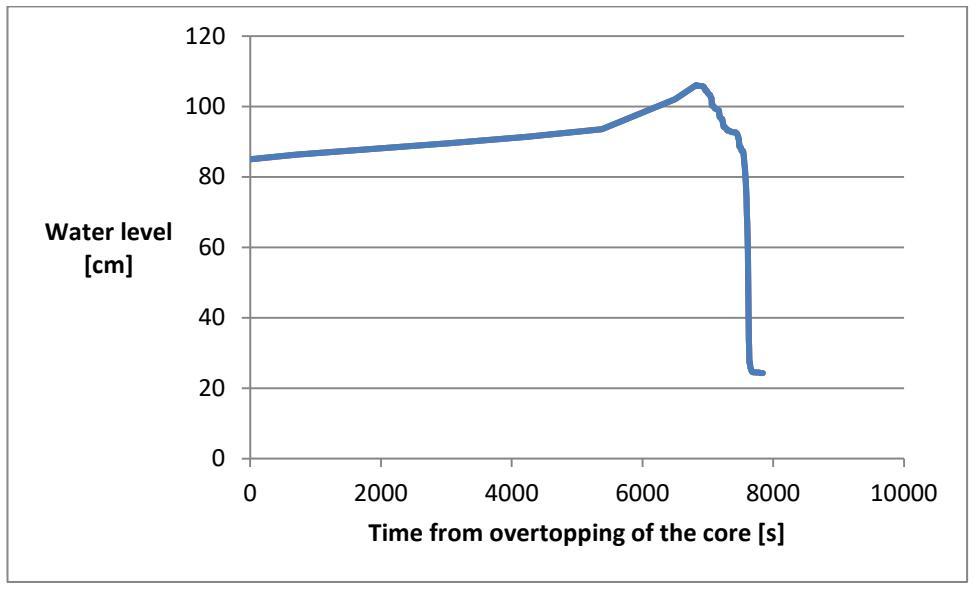
The reservoir level rose with a velocity of 0.06 m/h (1:3 rate of field test) during the main part of the test (Figure 11, 0-5,500 s). When the reservoir level exceeded the crest, the seepage through the crest increased. The inflow of water was difficult to control due to the excessive seepage occurring after the reservoir level had passed the crest of the core. The inflow of water became more and more difficult to control as the reservoir level continued to rise due to heavy seepage. At the final phase of the test the reservoir elevation velocity was 0.1 m/h.

Figure 11. Water level in the reservoir from overtopping of the core to the end of the test. Breach initiation at peak.

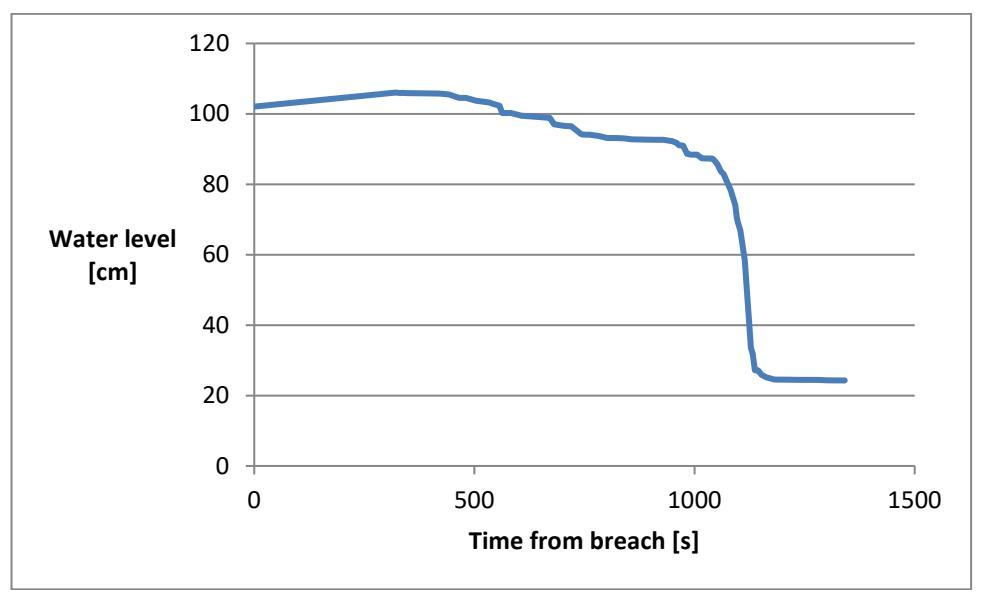
The time from breach initiation to a sudden collapse of the fuse plug was ~1,000 s (Figure 12). After the collapse of the fuse plug it took yet another 150 s for the fuse plug to be eroded down to a height of 24 cm. The inflow of water was thus not enough to erode the fuse plug completely (Figure 13). From the initial height of 97 cm, 25 % of the height of the fuse plug remained intact after the test was aborted.

Figure 12. Water level in the reservoir from the moment of breach (breach at 0 s) to the end of the test.

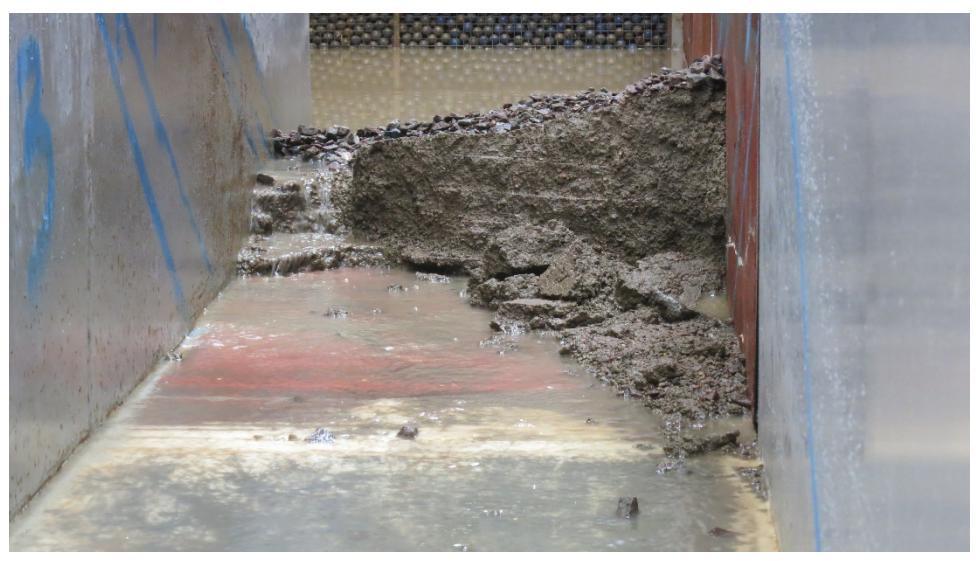
Figure 13. Fuse plug after the 1:3 scale test had been aborted.

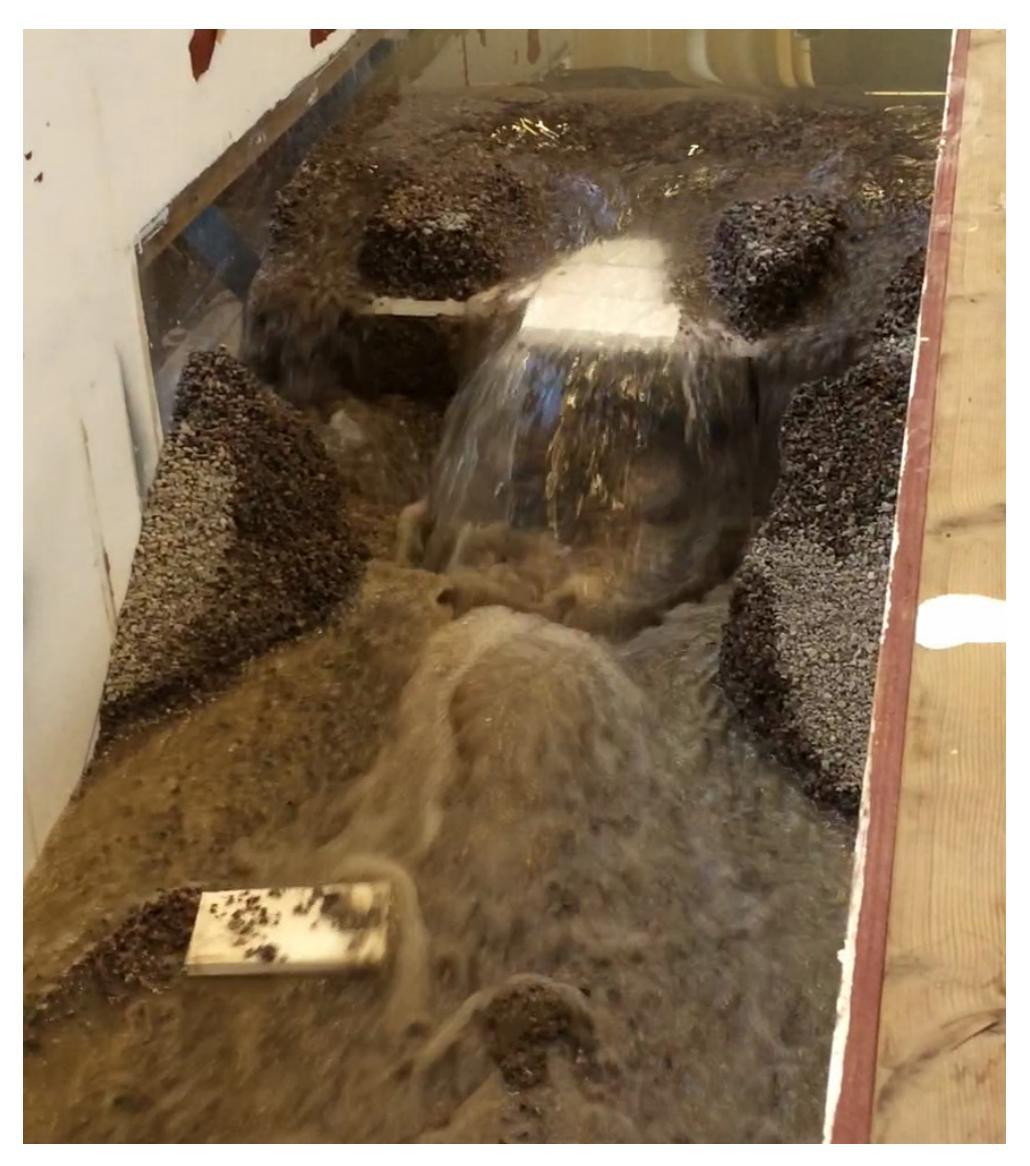
The breach initiation and development happened in a similar way to that of the field test (Figure 16 and Figure 17) but slightly different from the 1:3 scale test. All events happened in the same way except for the timing, which was much faster in the 1:6 scale test. The breach in the 1:6 scale test occurred before the crest was overtopped at all places. In accordance with the 1:3 scale test, the breach was initiated by a sudden collapse of the front section of the fuse plug at the downstream side of the pilot channel. Beside the difference in the timing of the breach initiation, the development of the breach itself was similar to the 1:3 scale test.

Figure 17. Breach propagation.

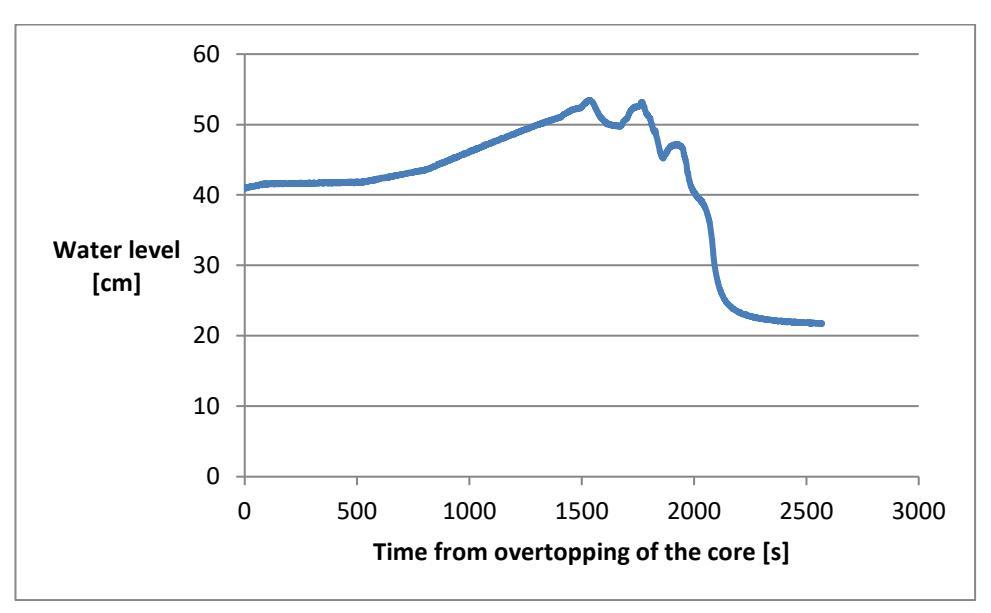
The increase of reservoir level was aimed at a velocity of 0.04 m/h during the main part of the test but in the end it was difficult to control due to waves forming inside the flume. The reservoir level increased with 0.25 m/h ~500 s prior to breach initiation (Figure 19).

Figure 19. Water level in the reservoir from overtopping the core to the end of the test. Breach initiation at 1.500 s from overtopping the core.

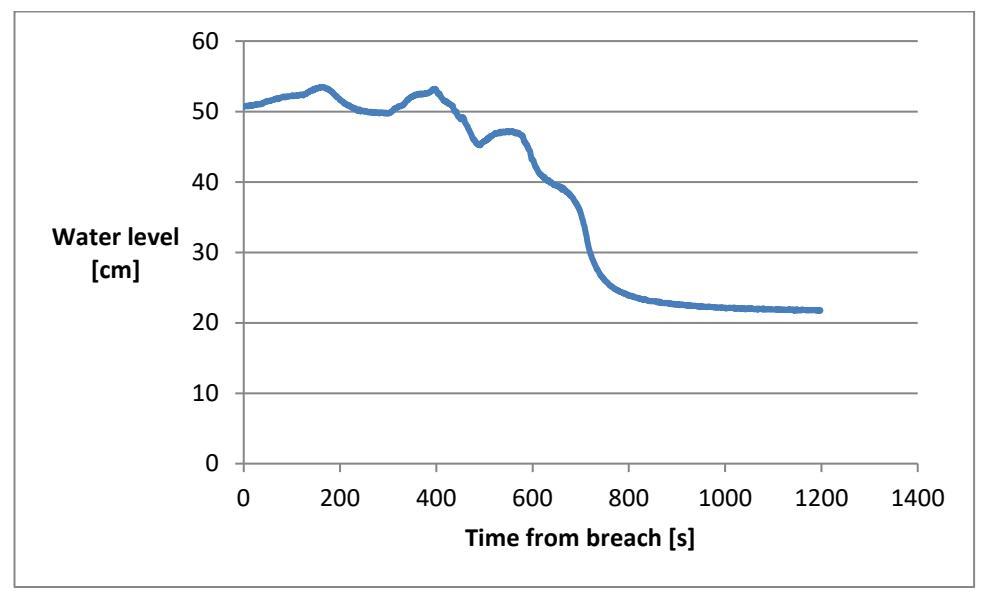
The time from breach initiation to a sudden collapse of the fuse plug was ~200 s (Figure 20). After the collapse of the fuse plug it took another 600 s for the fuse plug to be eroded down to a height of ~22 cm. The inflow of water was thus not enough to erode the fuse plug completely (Figure 21). From the initial height of 50 cm, 44 % of the height of the fuse plug remained intact after the test was aborted.

Figure 20. Water level in the reservoir from the moment of breach (breach at 0 s) to the end of the test.

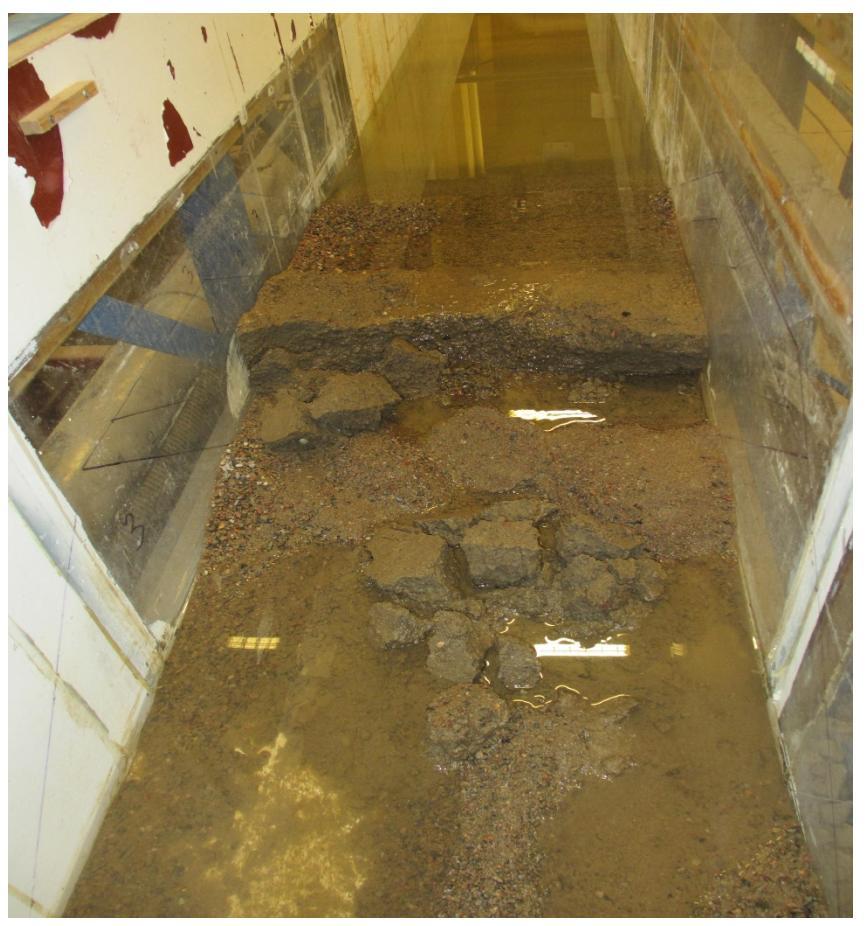
Figure 21. Fuse plug after the 1:6 scale test had been aborted.

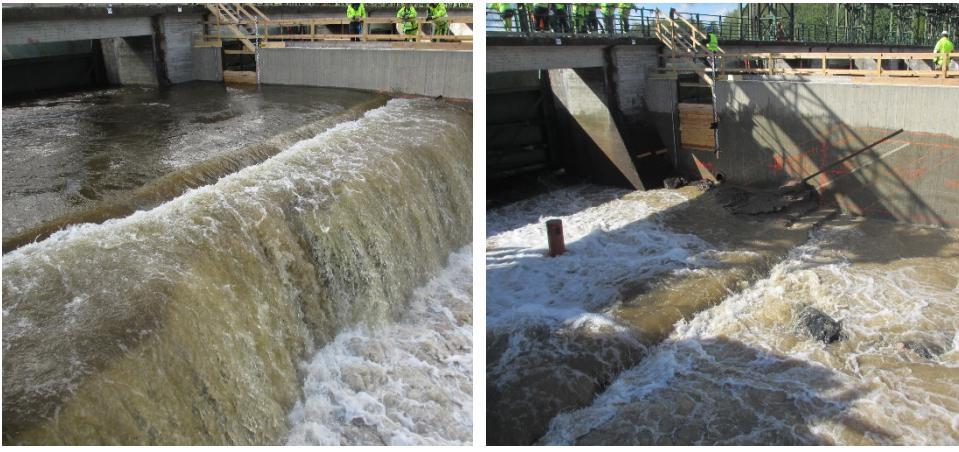
The breach progressed in the center of the fuse plug (Figure 31) in a "pushing action" caused by the water on the structural fill. The erosion then gradually spread sideways all along the crest of the fuse plug as the reservoir level slowly continued to rise (Figure 32). The structural fill on top of the insulation foam boards was quickly washed away. The insulation foam boards slowed down the erosion process of the core beneath them. The insulation foam boards were washed away one by one, gradually leaving the core exposed to the passing water. The insulation foam boards that were placed on the upstream side of the inclined filter sand were in particular responsible for protecting the core against erosion (Figure 33 left). As soon as these insulation foam boards were washed away the core was quickly eroded. The core in the beginning of the erosion process was "shaved off" layer by layer. After some progression of the erosion rate was increased (Figure 33 right).

Complete erosion of downstream structural fill at 11:55 am

Figure 33. Propagation and complete erosion of the fuse plug.

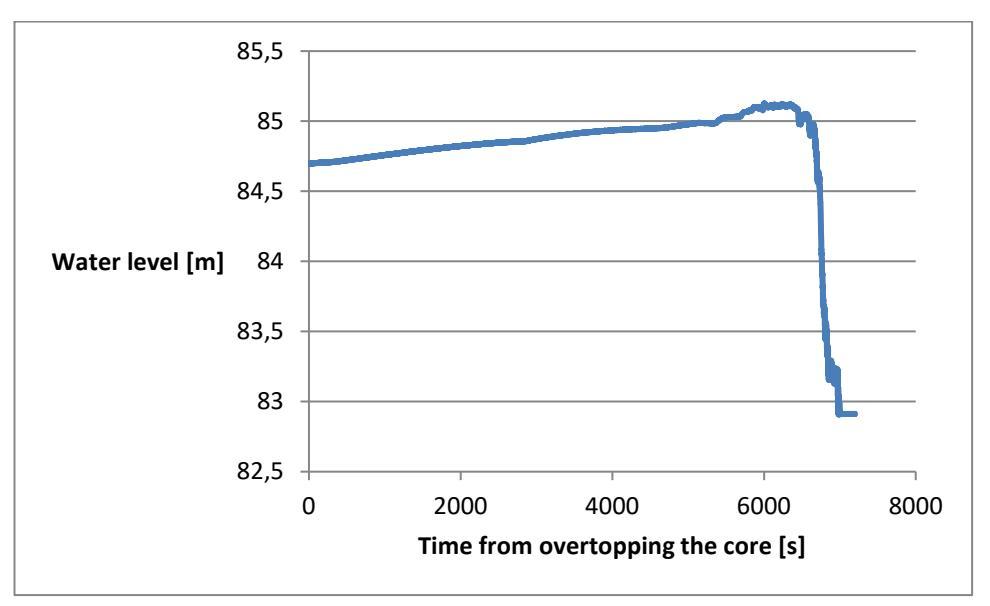
The upstream water level rose with a velocity of 0.2 m/h during the main part of the test (Figure 34, 0-5,000 s). When the water level exceeded the crest, the seepage through the crest increased. At 11:44 am (3 min after breach initiation the spillway gate had to be opened in order to aid the pumps (Figure 34 at ~5,200 s), thus compensating for the increased seepage.

Figure 34. Water level in the reservoir from overtopping the core to the end of the test. Core was overtopped at 10:15 am.

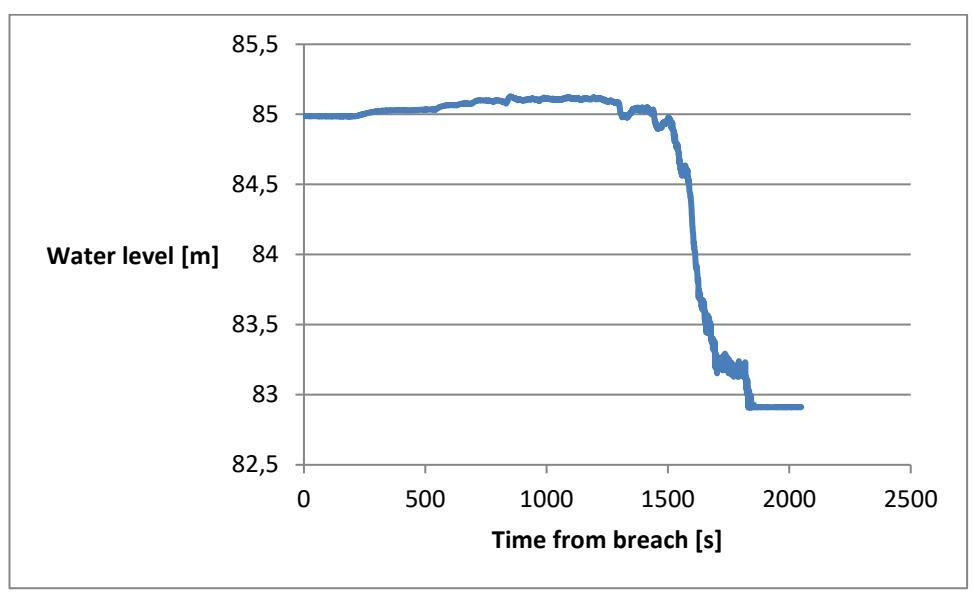
The time from breach initiation to a sudden collapse of the fuse plug was ~1,500 s (Figure 35). After the collapse of the fuse plug it took yet another 300 s for the fuse plug to be fully eroded. The time from breach initiation to a complete collapse was thus ~1,800 s (30 min).

Figure 35. Water level in the reservoir from the moment of breach to the end of the test. Breach occurred at 11:41 am.

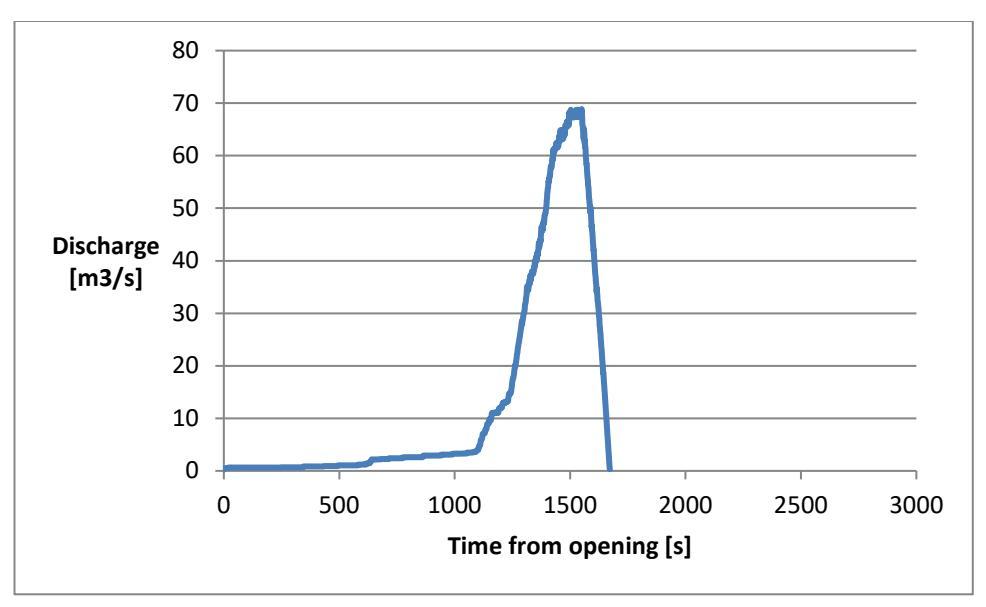
estimation was performed for the whole width of the fuse plug, i.e. 13.00 m. The maximum discharge of 68.6 m³/s (for the 13.0 m wide fuse plug) was attained ~1,600 s (25 min) after the spillway gate was opened (Figure 36). The time for the maximum discharge was 12:10 pm, 29 min after breach initiation. For each meter of fuse plug, the maximum discharge capacity during this test was 5169 l/s.

Figure 36. Discharge during the test after the gate was opened. Gate operation was started at 11:44 am.

Since the upstream water level decreased rapidly during the test the calculated discharge capacity from the test is to be regarded as a conservative measurement. In reality, it will be higher.
