COMBATING HIGH TEMPERATURE CORROSION BY NEW MATERIALS, TESTING PROCEDURES AND IMPROVED MATERIAL SELECTION

- CORROSION EXPOSURES IN THE WASTE FIRED CFB BOILER P15 AT HÄNDELÖ
- THE EFFECT OF INCREASED FRACTIONS OF WASTE WOOD ON WATER WALL- AND SUPERHEATER CORROSION

KME-711 & KME-720

L.PAZ, A.OLIVAS, T.JONSSON, A. PETTERSSON, F. MORADIAN, A.JONASSON, J. ASPEN, P. SCHNEIDER, J. MAHANEN, K. VÄNSKÄ, V. BARIŠIĆ, B.JÖNSSON, J. HERNBLOM, M. HUHTAKANGAS, J. LISKE

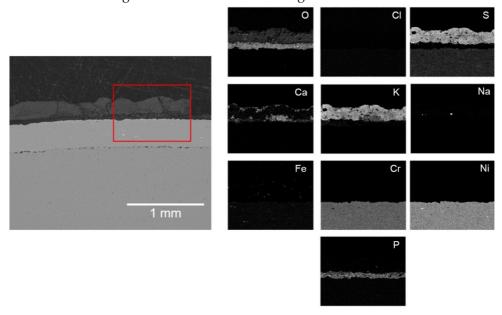
superheater region of the Örtofta boiler. The corrosion rate of the HVAF was neglible and the HVOF showed small wastages, up to 0.4 mm/year. The initial thicknesses of the coatings were about 350 – 360 μ m and 440 – 460 μ m of the HVAF and HVOF coatings, respectively.

The SEM/EDX cross section of the HVAF coating exposed for 5277 hours on SH I (about 450 °C material temperature) is seen in Figure 33. The HVAF coating is characterized as dense and homogeneous. In general, very low or almost no corrosion attack was observed, According to the EDX analysis, part of the deposit present on top of the coating contains mainly S, K and some Ca, probably present as K₂SO₄. The presence of Cl is low. In addition, a layer rich in phosphorous is observed in the deposit closest to the coating. The S map is overlapping with Mo and "S" content in the coating and base material is to be regarded as Mo.

Figure 33. SEM/EDX cross section of CorEr HVAF coating exposed for 5277 hours with 40% waste wood on SHI (about 450 °C material temperature). The red square marks the EDX map region.

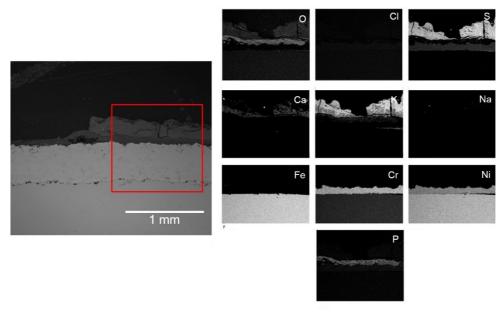
The corresponding HVOF applied coating exposed on SH I is shown in Figure 34. Compared to the HVAF coating, the HVOF coating is slightly more porous and the coating surface is more rough. The EDX analysis shows a well adherent deposit layer. The deposit layer is again dominated by K and S. The inner part of the deposit is enriched in P, originating from the coating application process. The S map is overlapping with Mo and the "S" content in the coating and base material is to be regarded as Mo.

Figure 34. SEM/EDX cross section of CorEr HVOF coating exposed for 5277 hours with 40% waste wood on SHI (about 450 °C material temperature). The red square marks the EDX map region.

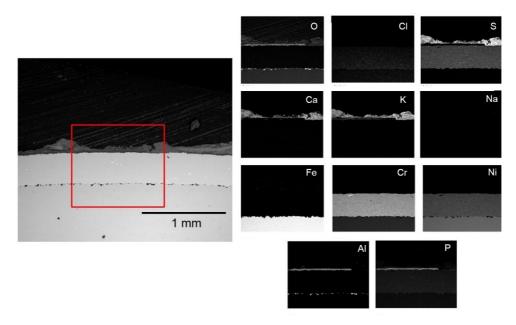
The coatings were also exposed at SH II, with and without insulation between the clamp and the superheater tube, corresponding to a material temperature of about 475 °C and 505 °C, respectively. In Figure 35, the HVAF coating without insulation is shown. Similar to the SH I position, the HVAF coating performs well in this environment, the coating remains dense and homogeneous. There is no indication of the corrosion attack being initiated. As on the samples exposed on the SH I position, the deposit is dominated by sulphates of potassium and calcium. The content of chlorine is below the detection limit. A P enriched layer is detected at the coating/deposit interface. This layer seems to be correlated to the presence of Al according to the EDX analysis. Both Al and P orginates from the coating application process.

Figure 35. SEM/EDX cross section of CorEr HVAF coating exposed for 5277 hours with 40% waste wood on SH II (about 475 °C material temperature). The red square marks the EDX map region.

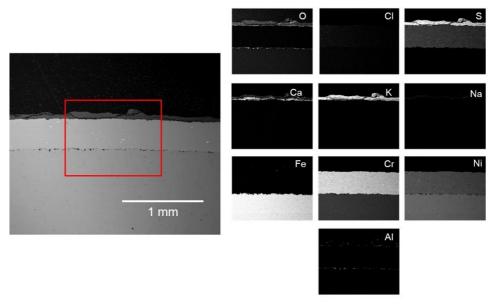
In Figure 37, a SEM/EDX cross section of the HVAF coating exposed on SH II with insulation between the clamp and the underlying superheater tube is shown. The material temperature (about $505~^{\circ}$ C) is slightly higher compared to the

corresponding samples exposed without the insulation layer. Despite the increase in temperature, the coating performs well and a relatively thin layer of well adherent deposit is observed and no indication of an accelerated corrosion attack can be observed. The slightly higher material temperature did not induce any differences in deposit composition; the deposit is dominated by potassium and calcium sulphates and the chlorine content is low. The "S" content in the coating and base material is to be regarded as Mo.

Figure 37. SEM/EDX cross section of CorEr HVAF coating exposed for 5277 hours with 40% waste wood on SH II with one round of insulation (about 505 °C material temperature). The red square marks the EDX map region.

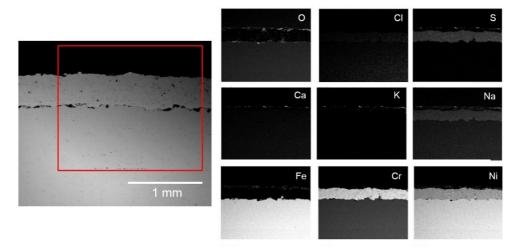
The SEM/EDX analysis of corresponding HVOF coating exposed on SH II with insulation, detected almost no deposit on top of the coating, see Figure 38. In addition, the surface of the coating seems to be slightly rougher and more porous than the HVAF coating. According to the material loss determination, this sample experienced the highest material loss of the exposed coatings, being about 0.12 mm/year. However, the corrosion rate is still rather low compared to the low alloyed steels.

Figure 38. SEM/EDX cross section of CorEr HVOF coating exposed for 5277 hours with 40% waste wood on SH II with one round of insulation (about 505 °C material temperature). The red square marks the EDX map region.

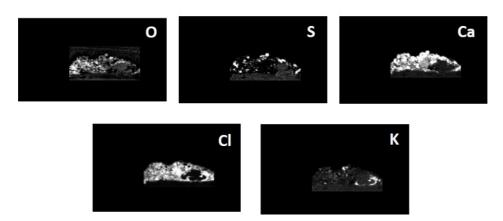
In addition to the 2 and 24 hours exposures, the cold probe was exposed for a very short time (15 min). The aim of this exposure was to analyze any deposition material during the first minutes of the exposure, when the heating of the test material takes place. The exposure was ended once the temperature material reached the set temperature of 600 °C. A thin layer of deposit (~40 μm) was observed on the sample. There were no direct signs of a corrosion attack. The EDX map of a cross section of a non-pre-oxidized sample briefly exposed is shown below, see Figure 43. The EDX map shows that the deposit material mainly contained chlorine and calcium along with some traces of potassium and sulphur. This suggests direct contact between chlorine and the metal surface from the first minutes of exposure.

Figure 43. EDX mapping from cross section of sample exposed 15 minutes, material temperature 600°C; cold testing probe.

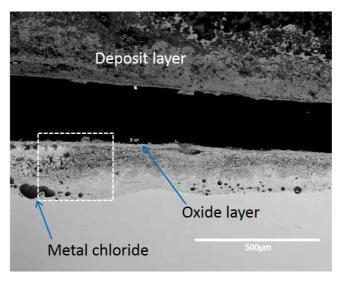
The sample exposed for 24 hours (Figure 44) exhibits a poorly adherent deposit/corrosion product layer. The detached oxide layer consists primarily of Fe, Cr and O. Still attached to the sample, a thin Fe,Cr,Ni oxide could be seen (see Figure 45). Below this oxide, a Fe and Cr depleted zone, enriched in Ni is present. This zone is about 175 µm in thickness and the oxygen level is around 10-15% in this region. In the middle of this nickel enriched metal, a Cr-rich oxide was detected. Furthermore, metal chlorides were observed at the oxide/metal interface. According to the EDX analysis, the metal chlorides are suggested to consist of chromium chlorides.

Figure 44. Cross section of samples exposed for 24 hours, material temperature 600 °C, cold testing probe.

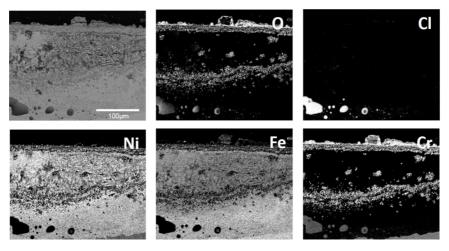
Figure 45. EDX mapping of samples exposed for 24 hours, material temperature 600 °C, cold testing probe.

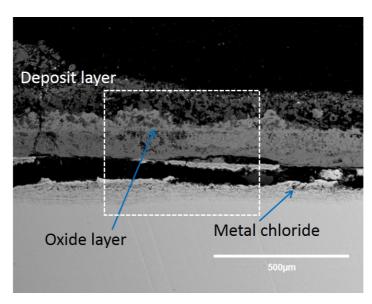
The preheated samples exposed for 24 hours (see Figure 46) do suffer from spallation and the corrosion product layer/deposit layer is detached from steel substrate. The EDX analysis shows that the main elements in the deposit layer are Ca, S and O, indicating the presence of CaSO4 (not shown). Dense oxide layers are formed underneath the deposit layer, see Figure 47. The oxide layer is enriched in Fe in the upper part and Cr in the inner part. The top part of the steel substrate consists of nickel enriched metal. However, compared to the corresponding samples exposed on the cold probe, the nickel enriched area on the preheated 24 hours sample was thinner. The thickness in the preheated case being about 75 μm, compared to 175 μm for the sample exposed from cold conditions. The presence of metal chlorides is again observed at the metal/oxide interface. The distribution of the chlorine in the metal/oxide interface differs slightly from the corresponding sample exposed on the cold probe, being less localized for the sample exposed on the preheated probe. The EDX results also indicate that the total amount of metal chlorides is slightly less on the samples exposed on the preheated probe. However, it should be noted that the difference between the two cases is rather minor. The formation of metal chlorides in the metal/oxide interface is severe in both cases.

Figure 46. Cross section of sample exposed 24 hours, material temperature 600 °C; pre-heated testing probe.

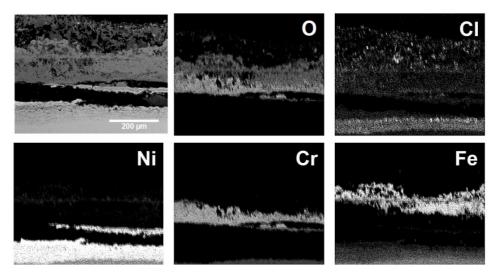
corresponding cold samples, the oxide layers formed exhibits poor adherence. According to EDX analysis the main species in the deposit are Ca, S, Na, Al, Si and O. The majority of the oxide layers has detached from the steel substrate. In the top of the steel substrate, a Ni-rich region is observed. The low levels of oxygen in this region suggest the presence of a nickel enriched metal area. In the bottom of this area, the presence of chlorides can be seen. However, compared to the corresponding samples exposed on the cold probe the results indicate slightly less metal chlorides.

Figure 47. EDX mapping from cross section of sample exposed 24 hours, material temperature 600 °C; preheated testing probe.

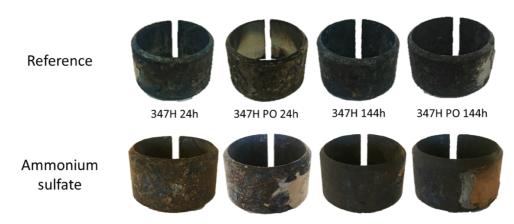
Optical examination of the samples was performed. However, when the samples were removed from the test probe almost all the deposit material was detached from the sample surface. According to the Figure 53, only few areas of the samples surfaces kept deposit material attached. No visible difference can be observed between the pre-oxidized and non-pre-oxidized samples.

Figure 53. Optical images of exposed samples after 24 hours and 144 hours with and without ammonium sulphate

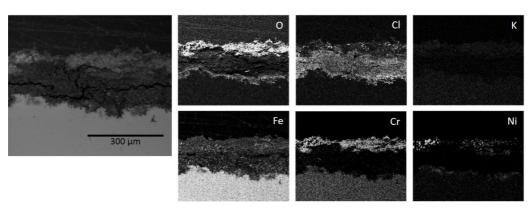
The deposit was rich in chlorine leading to an extended corrosion attack over the material surface. According to EDX analysis chlorine was observed in the oxide reaching the oxide/metal interface. Point analysis shows that iron, chromium and nickel are detected at the chlorine-rich layer. Accumulation of chromium and nickel is detected over the chlorine-rich layer. At the oxide/metal interface oxygen, iron and nickel are detected, however the amount of chromium is low.

Figure 55. EDX analysis of 347H reference exposure after 24 hours.

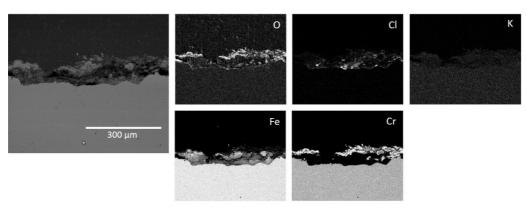
According to EDX analysis accumulation of chlorine close to the metal is detected. Iron, chromium and nickel are present in the oxide scale, however higher amount of chromium is located on the top of the oxide layer. Potassium was not detected in the scale which means that the potassium accumulated during the pre-oxidation reacted with the deposit material. According to the laboratory study that set the matrix for the current exposures, the potassium rich layer on the top of the oxide scale is suggested to react in presence of HCl(g) forming KCl(g) making potassium non-detectable in the oxide scale.

Figure 57. EDX analysis of pre-oxidized 347H reference exposure after 24 hours.

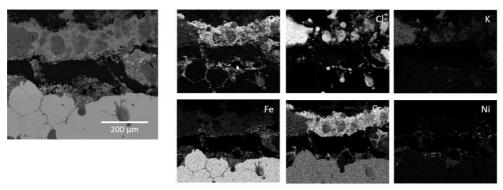
In the EDX analysis showed below, it is confirmed that chlorine is spread all over the oxide scale, the highest concentration of chlorine was detected at the surface of the scale. Chlorine was also detected in the attacked grain boundaries. Regarding the oxide scale, same behavior as the samples exposed during 24 hours was observed. The oxide consists of iron rich oxide. Accumulation of chromium at the scale surface and grain boundaries of the oxide in the bottom layer. Enrichment of nickel was detected at metal close to the oxide/metal interface.

Figure 59. EDX analysis of 347H reference exposure after 144 hours.

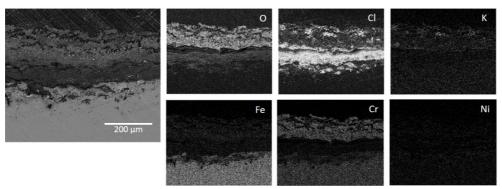
EDX analysis was performed in the region where the pre-formed oxide spalled off. The layer of corrosion products formed during exposure, two areas in the scale are observed. The top layer is rich in chromium and iron. In the bottom layer, the content of chromium decreases while the iron content is the same. Concentration of chlorine was detected in the bottom layer of the scale and the metal where grain boundary corrosion was observed. Presence of potassium was low, this was also observed after 24 hours.

Figure 61. EDX analysis of pre-oxidized 347H reference exposure after 144 hours.

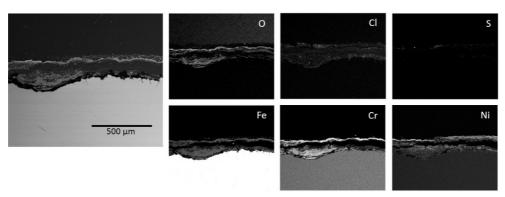
The following figure shows the EDX analysis of the sample. The oxide scale after 24 hours exposure has a similar chemical content compared to the sample exposed without the ammonium sulphate addition exposures. However, it is noticeable that the concentration of chlorine seems to be lower than the reference.

Figure 63. EDX analysis of 347H exposure with ammonium sulphate addition after 24 hours.

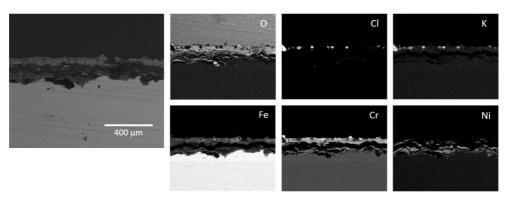
It is important to emphasize that only small amounts of chlorine were detected at the metal/oxide interface and KCl particles were found at the scale surface. The remained oxide scale seemed to be the oxide formed prior exposure according to the chemical analysis. However, the potassium rich region at the top of the scale was not detected, this was also observed in the samples exposed in absence of ammonium sulphate.

Figure 65. EDX analysis of pre-oxidized 347H exposure with ammonium sulphate addition after 24 hours.

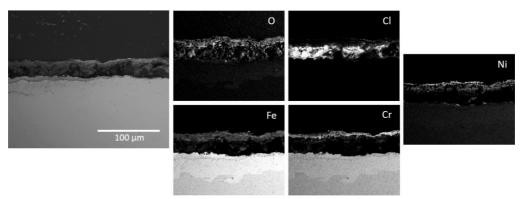
Chlorine was detected along the deposit/oxide layer all the way to the oxide/metal interface. On the top part of the layer iron, chromium and nickel were detected, which suggests the formation of the oxide scale typical of stainless steels.

Figure 67. EDX analysis of 347H exposure with ammonium sulphate addition after 144 hours.

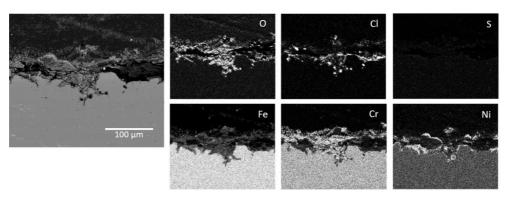
The EDX analysis shows that part of the oxide scale is still attached since the analyzed layer consisted of iron, chromium and some enrichments of nickel. Penetration of chlorine is detected at the oxide/metal interface and at the grain boundary attack. This behavior was also observed in the corresponding sample in absence of ammonium sulphate.

Figure 69. EDX analysis of pre-oxidized 347H exposure with ammonium sulphate addition after 144 hours.

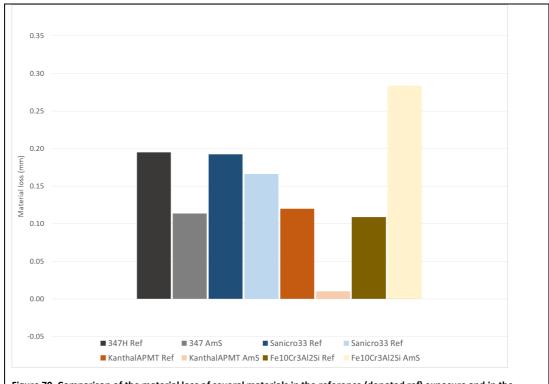
Figure 70. Comparison of the material loss of several materials in the reference (denoted ref) exposure and in the Ammonium sulphate addition exposure (denoted AmS)

According to the material loss data presented in Figure 70, there is a general trend that the corrosion was slightly milder in the Ammonium sulphate exposure, the exception being the FeCrAl model alloy which exhibited a higher mass loss in the Ammonium sulphate exposure. The Sanicro33 showed similar or slightly higher material losses compared to the 347H. For the alumina forming materials, KanthalAPMT and the FeCrAl model alloy, KanthalAPMT performed better compared to newly developed model alloy in the AmS exposure. In the reference exposure, the material loss was similar for the two materials.

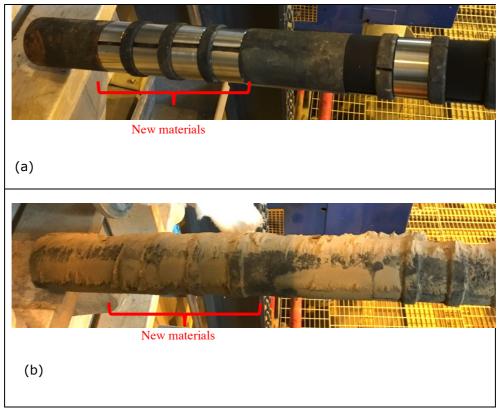
Figure 71 shows the probe (a) before and (b) after the 24 hours exposure. Both zones of the probe were set at $600\,^{\circ}$ C. The new material samples were placed in the zone closest to the tip. All samples are covered in rather loosely attached deposit after the exposure. As a consequence, a major part of the deposit was lost during the removal after exposure.

Figure 71 (a) Probe with the samples before exposure (b) Probe with the samples after 24 hours exposure in regular fuel conditions

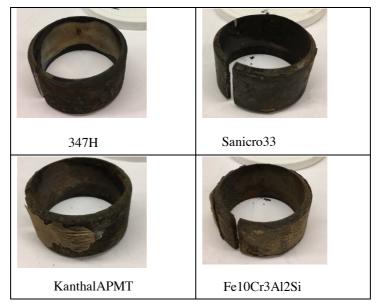
Figure 72. Optical images of the samples after 24 hours in the reference exposure

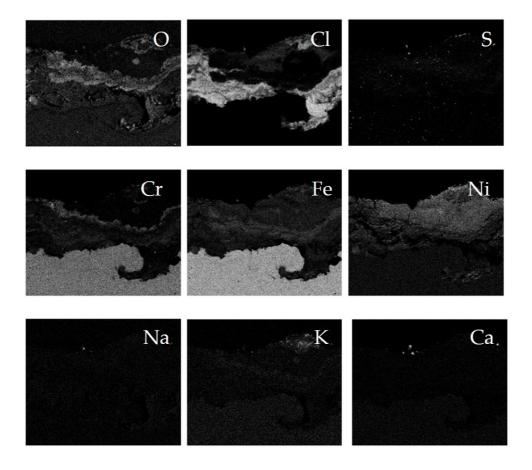
The cross section of the sample shows that some of the deposit is still present on top of the surface, see Figure 73. The EDX analysis presented in Figure 74 shows a non-homogeneous layer of corrosion products, dominated by chlorine. The chlorine is detected primarily in rather thick layer in the metal/oxide interface. Above this a mixed oxide containing chromium, iron and nickel oxides can be seen. The total thickness of the corrosion product layer is roughly 140 μ m, already after 24 hours of exposure showing a very fast corrosion attack. The chloride layer could be seen following a steel grain boundary into the steel substrate. Thus, the corrosion attack in the steel grain boundaries seems to be associated with chlorine, see Figure 73.

Figure 74. EDX mapping analysis of the 347H sample after 24 hours exposure in regular fuel conditions

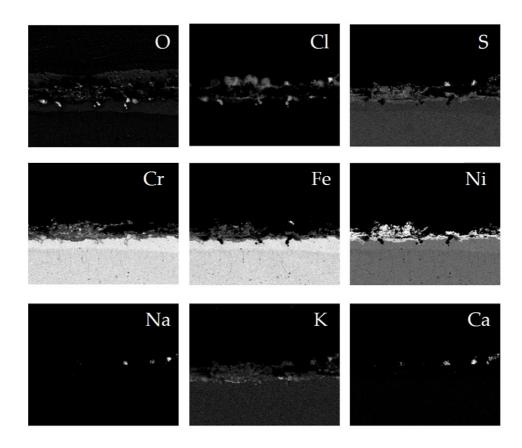
Figure 75 shows a SEM cross section of the Sanicro 33 sample after 24 hours in the reference exposure. The oxide scale is formed by a nickel rich non-homogeneous oxide which is present all over the surface, see Figure 76. The oxide layer is in the order of $20\text{-}30~\mu m$.

Some of the deposit formed during the exposure is still present on the sample. The EDX analysis shows that the deposit is dominated in chlorine and some metal chlorides has started to grow in the metal/oxide interface. The accumulation of metal chlorides are especially high in the steel grain boundaries. Compared to the corresponding 347H sample, the initial corrosion attack of Sanicro33 is more modest. However, the corrosion attack has started for both materials already after 24 hours of exposure.

Figure 76. EDX mapping analysis of the Sanicro 33 sample after 24 hours exposure in regular fuel conditions

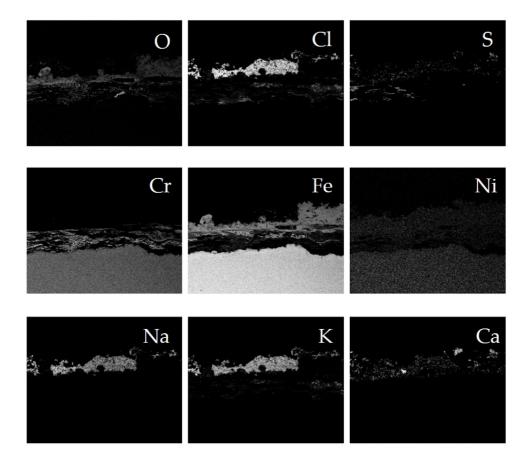
Figure 77 shows the KanthalAPMT sample after 24 hours in the reference exposure. A discontinuous chromium and iron inward growing oxide was detected over the surface, followed by an approximately 150 μ m thick outward growing iron oxide. No alumina was found over the surface after 24 hours exposure. The EDX maps presented in Figure 78 show that some deposit was still present over the sample after the preparation. It is mainly composed by sodium and potassium chlorides were found and also some calcium remains were detected.

Figure 78. EDX mapping analysis of KanthalAPMT after 24 hours in the reference exposure

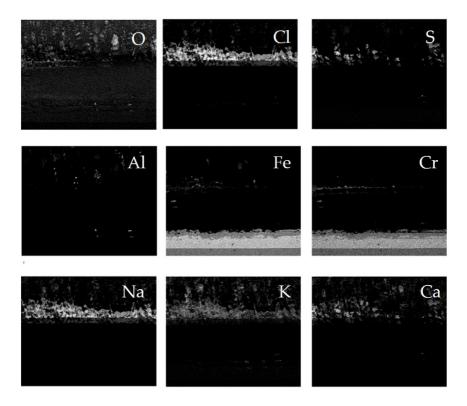
The Figure 79 shows the FeCrAl model alloy sample after 24 hours in the reference exposure. There is no visible corrosion attack according to the SEM cross section (Figure 79) and the corresponding EDX maps (Figure 80). Due to an electrical charge up of the sample in the SEM the EDX maps are slightly blurred. The gap between the deposit and the sample surface is an effect of the sample preparation. The analysis reveal no information of the formation of a oxide layer. Instead, the EDX maps detects a 300 μ m layer of deposit composed mainly of sodium, potassium, calcium and chloride was detected in the deposit. The results of the FeCrAl model alloy is compared to the commercial KanthalAPMT. According to the corrosion results of the initial phases, the FeCrAl model alloy performs better compared to KanthalAPMT.

Figure 80. EDX mapping analysis of the model alloy sample after 24 hours in regular fuel conditions

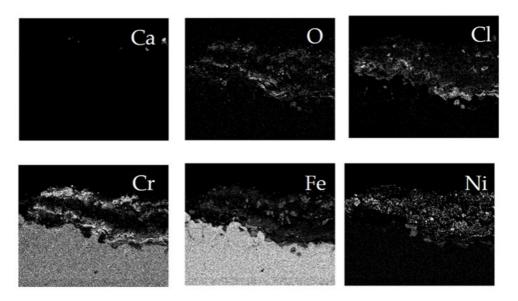
The cross section of the sample shows that the deposit layer had spalled off. However, some corrosion products are still attached on the sample, see Figure 83. The EDX analysis presented in Figure 84 shows that the presence of chlorine in the corrosion products is high. Similar to the corresponding sample exposed for 24 hours, the chlorine enrichment is primarily detected in the metal/oxide interface. Chromium, iron and nickel oxides are present above this chlorine enriched level. It is difficult to distinguish separate oxide layers in the oxide scale. It is therefore suggested that this oxide layer is a mixture of a spinel type oxide containing Fe, Cr and Ni. This type of oxide is usually growing inwardly to the metal, suggesting that the outer part of the corrosion product layer has been lost. The SEM/EDX analysis of the 347H sample does also show that the steel suffers from grain boundary attack (Figure 83). This is common when the deposit is rich in chlorine. The thickness of the remaining corrosion product layer is roughly 240 μ m, showing that the corrosion has progressed compared to the 24 hours exposure.

Figure 84. EDX mapping analysis of the 347H sample after 144 hours exposure in the reference exposure

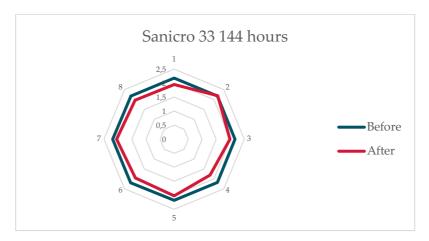
Figure 87. EDX mapping analysis of the Sanicro 33 sample after 144 hours exposure in the reference exposure. The thickness of the sample was measured before and after the exposure. The results are presented in Figure 88. The sample presents a maximum material loss of 0.22 mm in the flue gas side. The material loss is close to zero on the lee side of the sample.

Figure 88. Thickness of the Sanicro 33 sample before (blue) and after (red) 144 hours exposure in the reference exposure

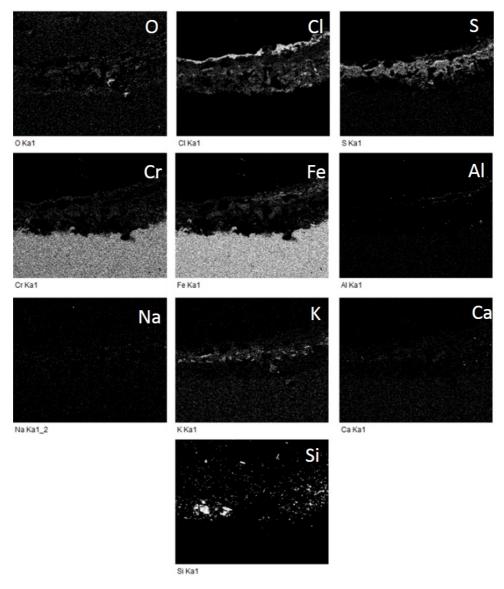
Figure 89 shows the Kanthal APMT sample after 144 hours exposure in regular fuel conditions. An approximately 200 μm thick deposit layer was found over the surface of the sample but no alumina was detected. The EDX maps presented in Figure 90 show that the deposit contains large amounts of chlorine, mainly concentrated in the outer part, while the inner part is mainly composed by sulphur and potassium. Some silicon was also detected close to the surface of the sample.

Figure 90. EDX mapping analysis of the APMT sample after 144 hours in the reference exposure

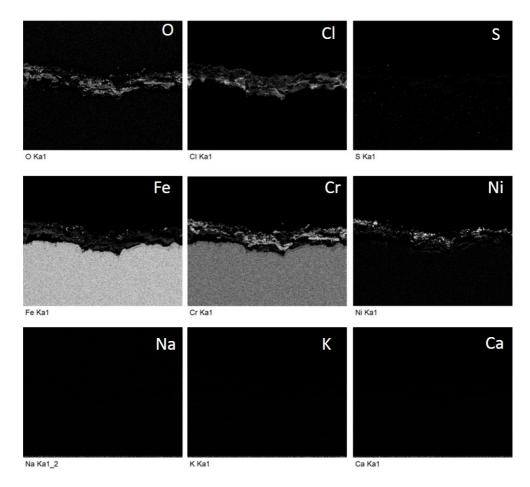
The SEM image of the cross section of the sample shows that no deposit is left but a corrosion products layer of about 90 μ m thickness was still present on the sample surface, see Figure 95. The EDX analysis presented in Figure 96 shows that the corrosion products are composed by non-homogeneous chromium, nickel and iron oxides. A large amount of chlorine was also found close to the surface of the sample.

Figure 96. EDX mapping analysis of the 347H sample after 144 hours exposure with ammonium sulphate addition

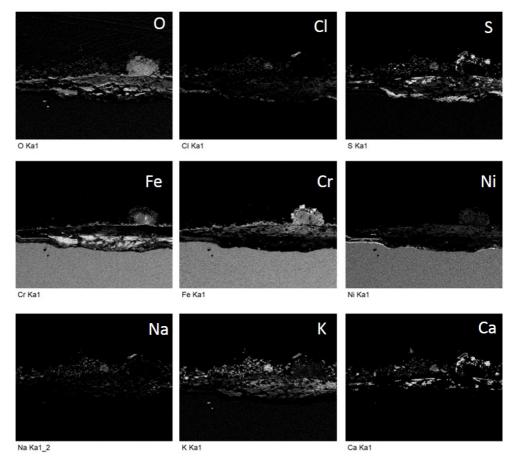
Some of the deposit formed during the exposure is present over the oxide. The EDX analysis presented in Figure 98 shows that it is composed mainly by calcium and potassium sulphates.

Figure 98. EDX mapping analysis of the Sanicro 33 sample after 24 hours exposure with ammonium sulphate addition

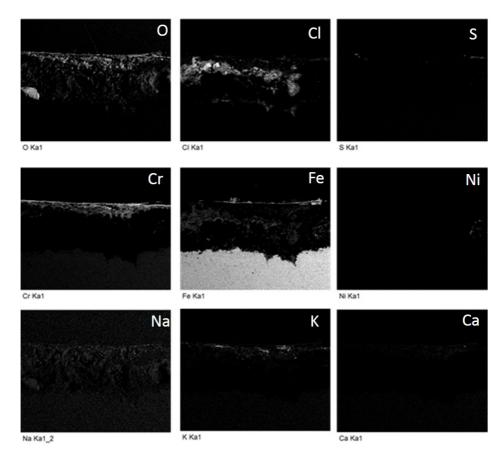
Figure 99 shows the FeCrAl model alloy sample after 24 hours exposure with ammonium sulphate addition. A chromium rich oxide layer was detected all over the surface followed by an iron oxide layer on the top. As an effect of sample preparation, a gap was found between the Cr-oxide and the surface of the alloy.

The EDX maps presented in Figure 100 shows that no deposit was left after the preparation of the samples. A big amount of chlorine was detected and it penetrates all the way through the formed oxides to the surface of the sample. No sulphur was detected.

Figure 100. EDX mapping analysis of the model alloy sample after 24 hours with ammonium sulphate addition

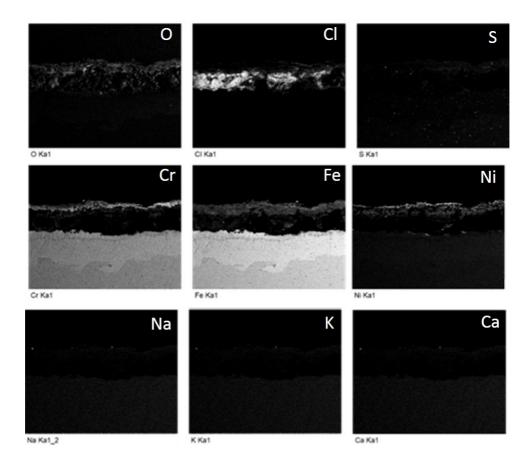
The EDX analysis presented in Figure 104 shows a very big amount of chlorine in the corrosion products, and, as it happened after the 24 hours exposure, it goes all the way through the formed oxides to the surface of the metal. No sulphur was detected.

Figure 104. EDX mapping analysis of the 347H sample after 144 hours exposure with ammonium sulphate addition

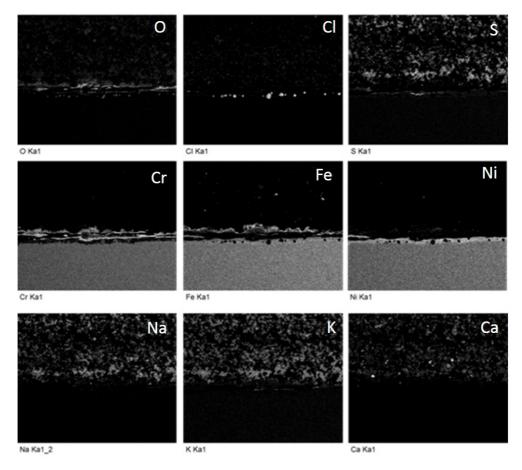
Figure 107. EDX mapping analysis of the Sanicro 33 sample after 144 hours exposure with ammonium sulphate addition

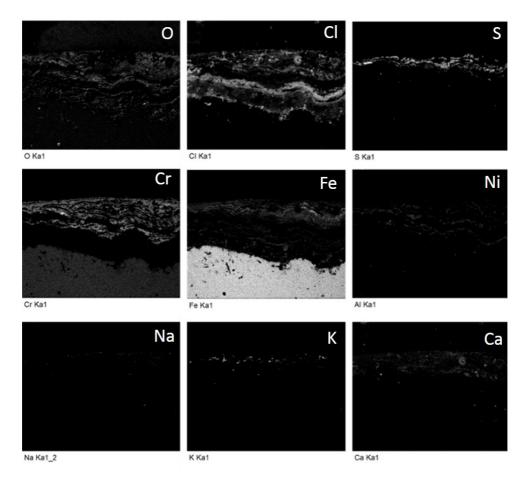
The Figure 112 shows the FeCrAl model alloy sample after 144 hours exposure with ammonium sulphate addition. A thick layer of more than 500 μ m of corrosion products is covering the surface of the sample. The EDX maps are presented in Figure 113. The layer of corrosion products is mainly composed of chromium and chlorine with some iron oxide on the top. A heterogenous sulphur-rich layer is covering the whole sample. No deposit is present on the sample.

Figure 113. EDX mapping analysis of the Fe10Cr3Al2Si sample after 144 hours with ammonium sulphate addition
