COMPOSITE METAL POLYMER (CMP) FOR NON-STICK IMPROVEMENTS IN CHP PLANTS

KME-715

MATTI HUHTAKANGAS, MH ENGINEERING AB

RAGNA ELGER, SWEREA KIMAB AB LEYLA WICKSTRÖM, SWEREA KIMAB AB RIKARD NORLING, SWEREA KIMAB AB

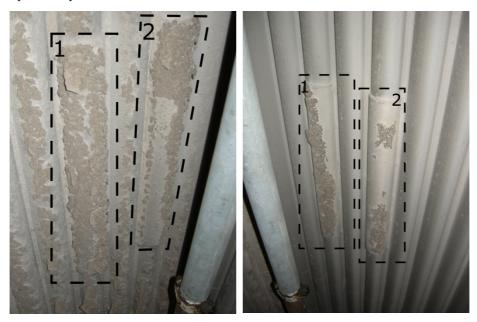
Figure 25. Images from inside of furnace. Material welded onto the northern wall (left) and material welded onto the eastern wall (right). Panels labelled 1 are spray coated with material 2 and 4, whereas panels labelled 2 are spray coated with material 5, 9 and 10.

The amount of deposit varied with location, as the northern wall displayed more deposit than the eastern wall. The samples which had been tack welded onto the furnace walls also displayed clearly more deposit than surrounding tubes, as shown in Figure 25. According to the furnace owner, the material generally used in the furnace was carbon steel St.45.8. The reason for the uneven deposit distribution might be temperature difference of the tack welded samples compared to surrounding material or geometric factors influencing the gas flow in the specific area. No analysis of the samples was performed in SEM/EDS.

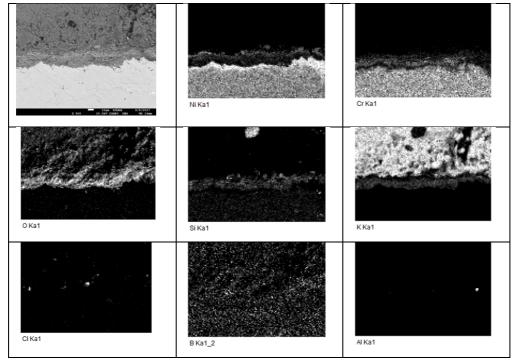
Figure 31. EDS analysis results of material 9 after exposure at Västhamnsverket in the superheater (SH-HT). Sample removed from site in 2017. Scale bar in the SEM image is 10 μ m.

Material 9 also showed a thick deposit layer (Figure 30-Figure 32). In some instances, the CMP layer had detached from the base material. No increased signal for boron or nitrogen could be detected at the CMP surface. A slight increase in the oxygen signal was observed at the CMP surface, indicating an oxide layer. At the base-metal/CMP interface, areas with elevated oxygen content were observed together with Al or Si and are probably a result of the initial surface treatment of the base metal. Interesting to note is the increase in oxygen signal in the interface between CMP and base metal in Figure 32. Even though particles of SiO₂ and Al₂O₃ are expected in the interface, the signal from Al and Si do not form a continuous layer as the oxygen signal. This might indicate an initial corrosion attack and initiation of CMP detachment. Material 9 was not examined before exposure.

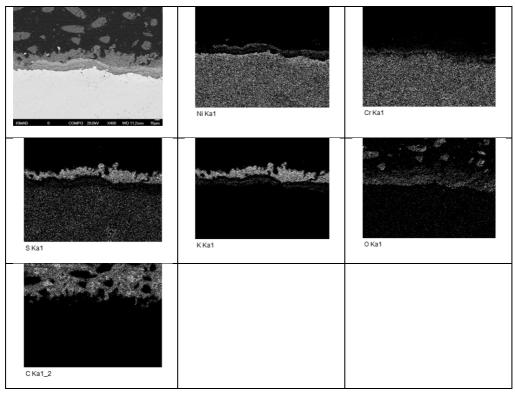
Figure 34. EDS analysis results of material 10 after exposure at Västhamnsverket in the superheater (SH-HT). Sample removed from site in 2017. Scale bar in the SEM image is 10 μ m.

The graphite based Material 10 showed good adhesion of the CMP layer, but there was no elevated carbon signal at the deposit/CMP interface. The amount of deposit varied over the cross-section as shown in the images in Figure 33. A layered oxide structure with Ni and Cr was observed at the surface, with no significant increase in carbon signal at the interface between deposit and CMP layer (Figure 34). It is suggested that the layer was too thin to be observed by SEM/EDS.

In summary, no top coating from materials 5, 9 or 10 could be detected. Material 10 showed areas with very little deposit. This might be due to a good release ability of the top coating, but may also depend on different handling of different samples during demounting of the samples from the superheater area.

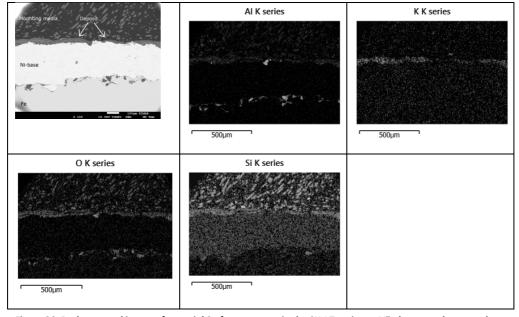
Figure 36. Backscattered image of material 8 after exposure in the SH-LT region at Västhamnsverket, sample removed 2016. The deposit is indicated in the SEM image. EDS elemental maps of Si, O, Al and K are included. The scale bar in the SEM image is at $100\mu m$ at $100 \times magnification$.

Material 8, which in the wear test exposures showed presence of Al and Si in the coated layer was examined after exposure in the SH-LT region. A complicating factor is that the expected deposit layer in a CHP plant is often rich in K, Ca, Si and O due to deposits from the flue gas. Thus, it may be hard to distinguish the coating from the expected deposit. After exposure during the first season, coating could only be identified occasionally in deep pits of the sprayed metal layer. Rather, most areas where Si, O and Al were observed, also showed presence of potassium (K) or zinc. As K was not present in the analysis after wear test exposures, a probable explanation is that K originates from the environment and that the larger share of the surface layers observed in Figure 35 - Figure 36 is deposit formed during exposure in the flue gas environment. As shown, the deposit layer (indicated in the images) shows presence of K, O and Si. The Si and K are suggested to originate from the environment. However, in some deep pits, the composite metal polymer surface appears to be intact. An example is shown in Figure 37, where no K or Ca was detected in a small part of the surface layer where Si and O were observed.

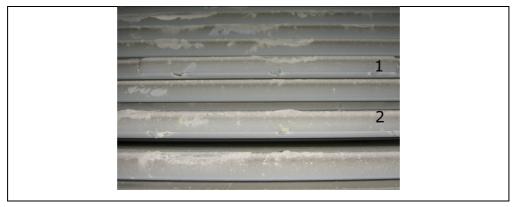
Figure 38. The tack-welded tubes in the economizer at Västhamnsverket. The tube named 1 was removed from the site in 2016 and the one named 2 in 2017.

In the economiser area, material 1 and 6 were exposed. There was no apparent difference in amount of deposit formation between the samples and the surrounding tubes (Figure 38).

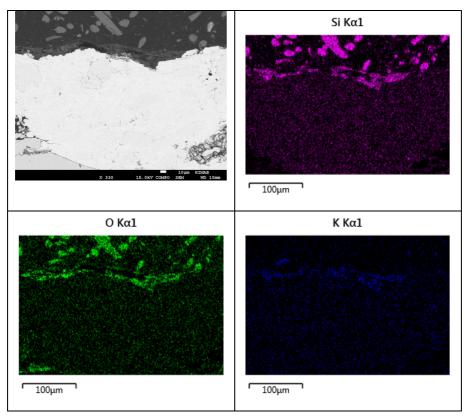
Figure 43. SEM images of material 6 after exposure at Västhamnsverket in the economizer. Sample removed from site in 2016. Scale bar at 330x magnification is 10 µm. EDS analysis for O and Si included to image that the coating is absent. K included as reference for deposit originating from exposure.

For material 6 removed in 2016, there was quite poor coverage, with the coating being either very thin or missing (Figure 42- Figure 43). The coating showed varied thickness and was sometimes quite thin on as received sample as well. Presence of deposit from the flue gas may have shielded any signal from the coating and made it difficult to compare the top coating coverage between the two samples. Thus EDS signal from K is included to image the parts of the deposit possibly originating from the flue gas. It cannot be excluded that K has been incorporated in the top coating. For the material removed in 2017, there was only sporadic detection of Si (Figure 44-Figure 45)

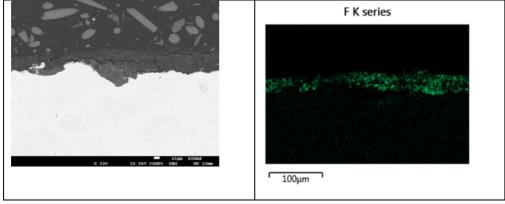
Figure 49. SEM image at 330x magnification and EDS analysis of F of material 1 after exposure at Västhamnsverket in the ESP cone. Sample removed from site in 2016. Scale bar in SEM image is 10 µm.

Figure 47. Material (from left) 1, 2, 3 and 6 after exposure in the ESP cone. Plate removed from site in 2017. For material 1 removed in 2016, good adherence of the PTFE layer was detected (Figure 48-Figure 49). Similarly good adhesion of the top coating was observed for the material removed in 2017, although it was missing in some regions (Figure 50-Figure 51). The amount of deposit was very low on the samples as discussed above.

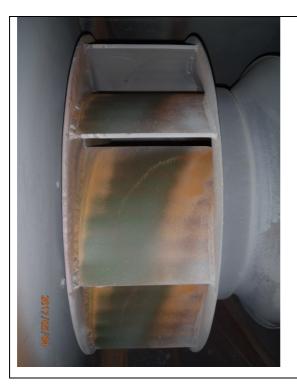
Figure 59. The flue gas fan at inspection 2017

The flue gas recirculation fan was originally sprayed with the polymeric material 1 as top coating in 2013 (Figure 56) At inspection in 2014, 2015 and 2017, the fan was photographed (Figure 57-Figure 59). As shown, the amount of deposit on the wheel is small and the sprayed coating is still visible after 4 years of operation. The maintenance

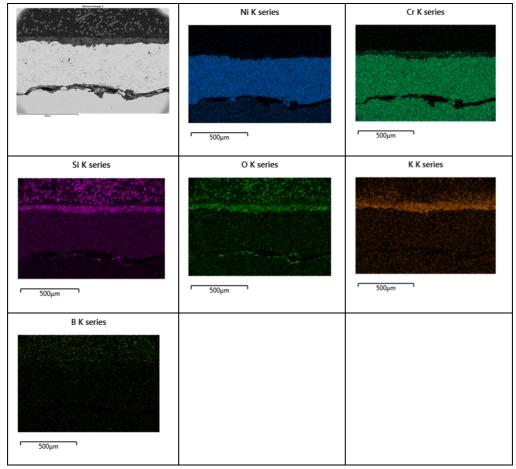
Figure 62. EDS analysis results of material 4 after exposure at D Ørsted /Avedöre in position A (SH-HT). Sample removed from site in 2017. Scale bar in SEM image is 500 μ m.

An image of the exposed materials 4, 7, 9 and 10 from position A is shown in Figure 60. By visual inspection, no difference in amount of deposit could be observed. The reference sample showed presence of K, P and S in the deposit layer. Also some oxide was observed, given by the signal of O and Fe (Figure 61). Material 4 was a boron-nitride silicate and material 9 a boron-nitride. For material 4, the silicon signal after exposure was more pronounced than for the reference material (Figure 61-Figure 62). However, in both cases, a distinct potassium layer was observed on the surface. For material 4, it is suggested that potassium might have interacted with the silicate layer. Boron could not be distinguished. For material 9, no top coating with boron nitride

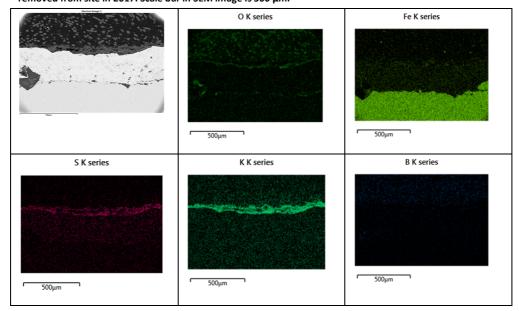
Figure 63. EDS analysis results of material 9 after exposure at Ørsted /Avedöre in the superheater (SH-HT). Sample removed from site in 2017. Scale bar in SEM image is $500~\mu m$.

could be observed after exposure (Figure 63). One reason might be a very thin top coating. As no unexposed material was analysed, no clear conclusions could be drawn regarding the expected appearance. Material 10 used a graphite based top coating. The graphite based top coating was not possible to detect in SEM/EDS.

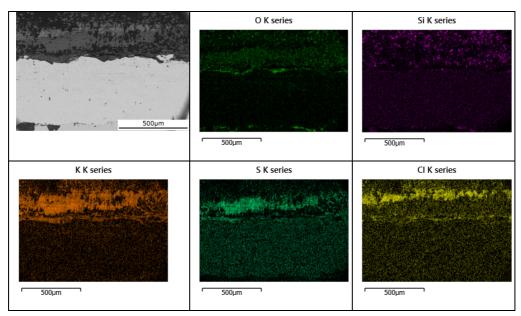
Figure 66. Back-scattered image of material 8 exposed in position B in Avedöre. EDS analysis included for given elements. The sample was removed from the site in 2017.

If the signal for Si is compared between material 8 and the reference (Figure 66 - Figure 67), the Si signal at the metal surface might be somewhat more distinct on material 8 (Figure 66). This indicates possible presence of the silicone layer on the test sample. A deposit layer rich in K/S/O/Cl was detected at the surface of both samples. Following sample preparation, there was occasional large crevice between the sample of material 8 and the mount, but there was still good adherence of the silicone layer.

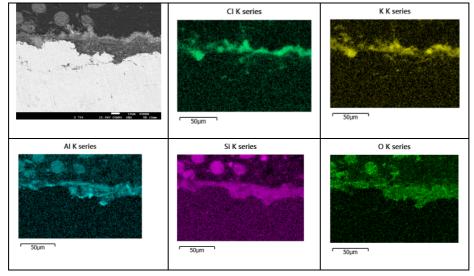
Figure 71. Back-scattered image at 700x magnification and EDS analysis of material 8 after exposure in Position C in Avedöre. The scale bar in the SEM image is $10\mu m$.

For material 8, the coverage after exposure was good for the coating after exposure. Some examples are given in Figure 70-Figure 72. A deposit layer was observed including K/Cl/Ca/S/O and some Si, which made the analysis a little more uncertain regarding origin of the Si. EDS analysis of the non-coated carbon steel reference material was included for comparison.

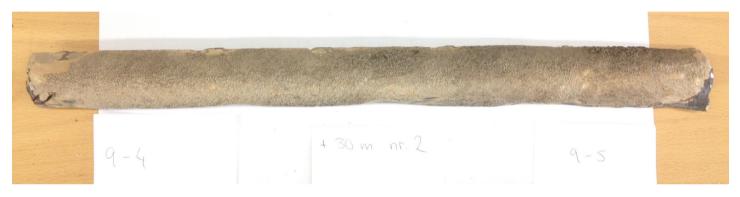
The samples of materials 4, 5, 9 and 10 that were exposed in high-temperature areas showed no clear top coating layer after exposure in neither Västhamnsverket nor Avedöre. However, as these materials were not examined before exposure, no conclusions regarding the possibility to observe the top coating by SEM/EDS could be drawn. A slight decrease in amount of deposit was observed on the graphite based material 10. However, the difference could be due to handling of the samples during demounting. No photographs before demounting were taken.

Figure 91. Material 4 (left part of tube) and material 5 (right part of tube) after exposure in the superheater (SH-HT). Removed from site in 2017.

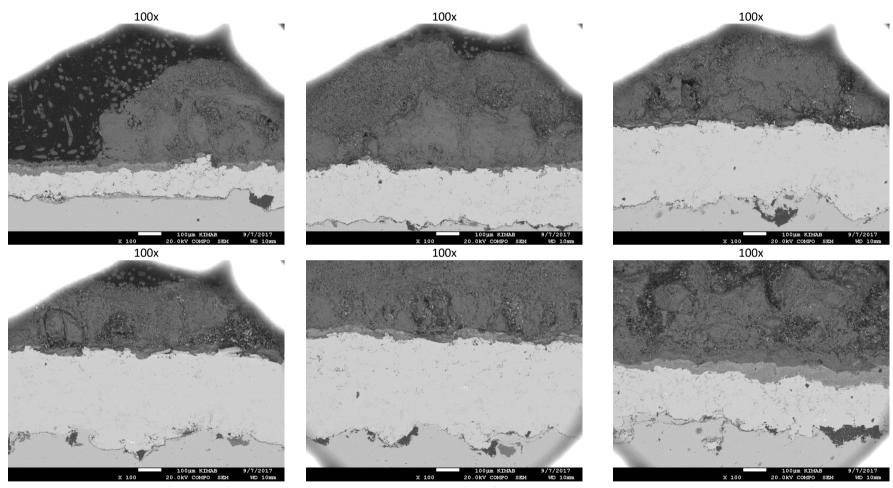
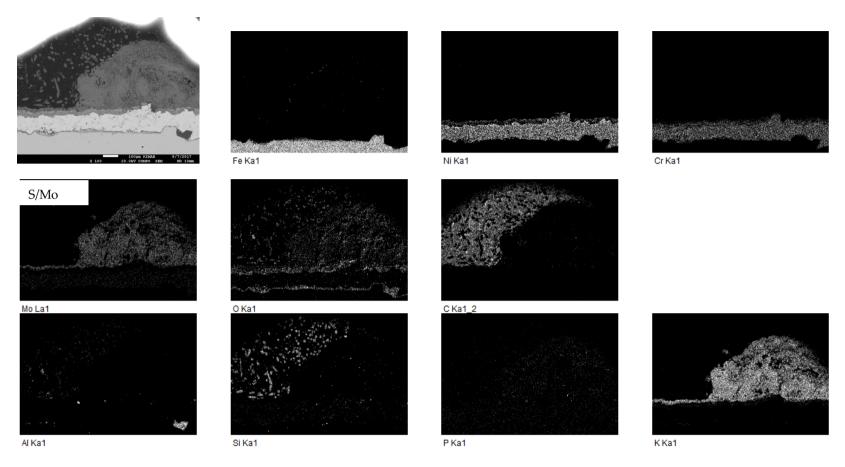
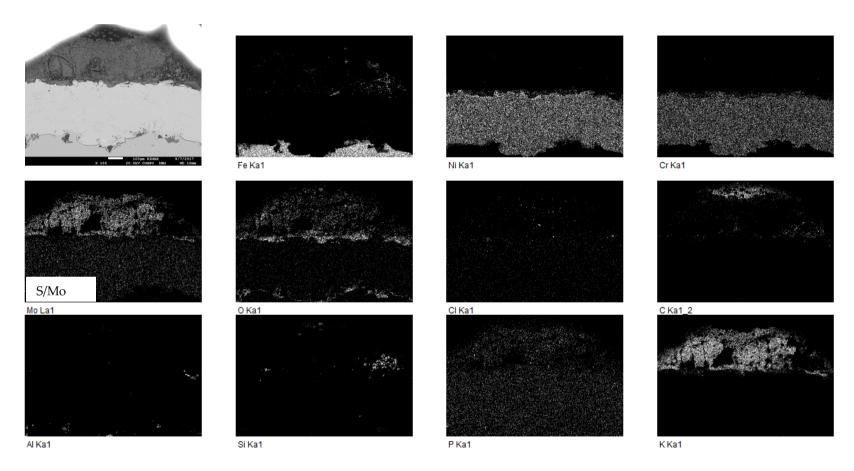
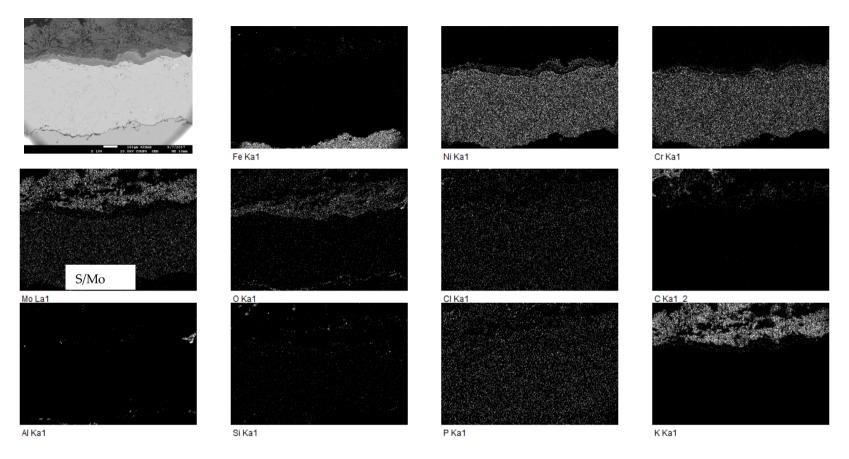
FMP, Al-phosphate (Mat 5), (9-5_+30m_nr2) (sample removed in 2017)

Figure 93. SEM images of material 5 after exposure at Västhamnsverket in the superheater (SH-HT). Sample removed from site in 2017. Scale bar is 100 µm at 100x magnification.

Figure 94. EDS analysis results of material 5 after exposure at Västhamnsverket in the superheater (SH-HT). Sample removed from site in 2017. Scale bar in the SEM image is 100 μm. The S and Mo maps were identical due to an overlap.

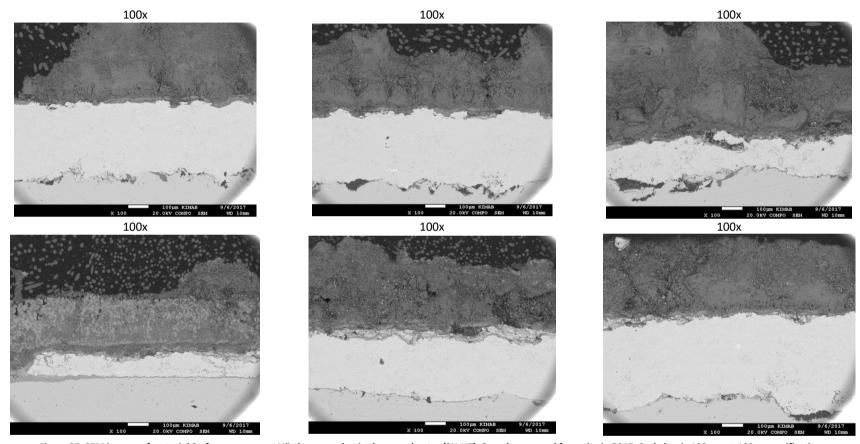
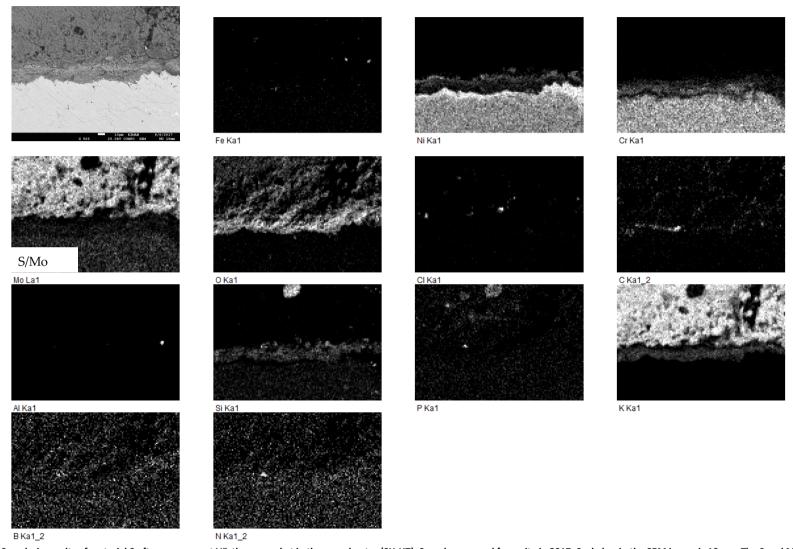
Aremco (BN) (Mat 9), (10-9_+30m nr 1) (sample removed in 2017)

Figure 97. SEM images of material 9 after exposure at Västhamnsverket in the superheater (SH-HT). Sample removed from site in 2017. Scale bar is 100 µm at 100x magnification.

Figure 99. EDS analysis results of material 9 after exposure at Västhamnsverket in the superheater (SH-HT). Sample removed from site in 2017. Scale bar in the SEM image is 10 μm. The S and Mo maps were identical due to an overlap.

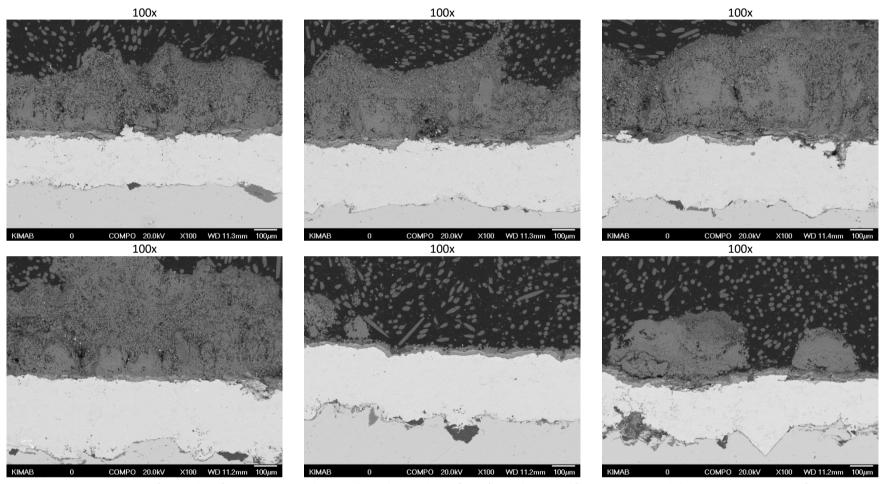
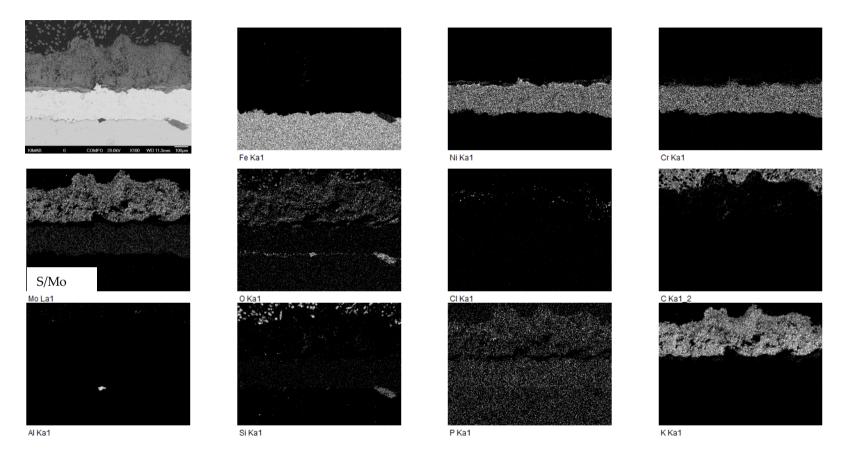
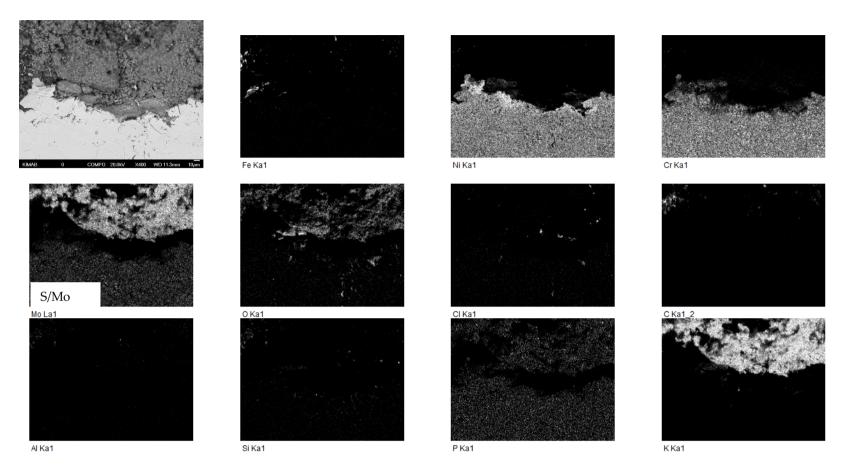
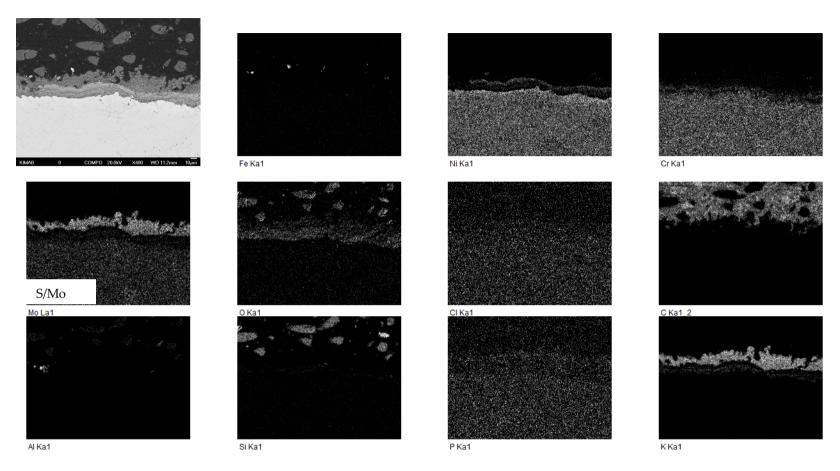
Aremco grå (Graphite), (Mat 10) (10-10_+30m_nr1) (sample removed in 2017)

Figure 101. SEM images of material 10 after exposure at Västhamnsverket in the superheater (SH-HT). Sample removed from site in 2017. Scale bar is 100 µm at 100x magnification.

Figure 102. EDS analysis results of material 10 after exposure at Västhamnsverket in the superheater (SH-HT). Sample removed from site in 2017. Scale bar in the SEM image is 100 μm. The S and Mo maps were identical due to an overlap.

Figure 103. EDS analysis results of material 10 after exposure at Västhamnsverket in the superheater (SH-HT). Sample removed from site in 2017. Scale bar in the SEM image is 10 μm. The S and Mo maps were identical due to an overlap.

Figure 104. EDS analysis results of material 10 after exposure at Västhamnsverket in the superheater (SH-HT). Sample removed from site in 2017. Scale bar in the SEM image is 10 μm. The S and Mo maps were identical due to an overlap.

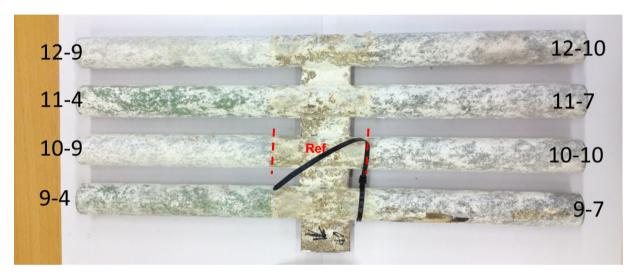
No top coating could be detected by SEM/EDS on the samples exposed in the superheater areas position A (Avedöre) or SH-HT (Västhamnsverket). This could possibly imply that only little or no top coatings were present after exposure. However, at least some coating of material 4 exposed in the superheater areas position A (Avedöre) remained, as could be observed by its visible green colour.

Figure 113. Photographs of tubes coated with material 4, 7, 9 and 10 (as highlighted in picture) after exposure at Ørsted Avedøre in the superheater (SH-HT). Tubes were removed from site in 2017. Reference sample was taken from non-coated region within dashed lines. Metallographic examination was carried out for the reference sample and samples 9-4, 9-7, 10-9 and 10-10.

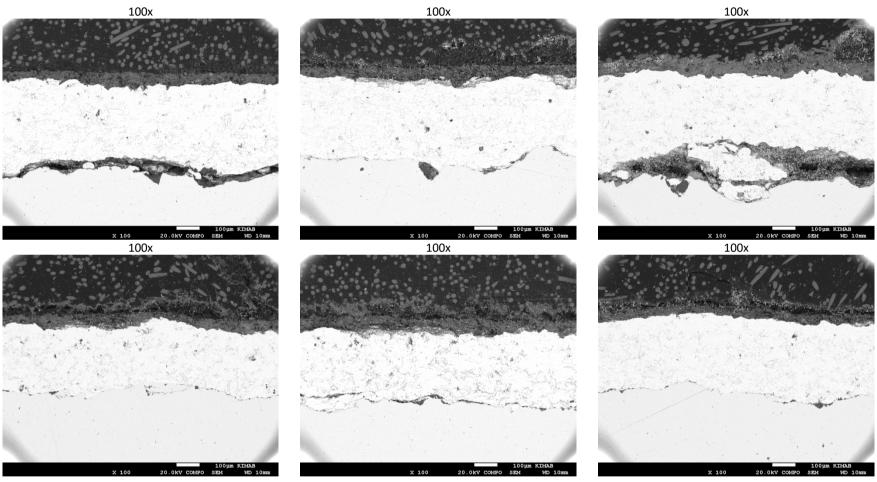
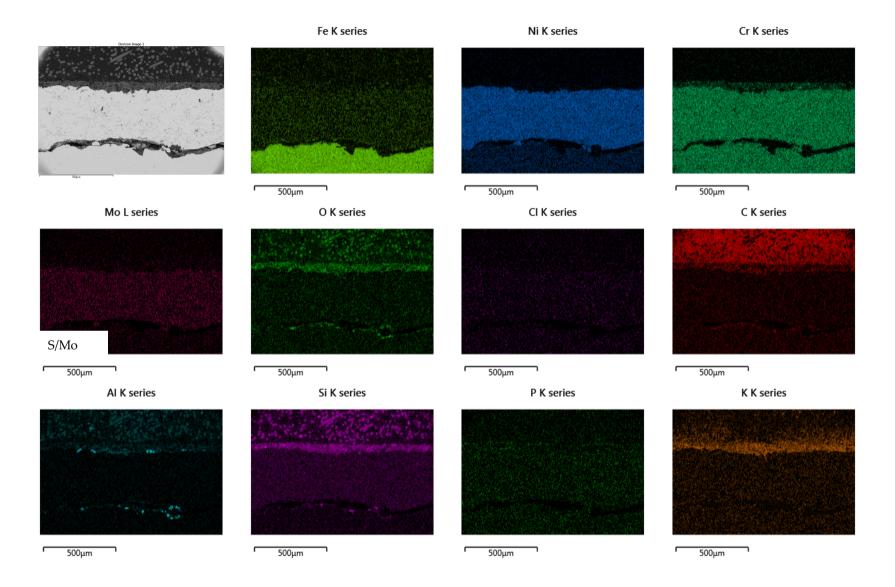
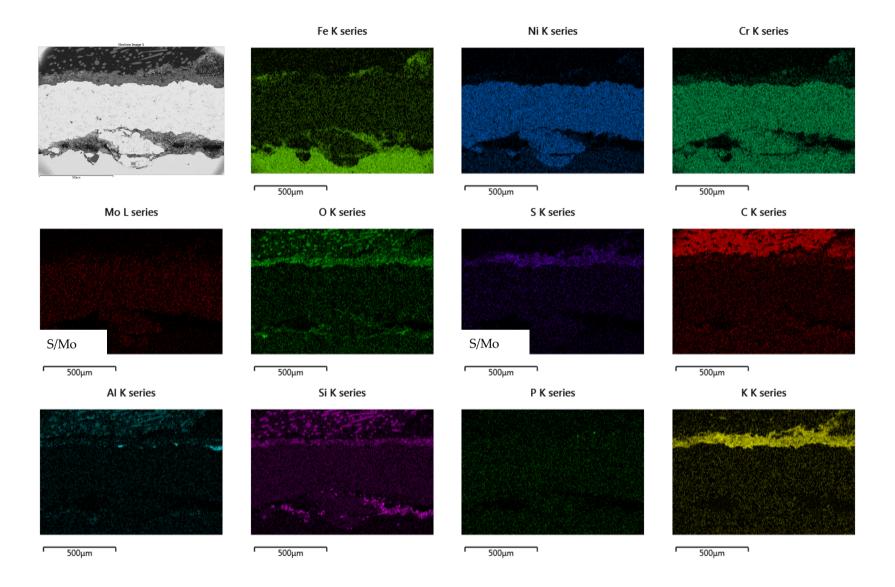
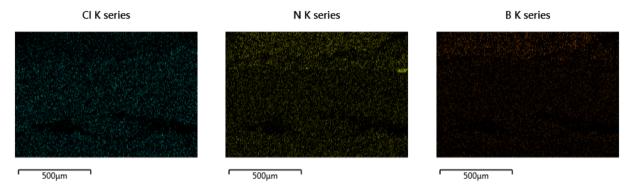
Beläggningstyp FMP (BN-silicate), Prov 2B (SH HT) (Mat 4) (sample removed in 2017)

Some oxide formation was observed on the samples exposed in position A in Avedöre. However, the Ni-base layer appeared to be intact in almost all examined samples.

Figure 115. SEM images of material 4 after exposure at Ørsted Avedøre in the superheater (SH-HT). Sample removed from site in 2017. Scale bar is 100 µm at 100x magnification.

Figure 116. EDS analysis results of material 4 after exposure at Ørsted Avedøre in the superheater (SH-HT). Sample removed from site in 2017. Scale bar in SEM image is 500 μm. The S and Mo maps were identical due to overlap.

Figure 117. EDS analysis results of material 4 after exposure at Ørsted Avedøre in the superheater (SH-HT). Sample removed from site in 2017. Scale bar in SEM image is 500 µm. Note the difference in sulphur and molybdenum signal despite ordinary EDS analysis. The maps are an indication of sulphur in the deposit layer and Mo in the nickel-base layer, but S and Mo normally overlap.

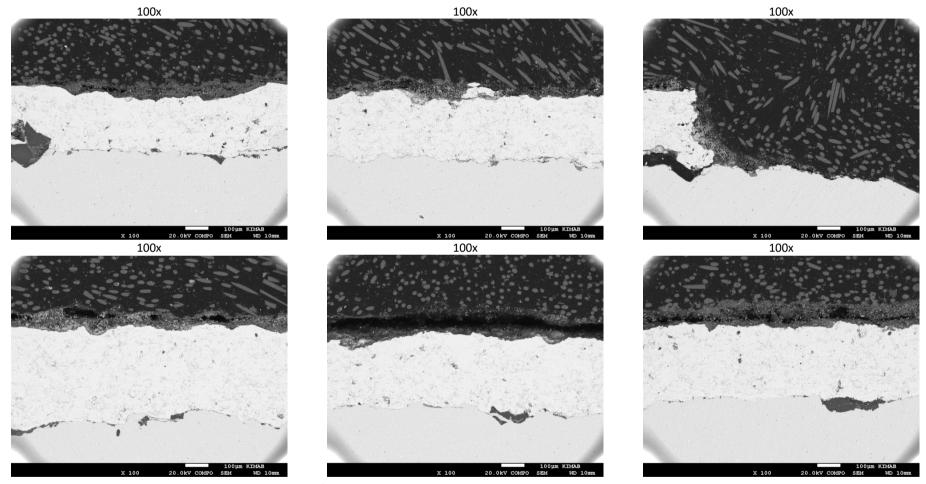
Beläggningstyp Aremco, BN, Prov 2D (SH HT) (Mat 9) (sample removed in 2017)

Figure 121. SEM images of material 9 after exposure at Ørsted Avedøre in the superheater (SH-HT). Sample removed from site in 2017. Scale bar is 100 µm at 100x magnification.

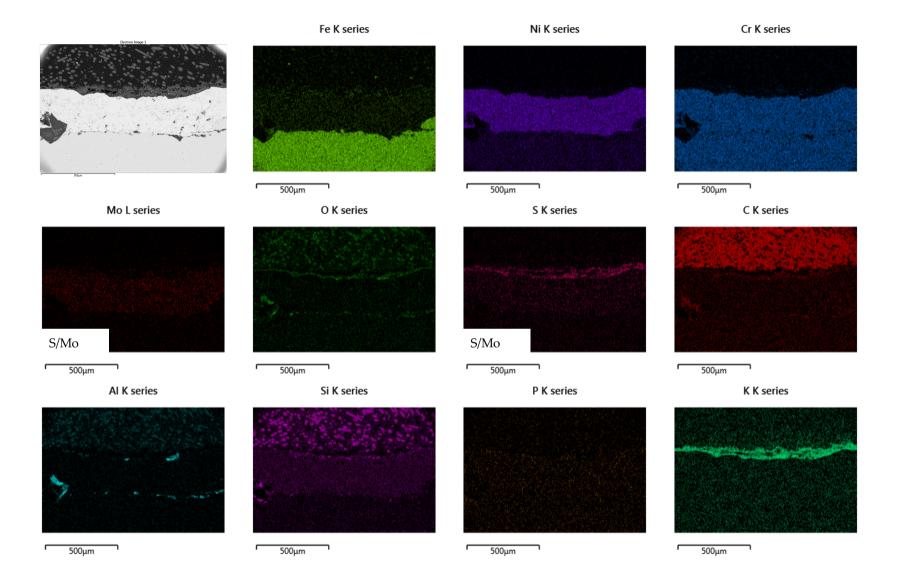
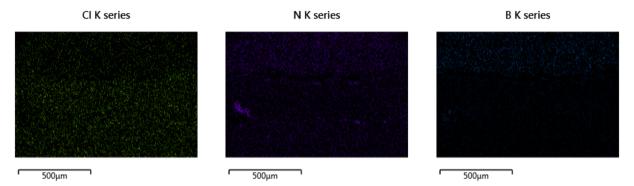
Figure 122. EDS analysis results of material 9 after exposure at Ørsted Avedøre in the superheater (SH-HT). Sample removed from site in 2017. Scale bar in SEM image is 500 μm. The maps are an indication of sulphur in the deposit layer and Mo in the nickel-base layer, but S and Mo normally overlap as indicated.

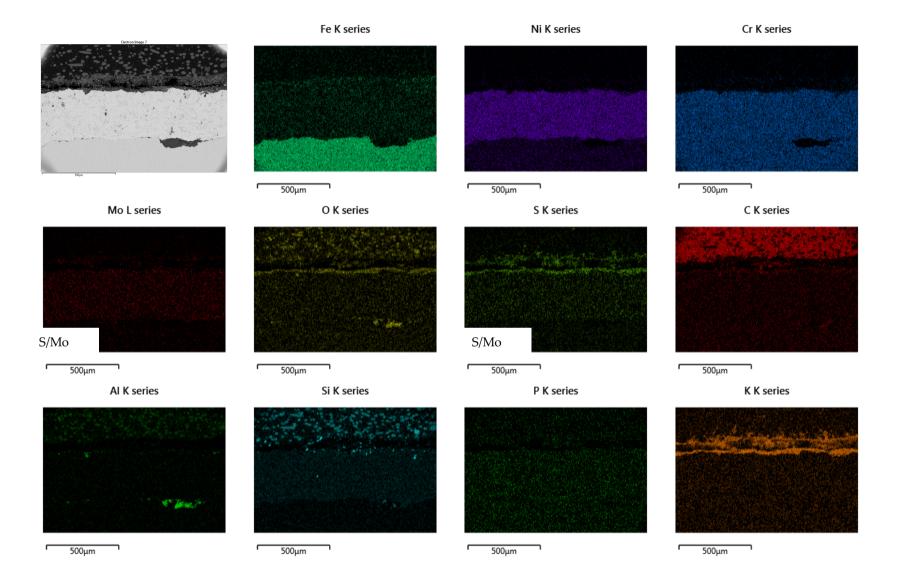
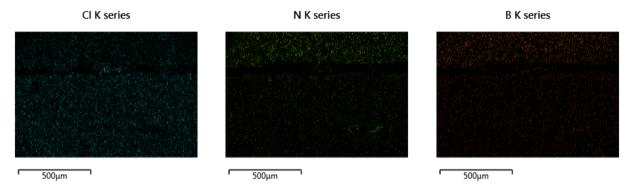
Figure 123. EDS analysis results of material 9 after exposure at Ørsted Avedøre in the superheater (SH-HT). Sample removed from site in 2017. Scale bar in SEM image is 500 μm. The maps are an indication of sulphur in the deposit layer and Mo in the nickel-base layer, but S and Mo normally overlap as indicated.

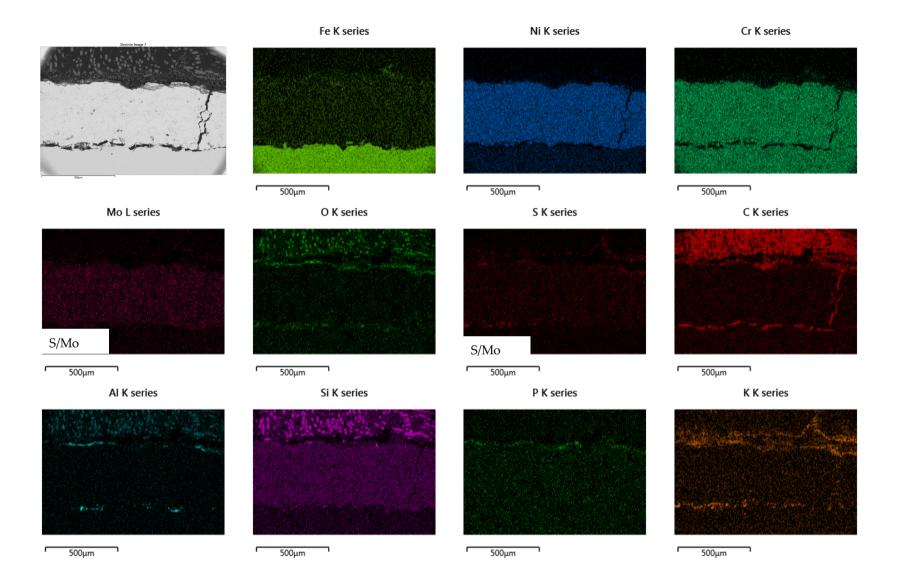
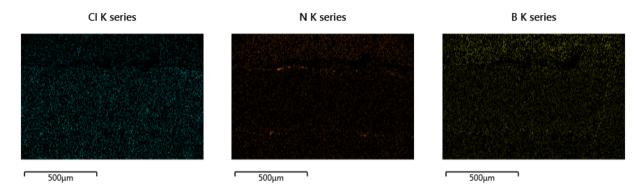
Figure 125. EDS analysis results of material 10 after exposure at Ørsted Avedøre in the superheater (SH-HT). Sample removed from site in 2017. Scale bar in SEM image is 500 µm. The maps are an indication of sulphur in the deposit layer and Mo in the nickel-base layer, but S and Mo normally overlap as indicated.

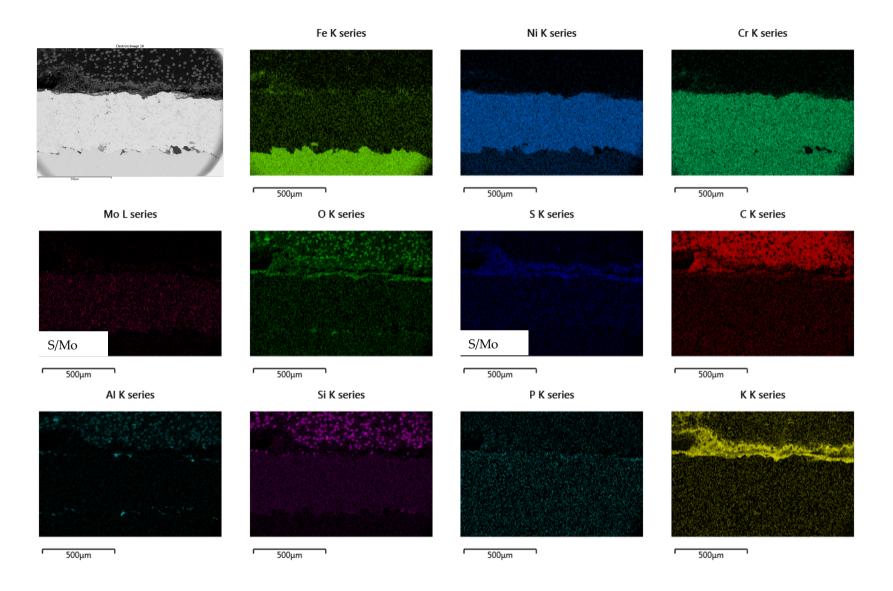
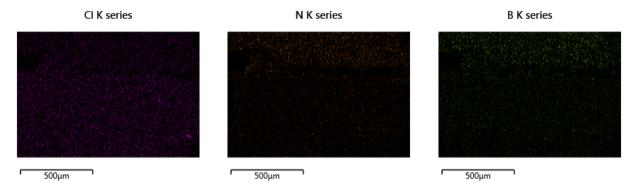
Figure 126. EDS analysis results of material 10 after exposure at Ørsted Avedøre in the superheater (SH-HT). Sample removed from site in 2017. Scale bar in SEM image is 500 µm. The maps are an indication of sulphur in the deposit layer and Mo in the nickel-base layer, but S and Mo normally overlap as indicated.

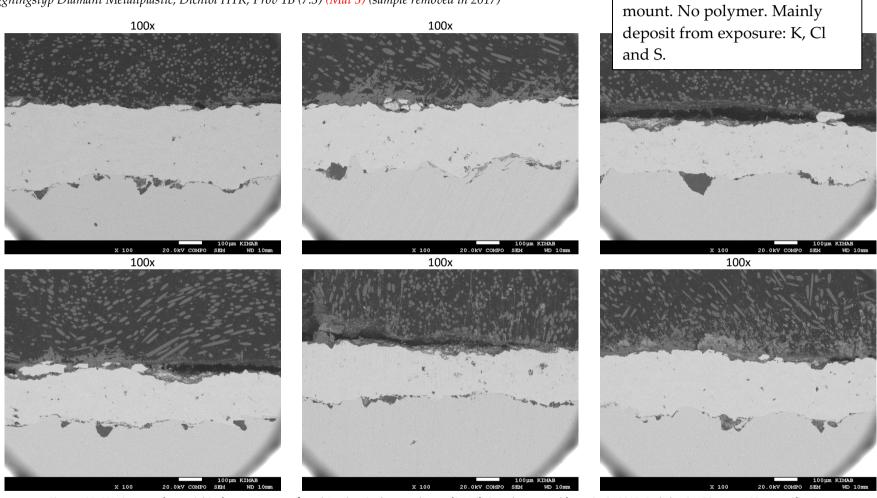
Beläggningstyp Diamant Metallplastic, Dichtol HTR, Prov 1B (7.3) (Mat 3) (sample removed in 2017)

Figure 127. SEM images of material 3 after exposure at Ørsted Avedøre in the superheater (SH-LT). Sample removed from site in 2017. Scale bar is 100 µm at 100x magnification.

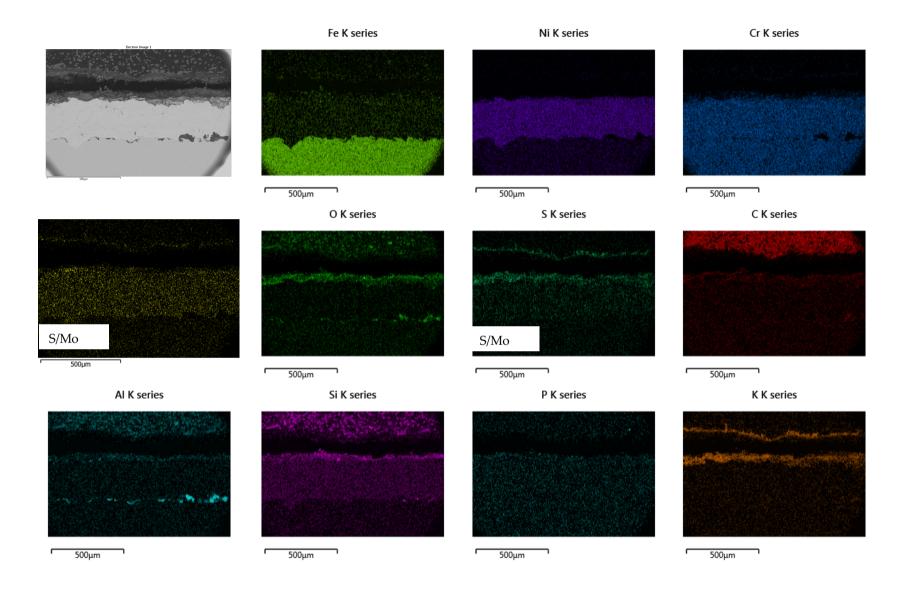
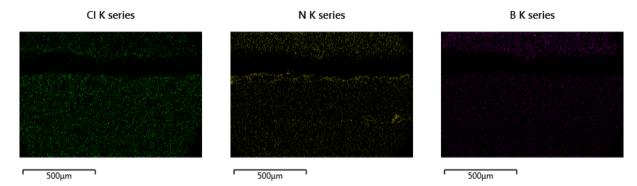
Figure 131. EDS analysis results of material 4 after exposure at Ørsted Avedøre in the superheater (SH-LT). Sample removed from site in 2017. Scale bar in SEM image is 500 μm. . The maps are an indication of sulphur in the deposit layer and Mo in the nickel-base layer, but S and Mo normally overlap as indicated.

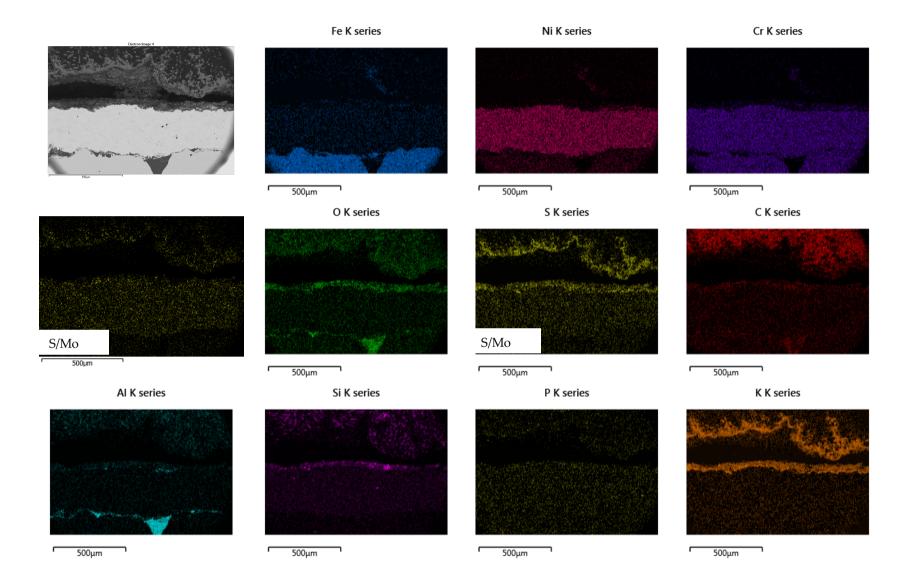
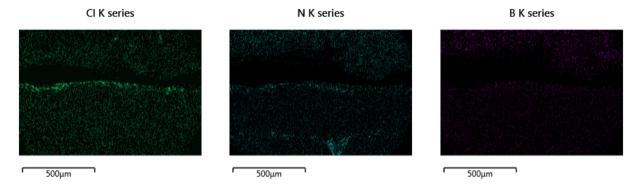
Figure 132. EDS analysis results of material 4 after exposure at Ørsted Avedøre in the superheater (SH-LT). Sample removed from site in 2017. Scale bar in SEM image is 500 μm. . The maps are an indication of sulphur in the deposit layer and Mo in the nickel-base layer, but S and Mo normally overlap as indicated.

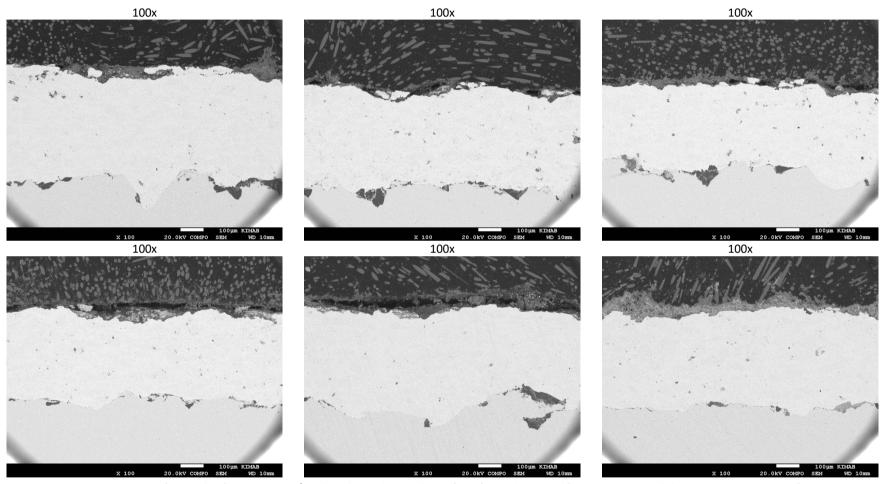
Beläggningstyp Millidyne, Prov 1D (8.7) (Mat 7) (sample removed in 2017)

Figure 133. SEM images of material 7 after exposure at Ørsted Avedøre in the superheater (SH-LT). Sample removed from site in 2017. Scale bar is 100 µm at 100x magnification.

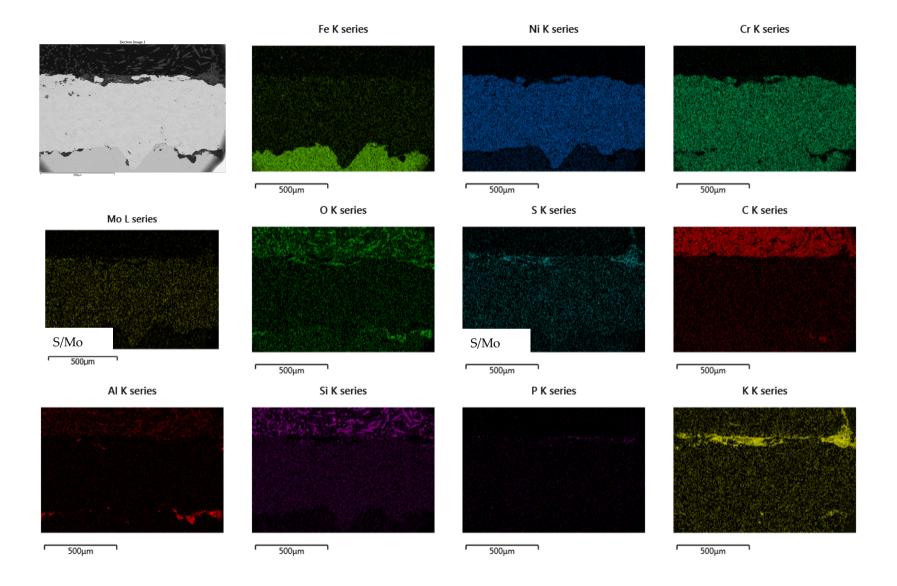
Figure 134. EDS analysis results of material 7 after exposure at Ørsted Avedøre in the superheater (SH-LT). Sample removed from site in 2017. Scale bar in SEM image is 500 μm. . The maps are an indication of sulphur in the deposit layer and Mo in the nickel-base layer, but S and Mo normally overlap as indicated.

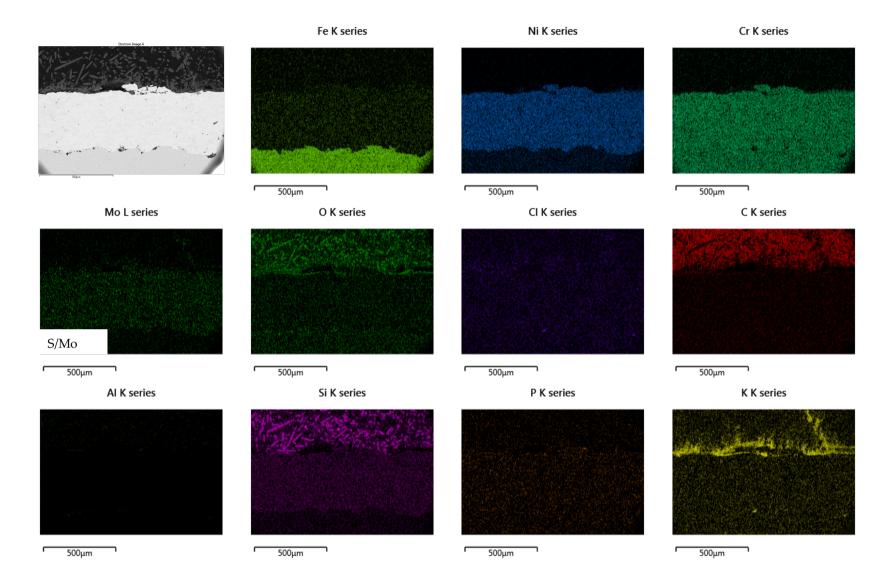
Figure 135. EDS analysis results of material 7 after exposure at Ørsted Avedøre in the superheater (SH-LT). Sample removed from site in 2017. Scale bar in SEM image is 500 μm. . The maps are an indication of sulphur in the deposit layer and Mo in the nickel-base layer, but S and Mo do overlap as indicated.

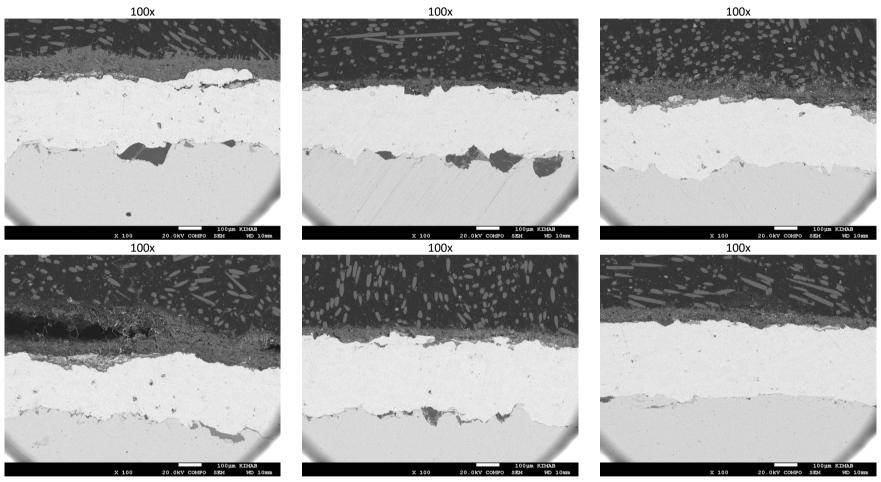
Beläggningstyp FMP (BN-silicate), Prov 3D (4.4) (Mat 4) (sample removed in 2017,instead of in 2016)

Figure 139. SEM images of material 4 after exposure at Ørsted Avedøre in the economizer. Sample removed from site in 2017 (instead of 2016). Scale bar is 100 μm at 100x magnification.

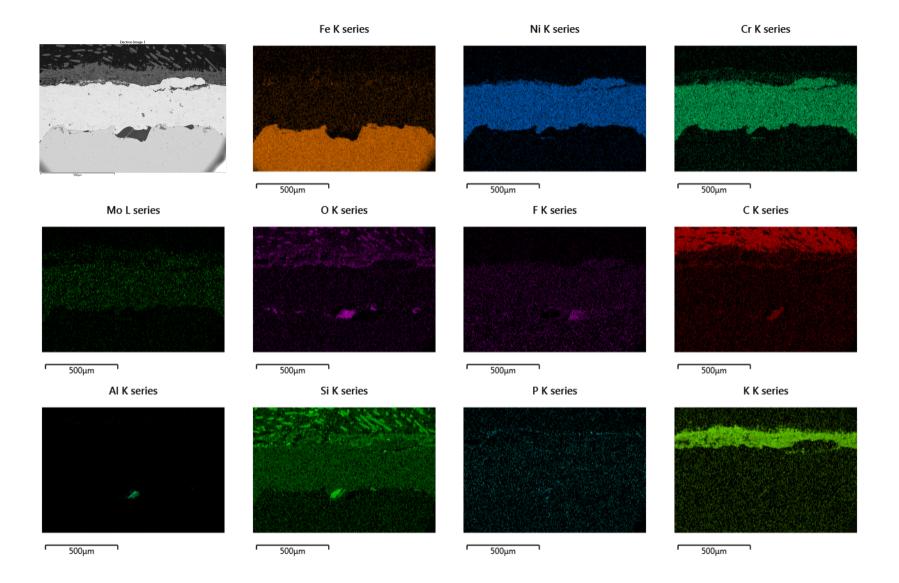
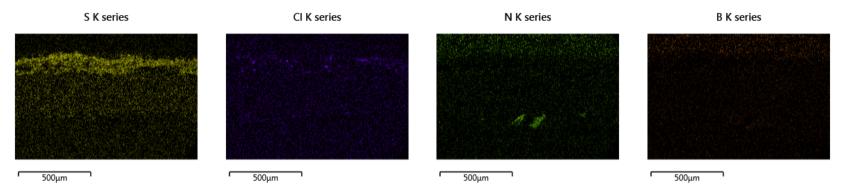
Figure 140. EDS analysis results of material 4 after exposure at Ørsted Avedøre in the economizer. Sample removed from site in 2017. Scale bar in SEM image is 500 μm. . The maps are an indication of sulphur in the deposit layer and Mo in the nickel-base layer, but S and Mo do overlap as indicated. The fluorine signal could be due to an overlap with Fe.

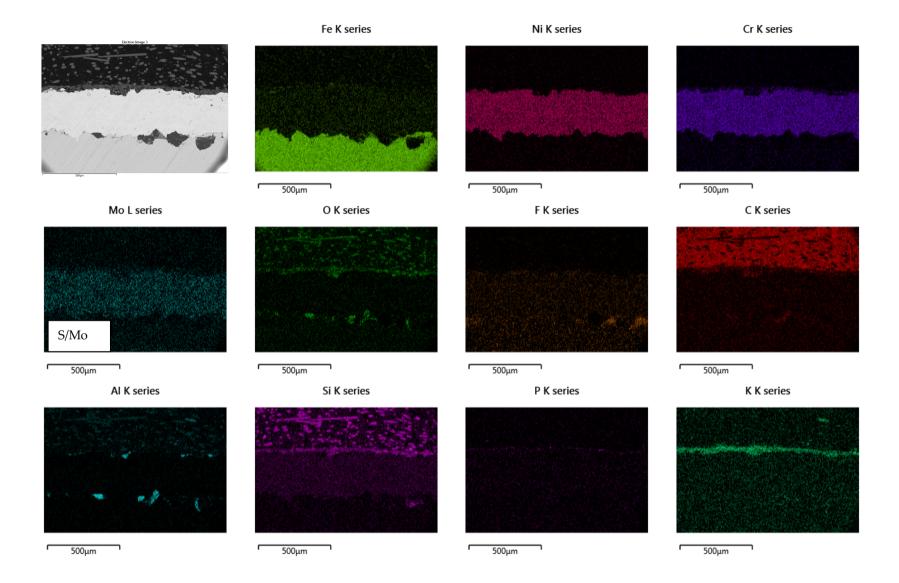
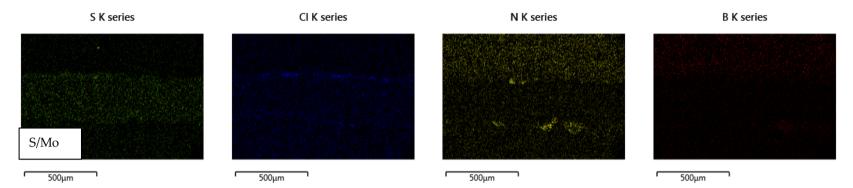
Figure 141. EDS analysis results of material 4 after exposure at Ørsted Avedøre in the economizer. Sample removed from site in 2017. Scale bar in SEM image is 500 µm. S and Mo overlap as indicated.

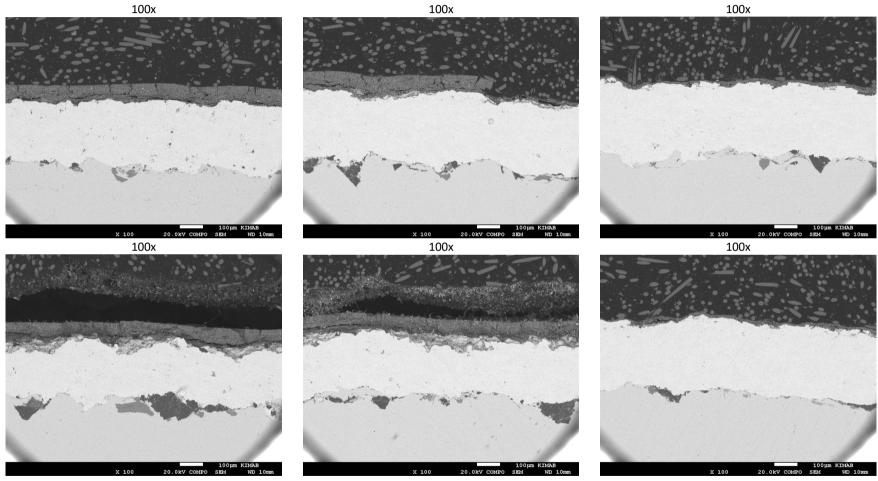
Figure 142. SEM images of material 2 after exposure at Ørsted Avedøre in the economizer. Sample removed from site in 2017 (instead of 2016). Scale bar is 100 µm at 100x magnification.

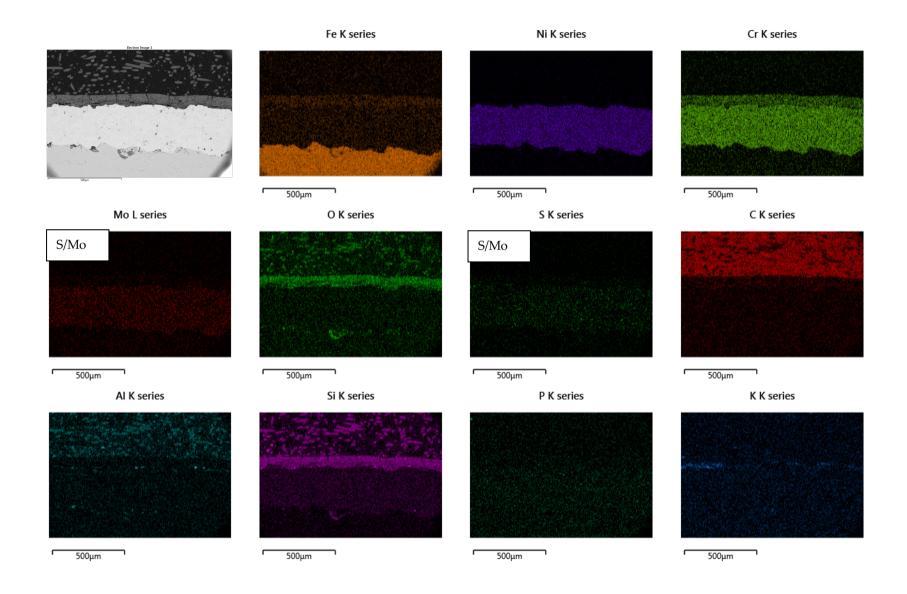
Figure 143. EDS analysis results of material 2 after exposure at Ørsted Avedøre in the economizer. Sample removed from site in 2017. Scale bar in SEM image is 500 μm. S and Mo do overlap as indicated.

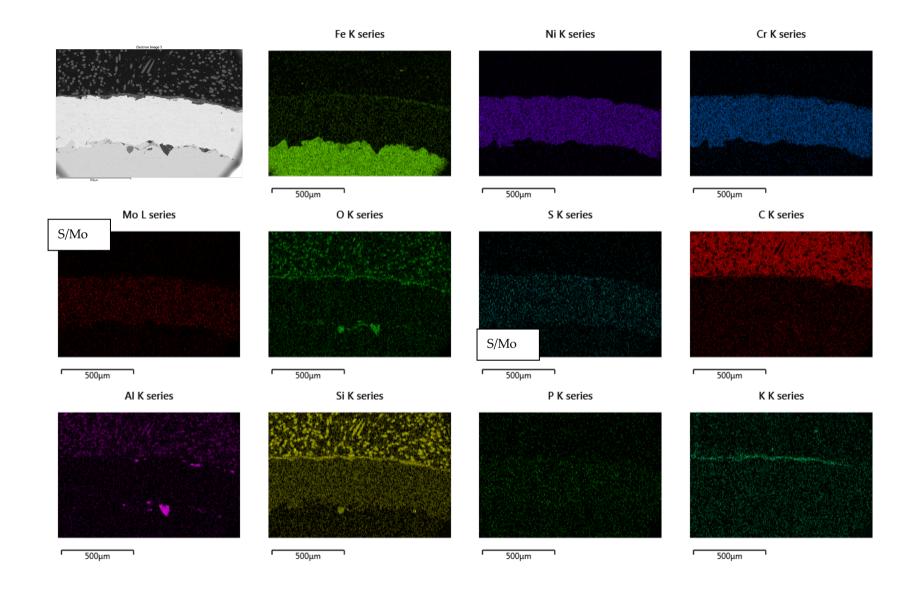
Figure 144. EDS analysis results of material 2 after exposure at Ørsted Avedøre in the economizer. Sample removed from site in 2017. Scale bar in SEM
