COMPOSITE METAL POLYMER (CMP) FOR NON-STICK IMPROVEMENTS IN CHP PLANTS

KME-715

MATTI HUHTAKANGAS, MH ENGINEERING AB

RAGNA ELGER, SWEREA KIMAB AB LEYLA WICKSTRÖM, SWEREA KIMAB AB RIKARD NORLING, SWEREA KIMAB AB

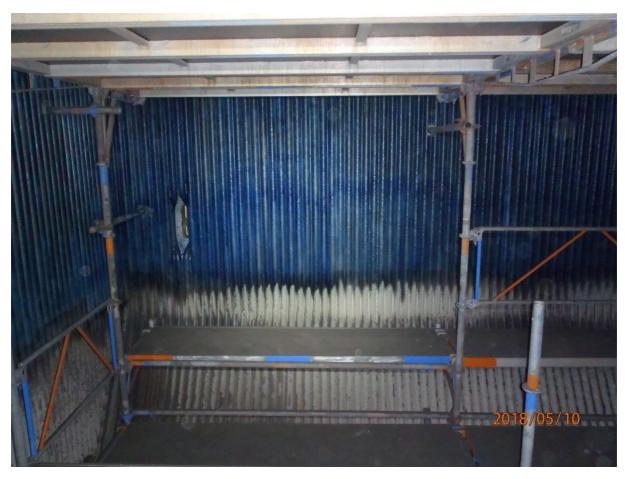
Figure 145. The west wall of the lower part of the furnace after it was cleaned and recoated in 2018.

After cleaning a layer of top-coating was reapplied to the furnace. Figure 145 shows part of the furnace after this procedure. The coating was tinted blue for improved visibility.
