# INCREASED STEAM TEMPERATURE IN GRATE FIRED BOILERS - STEAMBOOST

KME-709

## Increased steam temperature in grate fired boilers - Steamboost

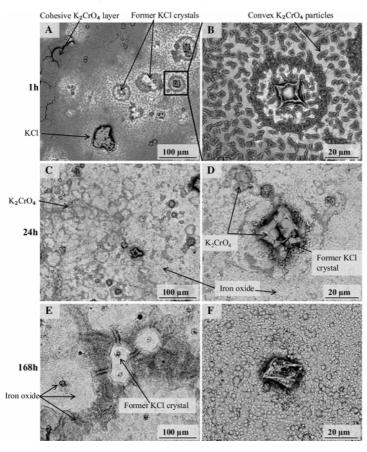
In Figure 16 plan view SEM/BSE images are shown of untreated samples exposed in the presence of KCl after different amount of times. Already after one hour of exposure K<sub>2</sub>CrO<sub>4</sub> particles are found around partly unreacted KCl particles and in some areas K<sub>2</sub>CrO<sub>4</sub> particles formed a layer that tend to crack (might be due to large expansion coefficient of K<sub>2</sub>CrO<sub>4</sub>). Some KCl particles are already at this stage overgrown by iron-rich oxide.

After 24 hours, most of the surface consisted of iron oxide and no KCl crystals were left unreacted. K<sub>2</sub>CrO<sub>4</sub> has grown in size and tend to agglomerate in certain areas, especially at former KCl crystals. Morphological features with similar distribution and shape as that of the K<sub>2</sub>CrO<sub>4</sub> particles after one hour could be seen but now seems to have been decomposed.

After 168 hours the entire surface was overgrown by iron-rich oxide with ridges of iron-rich oxide surrounding the former KCl crystals.

Figure 16: SEM/BSE images of Kanthal APMT exposed in 5%  $O_2$  +40%  $H_2O$  in the presence of KCI (0.1 mg/cm2) for 1h (a,b), 24h (c,d) and 168h (e,f)

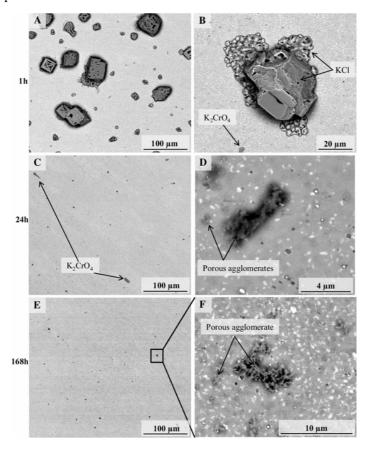
In Figure 17 plan view SEM/BSE images are shown of pre-oxidized samples exposed in the presence of KCl after different amount of times and can be compared to the case with untreated samples. After one-hour surface morphology has barely changed and shows a large difference from the case without pre-oxidation. Just a few K<sub>2</sub>CrO<sub>4</sub> particles can be found and the KCl particles are less reacted than in the case without pre-oxidation.

After 24 hours, no indication KCl crystals on the surface could be detected and no morphological traces were left either (probably KCl was evaporated). The amount of K<sub>2</sub>CrO<sub>4</sub> particles increased compared to after 1 hour (can be seen as dark spots in the image) but was much less than in the case without pre-oxidation.

After 168 hours the surface morphology looks similar to that after 24 hours with the only actual difference being that the  $K_2CrO_4$  particles had been replaced with porous agglomerates of similar size and distribution. This is assumed to be remnants of decomposed  $K_2CrO_4$  particles.

Figure 17: SEM/BSE images of pre-oxidized Kanthal APMT exposed in 5% O<sub>2</sub> +40% H<sub>2</sub>O in the presence of KCl (0.1 mg/cm2) for 1h (a,b), 24h (c,d) and 168h (e,f)

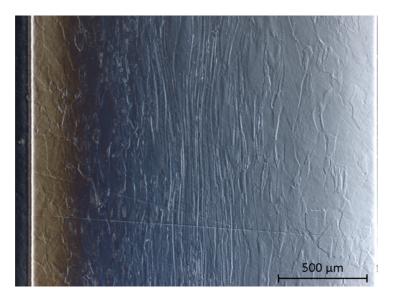
Heat treatments of FeCrAl model alloys were performed in order to minimize the grainsize distribution of the as-received alloys. Figure 18 shows an example of the as received microstructure. Large elongated grains could in addition be observed in the cross sections of the as-received alloys due to insufficient heat treatments, see Figure 19.

Figure 19: Image from optical microscope on the cross section of one of the as received FeCrAl model alloys.

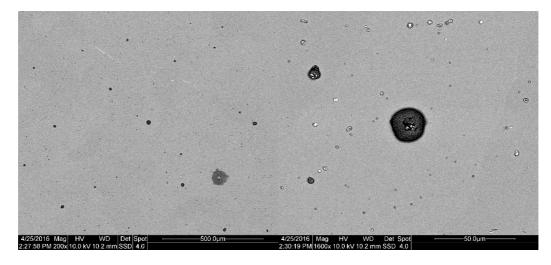
The resulting mass gains were low for all of the different alloys shown in Table 9. The resulting oxide layers on the samples were in the nanometre range, which could be concluded from the surface morphology/colour and mass gain of the samples after exposure. The oxide surface morphology was further studied with SEM, see Figure 22. In the image to the left, the grains of the alloy are visible, indicating that the oxide layer is very thin. As can be observed, small dark spots, corresponding to iron oxide, are scattered evenly on the surface. When looking at the right image (with higher magnification) smaller bright particles can also be observed which corresponds to zirconia particles. When taking a closer look at the larger of the dark iron oxide spots, zirconia particles can be seen in the centre of the spot. Similar features are observed in most of the other iron oxide crusts on the surface.

$\textbf{Figure 22:} \ \text{SEM BSE plan view images of Fe} \\ \textbf{SCrAl2Si sample exposed in 5\% O}_2 + 20\% \ H_2O + N_2 \ \text{at } 600^{\circ}\text{C for 168h}.$

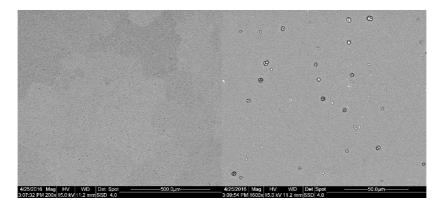
Figure 23 shows SEM/BSE images of two different alloys. The alloy grains of the sample with lowest mass gain can be observed indicating an even thinner oxide layer. Also, no dark iron oxide spots can be seen in either of the magnifications. In the image to the right bright zirconia particles can be observed.

Figure 23: SEM/BSE plan view images of Fe20CrAl2Si sample exposed in 5%  $O_2$  + 20%  $H_2$ O +  $N_2$  at 600°C for 168h

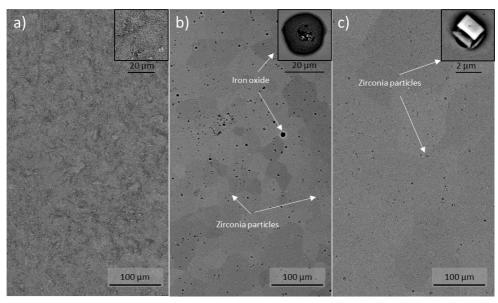
The resulting mass gains differed drastically. FeCrAl**0Si** has formed a very thick oxide while FeCrAl**1Si** and FeCrAl**2Si** have formed thin protective oxides which is shown in Figure 25. The much thicker oxide of FeCrAl**0Si** is indicated by the rough surface morphology (Figure 25(a)).

Figure 25: SEM BSE plan view images of (a) FeCrAlOSi, (b) FeCrAl1Si and (c) FeCrAl2Si exposed in  $5\% O_2 + 20\% H_2O + N_2$  at  $600^{\circ}C$  for 168h.

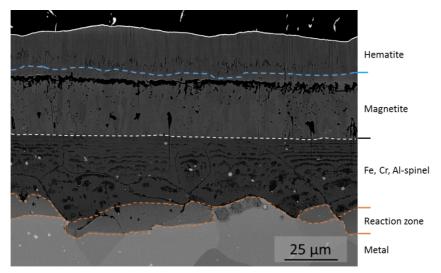
A cross-section image of FeCrAl**0Si** is presented in Figure 26, i.e. the only alloy that had a high mass gain in the reference environment. It shows a thick oxide of about 85  $\mu$ m thickness. It has formed an outward growing oxide consisting of an upper hematite layer, followed by a magnetite layer. Underneath the magnetite it has formed an Fe-, Cr-, Al-spinel followed by a reaction zone. The thickness is in good agreement with the reported mass gain.

Figure 26: SEM-BSE cross section image of FeCrAlOSi after exposure in  $5\%~O_2 + 20\%~H_2O + N_2$  at  $600^{\circ}C$  for 168h

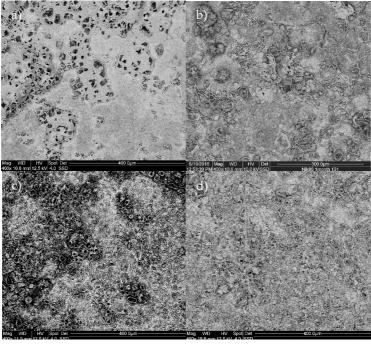
The samples were analysed with SEM/EDX both in plan view and in cross section. Figure 24 shows plan view images of the different model alloys. Figure 27(a) corresponds to Fe5CrAl2Si. A porous upper oxide layer can be seen consisting mainly of iron oxide. Figure 27(b) corresponds to Fe10CrAl2Si. The surface morphology is different and no porous oxide such as in (a) can be observed. When performing an EDX-mapping, indications of K2CrO4 was observed evenly distributed across the surface. Figure 27(c) corresponds to Fe15CrAl2Si. K2CrO4 was distributed in a similar way but more and larger dark regions was observed on Fe10CrAl2Si. Finally, Figure 27(d), corresponding to Fe20CrAl2Si, shows less dark areas but large amounts of K2CrO4 appear distributed over the whole surface.

Figure 27: SEM BSE plan view images. (a) Fe5CrAl2Si, (b) Fe10CrAl2Si, (c) Fe15CrAl2Si and (d) Fe20CrAl2Si after 168 hours exposure in 5% O<sub>2</sub> + 20% H<sub>2</sub>O + N<sub>2</sub> + 1.0 mg/cm<sup>2</sup> with KCl present at 600°C

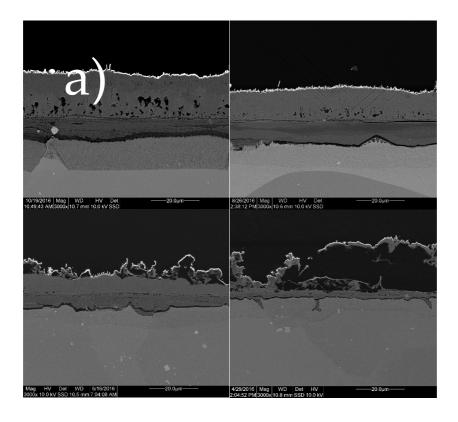
In Figure 28 the decrease in oxide thickness with an increase in Cr in the alloy can be observed. The oxide scales are well adherent to the substrate in all the alloys. The oxide thickness corresponds well with the mass gains ( Table 11), neglecting the crusts of K<sub>2</sub>CrO<sub>4</sub> on top of the base oxide on Fe15CrAl2Si and Fe20CrAl2Si. The oxides on Fe5CrAl2Si to Fe15CrAl2Si consist of an outward growing iron oxide and an inward growing spinel oxide. It is difficult to distinguish the original metal surface on Fe20CrAl2Si and therefore it is unclear if it has both an inward and outward growing oxide. However, chromium-rich oxide grows inward in the alloy on some parts indicating metal grain boundary attack. This phenomenon was also observed for Fe15CrAl2Si but not to the same extent as Fe20CrAl2Si. A nitridation zone beneath the oxide scale was observed on all of the model alloys.

Figure 28: SEM BSE cross section images of a) Fe5CrAl2Si, b) Fe10CrAl2Si, (c) Fe15CrAl2Si and (d) Fe20CrAl2Si after 168 hours exposure in  $5\% O_2 + 20\% H_2O + N_2 + 1.0 \text{ mg/cm}^2 \text{ KCl at } 600^{\circ}\text{C}$ .

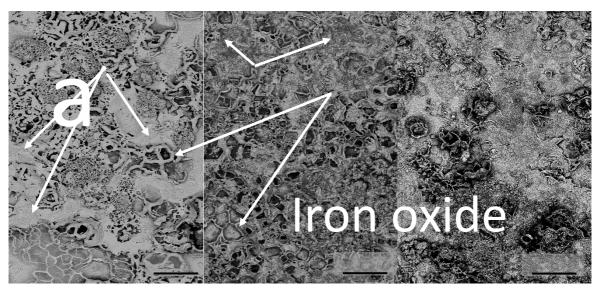
The plan view images in Figure 29 indicate that all three alloys have formed thick oxides, indicated by the rough surface morphology with  $K_2CrO_4$  spread out all over the surface, in good agreement with the mass gains. The thin protective scale formed in the reference environment with oxygen and water vapor has broken down at an earlier stage or not formed at all.

Figure 29: SEM-BSE plan view image of a) FeCrAl0Si, b) FeCrAl1Si and c) FeCrAl2Si after being exposed with KCl present for 168 hours at 600 °C.

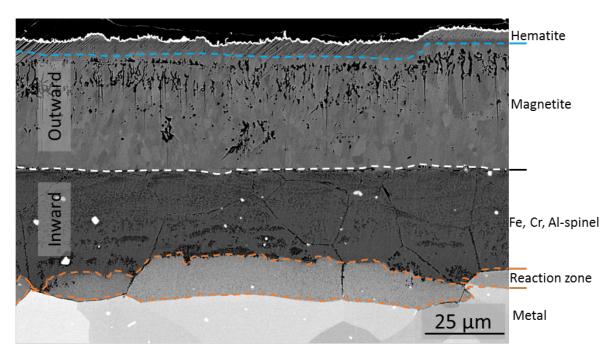
Figure 31 shows the oxide layer formed on FeCrAl0Si. An outward growing oxide consisting of a thin upper hematite layer followed by a much thicker magnetite layer, has grown. Underneath the magnetite layer it was found an inward growing oxide consisting of an Fe-, Cr-, Al-spinel followed by a reaction zone, indicated by the brighter contrast compared to the spinel (darker compared to the bulk).

Figure 31: SEM-BSE cross section image of FeCrAlOSi after exposure with KCl present for 168 hours at 600 °C.

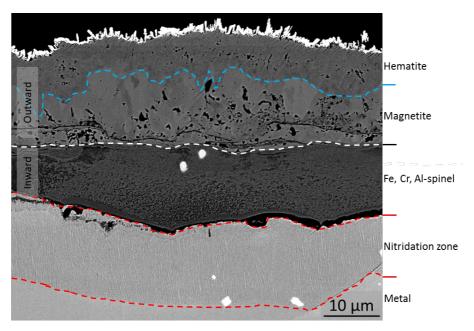
Figure 32 shows the different oxide layers of FeCrAl**1Si** in cross-section. It has formed an outward growing oxide consisting of an upper hematite layer followed by a magnetite layer. It has also formed an inward growing Fe-, Cr-, Al-spinel. Underneath the spinel, instead of a reaction zone, a nitridation zone has formed.

Figure 32: SEM-BSE cross section image of FeCrAl1Si after exposure with KCl present for 168 hours at 600 °C.

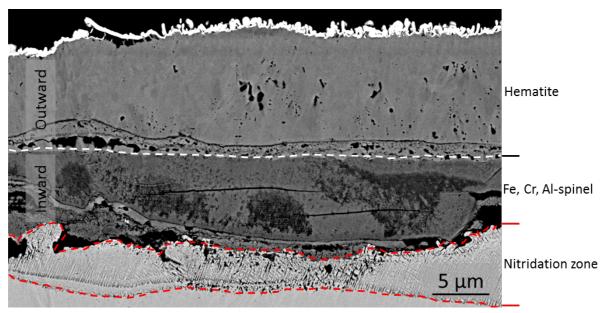
Figure 33 shows the different oxide layers of FeCrAl**2Si** in cross-section. It has formed an outward growing oxide but it only consists of a thicker hematite layer and no magnetite. Underneath the hematite it has formed an Fe-, Cr-, Al-spinel, followed by a nitridation zone.

Figure 33: SEM cross section image of FeCrAl2Si after exposure with KCl present for 168 hours.

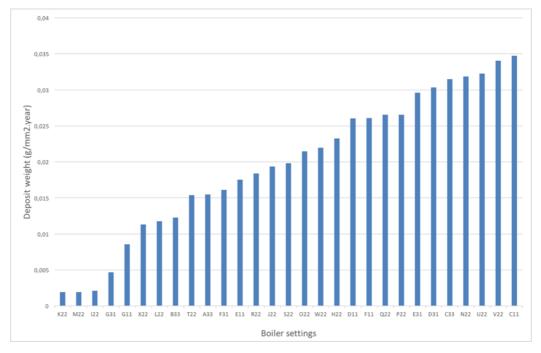
Figure 35. Amount of deposit in grams of the 29 settings tested in the boiler

The deposits generated during the 29 2h exposures with different settings of the boiler were analysed with Ion Chromatography. The amount of deposit, the chlorine content and the S/Cl ratio were calculated for all the settings. Figure 37 shows the different settings ordered by the chlorine content while the Figure 38 represents the settings ordered by the S/Cl ratio. The results were evaluated and the heat transfer was considered in order to decide on one setting for the corrosion test. The setting K22 (marked in red in Figure 37 and Figure 38) was selected for the corrosion test. The chlorine content is mild (around 6,5 % in weight) and the amount deposited is very low with a value of 0,002 g/mm²-year, see Figure 35.

The results show that it is possible to influence all aspects of the deposit formation by changing the settings of the boiler and the composition of the deposit amount ranged from 0,02 g - 0,5 g during the 2 h exposure on each ring (recalculated to g/mm2/year in Figure 35) and the Cl load from 3,5% to 21% during the 2h long exposures. Chlorine, alkali metals and sulphur are all known to influence the corrosiveness of the deposit and the analysis was focused on these species [15]. Specially, the formation of alkali and chlorine-induced corrosion is known to increase the corrosion rate and several mechanisms have been suggested to explain the role of alkali [12] and chlorine, see e.g. [6, 19]. Alkali was observed in all deposits and it has been shown that a very small amount is needed to breakdown the protective Cr rich oxide scale on stainless steels. In line with the presence of alkali in the deposit no protective Cr rich scales were observed after exposures on any of the exposed stainless steels, see below. The chlorine content in the formed deposit varied from 3.5% in the setting with less amount to 20.9% (mass) in the setting with most chlorine, see Figure 37. The selected setting for the corrosion investigation resulted in a deposit with approximately 6,5% Cl. There is a large difference in fuel mixes and boiler designs and it is therefore difficult to compare the Cl load with a deposit formed at the normal superheater position in the same boiler or any other boiler as no data is availble from the normal superheater position in the AffaldPlus boiler. The levels are in the same range as in the KME711/KME714 projects [20, 21]. However, the very high flue gas temperature in combination with the direct heat radiation from the grate makes it difficult to directly compare positions/deposits and more work is needed. One option to

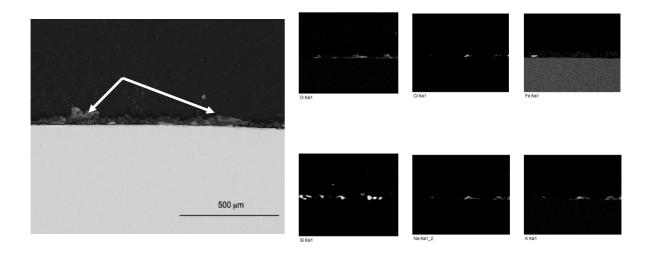
A selected reference sample was cast and cut in order analyse the deposit in cross-section with SEM/EDX. The aim was to check the amount of deposit and its composition and compare this with the IC results. After 2h exposure the amount of deposit was limited in this setting (setting C33 in Figure 35) and according to EDX it is mainly composed of silicon with some calcium and sodium (Figure 36).

Figure 36. Scanning Electron Microscopy backscattered image of a Sanicro 28 material exposed 2h in the Steamboost region

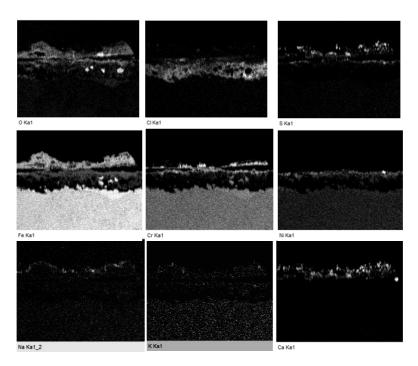
The SEM/EDX investigation of the cross-section shows that only small amounts of deposit are left on the sample, see Figure 45. The remaining deposit consist of K, Ca, Na and S while very little/no chlorine could be found in the deposit. The oxide scale is approximately 250  $\mu m$  and composed of an outward growing Fe rich oxide of about 100  $\mu m$ , and an inward growing FeCr-Ni oxide. In the inner part of the oxide scale chlorine could be detected indicating the presence of metal chlorides, see Figure 46. Indications of alloy grain boundary attack could be observed on some positions.

Figure 46. EDX mapping analysis of the 347H sample after 24h exposure

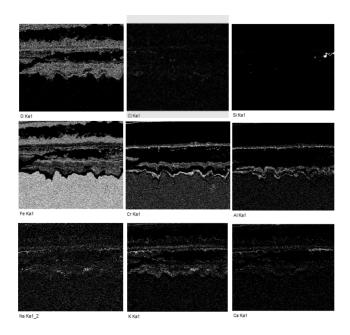
A representative image from the model alloy after 24h exposure is presented in Figure 49. The EDX analysis presented in Figure 50 shows that no or very little deposit was left after the handling of the sample. A chromium and aluminium oxide appears covering the whole surface of the sample and an approximately 100  $\mu$ m layered iron, chromium and aluminium oxide is formed over it.

Figure 50. EDX analysis of the model alloy sample after 24h exposure

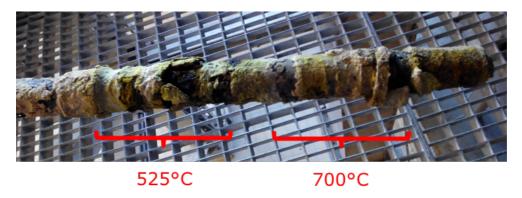
Figure 51. (a) Probe with the samples before exposure (b) Probe with the samples after 1000 h exposure in the Steamboost region

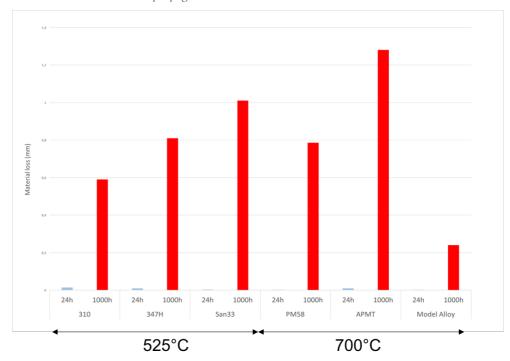
Figure 52 shows the material loss calculated for the materials exposed 1000h in the Steamboost region compared to the 24h exposure. The analyses were carried out as described in 3.2.6.3. The over welded materials were not included in the material loss measurements due to the high error that the shape of the weld seam introduces. It should be pointed out that the temperature control of the 700  $^{\circ}$ C temperature zone was lost for about 100h of the exposure. The corrosion rates are high and in line with the fast-initial corrosion attack observed on the 24 h samples. The two alumina forming alloys represent the highest material loss (Kanthal APMT) and the lowest material loss (Model alloy).

Figure 52. Material loss of the different materials exposed 24h and 1000h in the Steamboost region.

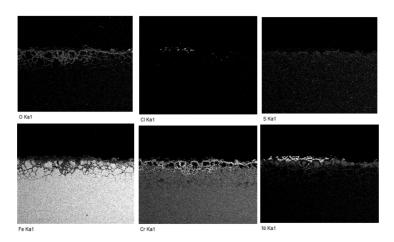
The SEM/EDX results show that very little of the oxide scale remains while a deep grain boundary attack could be observed. The attack penetrates about 300  $\mu$ m deep into the alloy. The EDX maps (Figure 54) shows that the oxide scale is formed mainly by chromium oxide at the grain boundaries and a nickel enriched metal close to the Cr rich oxide. Very little chlorine was detected and, when detected, it was at the outside of the alloy indicating spallation at the oxide/chloride/metal interface.

Figure 54. EDX mapping analysis of the 347H sample after 1000 h exposure

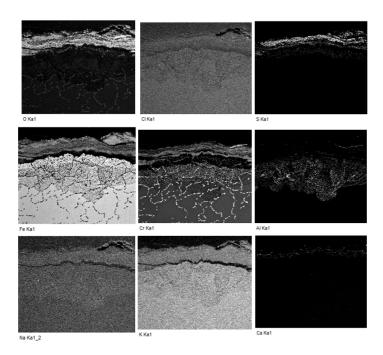
Figure 56. EDX mapping analysis of the Kanthal APMT sample after 1000h exposure

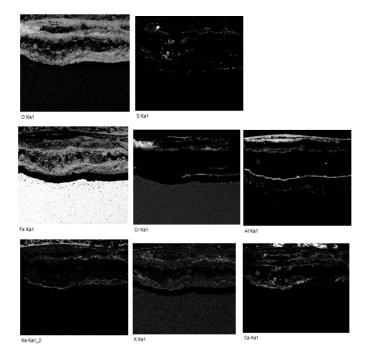
Figure 58. EDX mapping analysis of the model alloy sample after 1000h exposure (non-broken part)

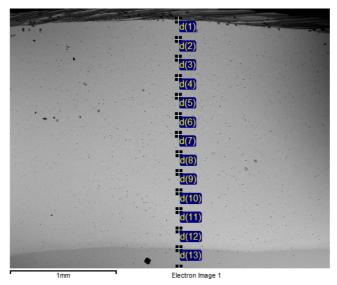
As mentioned earlier a reference ring, consisting of an Inconel 625 over weld was exposed together with the other FeCrAl alloy rings. A non-exposed Inconel 625 ring was analysed with EDX to investigate if Fe from the substrate had diffused into the Inconel over weld during the welding (see figure). The iron content remained constant at 1 at-% throughout the over weld layer.

Figure 65: SEM cross-section image of unexposed Inconel 625 over weld showing the points of EDX-analysis

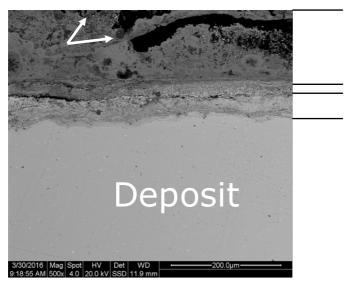
The Sanicro 33 sample presents a chromium oxide layer all over the surface (Figure 74). On the top of this layer, a Fe-Cr rich non-homogeneous outward growing oxide was found. A 50 om nickel rich oxide is present under the chromium oxide.

Figure 74. Backscattered SEM image of the Sanicro 33 sample after 24h exposure

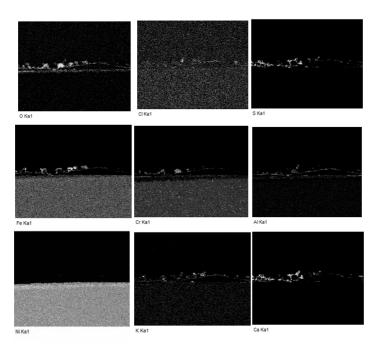
The Nikrothal PM58 presents a smooth surface with very little corrosion after the 24h exposure at 700°C (Figure 76). A very thin chromium-aluminium oxide is found all over the surface and a nickel enrichment is found under. The traces of the deposit over the surface are mainly potassium and calcium (Figure 77).

Figure 77. EDX mapping analysis of the Nikrothal 58 sample after 24h exposure

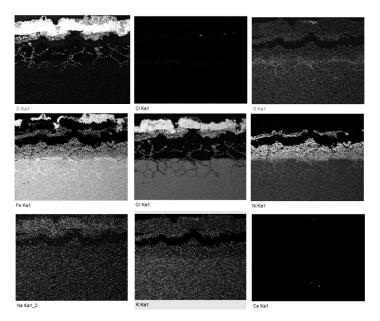
A cross section of the 310 sample after 1000h is presented in Figure 78. The corrosion products layer found is around 500 @m. According to the EDX analysis (Figure 79) it is composed by an outer iron oxide layer followed by a thick chromium oxide of about 50-80 @m. A thick and porous nickel rich oxide was found under that, followed by a deep grain boundary attack with mainly iron oxide in the grain boundaries and nickel enriched oxide when reaching the surface of the sample.

Figure 79. EDX mapping analysis of the 310 sample after 1000h exposure

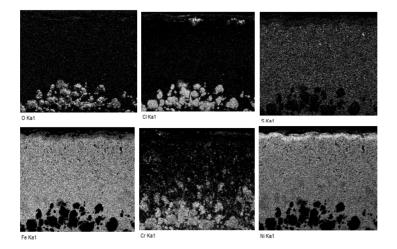
The most remarkable corrosion effect for this material, showed in the EDX analyses of Figure 81 is the effect of the chlorine penetration. Very big rounded-size chromium chlorates were found up to 500 om deep into the material. Some chlorine is still present on the surface of the sample and chromium enrichments were found all the way until the big chromium chlorates. This indicates that the chlorine was able to travel through the grain boundaries deep into the material causing a big corrosion attack.

Figure 81. EDX mapping analysis of the Sanicro 33 sample after 1000h exposure

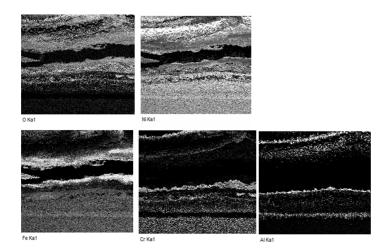
A cross-section of the Nikrotal PM58 sample after 1000h exposure is presented in Figure 82. It presents a very thick layer of corrosion products of around 1mm which has been separated from the surface due to sample preparation. It is possible that the corrosion products are even thicker than those shown in the figure as some parts could have been lost during the handling of the samples after the exposure. The EDX analysis presented in Figure 83 shows that the corrosion products are formed by non-homogeneous layers of different oxides. An aluminium oxide layer is covering the whole surface of the sample, followed by a chromium-nickel oxide. Another alumina layer has grown over that followed by a thicker chromium oxide. Over those oxide layers a thick layer of iron oxide has grown. The rest of the corrosion products over are a mix of nickel, iron and aluminium oxides.

Figure 83. EDX mapping analysis of the Nikrothal PM58 sample after 1000h exposure

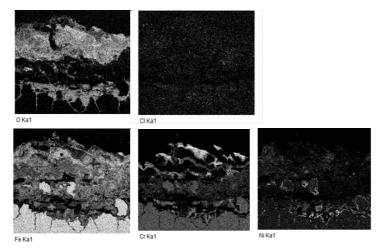
Figure 85. EDX analysis of the 347H sample after 8000 h exposure in Steamboost

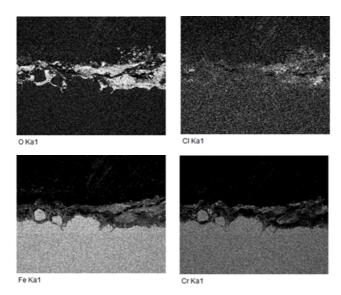
Figure 87. EDX analysis of the 310 sample after 8000 h exposure in Steamboost

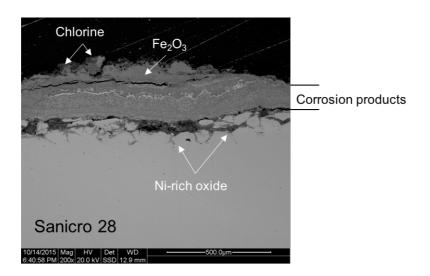
Figure 88. Backscattered SEM image of the Sanicro 28sample after 8000h exposure in Steamboost

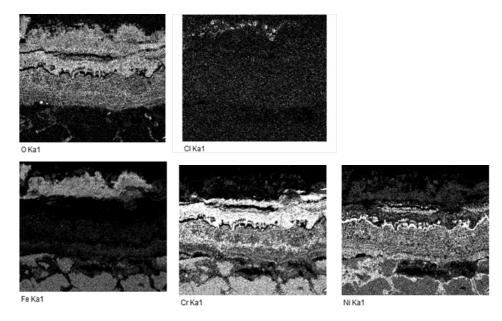
Figure 89. EDX analysis of the Sanicro 28sample after 8000 h exposure in Steamboost

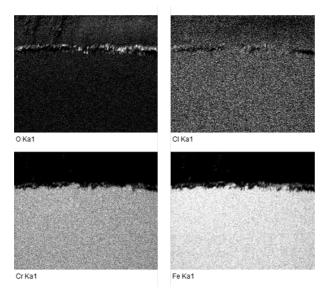
Figure 91. EDX analysis of the Esshete 1250 sample after 8000 h exposure in Steamboost

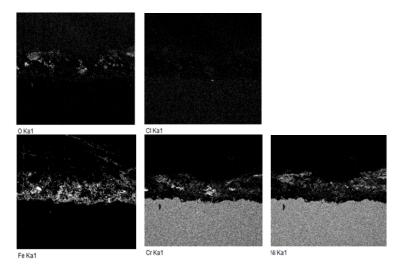
Figure 94. EDX analysis of the Inconel 686 sample after 8000 h exposure in Steamboost

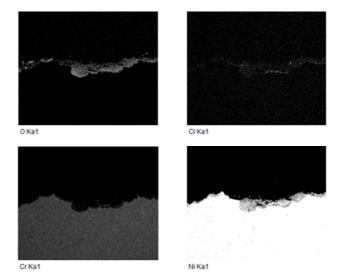
Figure 96. EDX analysis of the Haynes 214 sample after 8000 h exposure in Steamboost

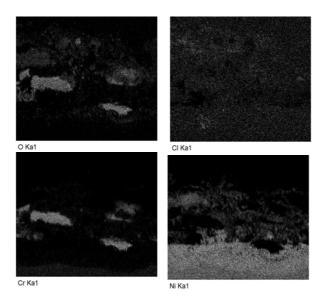
Figure 98. EDX analysis of the Haynes 214 heat treated sample after 8000 h exposure in Steamboost  $\,$
