'Management & Maintenance of a Legacy (but Critical) Data Processing & Control System' A. Milne (System Engineer)

1 Torness Equipment Reliability System Review

## **Description of system**

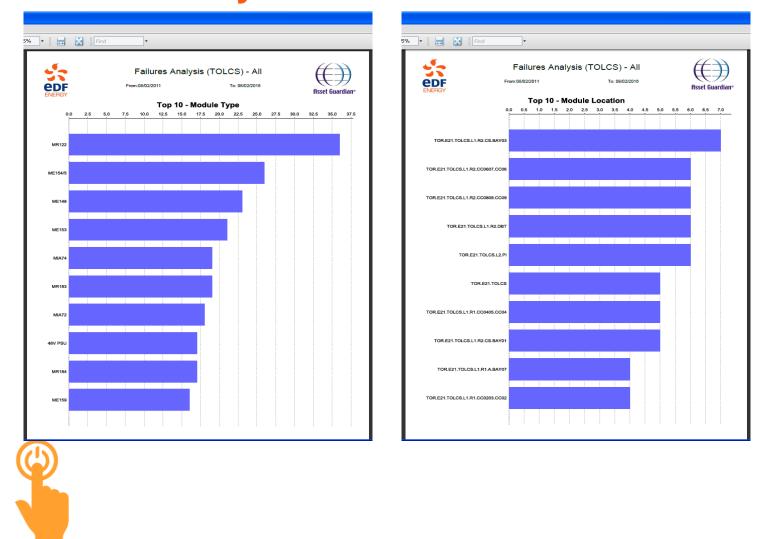
# Underpinning Tools & Techniques (4) Failure Analysis

- Failure rates per module/location trends?
- Which components are failing?
- Supports SAR forecasting
- MTBF/Industry OPEX

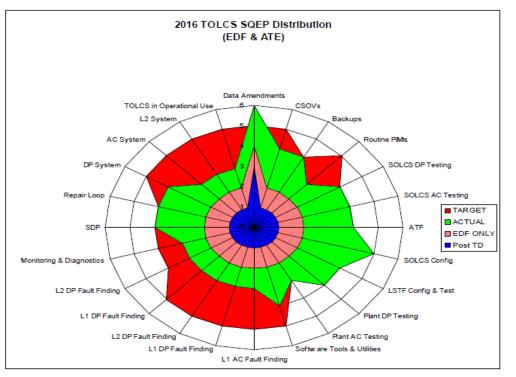
# Underpinning Tools & Techniques (5) SQEP Planning

Axis : The numerical value on the graph represents the number of people for that role.
