# CORROSION OF STEEL IN CONCRETE AT VARIOUS MOISTURE AND CHLORIDE LEVELS

RAPPORT 2015:133

# **Corrosion of steel in concrete at various moisture and chloride levels**

**JOHAN AHLSTRÖM, LUND UNIVERSITY AND SWEREA/KIMAB**

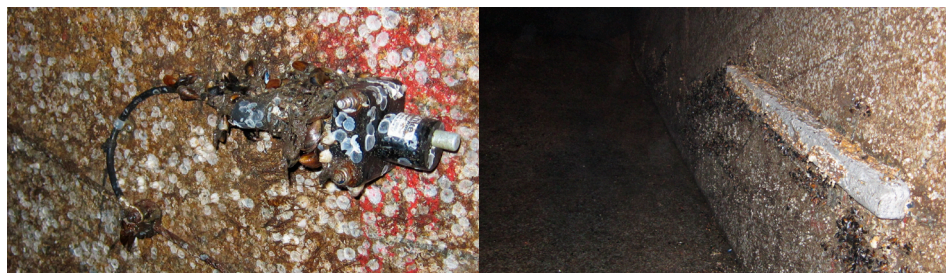
Figure 5: The potential logger mounted on the concrete wall is shown to the left and an sacrificial anode mounted on the concrete wall is shown to the right.

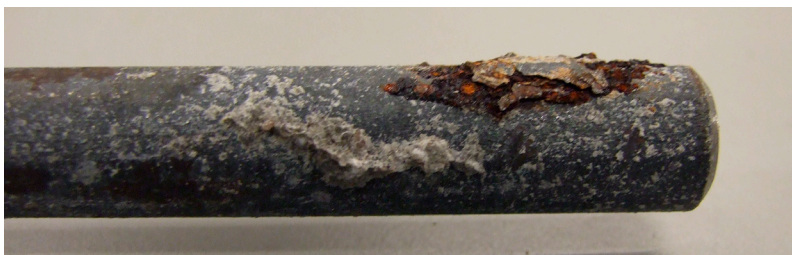
Figure 10: The surface of a steel sample cast in mortar with 1% Cl by mass of cement exposed to 97% RH. The figure shows that a part of the mill scale is detached from the steel surface probably due to formed corrosion products beneath the mill scale.

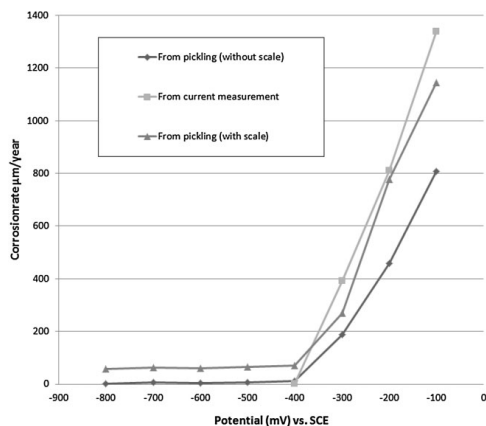
Figure 4. Corrosion rate for samples with 2% chlorides by mass of cement. Corrosion rate is measured by repeated pickling calculated with and without the oxide scale and calculated from the average corrosion current during polarization
